Marseilles Dam Emergency Response Fact Sheet

U.S. ARMY CORPS OF ENGINEERS

This project is located along the Illinois River Waterway in Marseilles, Ill. at the Marseilles Lock and Dam complex between river miles (RM) 247.5 and 246.9.

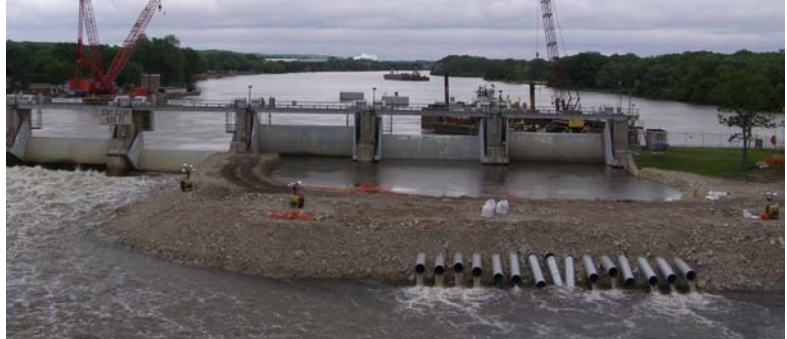
The gated dam control structure (dam) and earthen dike structure (earth dike) were damaged during an April 2013 flood event. Five of eight 60-foot wide tainter gates were impacted by seven barges that had broken loose during high flows. Two Tainter gates (2 and 3) on the dam were rendered inoperable, as their common trunnion anchorage on Pier 2 was broken free from the dam. Gates 4, 5 and 6 were also impacted but did not lose their trunnion anchorage and are currently being used to regulate flow. The barges were removed during the period of April 25 to June 17.
