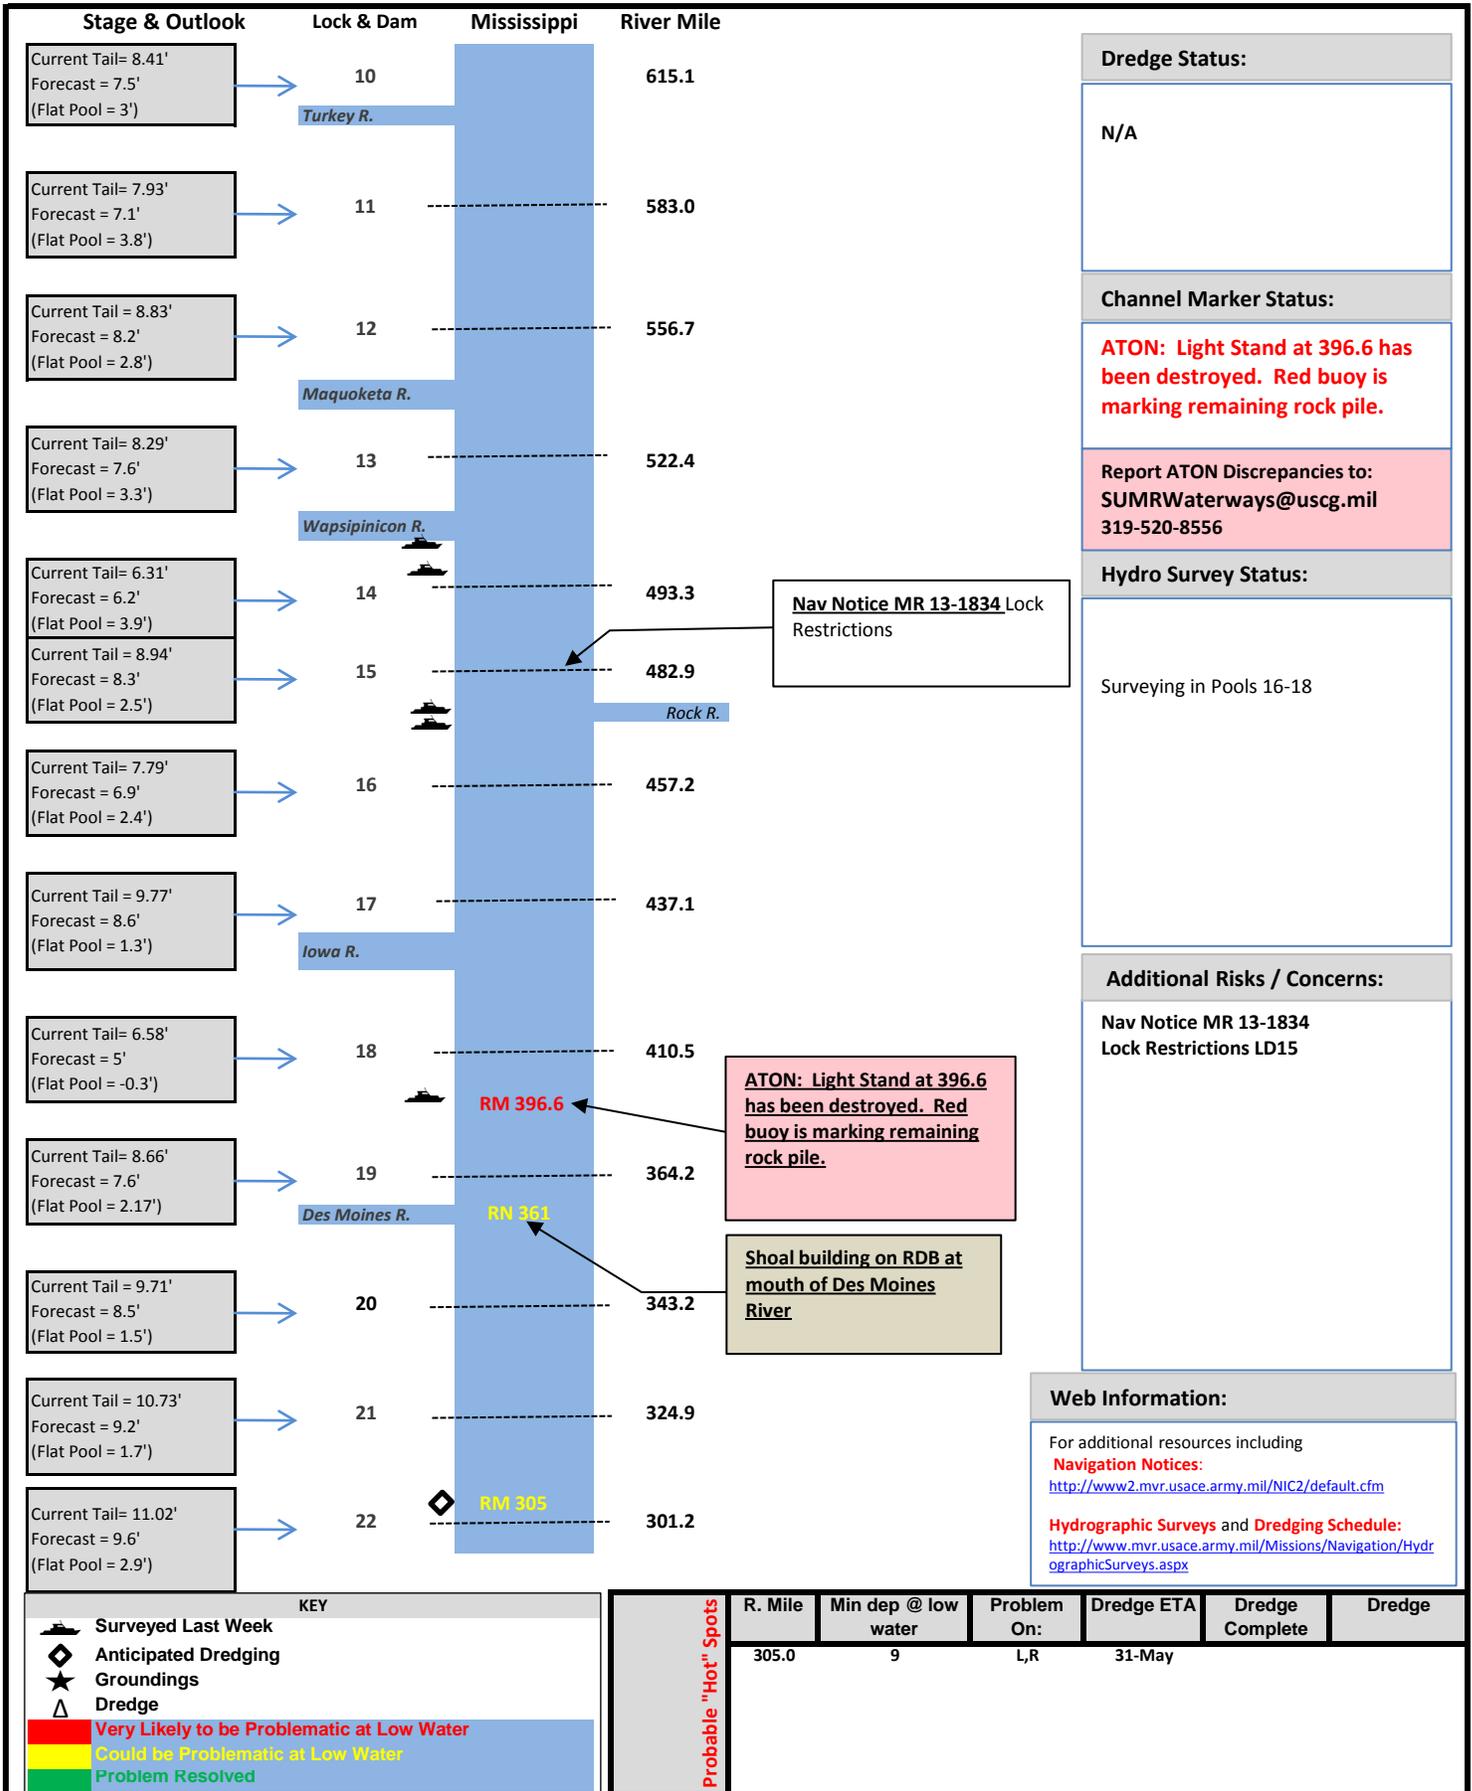
Channel Marker Status:
ATON: Light Stand at 396.6 has been destroyed. Red buoy is marking remaining rock pile.

Hydro Survey Status:
Surveying in Pools 16-18

Additional Risks / Concerns:
Nav Notice MR 13-1834
Lock Restrictions LD15

Probable "Hot" Spots	R. Mile	Min dep @ low water	Problem On:	Dredge ETA	Dredge Complete	Dredge
		305.0	9	L,R	31-May

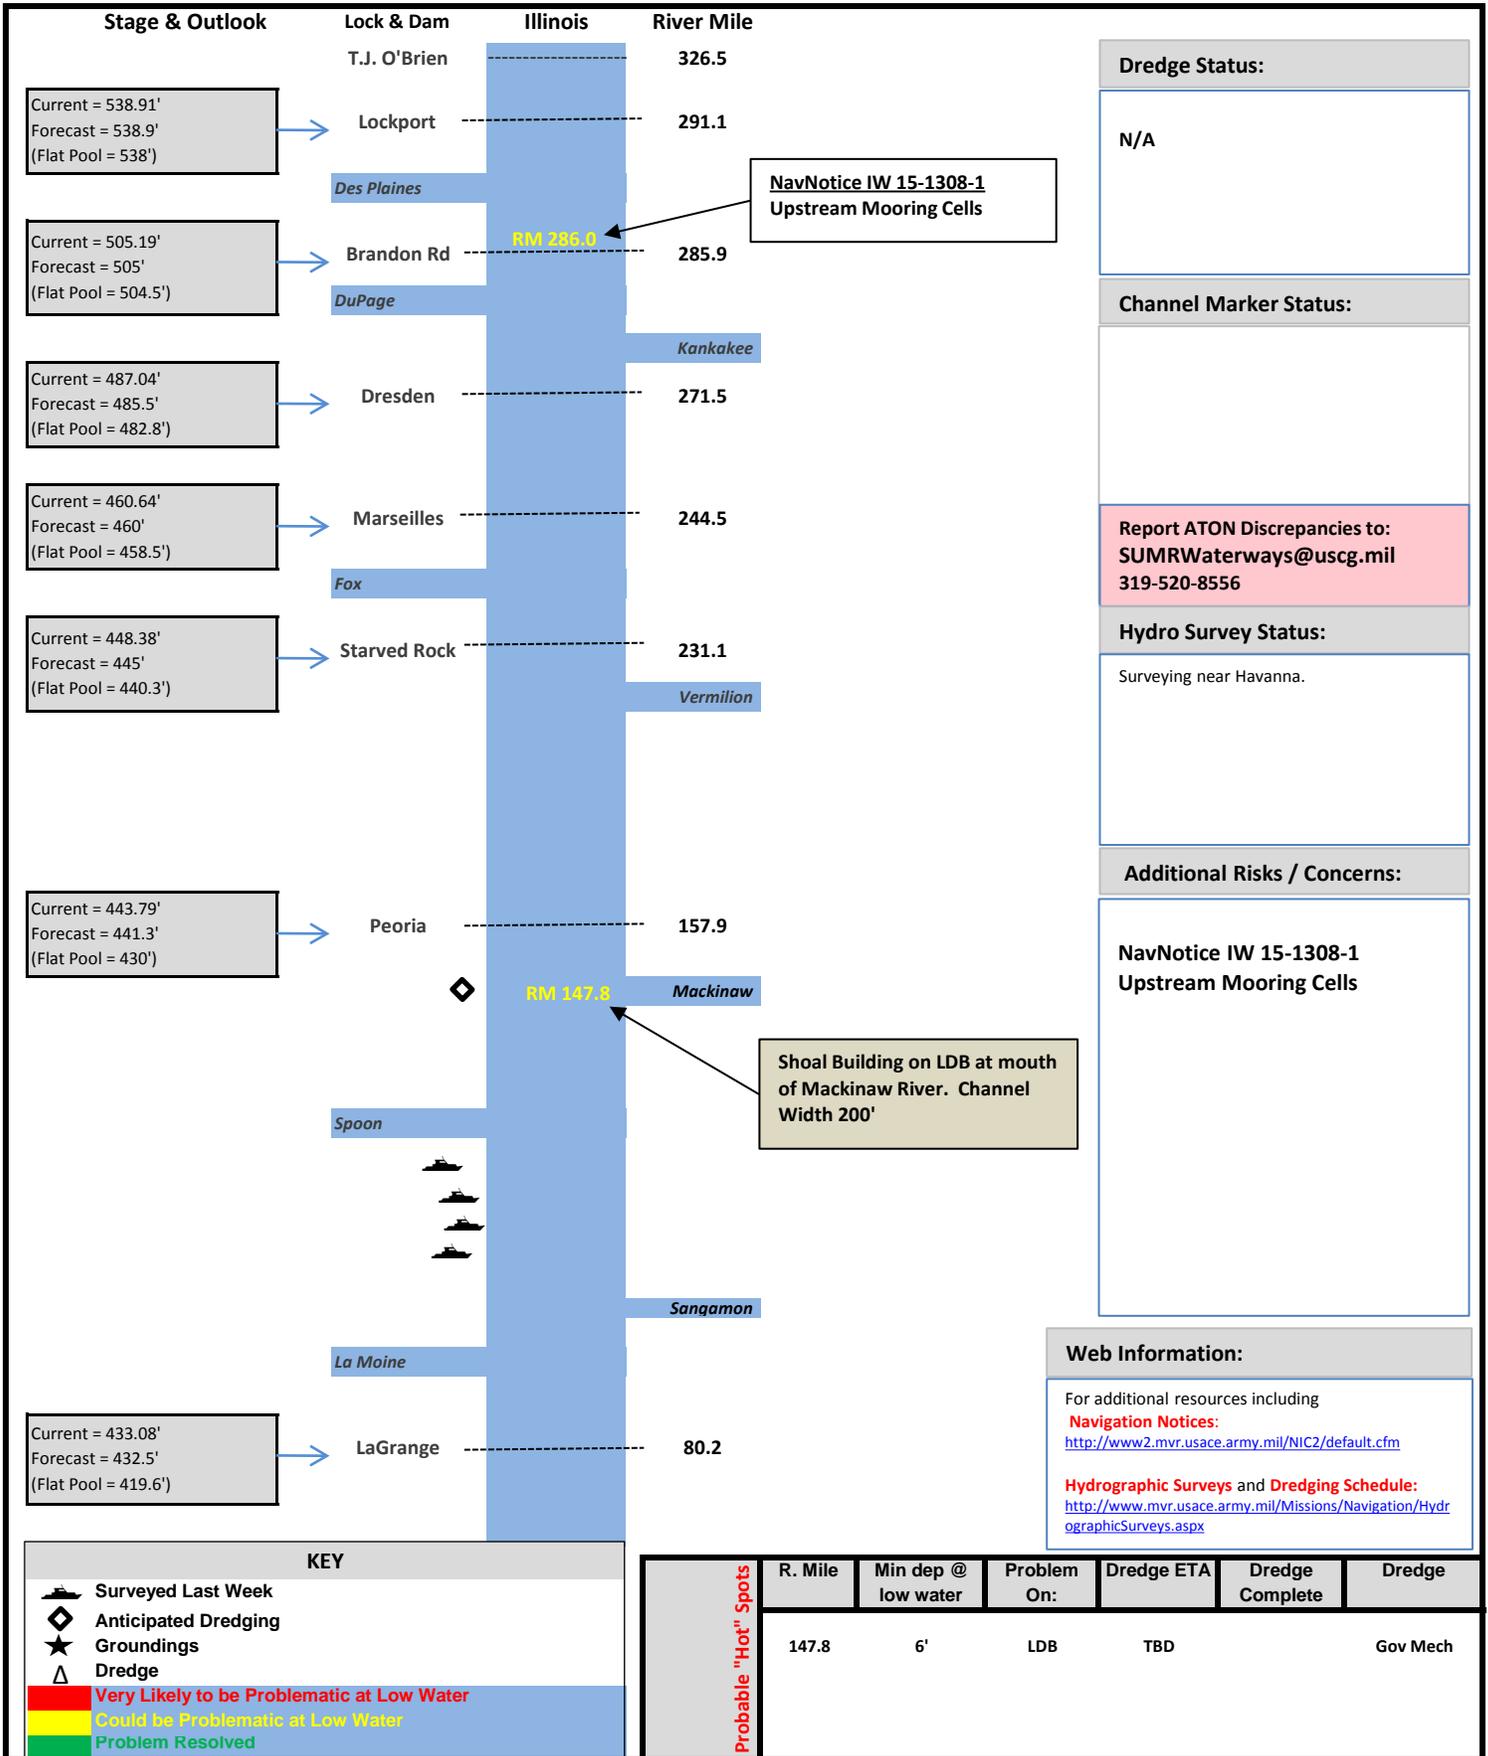
Surveying near Havanna.

NavNotice IW 15-1308-1
 Upstream Mooring Cells

Probable "Hot" Spots	R. Mile	Min dep @ low water	Problem On:	Dredge ETA	Dredge Complete	Dredge
	147.8	6'	LDB	TBD		Gov Mech
