## Chapter 6. The Illinois Waterway

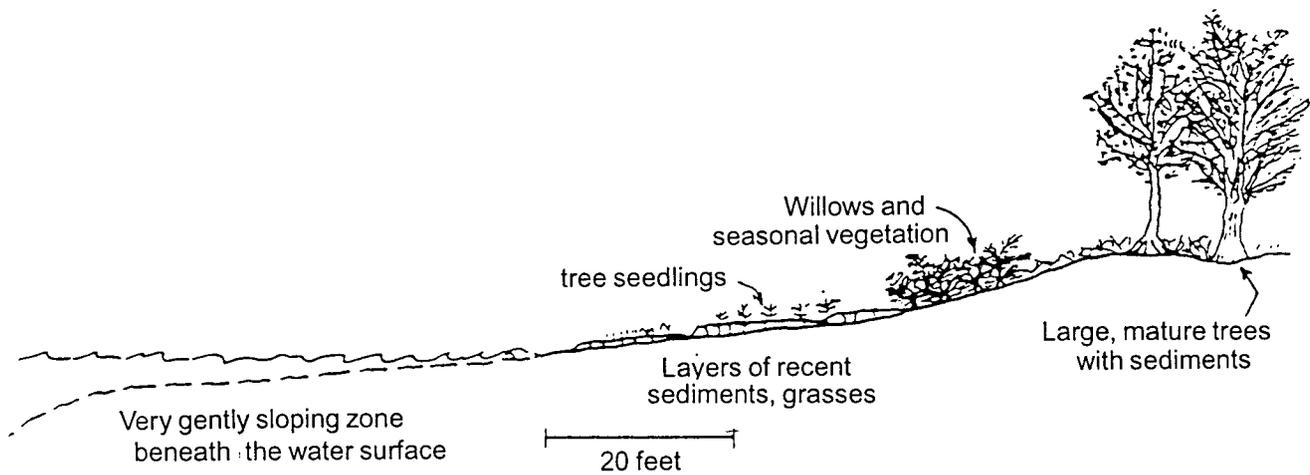
Figure 6-9 shows a sketch of a "Type 5 site: At this category site, the subaqueous bench was very gently sloping and extended far out under the water. Sediments had been deposited within shallow water near bank bench areas. Seasonal grasses and tree seedlings were often encountered on the lower bank at these sites. Somewhat steeper midbank areas often contained slumped alluvium and recently deposited sediments. This intermediate bank zone was 2 to 3 feet high and typically was sloped at 1 vertical on about 6 horizontal. Above the zone of recent sediment accumulation the

variable bank slope increased slightly. Numerous trees and dense brush were found on the upper bank. These type 5 site conditions were indicative of relative bank stability” (page 23).

**Figure 6-9. Type 5 site--relatively stable with significant deposition and relatively dense vegetation cover, after Hagerty (1988)**

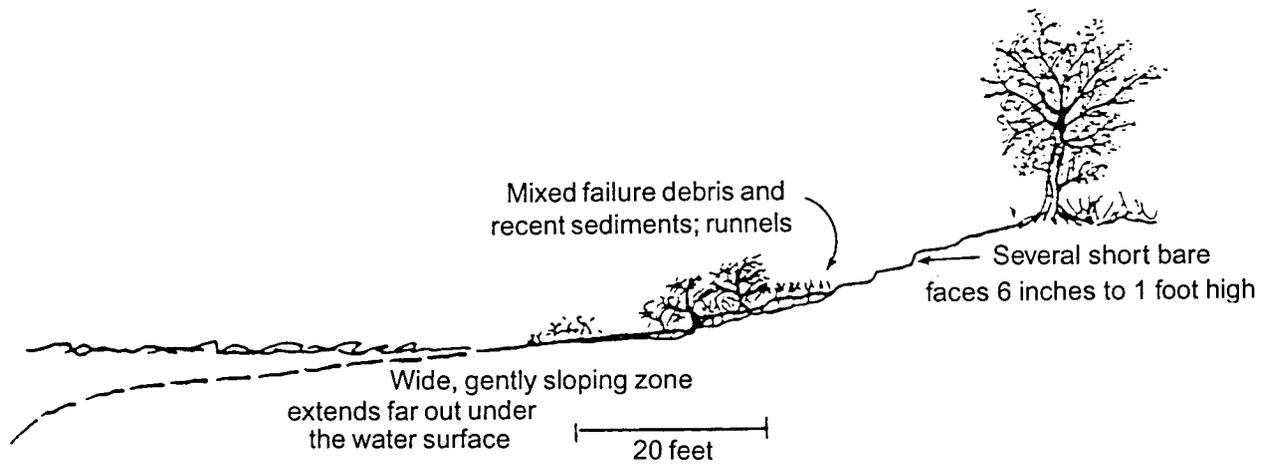
Figure 6-10 shows a “Type 4 site: The subaqueous bench on this type of site was very similar to that at a type 5 site, but did not extend as far channelward. The gently sloping lower bank was also narrower than at a type 5 site. Accumulations of failed soils and recently deposited sediments formed berms within the midbank. The midbank sloped from 1 vertical on 6 horizontal, to 1 vertical on 4 horizontal, and the height varied between 1 and 4 feet. These berms were deeply cut by runnels. Sparse seasonal grasses were growing in this area of the bank. The upper bank contained seasonal vegetation and willow above several nearly vertical faces 0.5 to 1.0 feet high” (pages 23-24).

**Figure 6-10. Type 4 site--site of only slight apparent erosion; deposition and accumulation of failure debris on middle and lower bank, with willows and seasonal vegetation cover, after Hagerty (1988)**

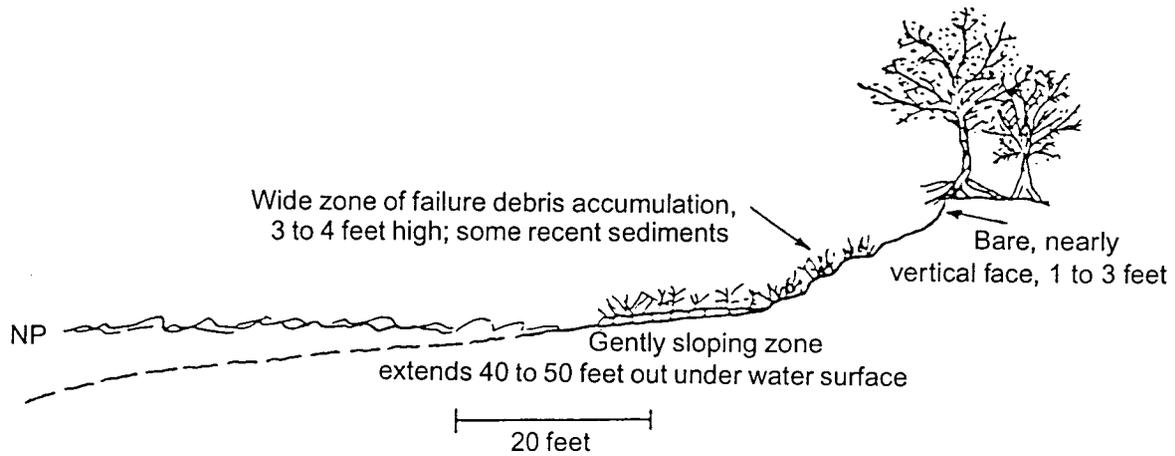
Figure 6-11 shows a “Type 3 site: The type 3 site included a gently sloping lower bank bench and wide berm of recently deposited sediments and failed soils from upper bank collapse. Typically, this area of failed soil accumulations was 3 to 4 feet high on a slope of approximately 1 vertical on 4 horizontal. Above the berm a nearly vertical bare face 1 to 3 feet high was encountered. Pronounced runnels cut through middle bank berms. Tree roots were typically exposed within upper bank faces” (page 24).

**Figure 6-11. Type 3 site--site of moderate to slight erosion, with some sedimentation and moderate vegetation cover, after Hagerty (1988)**

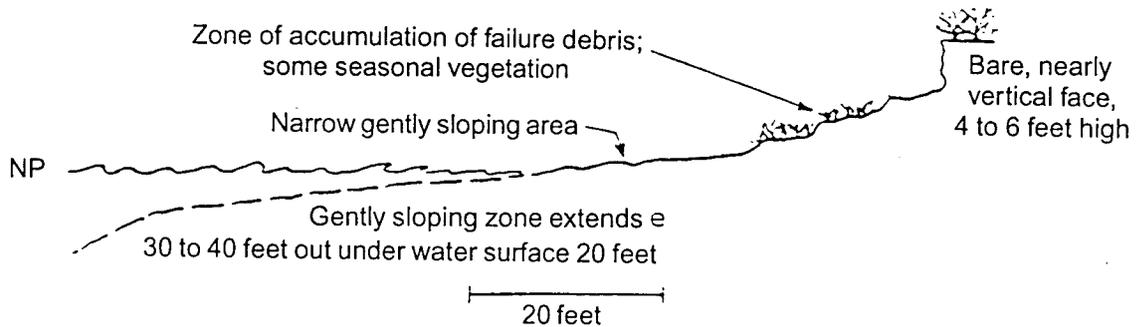
Figure 6-12 shows a “Type 2 site: At this site, the subaqueous bench dropped off steeply. The lower bank subaerial bench was narrow. Recently deposited sediments and failed soil accumulations formed berms 1 to 3 feet high in the middle portion of the bank. These berms contained deep runnels and seasonal vegetation. Nearly vertical faces 4 to 6 feet high were encountered within upper bank areas” (page 24).

**Figure 6-12. Type 2 site--apparently active site of moderate erosion very sparse cover of vegetation, after Hagerty (1988)**

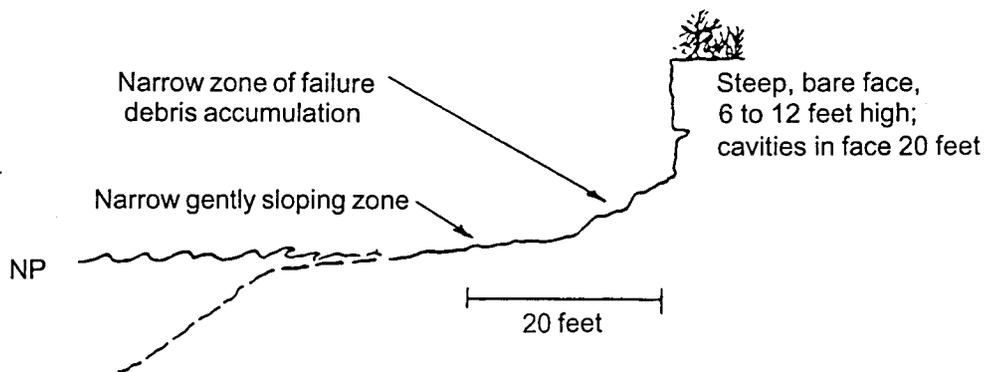
Figure 6-13 shows a “Type 1 site: At this site, the gently sloping subaqueous bench was narrow or absent. The subaqueous bench dropped steeply away from the gently sloping lower bank. Midbank benches and berms were narrow. Above these berms, the bank was nearly vertical with bare faces 6 to 9 feet high or higher. Cavities were encountered within and at the base of these upper bank faces. Vegetation on these sites was sparse, except for floodplain areas adjacent to the top of bank” (page 24).

**Figure 6-13. Type 1 site--apparently active site of most severe erosion little or no vegetation cover, after Hagerty (1988)**
