Figure 6-35. Bank sections at site UP1 (concluded)

Site UP2, Marseilles Pool, 9/18/95. This site is located on the Left Descending Bank (LDB) at RM 270.8, opposite site UP1. Figure 6-33 shows the position of the site on a GIS-based map of the Illinois navigation chart, and figure 6-36 shows one photograph of the site.

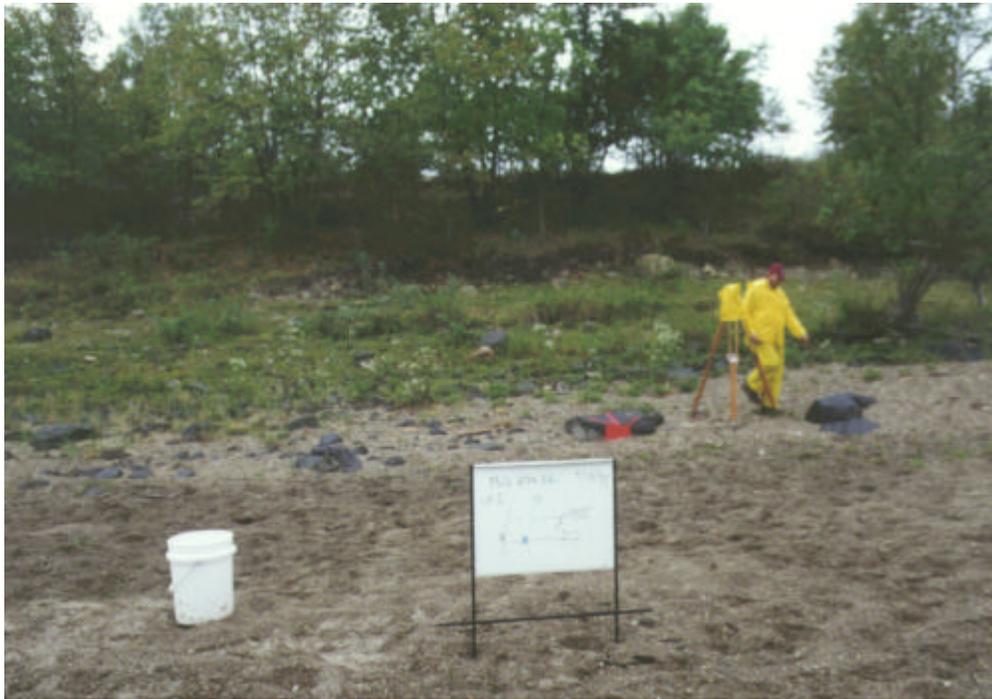
Figure 6-36. Site UP2 on the Illinois Waterway

The site is about 280 feet from the sailing line and no major tributary enters the IWW at this location. In Bhowmik and Schicht's (1980) note, this side was marked as a dredge material displacement site. Trees and grass covered an obvious scarp approximately 3 feet in height 100

feet from the water's edge. The bench was composed of coarse sand, gravel, and boulders. More boulders were encountered between the scarp face and the bench.

The bench slope was 1V:11.H, and the bench was covered with noncohesive sandy soil. This site can be classified as type 5 (see figure 6-22 and table 6-4). The scarp was above OHW stage. Erosion could have occurred during flood stages. The base of the scarp showed sand deposits indicating that seepage at the base could weaken the bank. Waves and currents could remove/transport failed soils that mantle the bench.

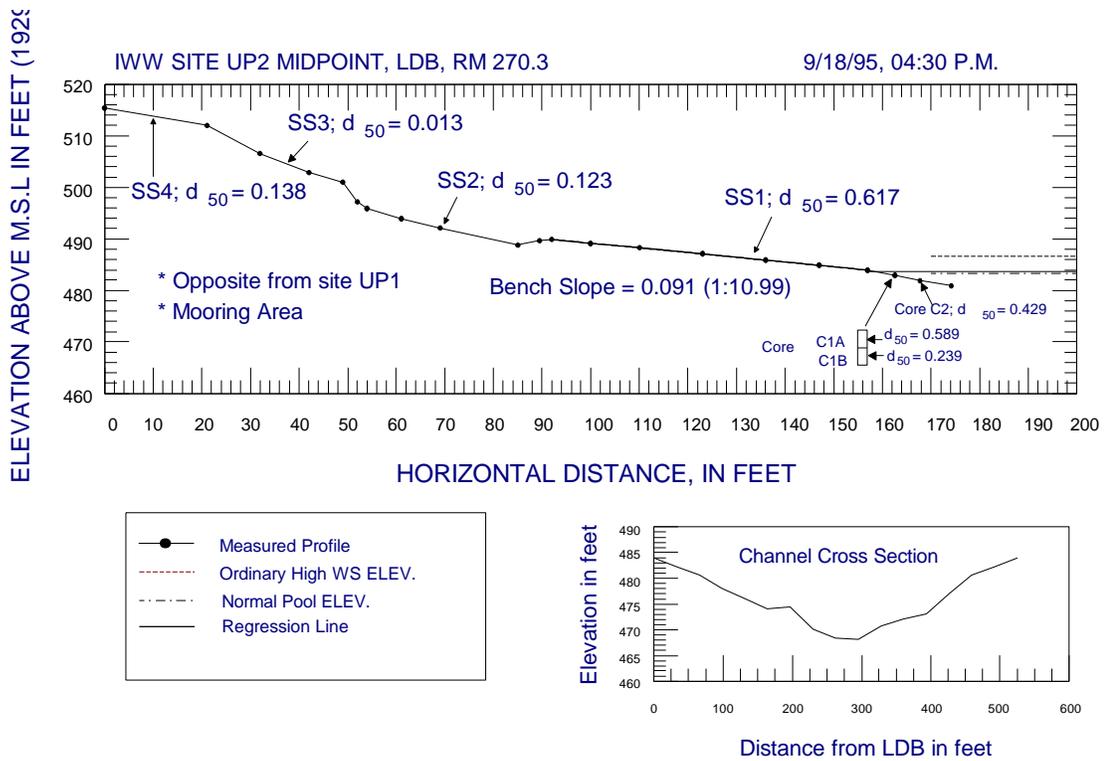
Figure 6-37. Bank section at site UP2, midsection

Figure 6-37 shows the plot of the bank sections and a cross section. Only one river cross section and one bank section were measured at this site. The OHW is the same as site UP1 at 486.6 feet above msl, and NP at 483.3 feet above msl. On this side of the river, the OHW is on the bench area and only stages exceeding 10% occurrence level (table 6-7) can reach to the base of the minor scarp face at about 494 feet above msl.

The d_{50} varied from 0.138 mm at the top surface of the bank to 0.429 mm for a core sample at a depth of about 2 feet of water. Another core sample at 1 foot of water showed coarse sand ($d_{50} = 0.589$ mm) on top and fine sand ($d_{50} = 0.239$) at the bottom. Gradation plots of bank soils and nearshore sediment are presented in appendix F. The detailed cross section and coordinates are shown in appendix G.

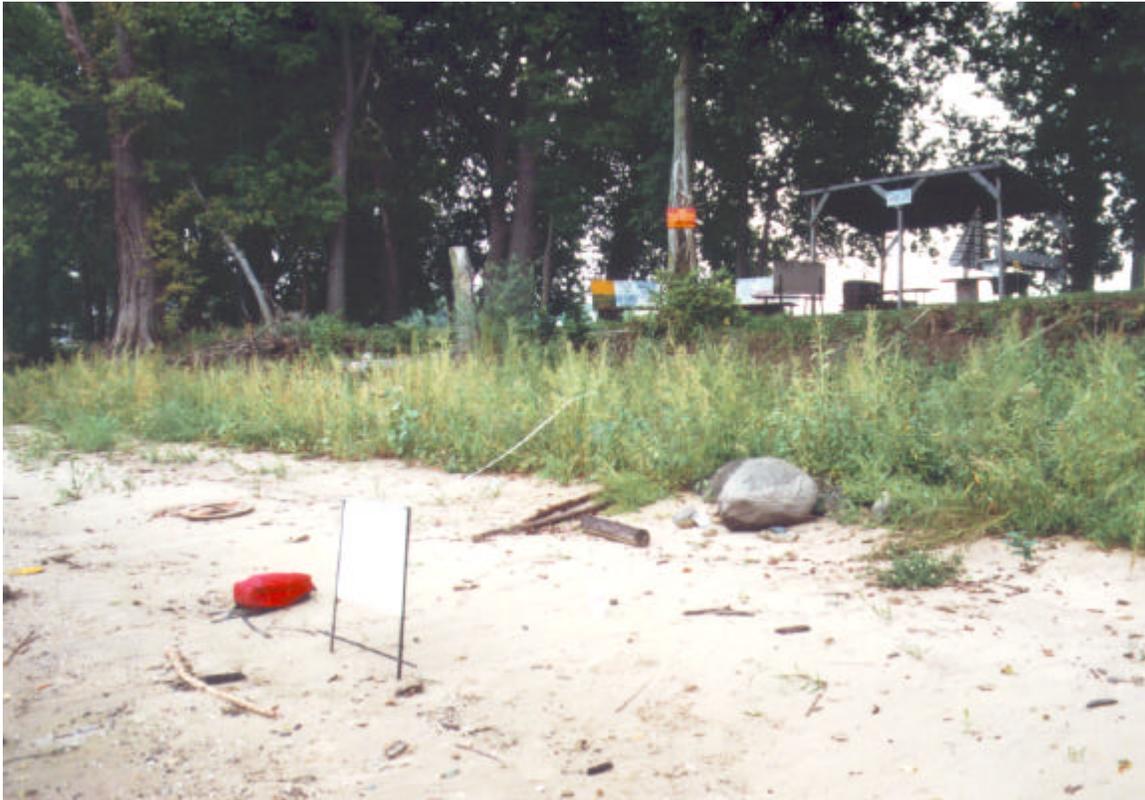
Figure 6-39. Site UP3 on the Illinois Waterway

The site is about 250 feet from the sailing line as measured from the navigation chart. Both Bhowmik and Schicht (1980) and Hagerty (1988) indicated the existence of a significantly long stretch of bank erosion on the LDB. The site is currently used as a trailer park located at the top of the bank, and boat docks were installed. An abandoned boat ramp was found at the upstream end of the site. Quite a few boulders were found in the nearshore area. When taking core samples, the crew noted that sediments showed a very high level of oil staining, and oil emerged when the crew split samples.

An obvious scarp approximately 5 to 10 feet high was present at this site. Erosion of the bench area, if not retreat of the bank line, could be described as significant when compared with a 1988 photo. Figure 6-40 shows the three measured bank sections and a reduced cross section. At the downstream section, a concave bank face was observed. The OHW is at 485.7 feet and NP is at 483.3 feet above msl. The NP elevation corresponds to a break in the subaqueous bench slope. The OHW reaches to the upper part of the bench and corresponded well with the lower end of the weed zone. The bank top is relatively high and only high stages exceeding the 10% occurrence frequency (at 488 feet, see table 6-8) can reach the berm or the scarp.

Bench slopes varied only slightly from 1V:21.7H, and the bench was covered with noncohesive sandy materials. This site can be classified as type 3 (see figure 6-20 and table 6-4). Erosional undercutting, rework and transport by waves and currents at high stages or during floods could be major causes of erosion at this site. After the flood receded, the bank soil may slip and fall as blocks, as shown in the downstream section. Land use as a trailer park can be a factor at this site too. Seepage at the recession stage of a flood could also play a significant role in bank failure. Waves and disturbances created by local boating activities can cause entrainment of recently deposited sediments from bench areas.

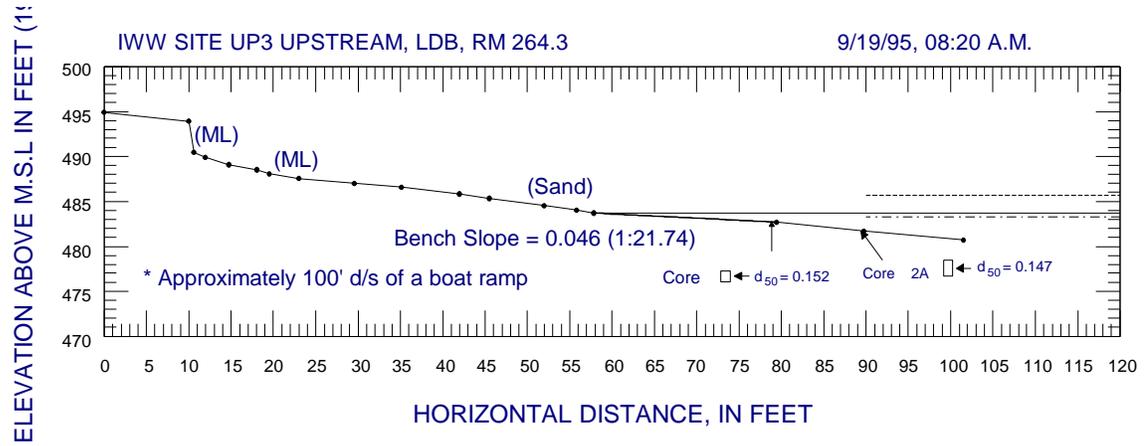
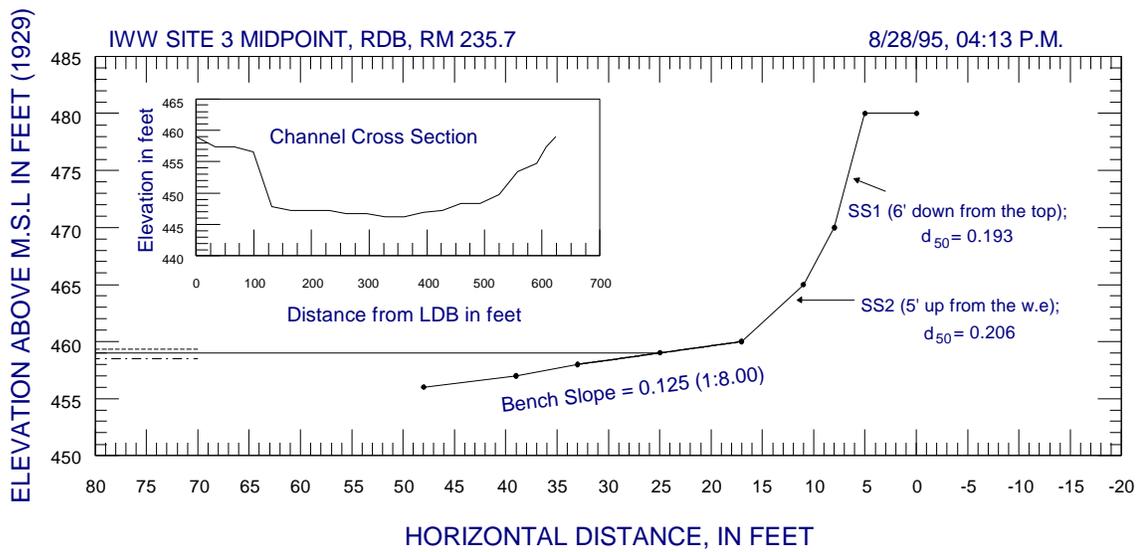
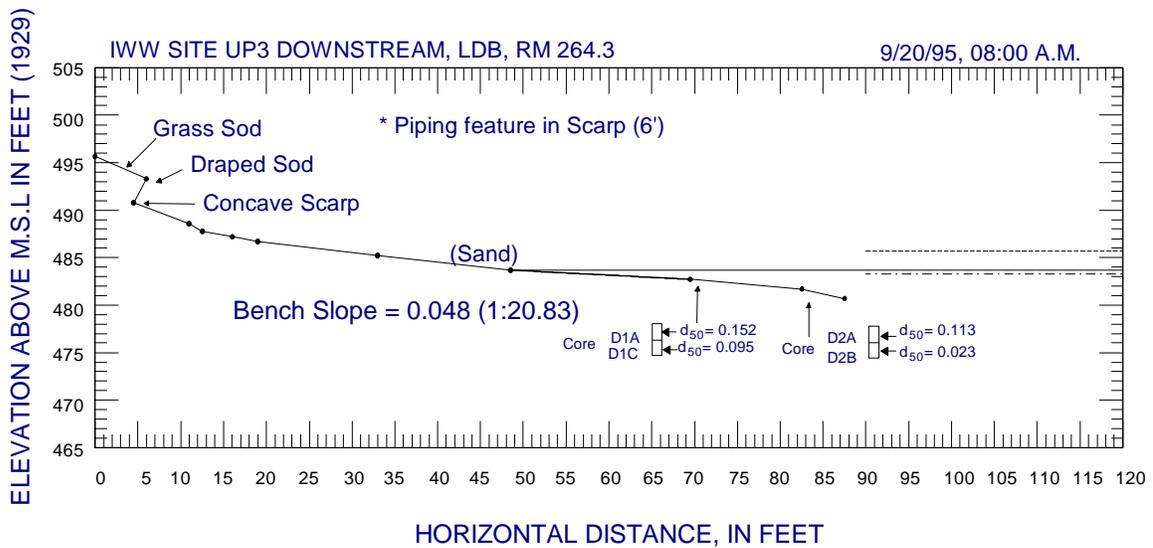
Figure 6-40. Bank sections at site UP3

At the midsection, the d_{50} varies from 0.023 mm at the top surface of the bank to 0.419 mm for a core sample at a depth of about 2 feet of water. Gradation plots of bank soils and nearshore sediment cores are presented in appendix F. The detailed cross section and coordinates are shown in appendix G.

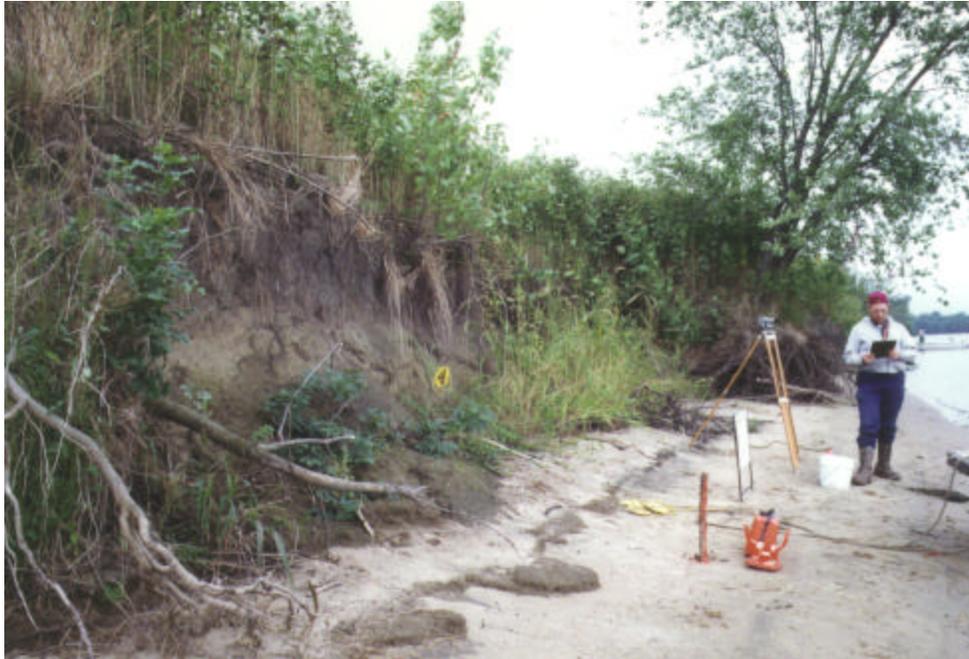
Figure 6-42. Site UP4 on the Illinois Waterway

Site UP4 is in a fleeting area where the distance to a red buoy marking the navigation channel was less than 50 feet from shore. Land use on top of the bank was agriculture (corn), and tall weeds were encountered on the bank crest. A scarp 5 to 10 feet high had its top portion covered with exposed roots and its lower portion had piping holes. The lower bank was a narrow sand bench. Failed riprap existed downstream of the site at an entrance channel to a gravel pit. Local tow traffic at this reach can be very frequent. Figure 6-43 shows the three measured bank sections and a reduced cross section. A slumped bank face was observed at the downstream section. The OHW is at 485.5 feet and NP is at 483.3 feet above msl. Except at the downstream section, the base of the scarp is slightly higher than the OHW level. At higher stages (10% occurrence frequency, 488 feet, see table 6-9) wave and current can have a direct contact on the scarp.

Bench slopes varied from 1V:12.5H to 1V:7.5H, and the subaqueous bench becomes steeper. Piping holes at the scarp and moist soils on the lower portion of the bank were noted. This site can be classified as a combination of types 2 and 3 (see figures 6-19, 6-20, and table 6-4). The bank soils appeared to be cohesive, but the bench was sandy with several clay outcrops. Seepage could weaken the base support and cause the bank to slip, as shown at the downstream section. Failed soils and/or recently deposited sediment on the bench are reworked and transported by wind or tow-generated waves. The steep dropoff in subaqueous benches is indicative of effects of direct vessel contact or traffic-induced velocities.

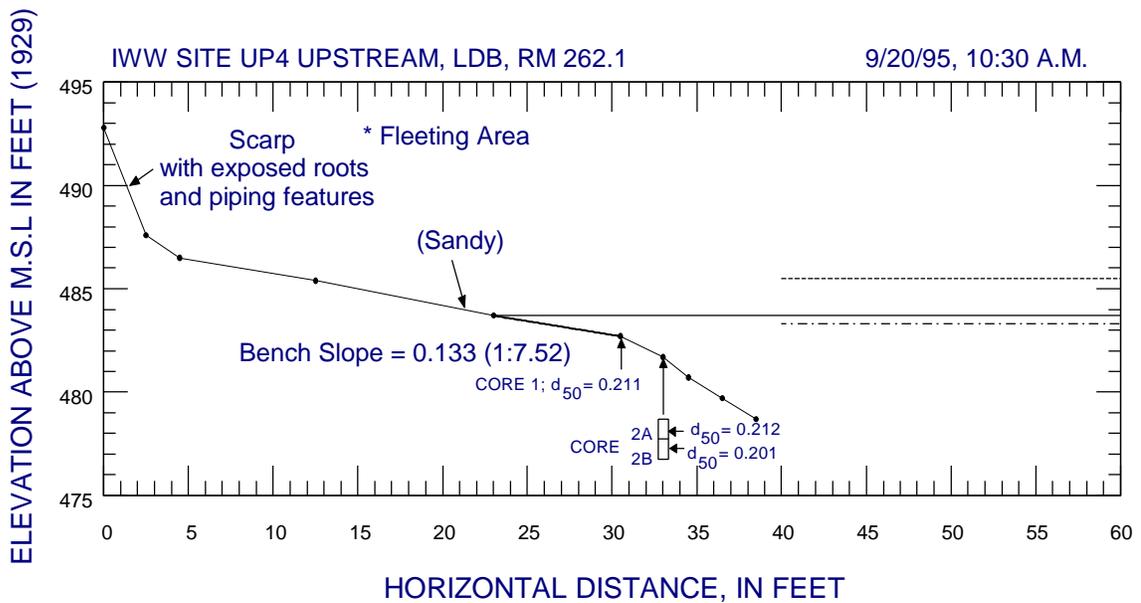
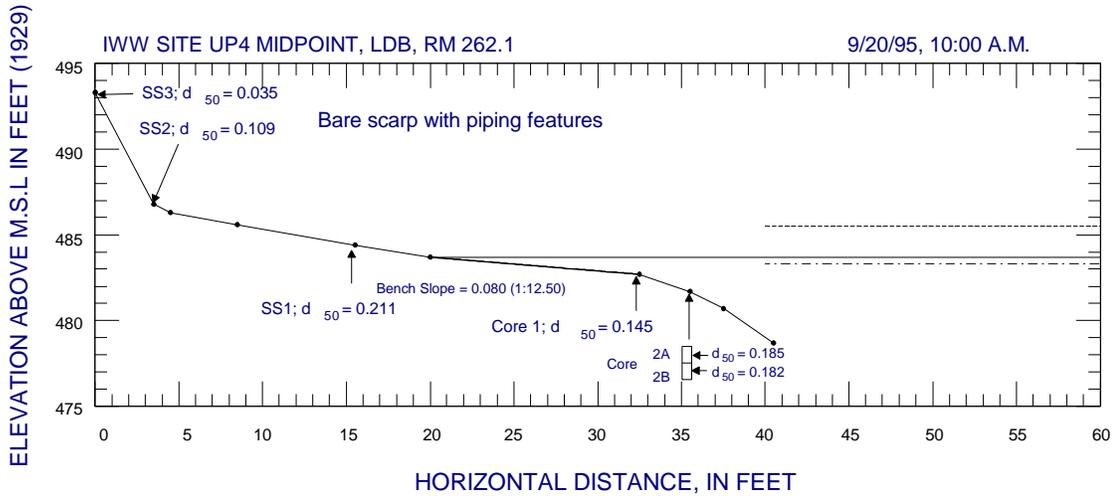
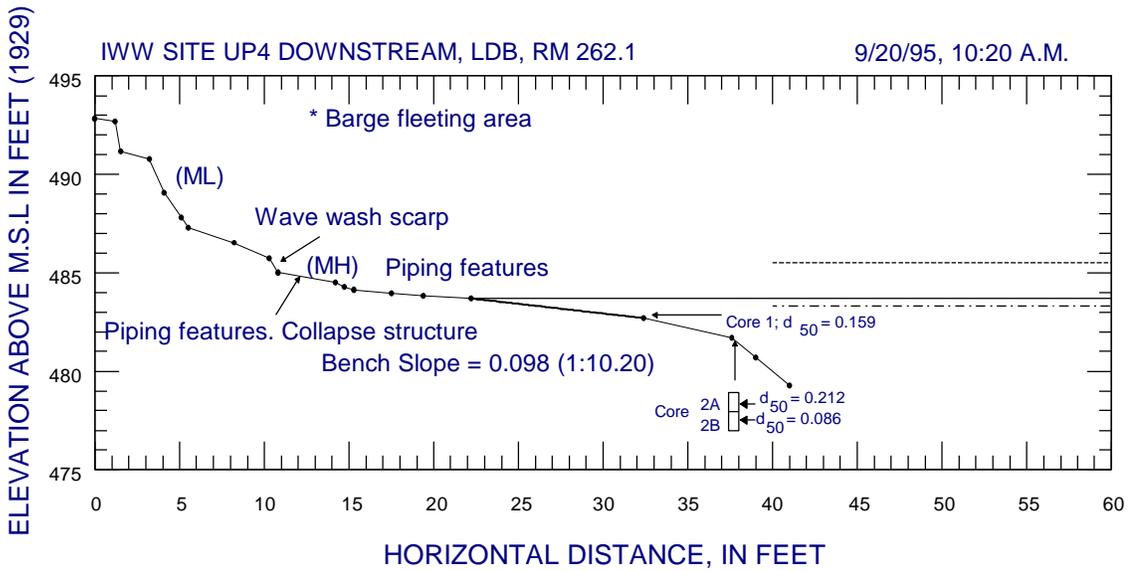
Figure 6-43. Bank sections at site UP4

At the midsection, the d₅₀ varied from 0.035 mm at the top of the bank to 0.185 mm for the top portion of a core sample at a water depth of about 2 feet. The bank scarp consisted of

cohesive materials and the sediments are of fine sand fairly consistently at three sections. Gradation plots of bank soils and nearshore sediment are presented in appendix F. The detailed cross section and coordinates are shown in appendix G.

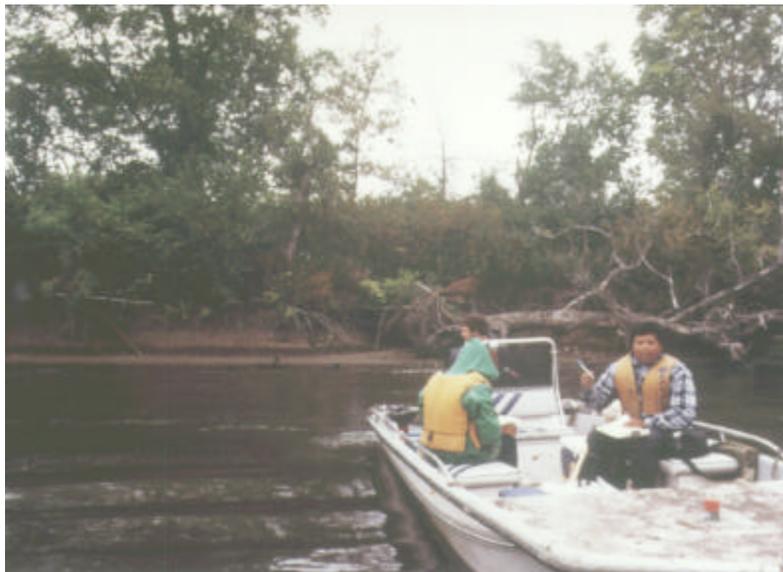
Figure 6-44. Site UP5 on the Illinois Waterway

The site is about 300 feet from the sailing line and there is no major tributary at this location. The bank section has a scarp with exposed roots and piping holes. However, the bench was wet and did not have heavy sand deposition as on the opposite bank. A subaqueous scarp was found at the water's edge. Figure 6-45 shows one measured bank section and a reduced cross section. The OHW is at 485.5 feet and NP is at 483.3 feet above msl. The subaqueous bench extends at least about 100 feet from the water's edge. A 10-year stage data analysis (table 6-10) shows that stages higher than 25% recurrence frequency (the OHW) would submerge the base of the scarp; those higher than 10% recurrence frequency (above 490 feet) will overtop the bank.

The bench slope was 1V:26H. Some algae were observed on the subaerial bench. This site is classified as a combination of types 4 and 5 (see figures 6-21 and 6-22 and table 6-4). Banks are susceptible to erosion by tractive forces from flows at OHW or during floods. Piping, seepage, and weathering could loosen the bank soils which are then subject to removal by currents and waves. At this site, traffic-induced currents and waves can erode failed soils and recently deposited sediments within bench areas during periods of normal pool stages.

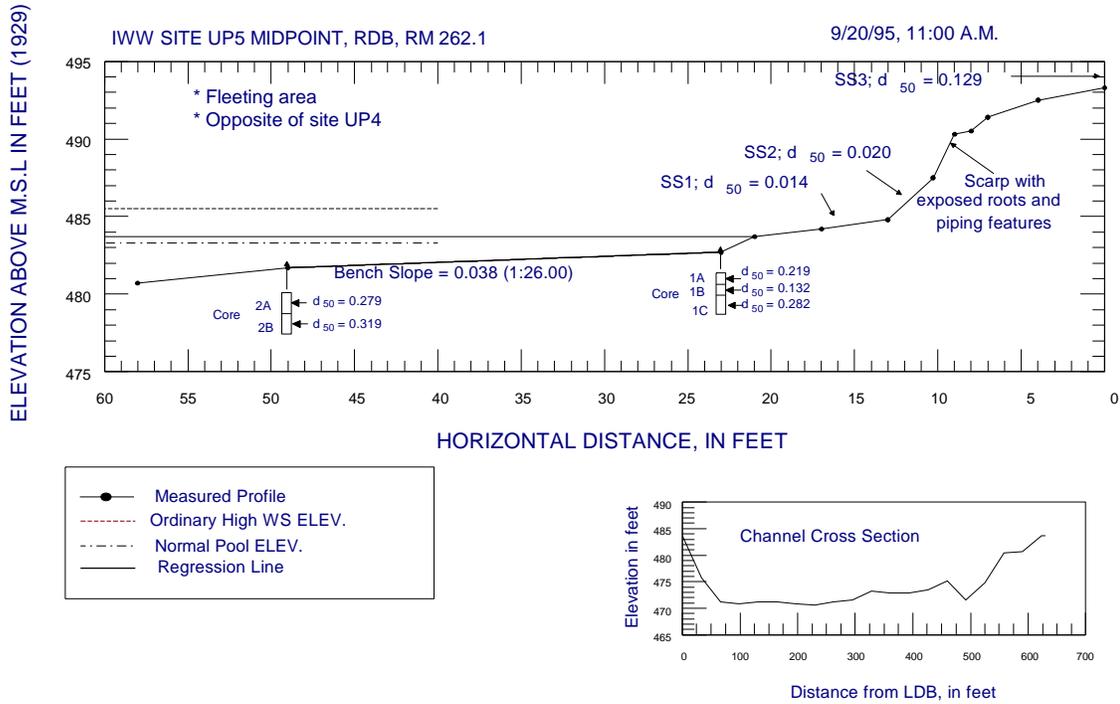
Figure 6-45. Bank section at site UP5

At the midsection, the d_{50} varies from 0.129 mm at the top surface of the bank to 0.279 mm for the top portion of a core sample at a water depth of about 2 feet. Core samples are similar to those at site UP4. Gradation plots of bank soils and nearshore sediment are presented in appendix F. The detailed river cross section and coordinates are shown in appendix G.

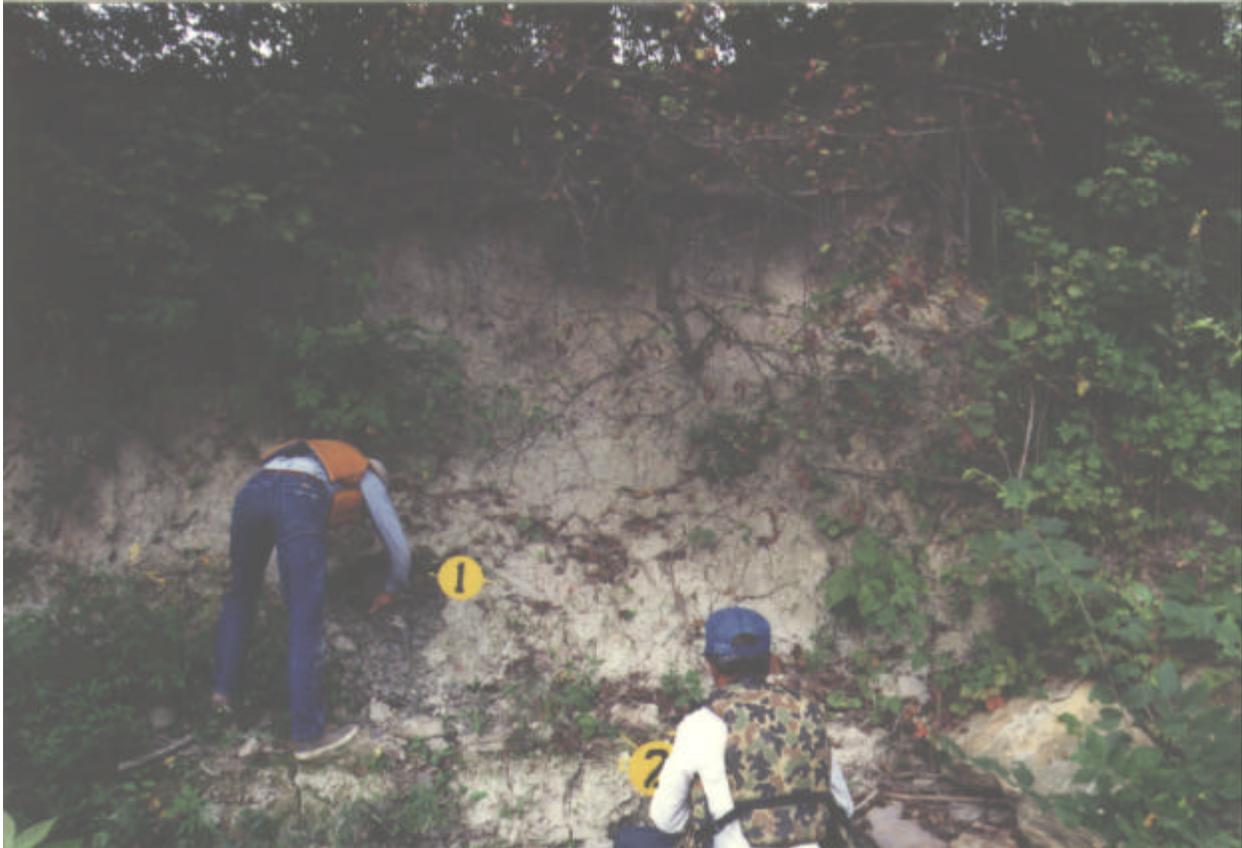
Figure 6-47. Site 1 on the Illinois Waterway

Neither Bhowmik and Schicht (1980) nor Hagerty (1988) observed erosion at this site. Hagerty (1988) noted rock instead. During this survey a near vertical scarp about 8 feet high was encountered. Exposed tree and grass roots covered the top of the scarp, and some leaning tall trees were found on the scarp. Flat slabs or rocks approximately 1 to 2 inches in length and only about quarter inch in thickness were found on the bench at the foot of the scarp. Rocks increased in size to about 4 or 5 inches long near the waters edge. Rock crops out along the Moores Creek. Figure 6-48 shows the two measured bank sections and a reduced cross section. Available stage data from the Marseilles Lock and Dam is used for interpolating stage information at this site (table 6-11). The OHW is at 460 feet and NP is at 458.5 feet above msl. Stages higher than 461.8 feet will submerge the scarp.

Bench slopes varied from 1V:6.1H to 1V:17.2H. This site can be classified as type 1 (figure 6-18 and table 6-4). Surficial bank materials slake and are loosened by weathering with subsequent collapse. Reworking and transport of failed materials and recently deposited sediments occurs within bench areas during high flows.

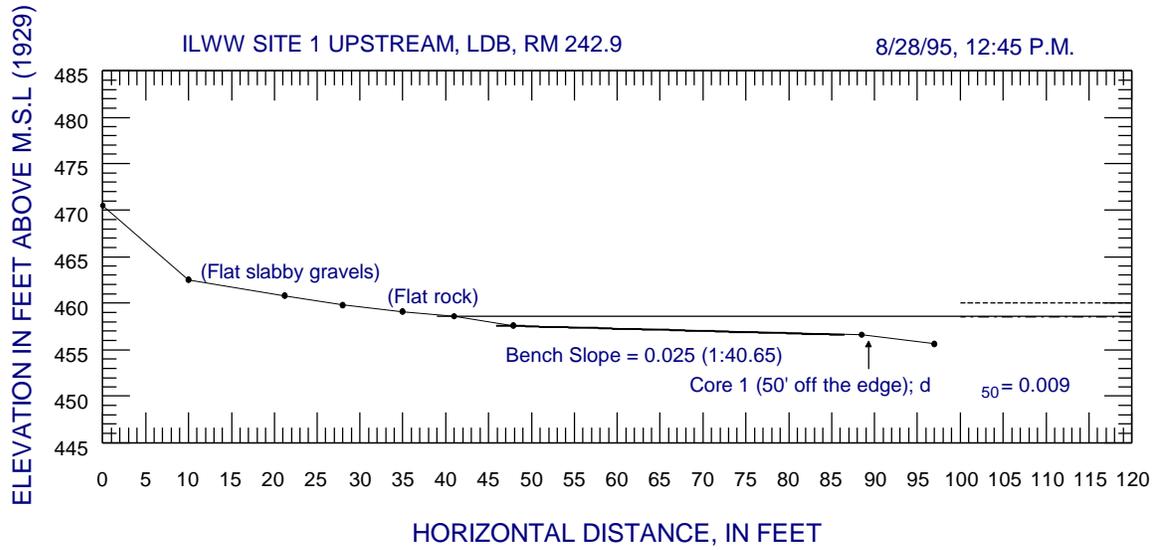
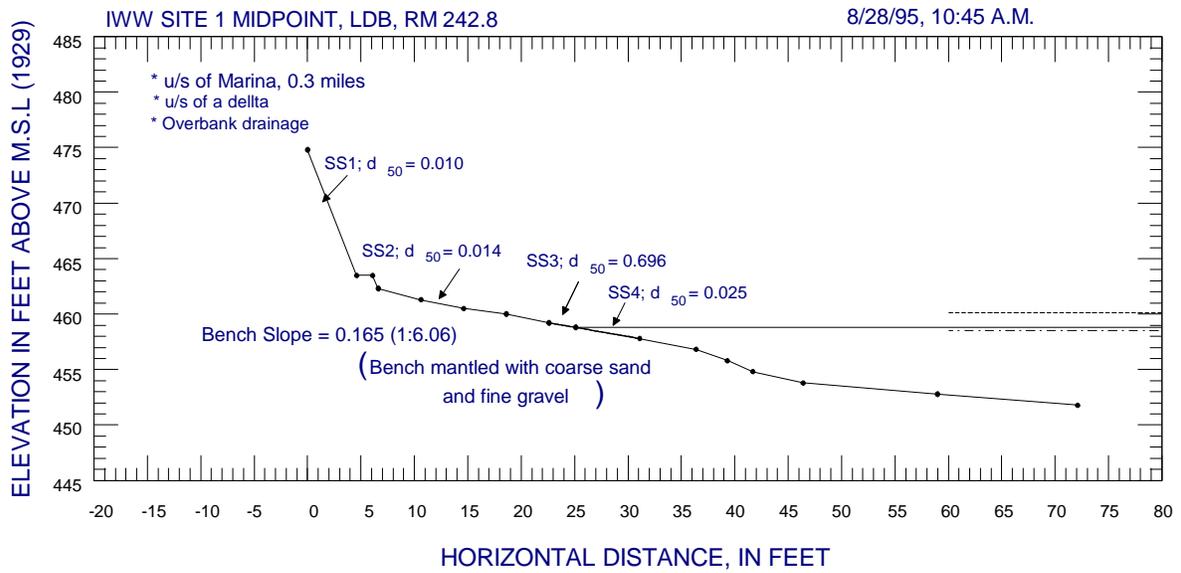
Figure 6-48. Bank sections at site 1

At the midsection, the d_{50} varies from 0.010 mm at the surface of the bank to 0.696 mm at the edge of water to 0.025 mm for a core sample at a depth of about 1 foot of water. Gradation plots of bank soils, and nearshore sediment are presented in appendix F. The detailed cross section and coordinates are shown in appendix G.

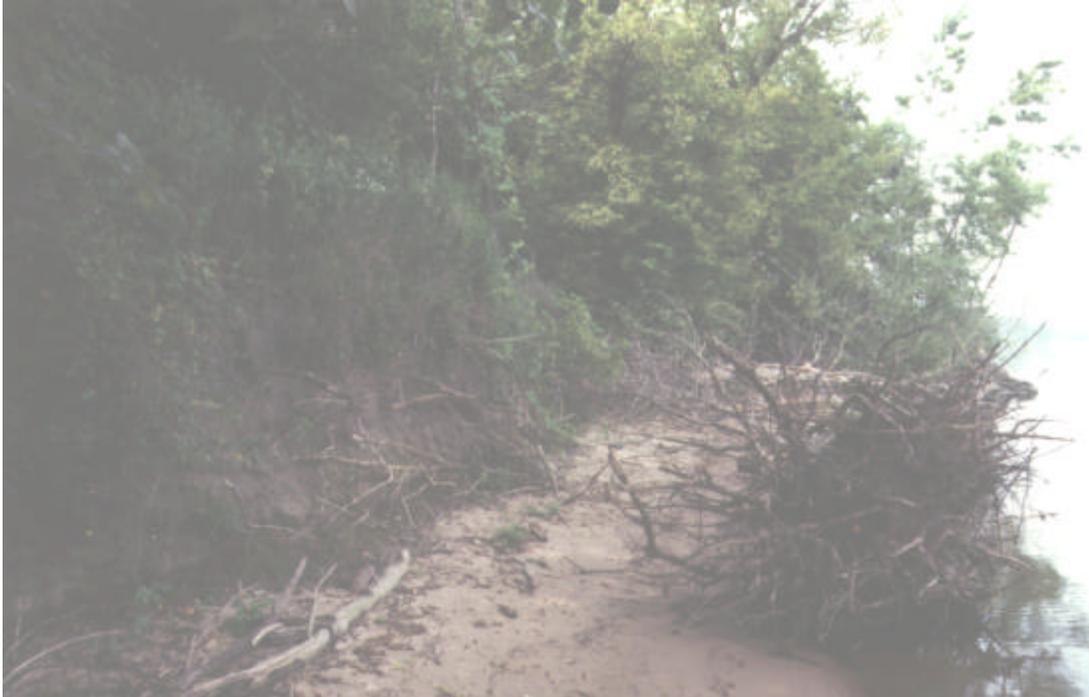
Figure 6-49. Site 2 on the Illinois Waterway

Hagerty (1988) noted erosion, but Bhowmik and Schicht (1980) indicated riprap at this site. During the survey there was a fairly long stretch of eroded bank with a nearly vertical scarp about 6 to 7 feet in height. Trees of 6 inch diameter stood at the edge of the scarp, some with extensive root exposure on the bank face, and some downed trees were lying on the bench. The relatively narrow bench was covered with fine sand. Nearshore materials were mostly fine sand on soft silt.

and table 6-4). The scarp was nearly vertical and covered with fine roots. There was a moist layer at the base of the scarp and the subaerial bench was narrow and covered with sand. Several factors contribute to bank failure: tractive forces during floods, wave and current actions at stages above OHW, and seepage at the base of scarp could all contribute to the rework and erosion of failed bank soils and recently deposited sediment.

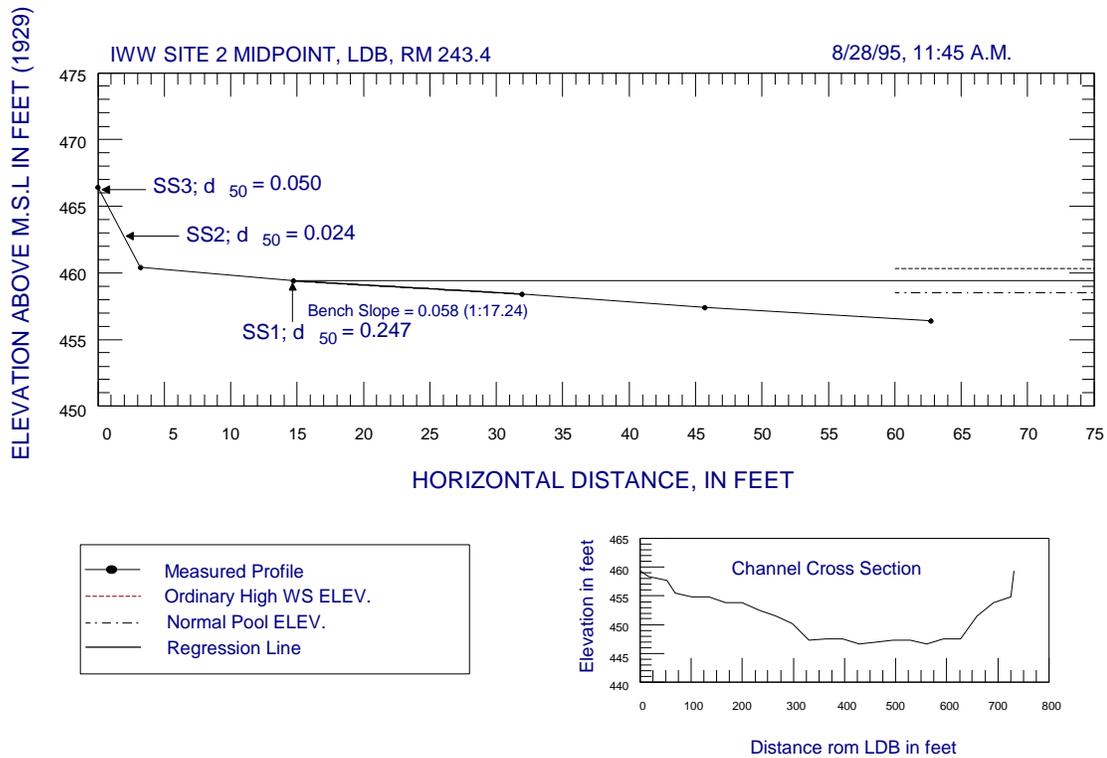
Figure 6-50. Bank section at site 2

Figure 6-50 shows the measured bank section and a reduced cross section. The OHW is 459.5 feet and NP is 458.5 feet above msl. According to 10-year stage data (Table 6-12), stages with 25% or less exceedence frequencies will reach the base of the scarp, and any stage higher than OHW elevation will be on the scarp.

The d_{50} varied from 0.050 mm at the top of the bank face to 0.247 mm for a core sample at the edge of water. Gradation plots of bank soils and nearshore sediment are presented in appendix F. the detailed cross section and coordinates are shown in appendix G.

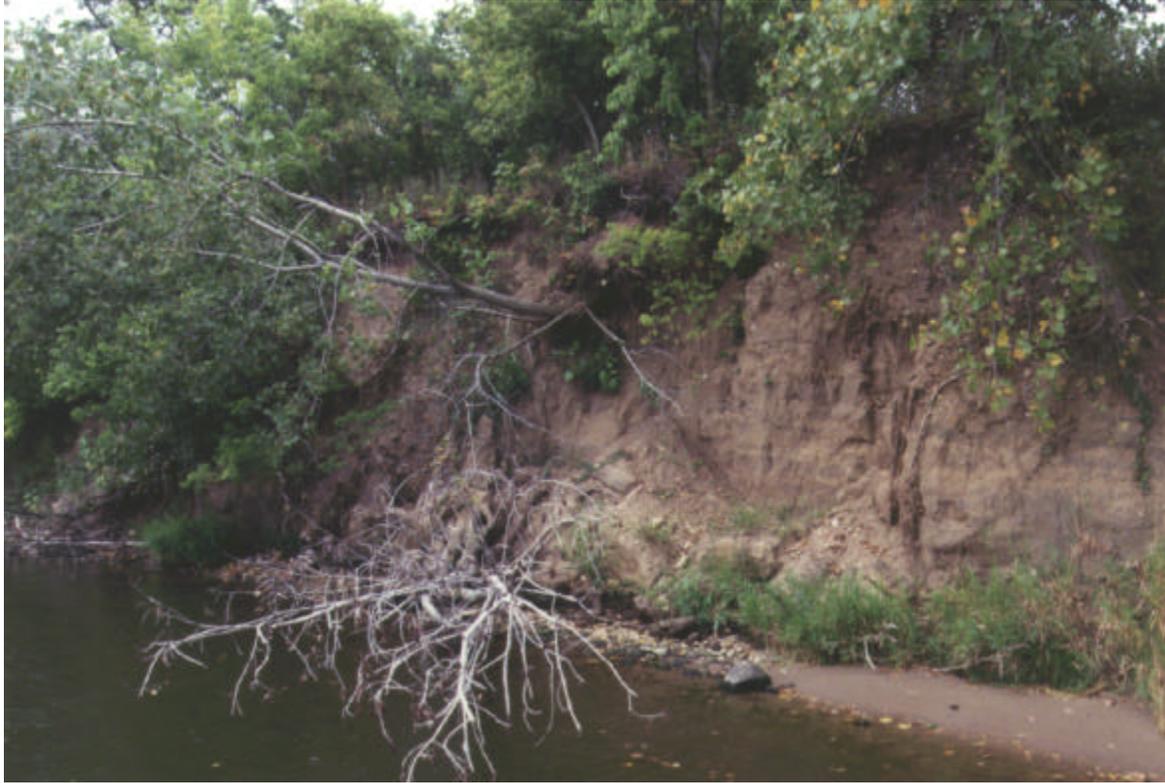
Figure 6-52. Site 3 on the Illinois Waterway

The bank consisted of a bare face approximately 15 to 20 feet high. Toppled trees halfway up the bank face supported stems re-grown to upright directions. Fine sand and gravel were found at the water's edge. Although the reach is straight, the three sections surveyed all were measured from locally concave banklines. These concavities were about 50 feet wide, and all had either gravel or trees at the water's edge, at the upstream end. Several mass failures had occurred at the downstream ends, which indicated the concave sections were widening.

Bench slopes varied from 1V:50H at the upstream section to 1V:8H at the midsection. The bank consisted mostly of noncohesive sandy materials. The three sections can be classified as a combination of types 1 and 6 because of the extended subaqueous bench width (figures 6-18 and 6-23, and table 6-4). Rework and transport of failed soils and recently deposited sediment occur during floods. Eddy currents induced by the trees or gravel upstream of concave sections can cause bank failure and eddies are generated at stages when the flows are disturbed by trees or gravel.

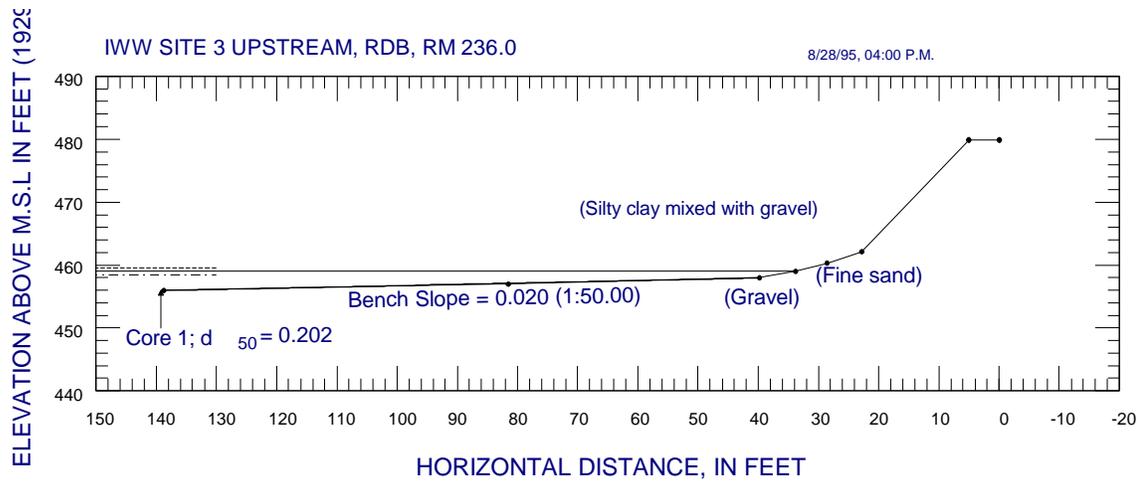
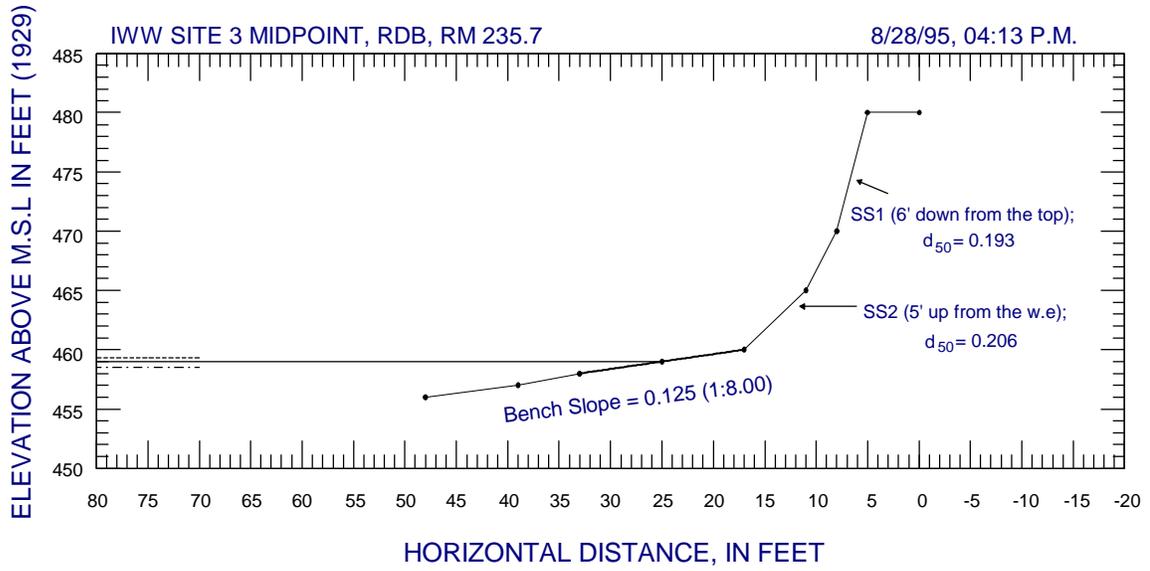
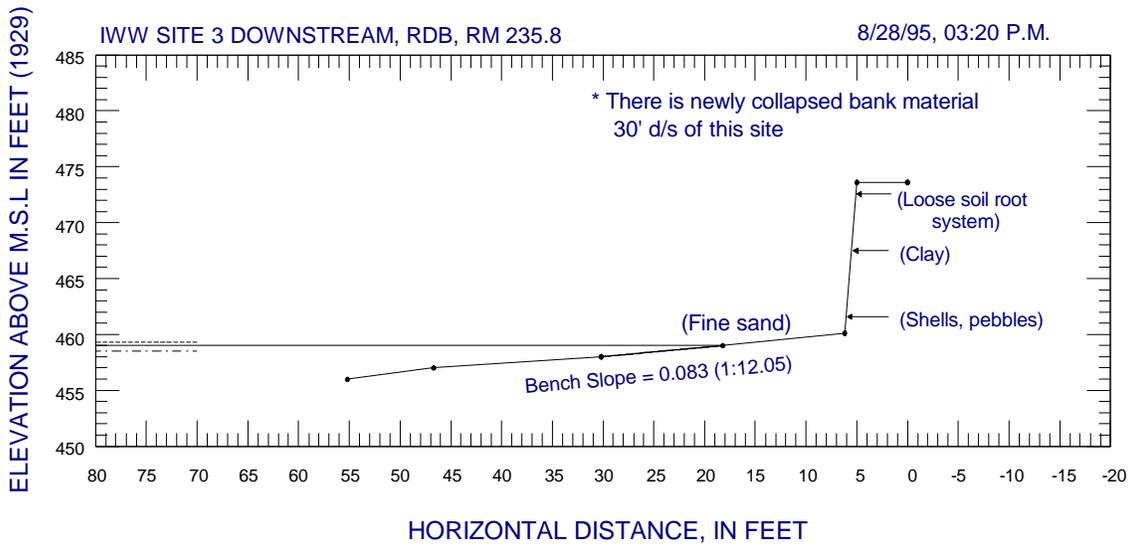
Figure 6-53. Bank sections at site 3

Figure 6-53 shows the three measured bank sections and a reduced cross section. The bank slopes were steeper towards the downstream limit. The OHW is 459.3 feet and NP is 458.5 feet above msl. This range of fluctuation is within the bench area. Ten-year stage data (table 6-13) shows that only stages with less than 10% recurrence frequency can reach the base of the bank face.

At the midsection, the d_{50} varied from 0.193 mm at the upper part of bank surface to 0.206 mm at the base of the bank. A core sample at 2 feet of depth on the upstream section had d_{50} of 0.202 mm. Gradation plots of bank soils and nearshore sediment are presented in appendix F. The detailed cross section and coordinates are shown in appendix G.
