**Figure 6-54. Locations of sites 4 and 5 on the Illinois Waterway**

**Site 5, Peoria Pool, 8/28/95.** This site is located on the RDB at RM 228.5, slightly upstream from site 4 on the LDB. Figure 6-54 shows the position of the site on a GIS-based map of the Illinois navigation chart.

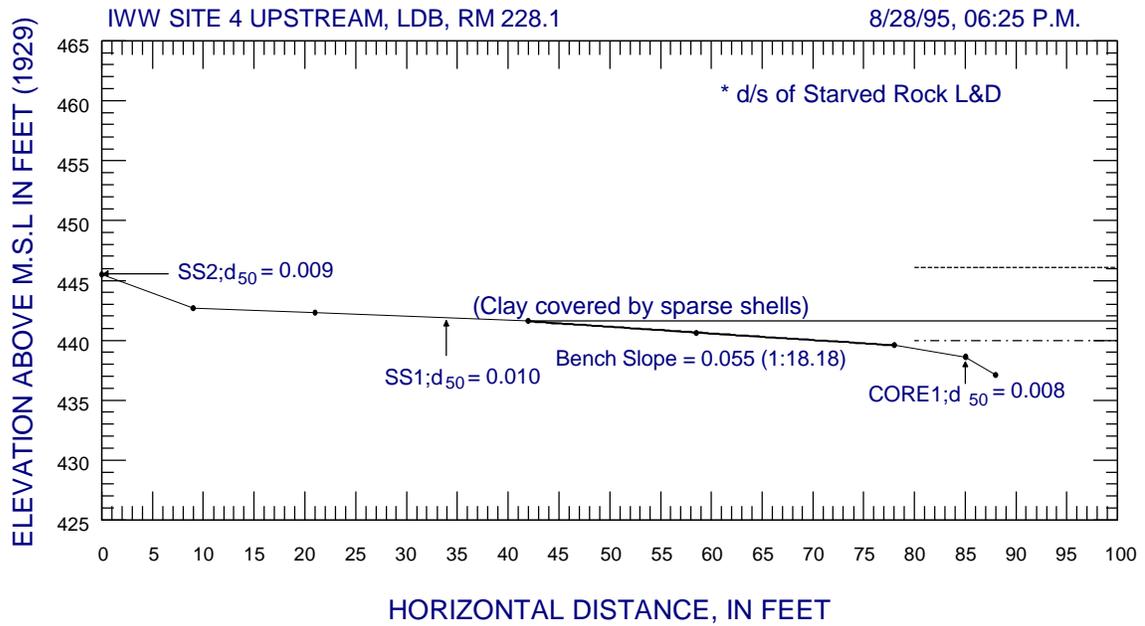
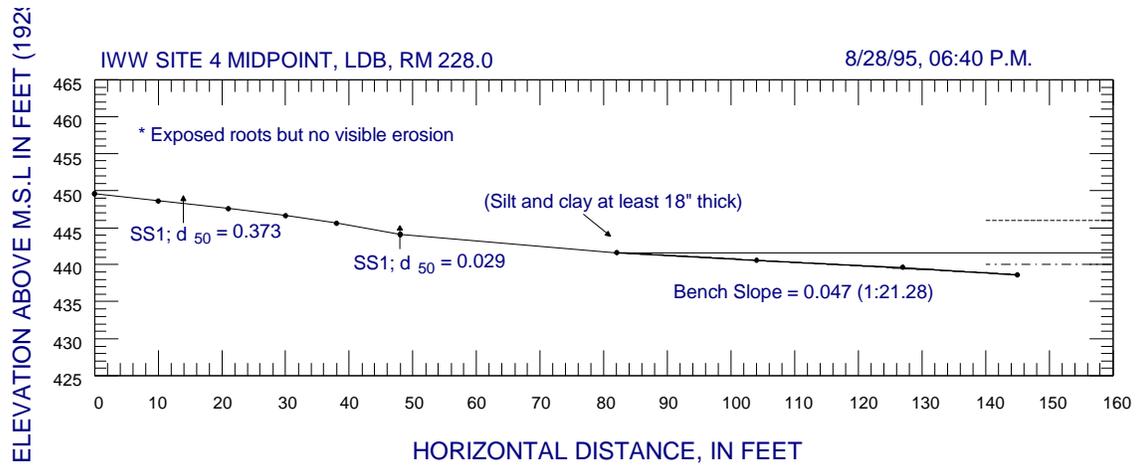
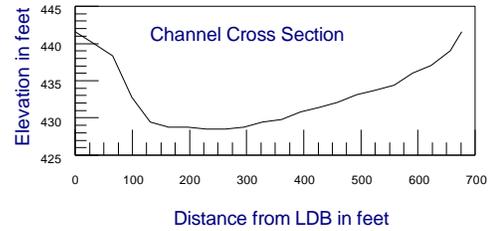
**Figure 6-56. Bank sections at site 4**

Figure 6-56 shows the three measured bank sections and a reduced cross section. Bank sections were fairly uniform at this site. The OHW is 446 feet and NP is 440 feet above msl. The range of fluctuation between the OHW and NP covers the entire bench.

At the midsection, the  $d_{50}$  varied from 0.373 mm for materials on the scarp under the exposed tree roots of a mature tree to 0.029 mm on the bench. Mean particle size at the upstream section varied from 0.009 mm at the top surface of the bank to 0.008 mm for a core sample at a water depth of about 1 foot. Gradation plots of bank soils and nearshore sediment are presented in appendix F. The detailed cross section and coordinates are shown in appendix G.

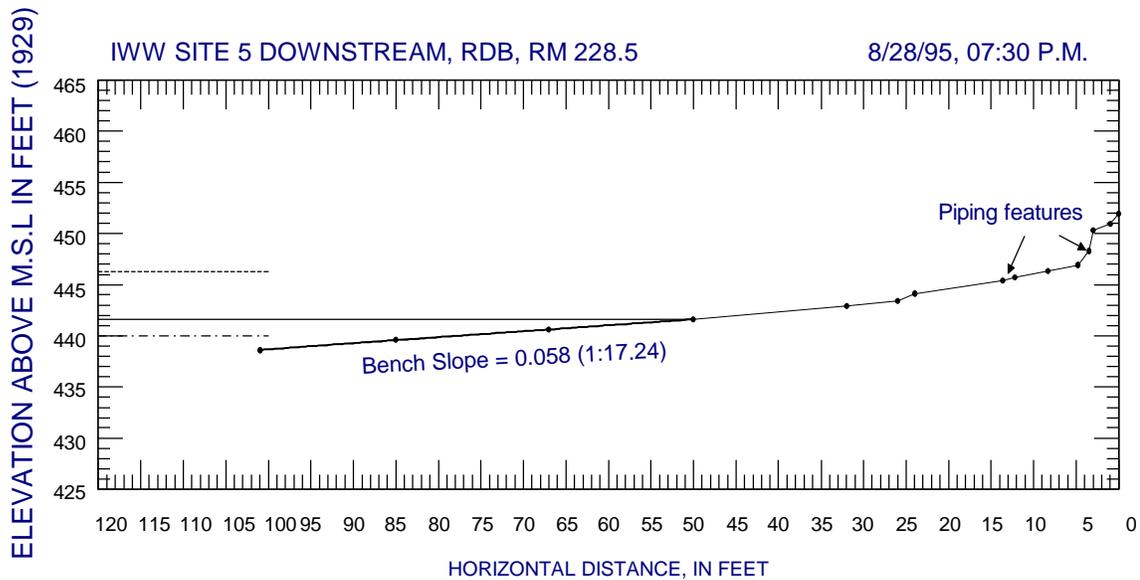
**Figure 6-57. Bank sections at site 5**

Figure 6-57 shows the three measured bank sections and a reduced cross section. The OHW is 446.2 feet and NP is 440.0 feet above msl. The OHW elevation was at the base of the scarp at all three sections, while the NP was at a break in the subaqueous slope at the upstream section. According to the stage analysis using 10-year data (see table 6-15), river stages with 25% or less occurrence frequency reach the scarp and stages with 10% or less occurrence frequency top the bank.

At the midsection, the  $d_{50}$  varied from 0.023 mm at the top surface of the bank to 0.161 mm for a core sample at a water depth of about 1 foot. Gradation plots of bank soils and nearshore sediment are presented in appendix F. The detailed cross section and coordinates are shown in appendix G.

Bench slopes varied slightly between 1V:23.8H and 1V:17.2H. With a scarp over a gentle bench slope, this site is classified as a combination of types 3 and 5 (figures 6-20 and 6-22, and table 6-4). The scarps have layered failure features and were initiated by piping and surface drainage. Waves and currents at OHW cause erosion of failed soil or recent sediments on the bench area.

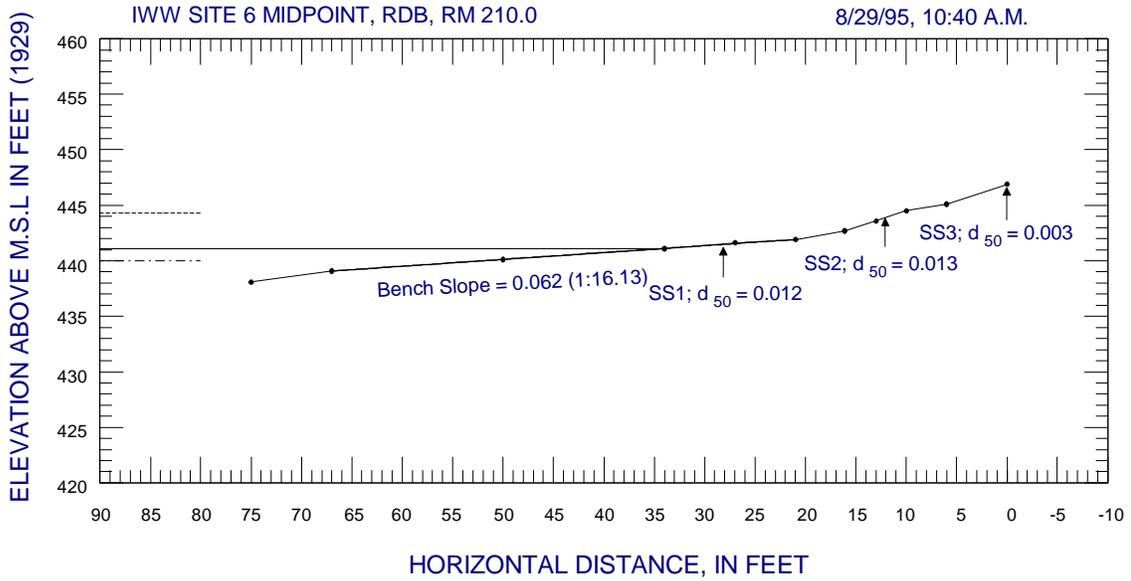
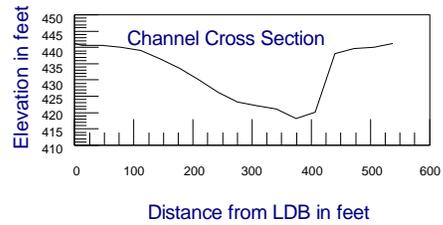
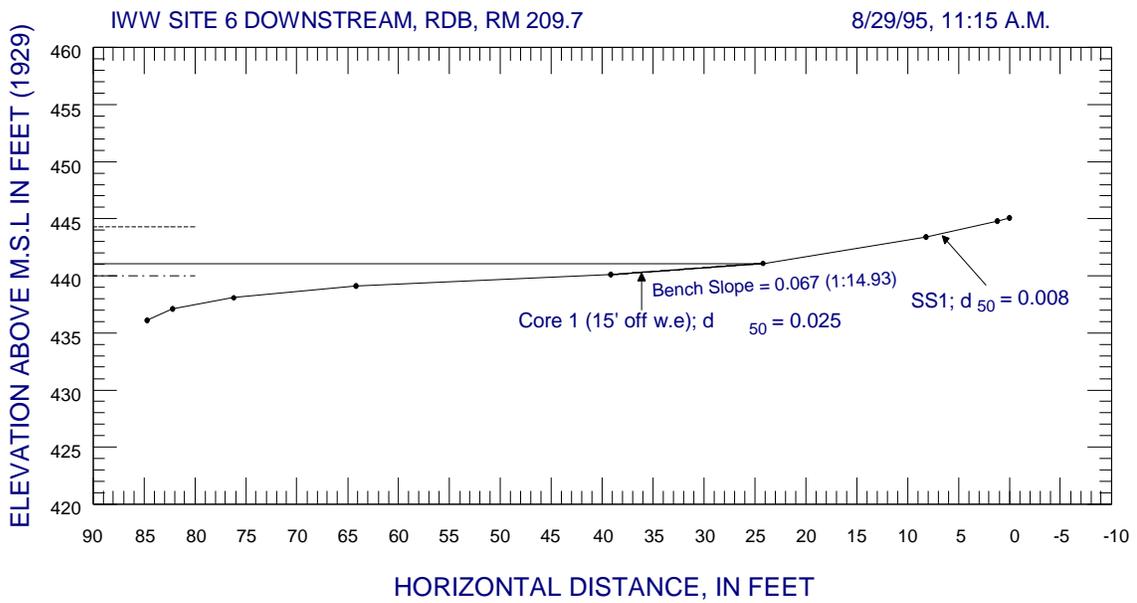
**Figures 6-60. Bank sections at site 6**

Figure 6-60 shows the three measured bank sections and two reduced cross sections. The thalweg was farther away from the water's edge downstream. The OHW is 443.2 feet and NP is 440.0 feet above msl. Mature trees were growing at the water's edge; the midsection and downstream section were measured between trees. Banks between the trees were eroded. The crown of the tree roots appeared to be higher than the bank top. A flood stage higher than 10% recurrence frequency will overtop the bank (see table 6-16). Standing (but dead) trees were in place in water at the NP level.

At the midsection, the  $d_{50}$  varied from 0.003 mm at the top surface of the bank to 0.012 mm on the bench. A core sample at a depth of about 1 foot of water on the downstream section had  $d_{50}$  equal to 0.025 mm. Gradation plots of bank soils and nearshore sediment are presented in appendix F. The detailed river cross-section and coordinates are shown in appendix G.

Bench slopes varied only slightly from 1V:16.1H at the midsection and downstream section. The three sections, from upstream to downstream, are classified as types 4, 5, and 6 (figures 6-21, 6-22, 6-23, and table 6-4). Traffic-induced currents appear to be a significant factor for the subaqueous scarp at the upstream section. Small worms nesting in the bank soils also will weaken the bank strength. Eddy currents, induced by fallen trees or nearshore land features, exist at the midsection and downstream section. These eddy currents can cause local scours. Other erosion mechanisms include surface drainage for the upstream section, piping, and floods for the whole reach.

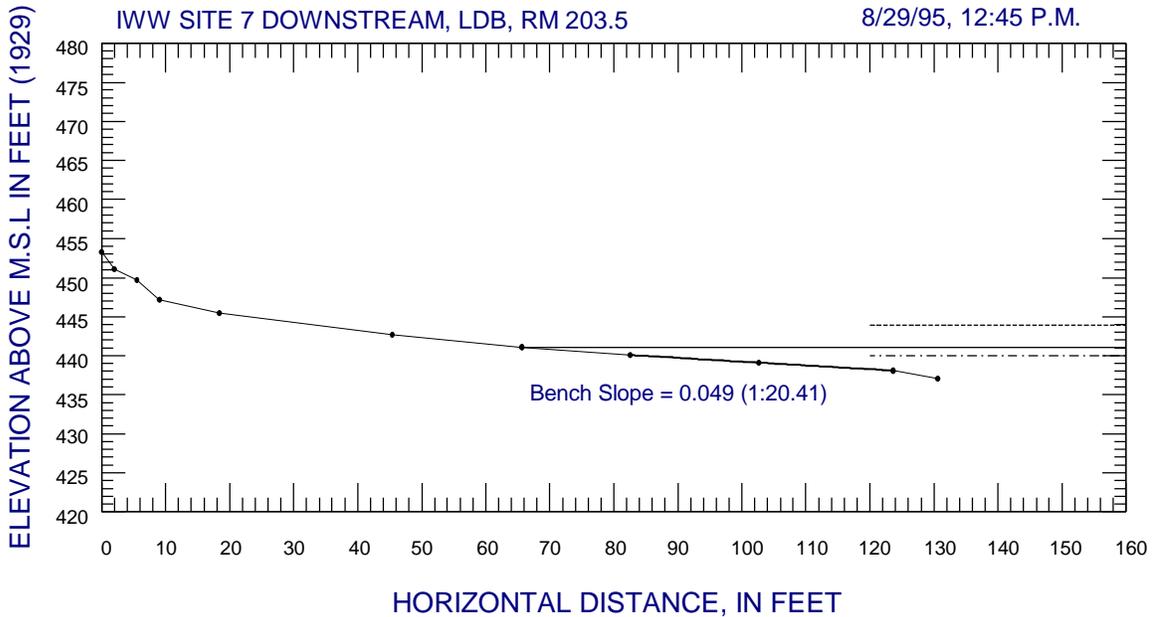
**Figure 6-63. Bank sections at site 7**

At the site, a scarp 3-5 feet high was located about 2 to 4 feet below the levee crown. Tall weeds were growing on the berm and many small scarps were observed on the bench. Figure 6-63 shows the three measured bank sections and a reduced cross section. The OHW is 443.9 feet and NP is 440.0 feet above msl. The OHW corresponded well with the lower edge of the weed zone on the shore where debris was found, in the bench area. Stages above 447.5 feet (about 10% recurrence frequency, see table 6-17), reach the base of the scarp near the top of the levee.

At the upstream section, the  $d_{50}$  varied from 0.018 mm at the surface of the scarp to 0.021 mm for a core sample at a water depth of about 1 foot. Gradation plots of bank soils and nearshore sediment are presented in appendix F. The detailed cross section and coordinates are shown in appendix G.

Bench slopes varied only slightly from 1V:23.3H. This site can be classified as type 5 (figure 6-22 and table 6-4). The scarp was located above most flood stages. Rework and transport by wave and currents are major factors in removing failed soil or recent sediments from the bench.

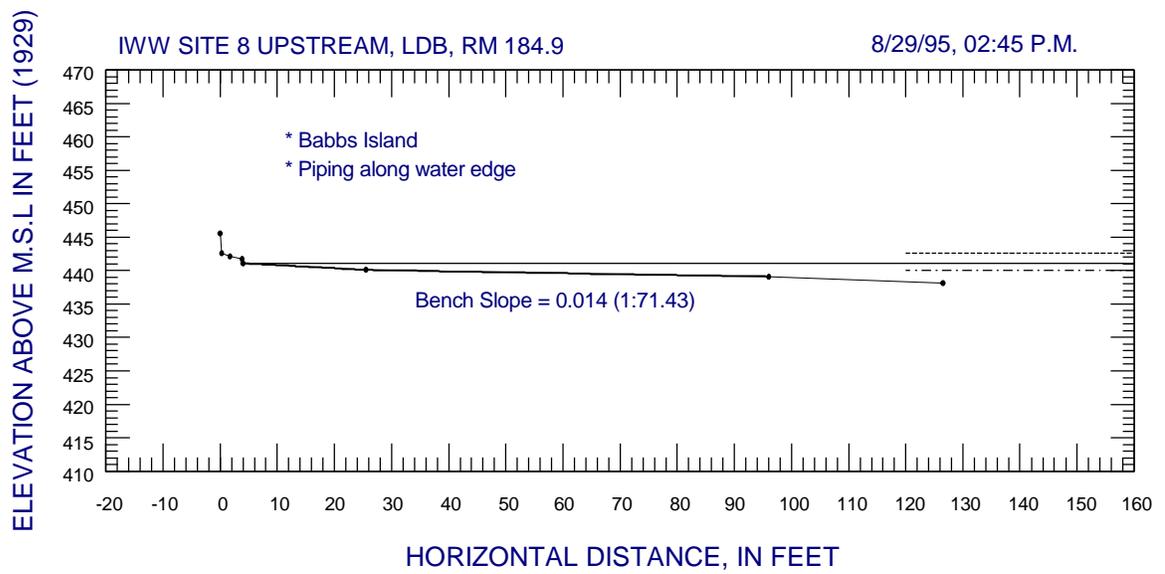
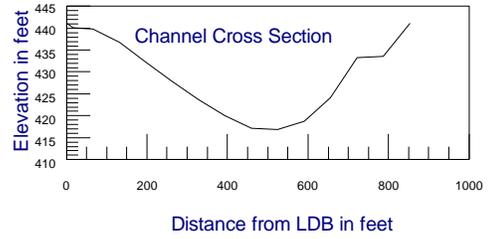
**Figure 6-66. Bank sections at site 8**

At the midsection, the  $d_{50}$  varied from 0.005 mm at the surface of the top of the bank to 0.018 mm for a core sample at a water depth of about 1 foot. Gradation plots of bank soils and nearshore sediment are presented in appendix F. The detailed cross section and coordinates are shown in appendix G.

Figure 6-66 shows the three measured bank sections and a reduced cross section. The OHW is 442.6 feet and NP is 440.0 feet above msl. The OHW corresponds to the base of the scarp. Floods with stage higher than 447.5 feet (about 10% recurrence frequency) overtop the bank (table 6-18).

Bench slopes varied from 1V:83.3H to 1V:47.6H. This site is classified as a combination of types 4 and 5 (figures 6-21, 6-22, and table 6-4). Bank failures are initiated by piping or burrowing activities from riverine animals. Rework and transport of failed bank soils by wave action at NP appeared to be significant. Wave action probably was responsible for an erosion scarp at water's edge.

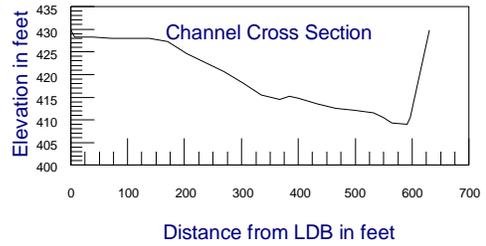
**Figure 6-69. Bank sections at site 9**

Figure 6-69 shows the three measured bank sections and a reduced cross section. The OHW is 442.4 feet and NP is 440.0 feet above msl. The OHW corresponds well to the lower edge of the weed zone. Stage exceeding 447.5 feet (10% recurrence frequency, table 6-19) submerges the entire bank.

The  $d_{50}$  on the bench varied from 0.208 mm at the upstream section to 0.035 mm at the downstream section. Gradation plots of bank soils and nearshore sediment are presented in appendix F. The detailed cross section and coordinates are shown in appendix G.

Bench slopes varied from 1V:21.3H at the upstream section to 1V:14.1H at the downstream section. This site is classified as types 4 and 6 (figure 6-23, and table 6-4). The combinations of wave actions and seepage within bench near NP elevations could be the major causes of erosion at this site. Recreational and commercial traffic volumes are high at site 9. Traffic-induced waves and current can also be the cause of erosion at this site.
