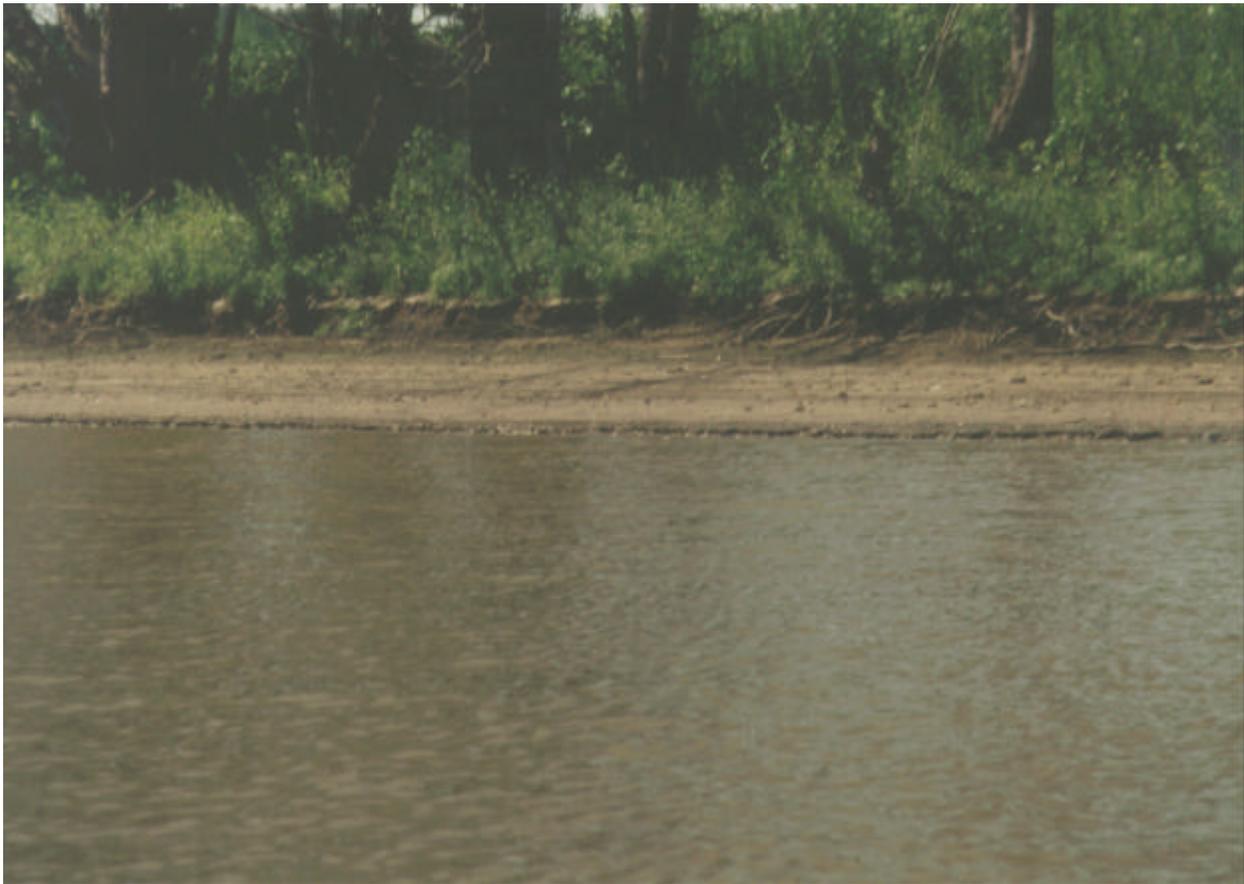
Figure 105. Site 22 on the Illinois Waterway

high. Below the scarp, a bench was composed of very soft silty soil with many peds on the silt surface. The bench was fairly moist.

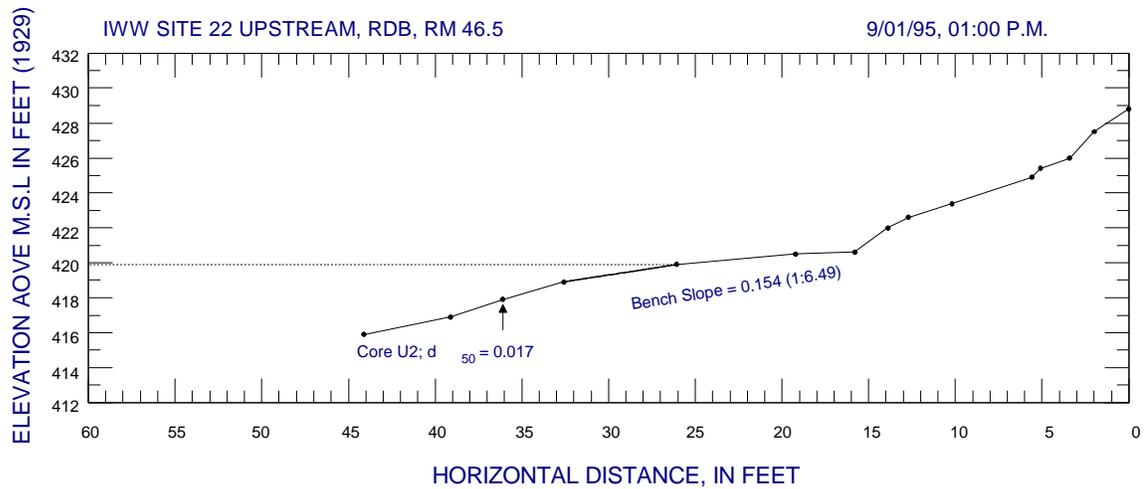
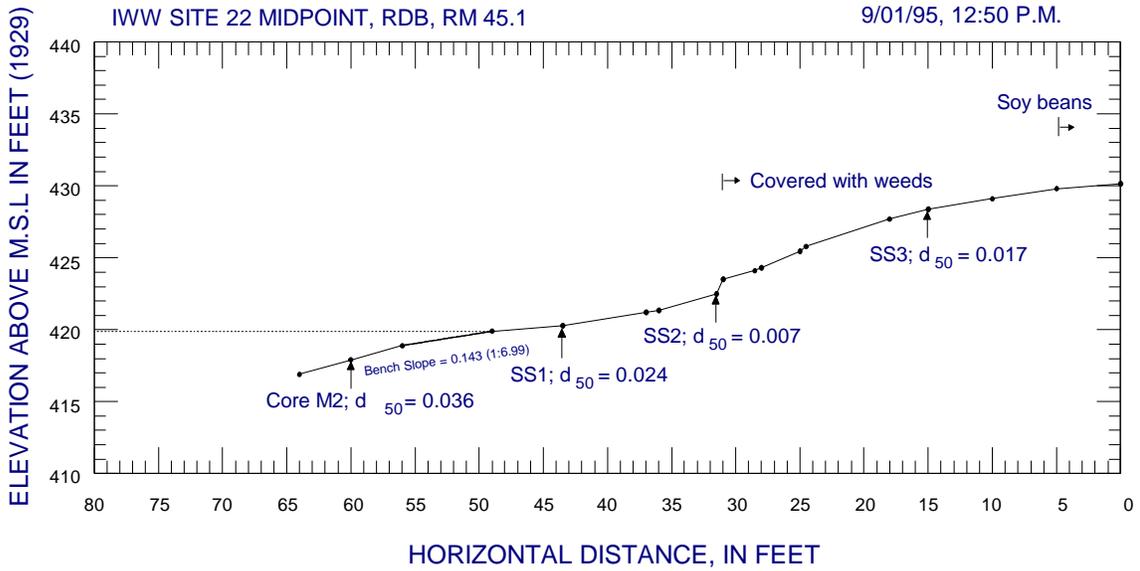
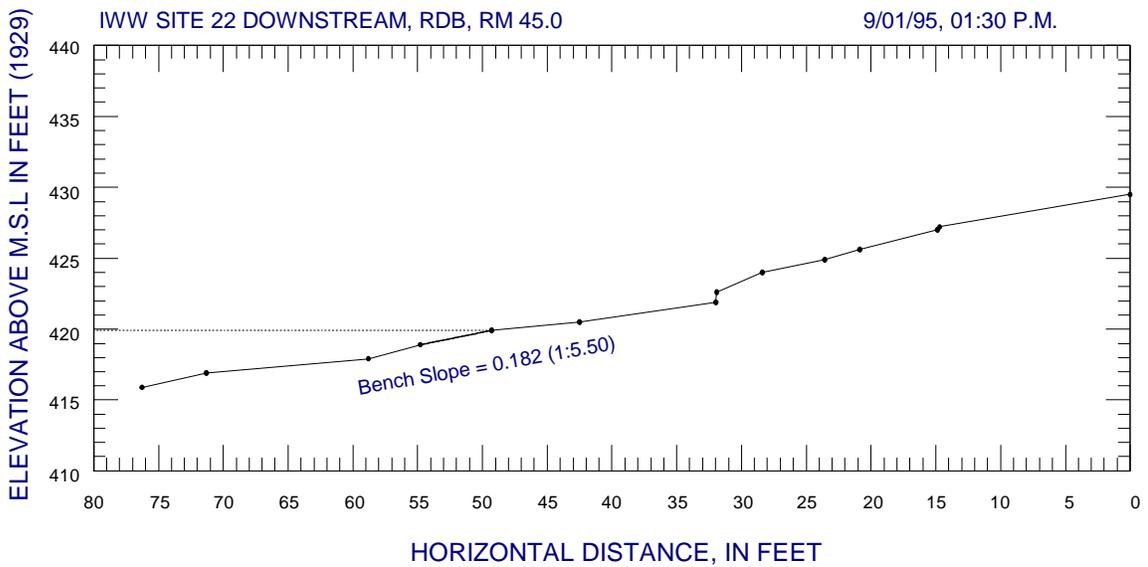
Figure 106. Bank sections at site 22

Figure 6-106 shows the three measured bank sections and a reduced cross section. The stage at the time of measurement corresponded approximately to the 85% recurrence frequency. The 50% and 25% recurrence stages (see table 6-32) are 422.4 and 425.9 feet above msl, respectively. The base of the scarp at the end of the weed zone was about 422.4 feet above msl.

Bench slopes varied from 0.143 1V:7.0H to 1V:5.5H. This site can be classified as a combination of types 5 and 4 (figure 6-22 and 6-21, and table 6-4). Apparent erosion mechanisms were emergent to seepage on the subaerial bench, rework and transport by waves and currents at various stages between NP and OHW.

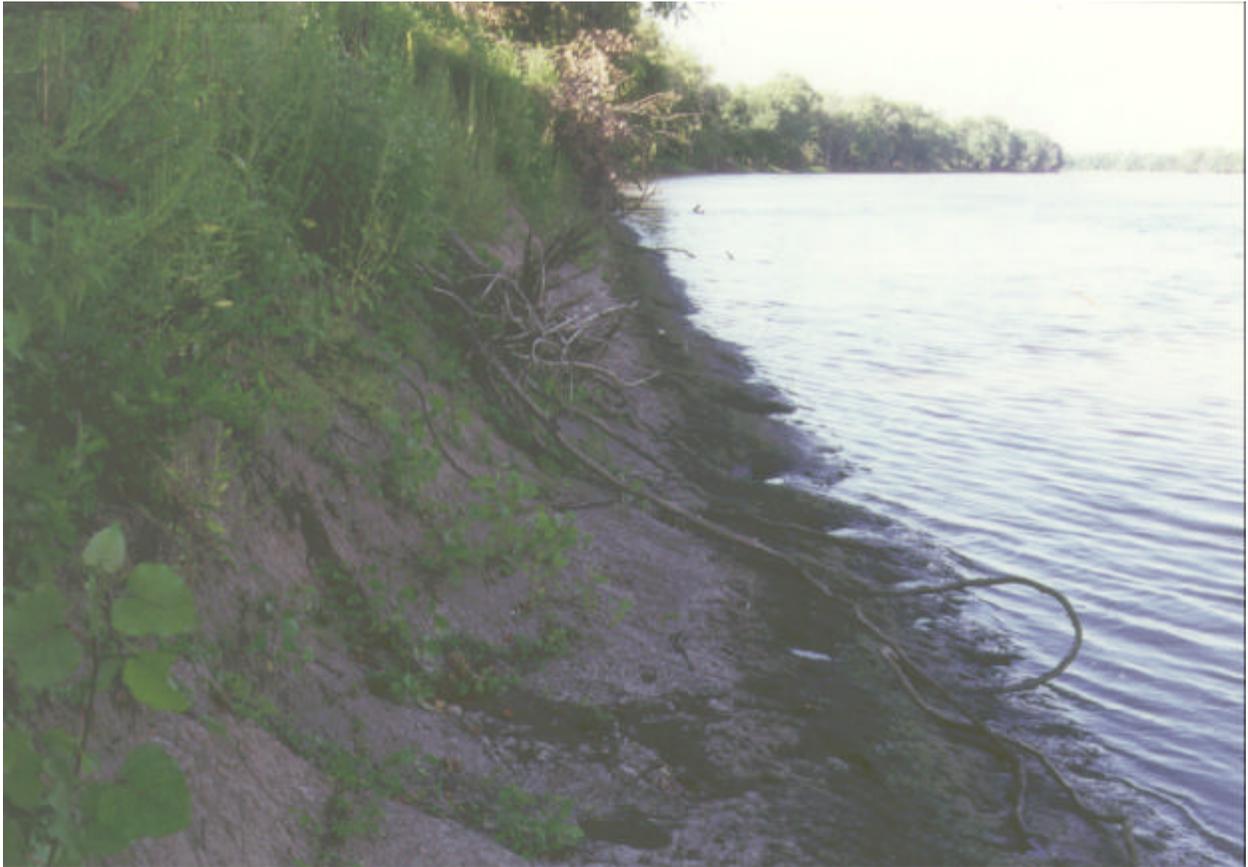
Figure 6-108. Site 23 on the Illinois Waterway

Site 23, Alton Pool, 9/1/95. This site is located on the RDB at RM 23.5 in a crossover from a gentle bend. This site is near the downstream tail of Diamond Island; Dark Chute runs from the back (west) side of the island and to the confluence with the Illinois River at RM 22.7. Figure 6-107 shows the position of the site on a GIS-based map of the Illinois navigation chart, and figure 6-108 shows a photograph of the site.

The navigation channel is close to this site; the bank is about 180 feet from the sailing line. Bhowmik and Schicht's (1980) Reach 1 was located at RM 24.0 on the opposite bank. Hagerty (1988) marked erosion on both bank sections, but eroded reaches were shown in several segments. For this site, Hagerty (1988) noted 6 feet of bare scarp.

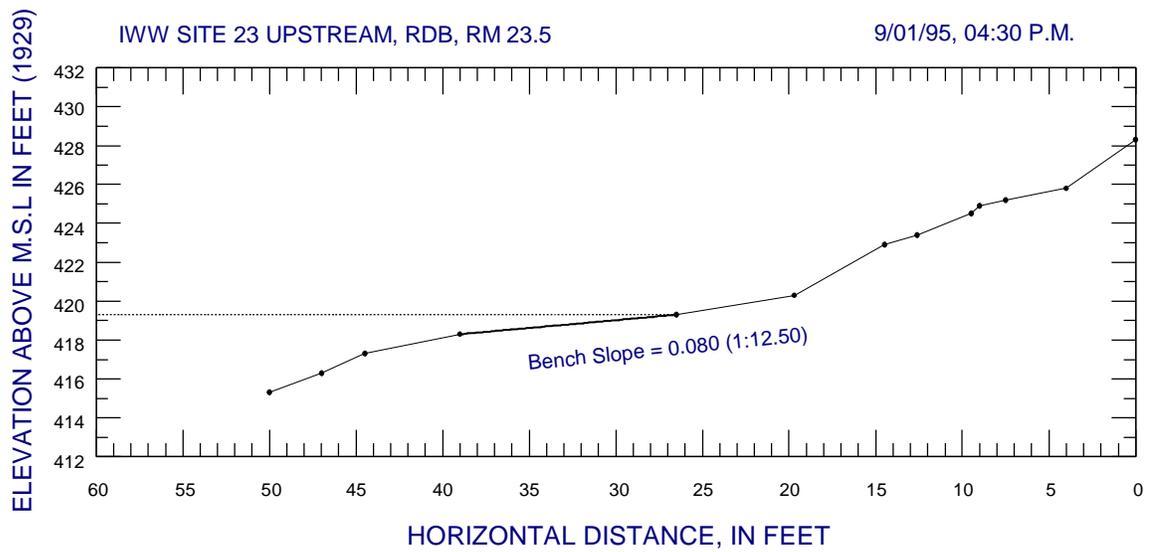
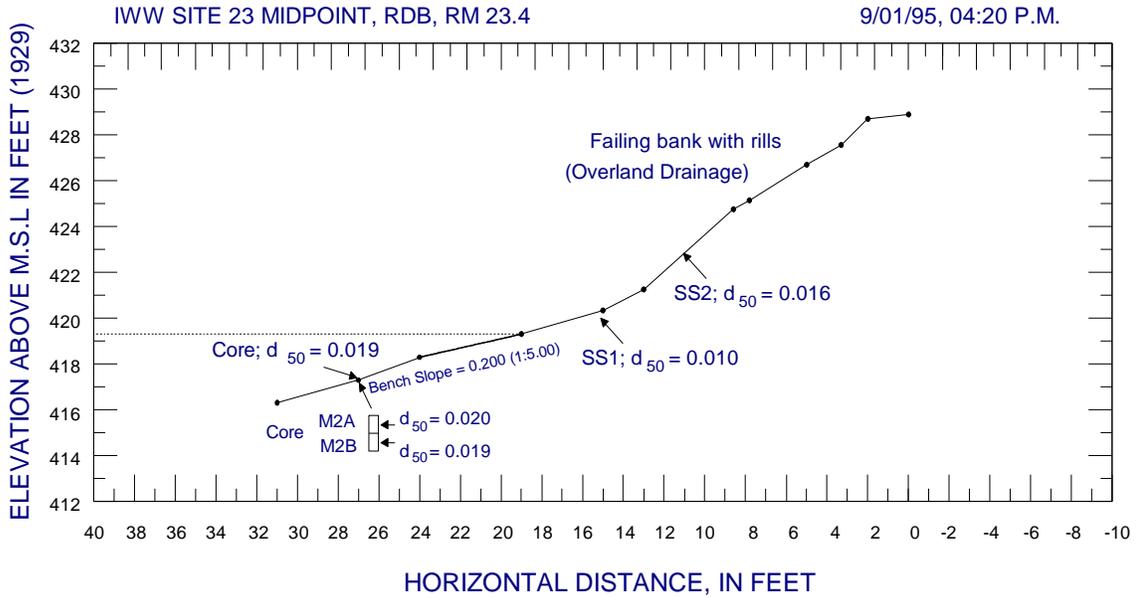
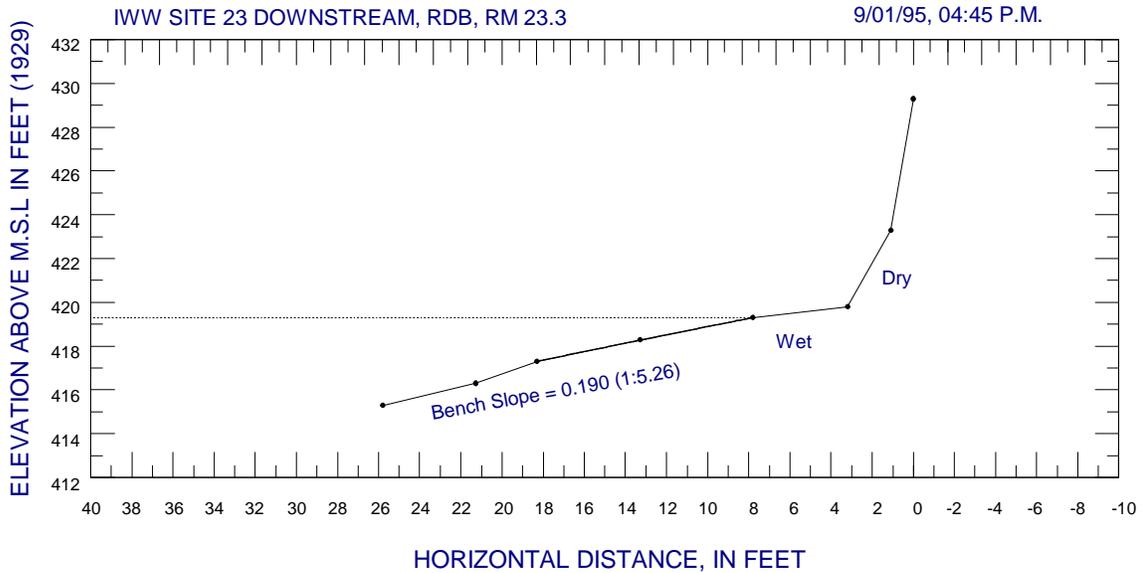
Figure 6-109. Bank sections at site 23

Figure 6-109 shows the three measured bank sections and a reduced cross section. The stage at the time of survey was at about the 90% recurrence frequency stage. Dense seasonal vegetation covered the upper portion of the bank face, and the bank slope was steeper downstream. Bank materials were similar to those at other bank sections in the Alton Pool, with a hard clayey layer at the upper part of the bank, and a lower bank covered by moist, soft clayey soil. Algae were growing near the water's edge. As shown in table 6-33, the bare bank face corresponds well to the stage ranging between 50% and 25% recurrence frequencies. The 50% recurrence stage is about 420.3 feet at the base of the scarp.

Bench slopes varied from 1V:12.5H at the upstream section to about 1V:5.0H at the midsection and downstream section. The upstream section and midsection are classified as type 4 and the downstream section is classified as type 2 (figures 6-21 and 6-19 and table 6-4). There was erosion due to surface drainage; other apparent causes are seepage, rework, and transport by levees and currents at various stages of pool-level fluctuations.

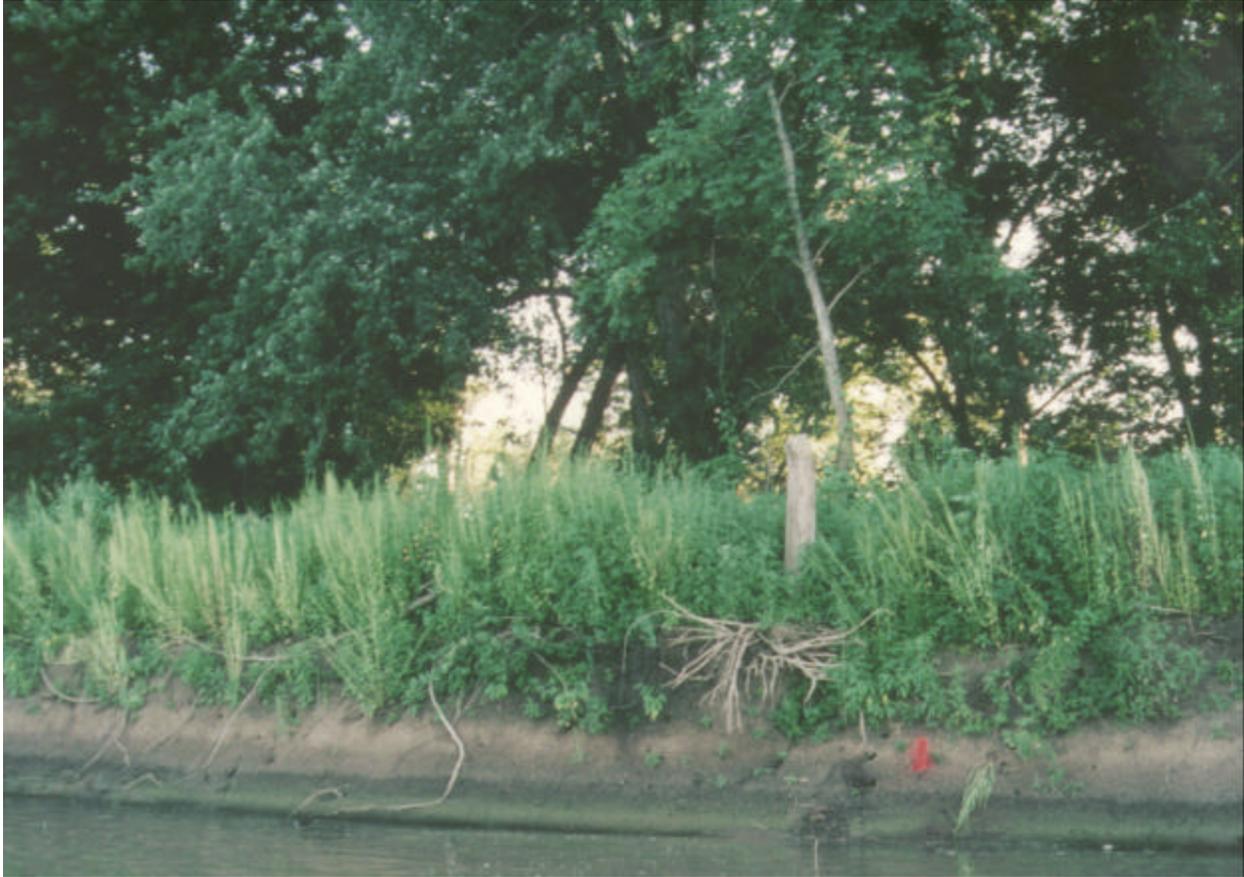
Figure 6-111. Site 24 on the Illinois Waterway

Site 24, Alton Pool, 9/1/95. This site is located on the RDB at RM 13.1 on the outside of a bend. Upstream on the RDB is the (old) Hadley's Landing (RM 13.4) and across the river is Twelve Mile Island. Figure 6-110 shows the position of the site on a GIS-based map of the Illinois navigation chart, and figure 6-111 shows a photograph of the site.

The site is about 430 feet from the sailing line, and no major tributary enters the IWW at this location. Bhowmik and Schicht (1980) marked the site as a "Wave Study" site. Hagerty's 1988 erosion site was at RM 13.4 immediately downstream from Hadley's Landing.

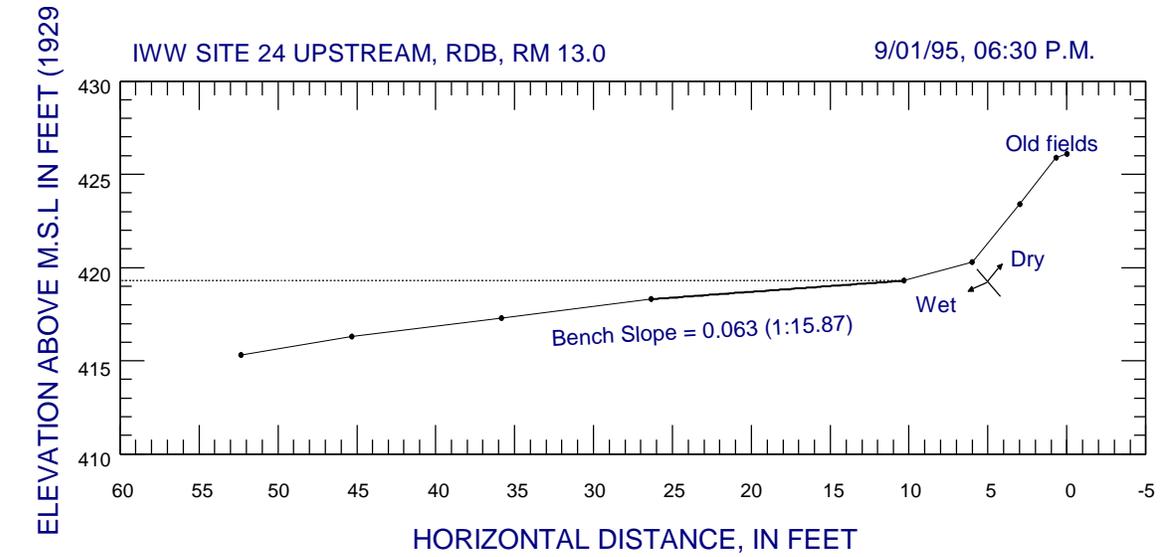
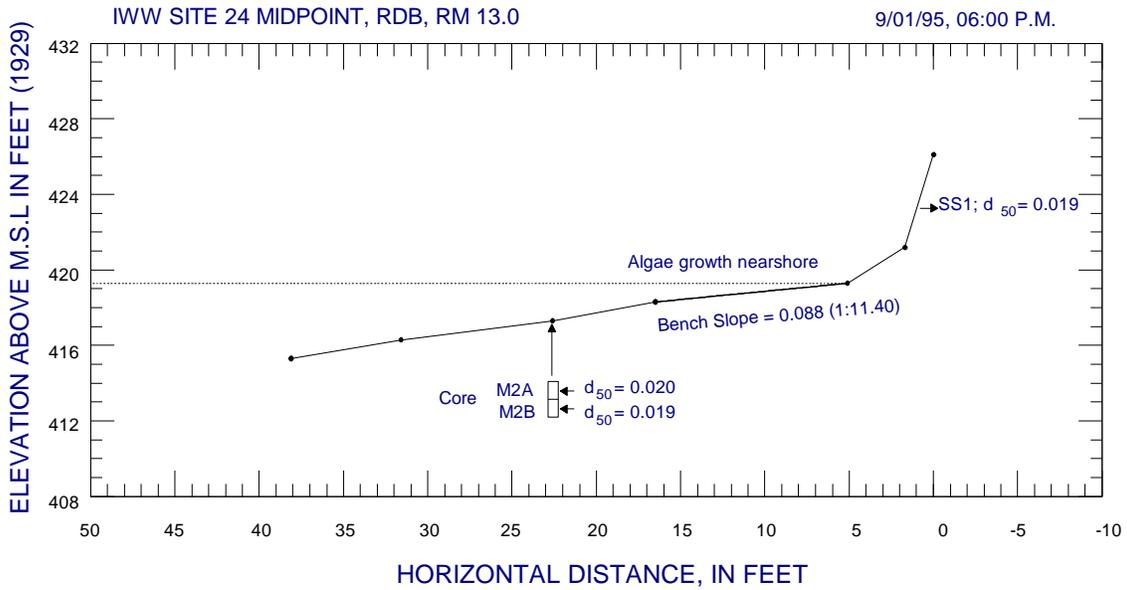
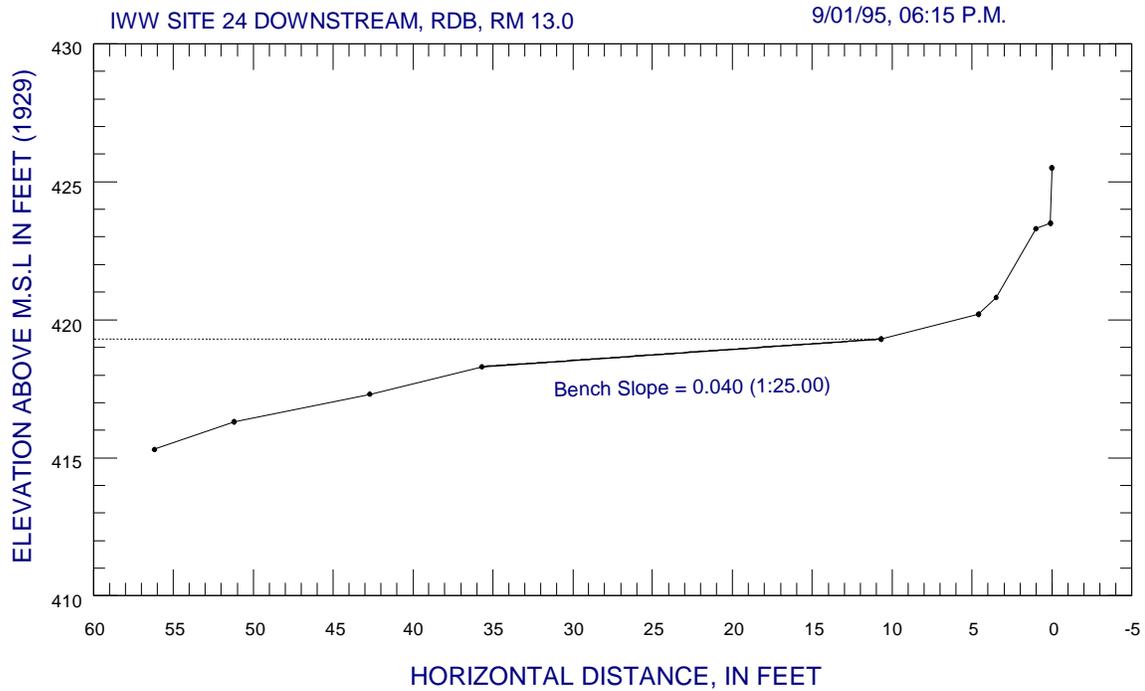
Figure 6-112. Bank sections at site 24

The bank characteristics are similar to those at other sites in the Alton Pool. Figure 6-112 shows the three measured bank sections and a reduced cross section. Land cover on the top and upper portion of the bank was dense seasonal vegetation, mostly above the water line. The sloping bank below the vegetation zone was bare; the base of the bare area was moist and algae was growing near the water's edge. The stage at the time of the survey was at about the 90% recurrence frequency stage. The subaqueous bench at the site was broader and flatter than the bench at site 23. The bench was covered with a layer of thick sediment in the nearshore area, but farther riverward the bench surface was hard. The stage analysis (table 6-34) indicated that the bare bank face was located between the 50% and 25% recurrence stages. The 50% recurrence stage, 420.3 feet, was at the base of the scarp.

Bench slopes varied slightly from 1V:25.0H to 1V:15.9H in this reach. The bank soils were cohesive. This site can be classified as a combination of types 2 and 5 (figures 6-19, 6-22, and table 6-4). Erosion processes could be traced as initiated by piping; debris-induced local currents and wave wash extend the erosion; rework and transport by waves and currents at various stages of pool-level fluctuation then remove the failed soils or recently deposited sediment.
