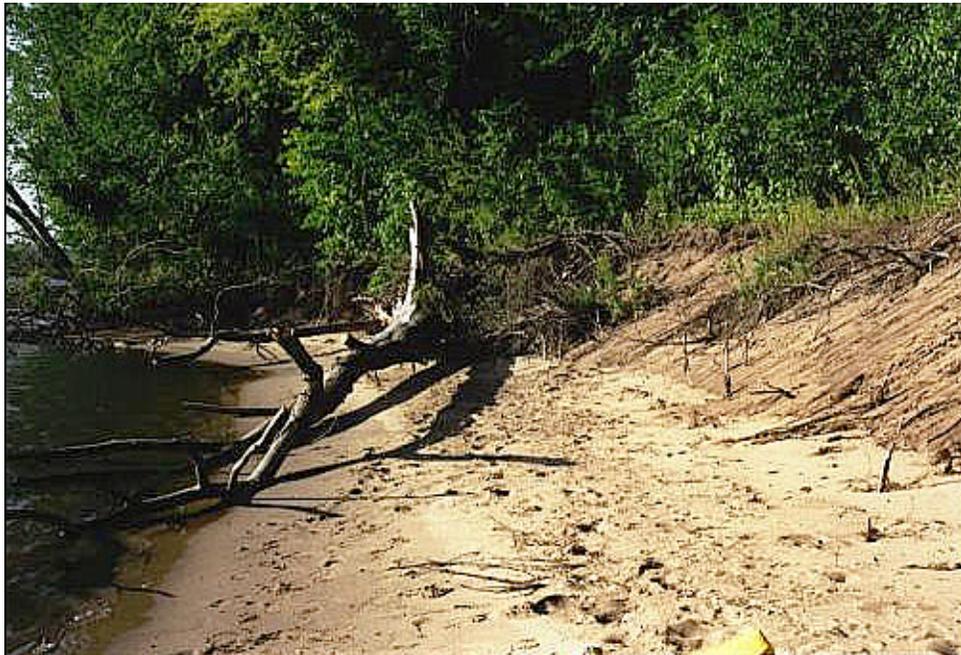
Primary causative factors for bank retreat at this site include flood erosion, wave and rework-transport within bench and berm areas, and minor piping. Because bench cover is primarily sand, erosion by traffic-induced waves was observed. This site is classified as bank Type E.

Photo 7-22 An upstream view of Site 7 midpoint

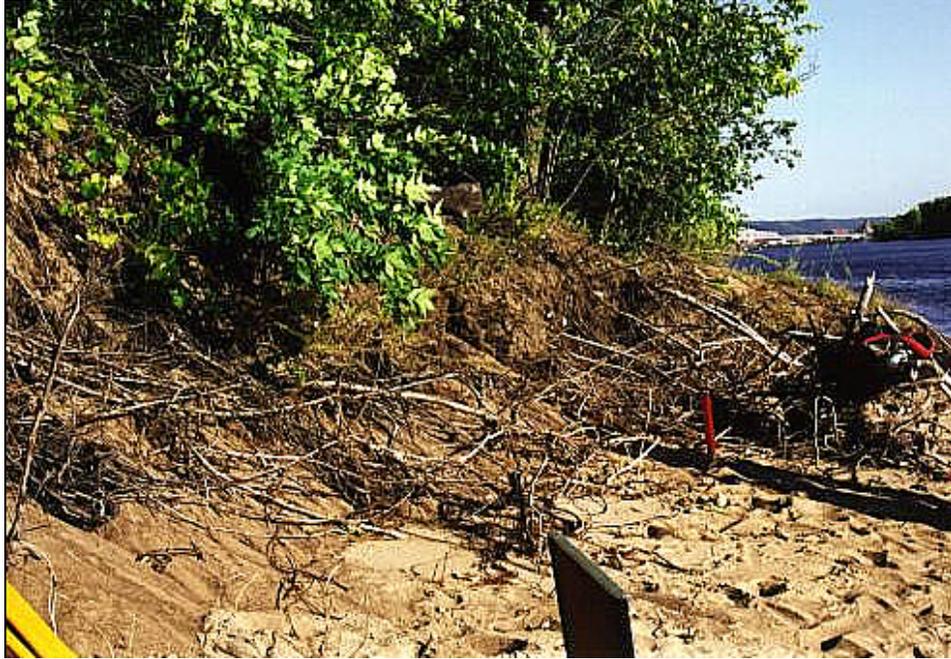
Photo 7-23 A down stream view of Site 7 midpoint

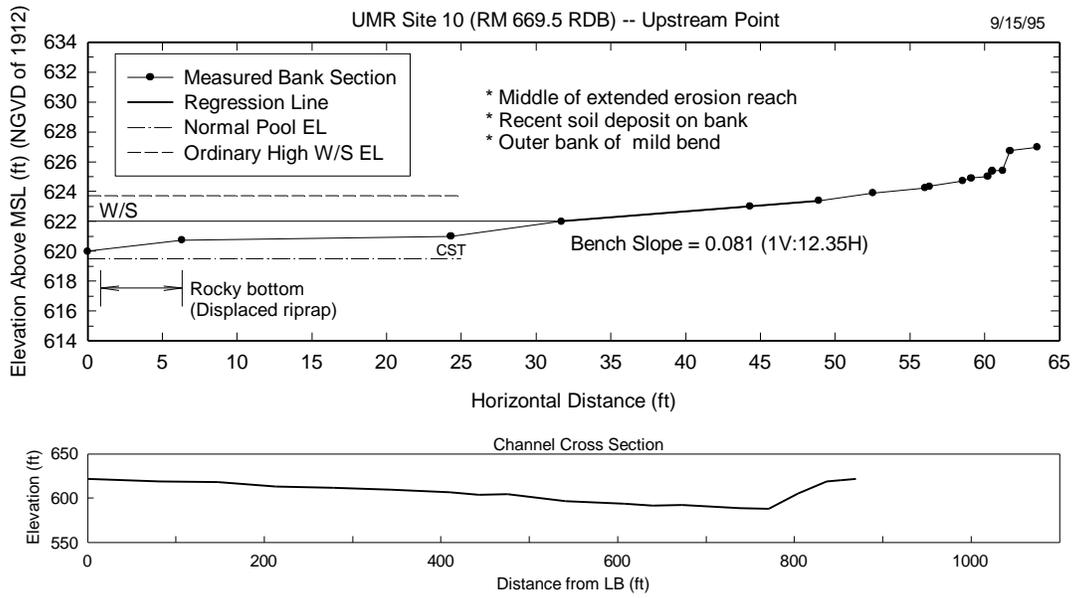
bench, which indicates that Site 10 is an active bank failure and erosion location. At the upstream section, a rocky bottom was observed about 30 ft from the water's edge (see figure 7-35).

Figure 7-35 Bank section and channel cross section measured at Site 10 upstream point

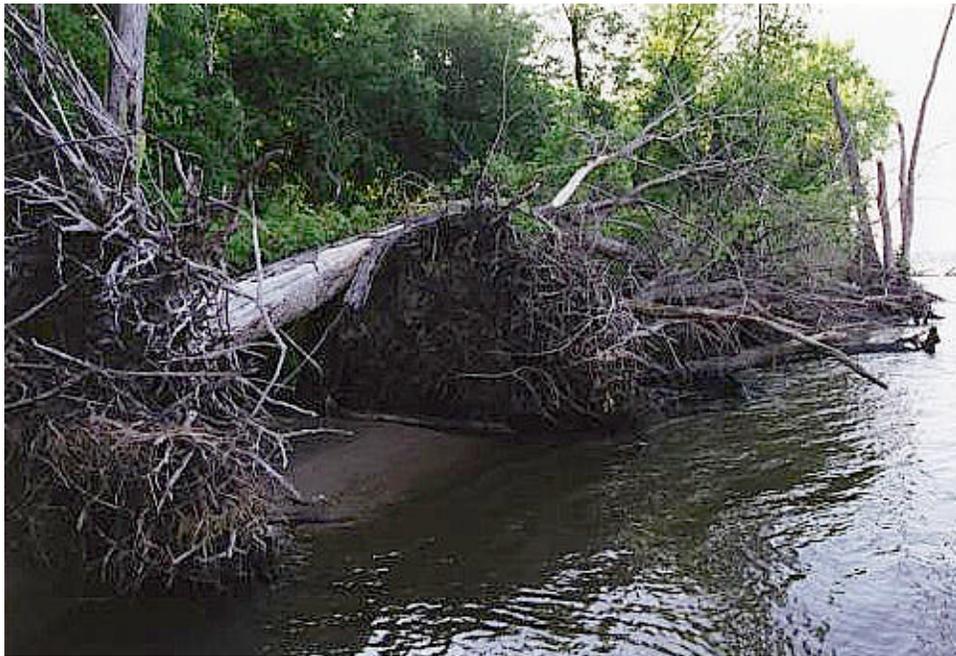
Photo 7-29 A downstream view of Site 11 midpoint

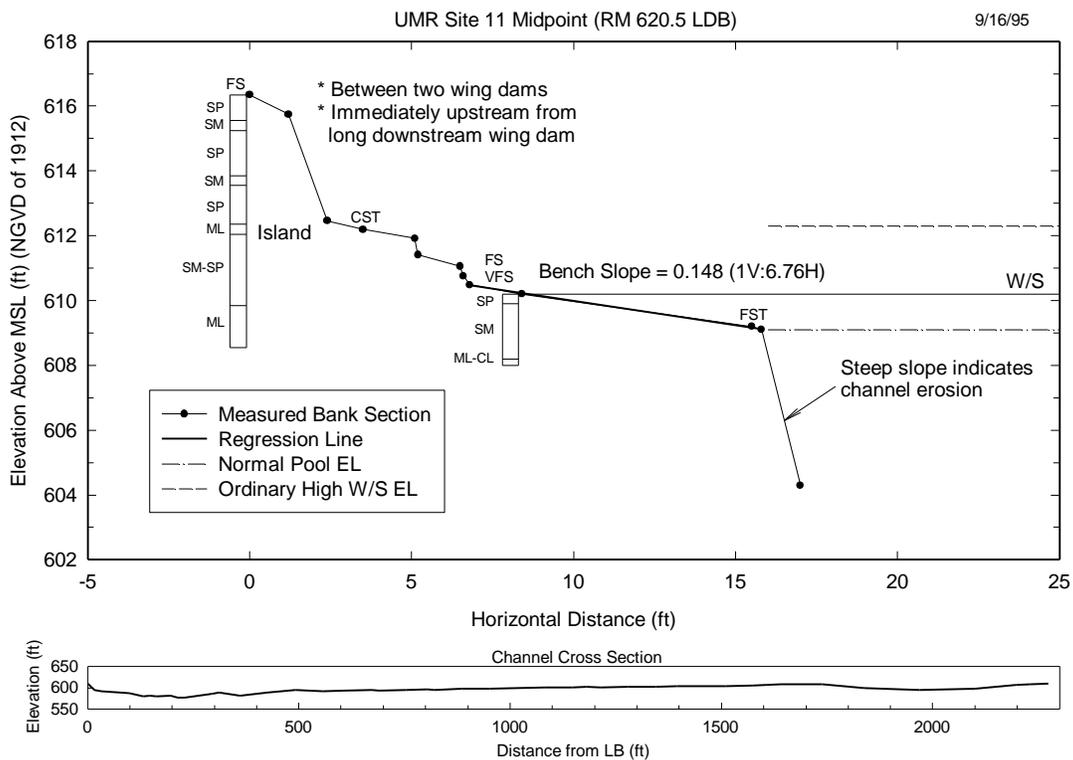
cross section in figure 7-40 seems to indicate that the thalweg developed along this left bank. It appears that the shorter upstream wing dam is not able to direct river flow

Figure 7-40 Bank section and channel cross section measured at Site 11 midpoint

toward the main channel, which resulted in strong currents impinging on the longer downstream wing dam, eroding the subaqueous bank at the midpoint section. The bank section in figure 7-40 shows a sharp drop of the bed near the bank. At both the upstream and downstream sections, near-bank water depth was small. The bank soils consist primarily of coarse silt (CST) and sand (VFS-FS).

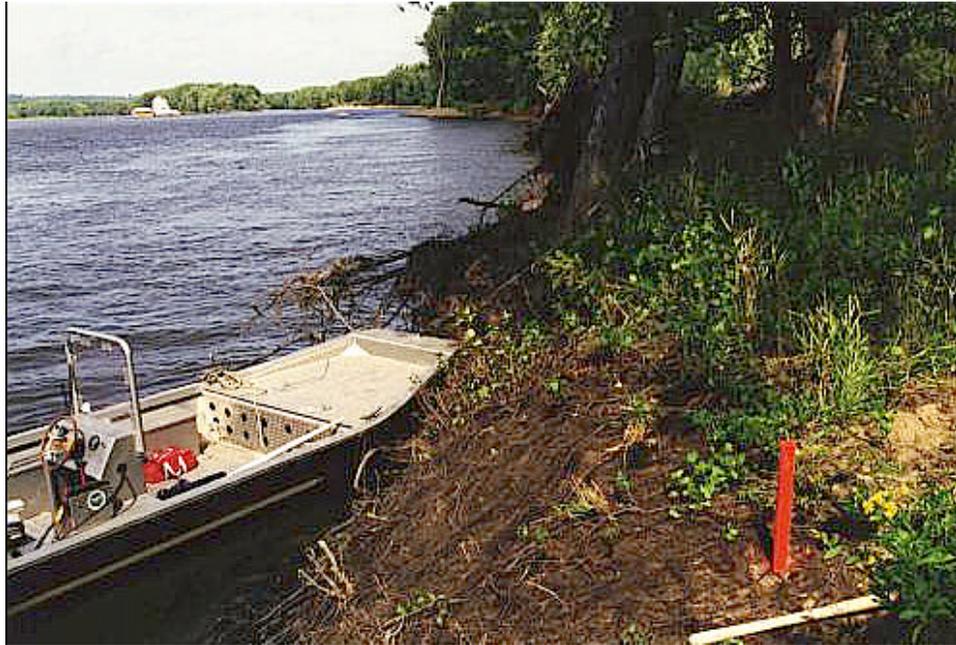
Photo 7-30 An upstream view of Site 12 midpoint

Causative factors for bank retreat at this site include flood damage which includes erosional oversteepening and rapid recessional loading and failure, wave and rework-transport of failed soils and recently deposited sediments within berm and bench areas, cleft pressures and block displacement, and minor piping. There is potential for traffic-generated wave erosion at this site. This bank section is classified as a combination of bank Type E and Type F.

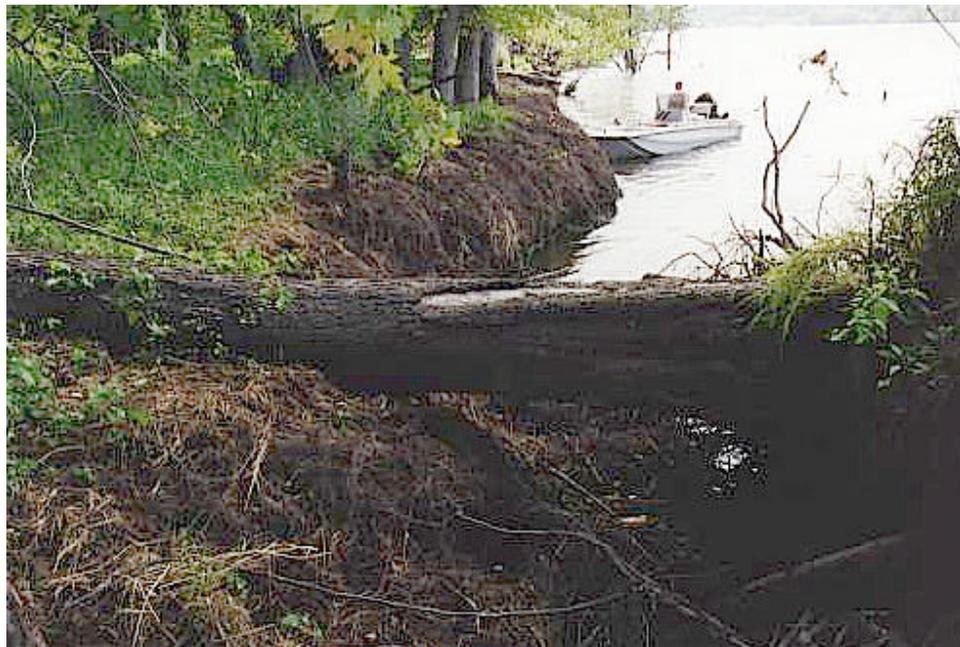
Photo 7-31 A downstream view of Site 12 midpoint

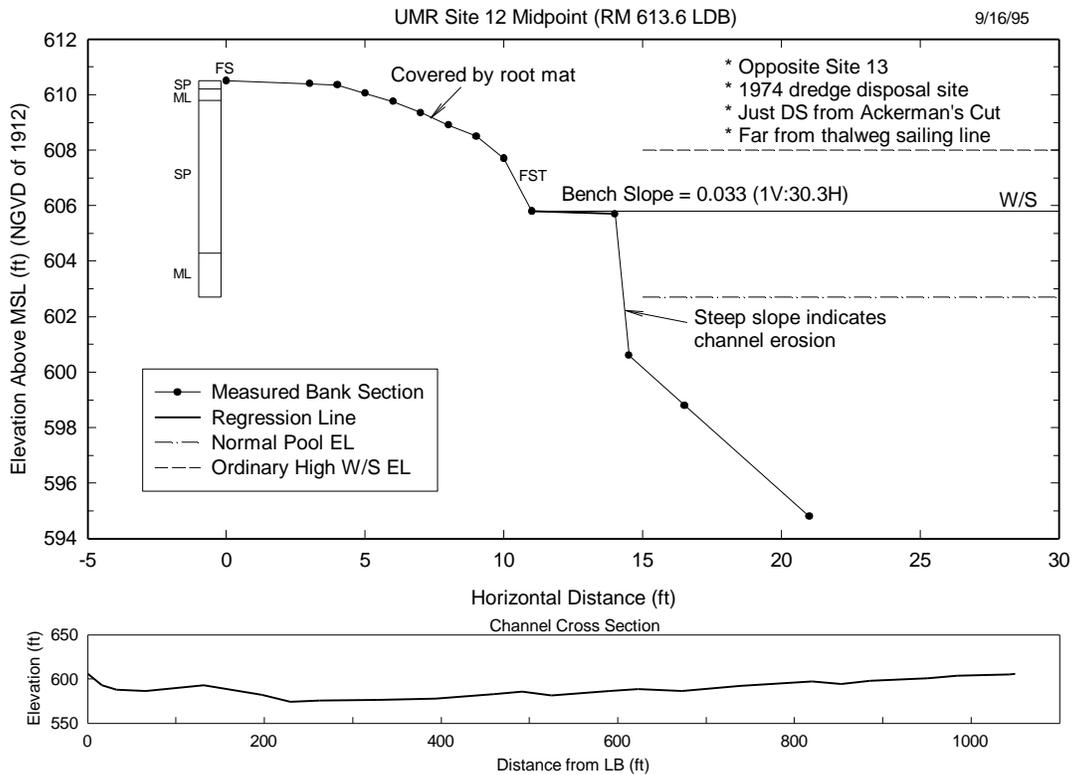
Figure 7-44 Bank section and channel cross section measured at Site 12 midpoint

7-43 through 7-45. Bank retreat at Site 12 since 1984 is apparent in figure 7-42. As can be seen in figure 7-44, the thalweg is very close to this left bank, and evidence of severe channel erosion was observed at the site. This site was a dredged material disposal site. At the upstream section, failed revetment rocks were found adjacent to the water's edge (see figure 7-43). Since the upper end of Cassville Slough (eastern limb of the MR) was closed when Lock & Dam No. 10 was completed in 1938, the new MR channel flow, downstream from the dam spillways located on the west side of the river, had a tendency to return to the old channel slough, resulting in Ackerman's Cut. According to Nakato (1983), as much as 28 percent of the river flow was passing through Ackerman's Cut, causing reduction of sediment-transport capacity of the main channel and transport of sediment into the slough. In order to protect the fishery resources of Cassville Slough and to reduce dredging requirements in the downstream navigation channel, the COE-RID constructed partial closure structures in Ackerman's Cut in 1985. A post-construction study was conducted in 1986 and it was found that the flow diversion rate was reduced to 18 percent from the previous 28 percent (Toda and Nakato 1987). The bank was covered

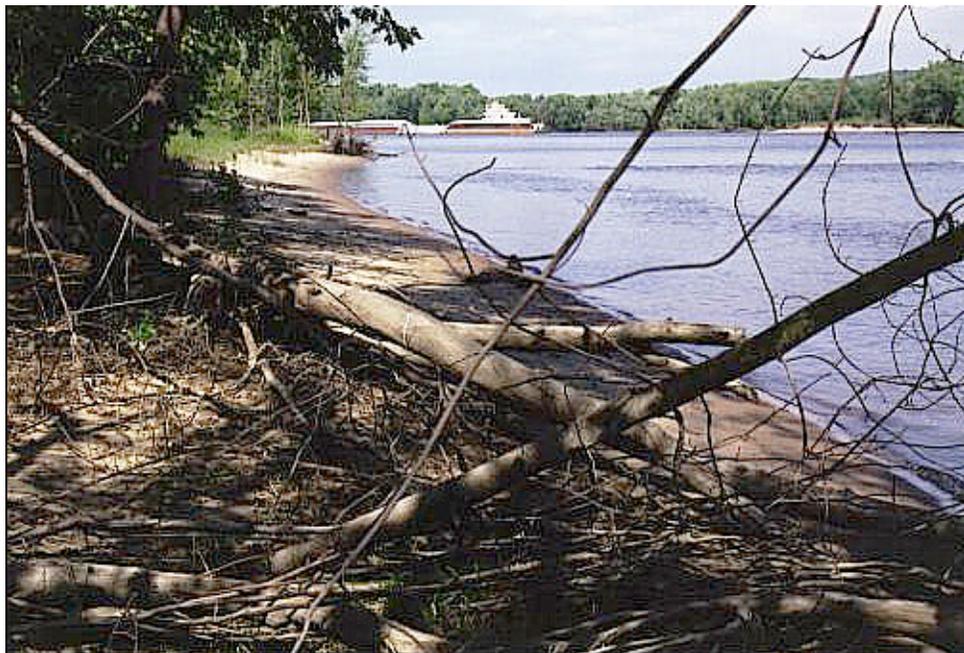
Photo 7-32 An upstream view of Site 13 midpoint

Causative factors for bank retreat at this site include piping failure, and wave and flow rework-transport of recently deposited sediments in bench areas. This site is classified as bank Type E.

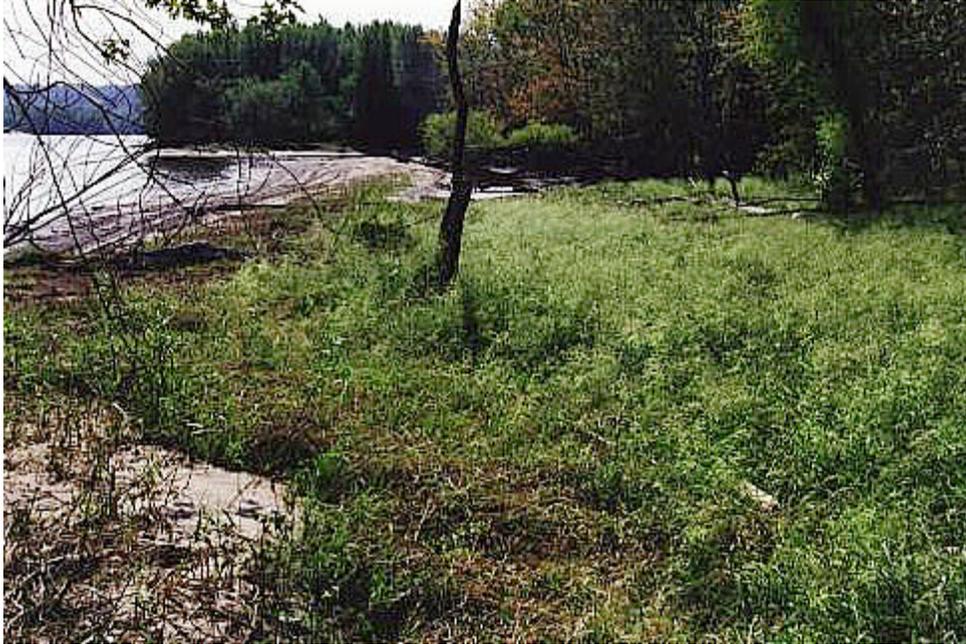
Photo 7-33 A downstream view of Site 13 midpoint

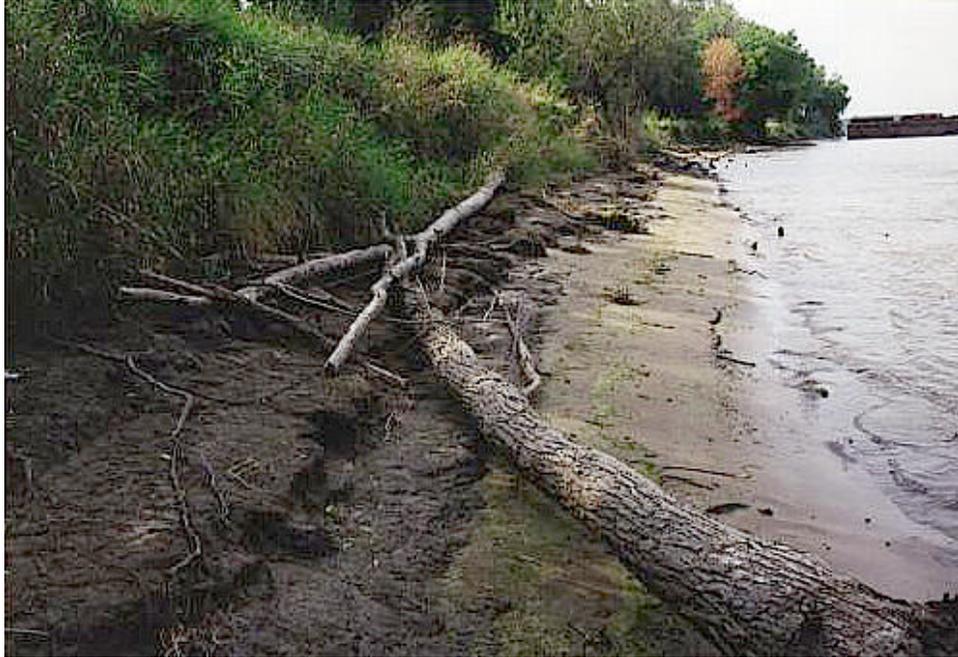
Photo 7-34 An upstream view of Site 14 midpoint

50. The bank soils consist of fine silt (FST) to coarse silt (CST). Fallen soil blocks were observed at the base of the scarp, and piping features were observed within the bank scarp as well as at minor scarps within the berm and bench rework-transport zones. As can be seen in figure 7-49, the surveyed river cross section is atypical for a river bend because the site is located near the upstream end of the bend.

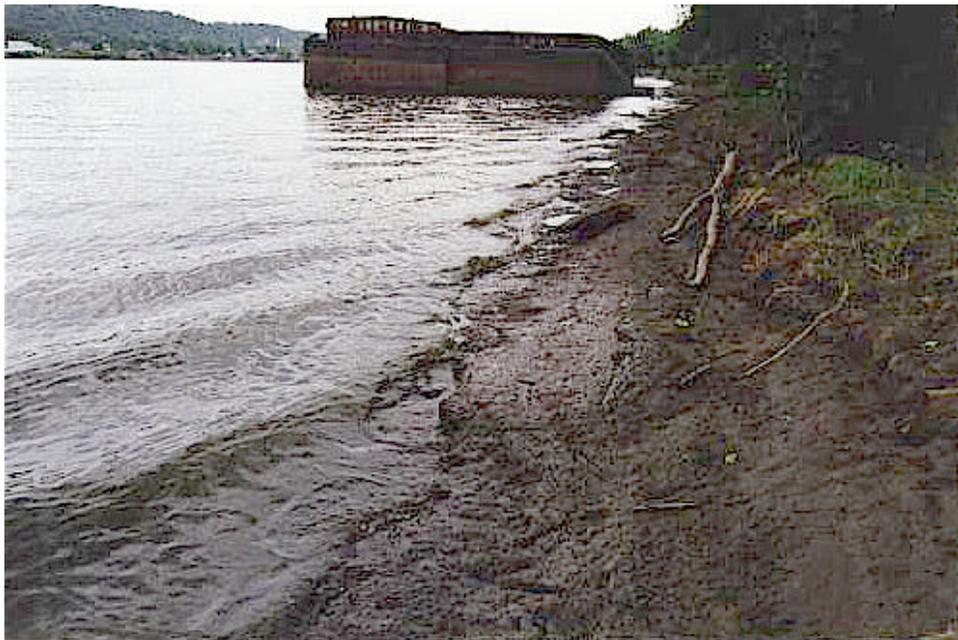
Photo 7-35 A downstream view of Site 14 midpoint

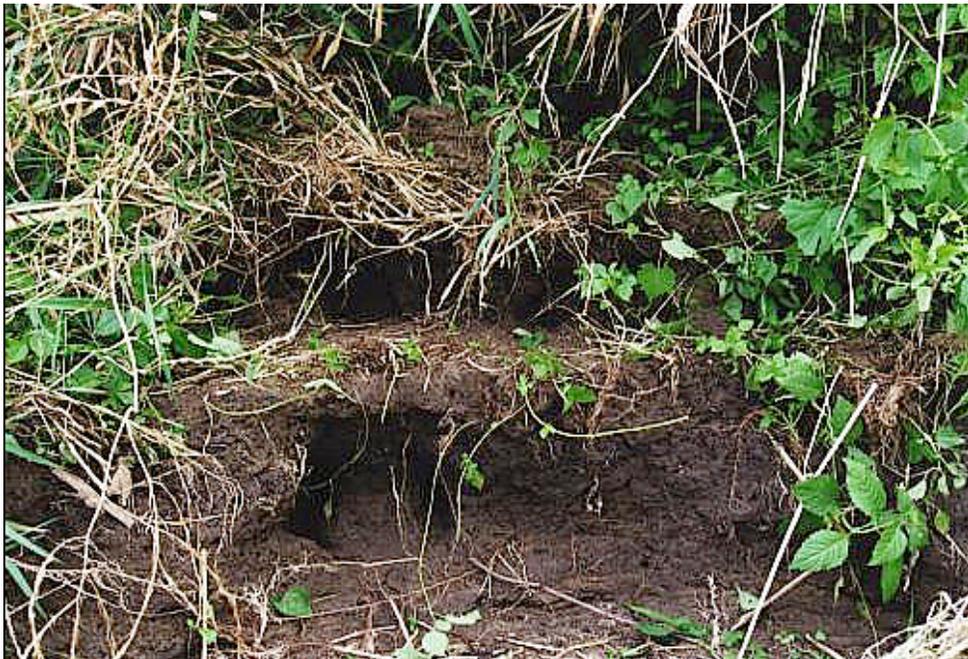
Photo 7-36 Piping feature of Site 14 midpoint
