Guttenberg Waterfowl Ponds Habitat Rehabilitation and Enhancement Project Evaluation Report

Upper Mississippi River Environmental Management Program

Guttenberg Waterfowl Ponds HREP

2010 Annual Inspection Report

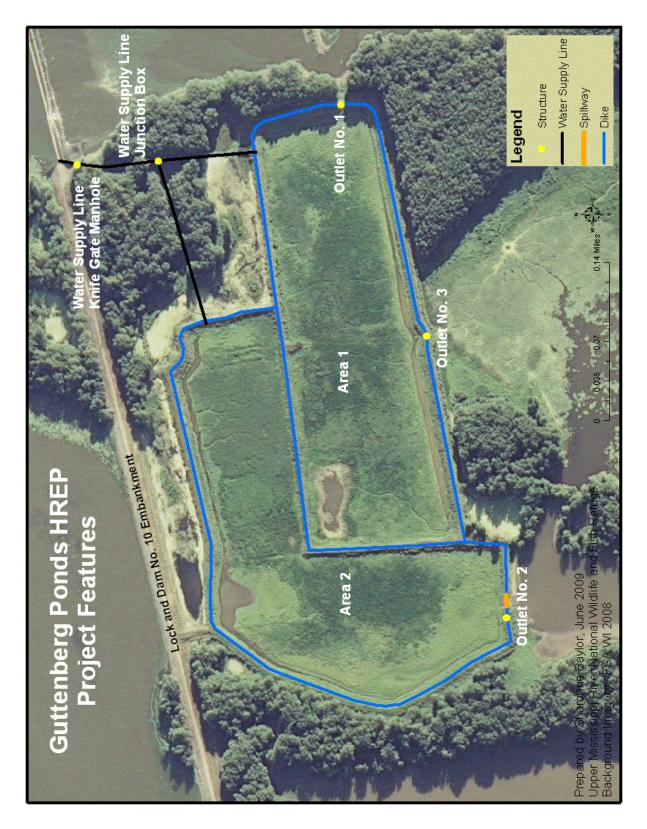
Figure 4. Final Project Plan View (prepared by Sharonne Baylor, FWS, June 2009)

Overtopping by high water in 1993 and 1996 resulted in erosion in the Pond 2 dike where it crosses Deadman's Slough (near Outlet 2 on Figure 4). Settlement in this area creates a low spot where water crossing the dike eroded the sand sediments with which the dike was constructed. To alleviate this problem, a rock overflow section was placed in this section of the dike in October 1996 at a cost of \$29,000. Another floodwater overflow spillway was added to Pond 2 after the 2001 flood. Outlet 3 was repaired by the Corps after flooding in 2003 at a cost of \$19,800. Table 4 provides the history of major disturbances.

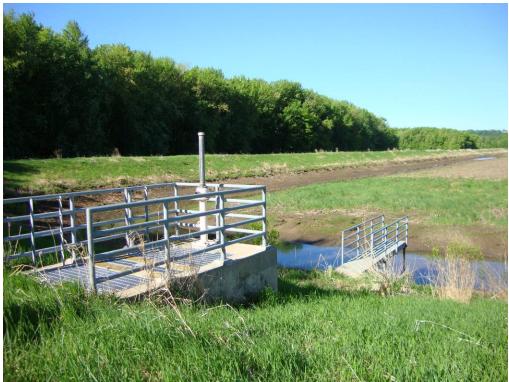
Photo 1: Outlet No. 1 looking southwest. Area 1 dewatered.

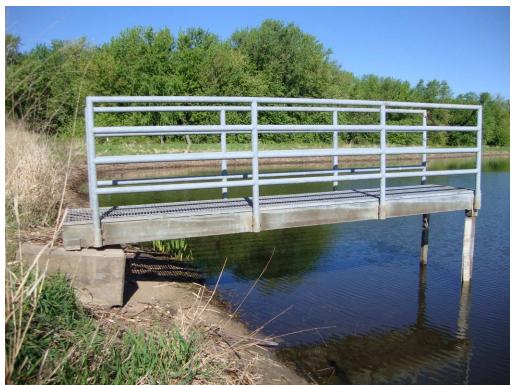
Photo 5: Outlet No. 2 walkway upper footing undermined.

- 1. Repair Outlet No. 2 walkway upper footing.
- 2. Repair Outlet No. 1 broken bracket bolt.
- 3. Replace Outlet No. 2 broken stem cover plexiglass.
- 4. Repair water supply line broken brackets and missing bolts.
- 5. Replace apron on end of water supply line Area 1 outlet.
- 6. Add support below water supply line pipe between wingwall and knife gate.
- 7. Remove sediment and debris from knife gate structure.
- 8. Inspect inside of structures and gates in fall when moving gates.

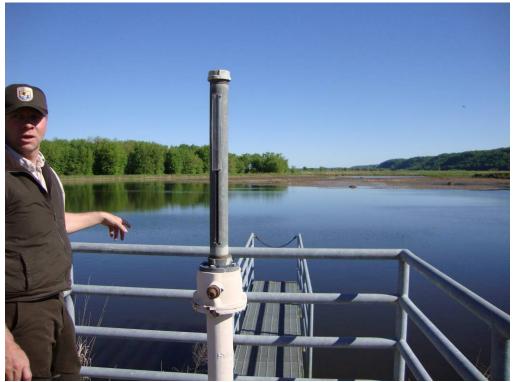
Photo 6: Outlet No. 2 broken Plexiglas on gate well stem cover. Yager.

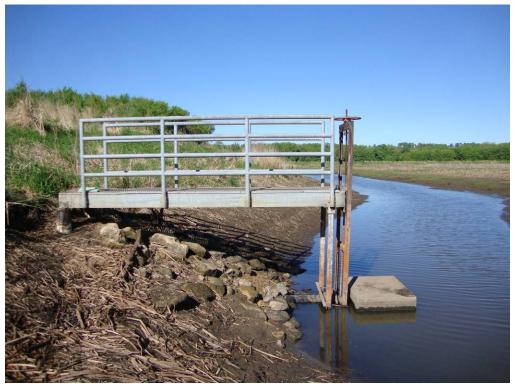
Photo 8: Outlet No. 3, looking west. Area 1 dewatered.

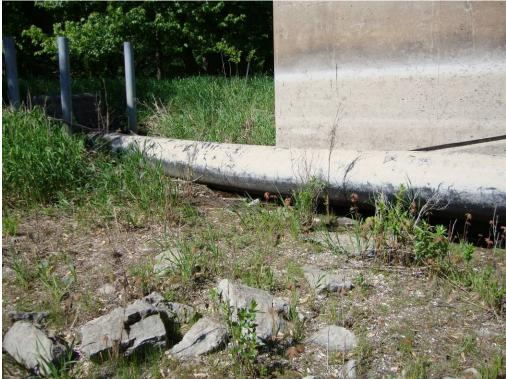
Photo 10: Water supply line looking toward manhole. Losing support underneath this portion of pipe.

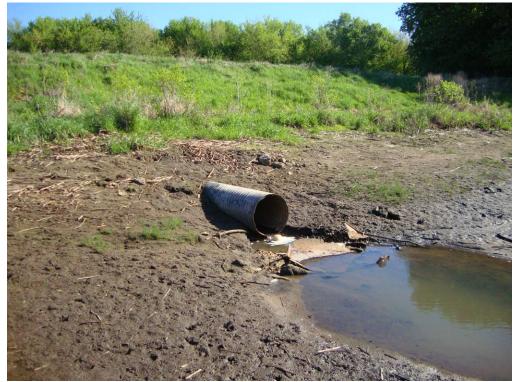
Photo 12: Water supply line, outlet into Area 1. Apron rusted and no longer on end of pipe.

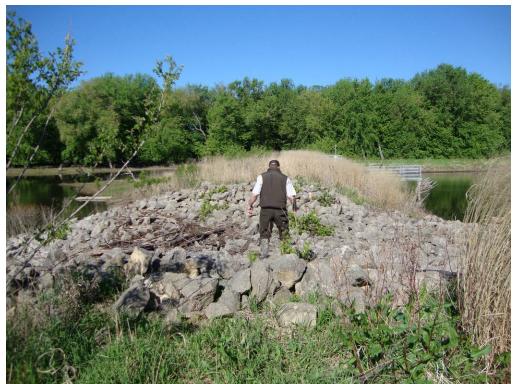
Photo 13: Spillway looking west. Yager.

Outlet No. 3	Structure is in good shape. Grating and handrail ok. No erosion around structure. Photo 8.	Inspect inside of structures and gates in fall when moving gates.			
Water Supply Line	Broken brackets and missing bolts on supply pipeline next to Lock and Dam No. 10 spillway wall. Appears pipe losing groundline support between wingwall and manhole.	Replace broken brackets and missing bolts. Add support below pipe.			
	Knife gate structure interior has debris and vegetation growing in it. Area 1 pipe outlet apron rusted off end of pipe. Junction Box structure ok. Photos 9-12, 14.	Clean knife gate structure interior. Replace Area 1 pipe outlet apron. Inspect inside of structures and gates in fall when moving gates.			
Spillway	Spillway rock in place and free of woody vegetation. Photo 13.	Continue to keep woody vegetation out of spillway rock.
