**UPPER MISSISSIPPI RIVER RESTORATION
ENVIRONMENTAL MANAGEMENT PROGRAM
POST-CONSTRUCTION
FINAL PERFORMANCE EVALUATION REPORT
2013
POOL 9 ISLAND
HABITAT REHABILITATION AND ENHANCEMENT PROJECT**

POOL 9

RIVER MILE 655 TO 656

CRAWFORD COUNTY, WISCONSIN

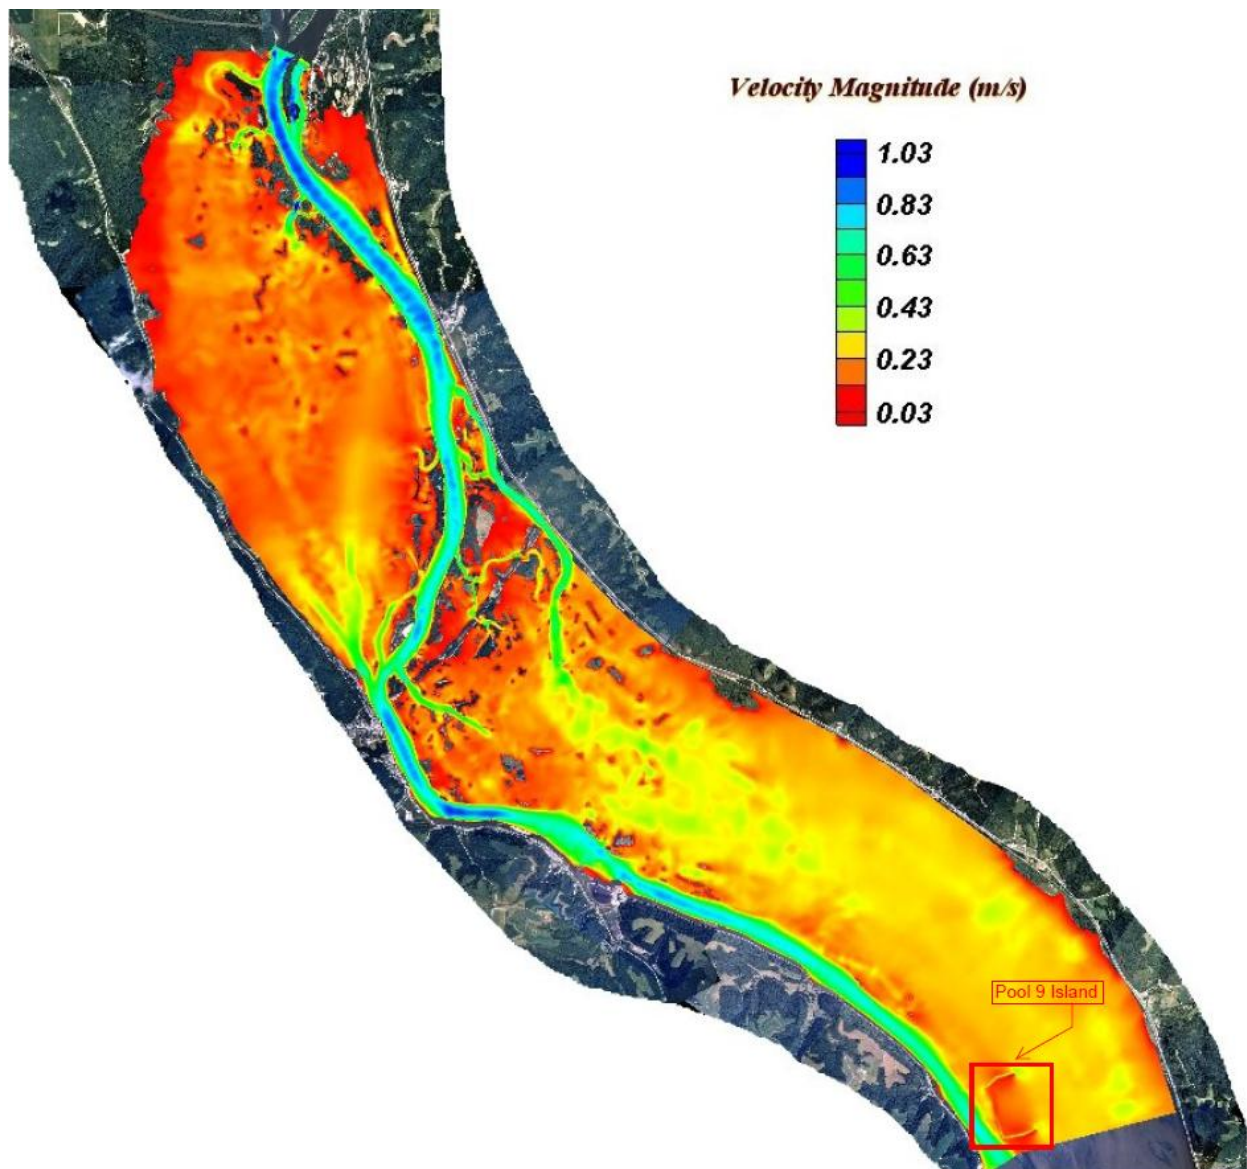
Figure 3. Pool 9 flow velocity with moderate flow conditions

Pre- and Post-Project Conditions. The plant beds and deeper areas in the project area were historically afforded protection by islands that bordered about 3,000 feet of the main navigation channel of the Mississippi River in the study area. The remaining islands prior to construction had an estimated total area of less than 1 acre at normal pool. Pre-project flow measurements obtained in 1992 indicated that 5- to 6-percent of the total river flow was conveyed through the project area. These measurements were taken along three transects within the project area; these were roughly parallel to and about the same length as Islands A and B. The flow direction observed during these measurements indicated that flow was from Winneshiek Lake and the upstream Capoli Slough area rather than from the main channel as had been the assumption. This was confirmed through the inspection of aerial photography. The velocity range for the low flow measurements on 27 August, 1992 was 0.2 to 0.5 fps, and for the higher flow measurements on 23 September it was 0.4 to 0.8 fps. The newly-constructed island complex parallels the main channel for 3,000 feet and extends into the backwater about 1,600 feet at the upper end and 1,900 feet at the lower end as shown in Figure 2. Post-project flow measurements have not been obtained in the project area. However, based on the fact that these islands are a barrier to flowing water, the amount of flow through the project area was certainly reduced for low flow conditions. Figure 3, which shows flow velocity for a moderate flow condition, indicates that velocity is reduced in the vicinity of the Pool 9 Islands compared to the areas around it. The reduction in flow has contributed to the expansion of SAV in the project area.

Conclusion. The project measures were successful in reducing flows since the combination of the islands function as a barrier to flow. The island barrier has protected the plant beds in the project area from being uprooted by wave action and high sediment laden flows, and has allowed the vegetation to stabilize and grow. The measurable objectives have been achieved and no additional actions are required for this objective. The rockfill island complex has not required very much maintenance; although it should continue to be monitored periodically for repair and maintenance purposes.

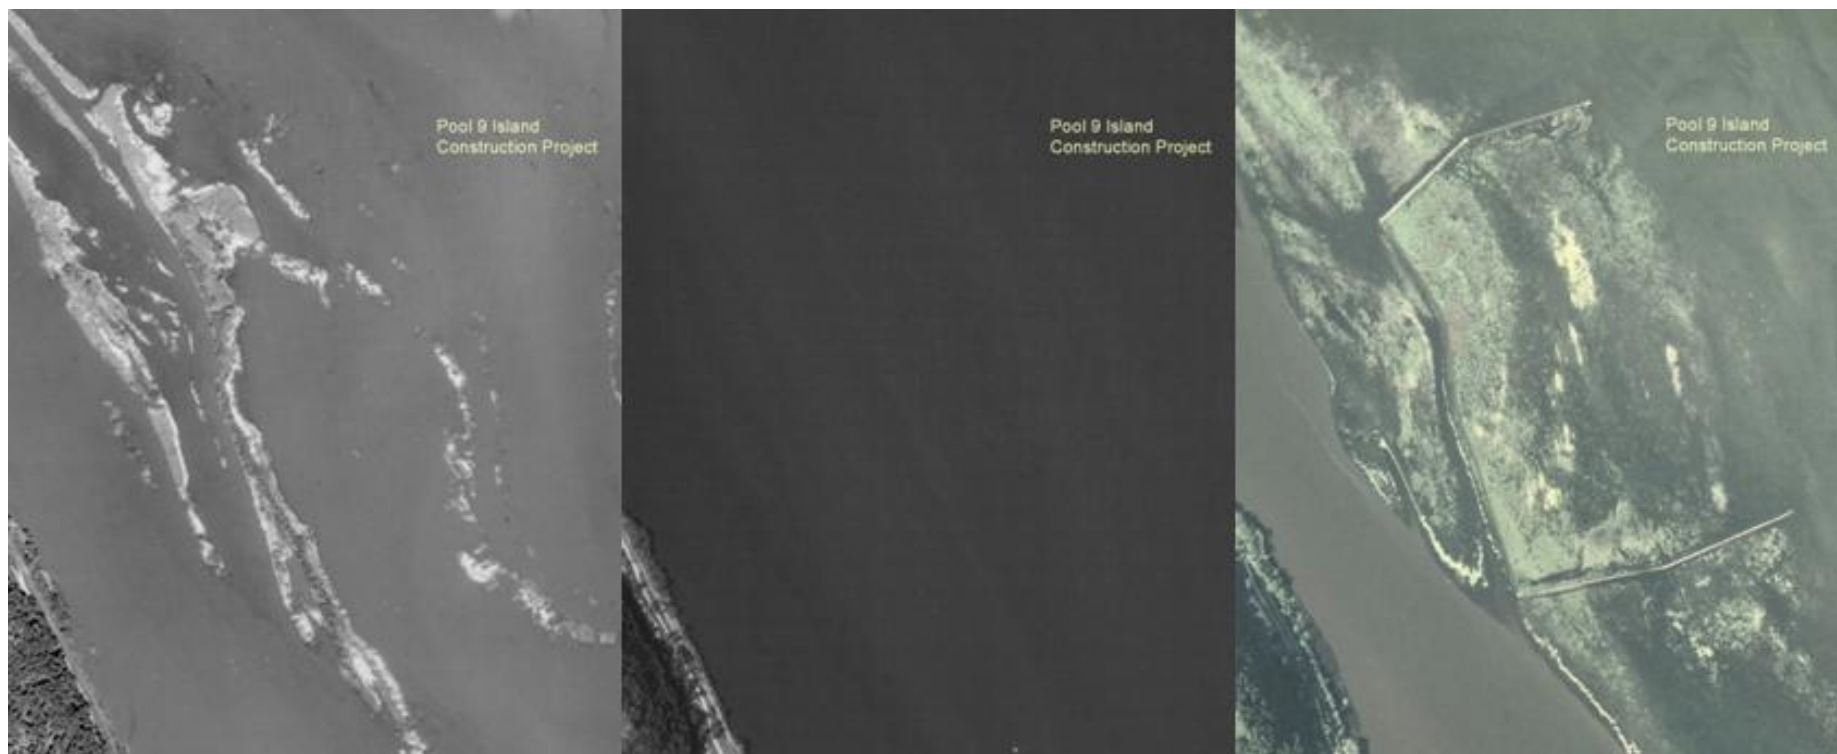
Figure 4. Island landmass in the 1950s (left), 1990s (middle), and 2009 (right)

Pre- and Post-Project Conditions. The continuing erosion of island landmass, as shown in Figure 4, was expected to contribute greatly and lead to the eventual loss of about 40 acres of submerged aquatic vegetation necessary in providing a shallow aquatic habitat for waterfowl and fish. This loss was being caused primarily by wave action and to a lesser extent from flow.

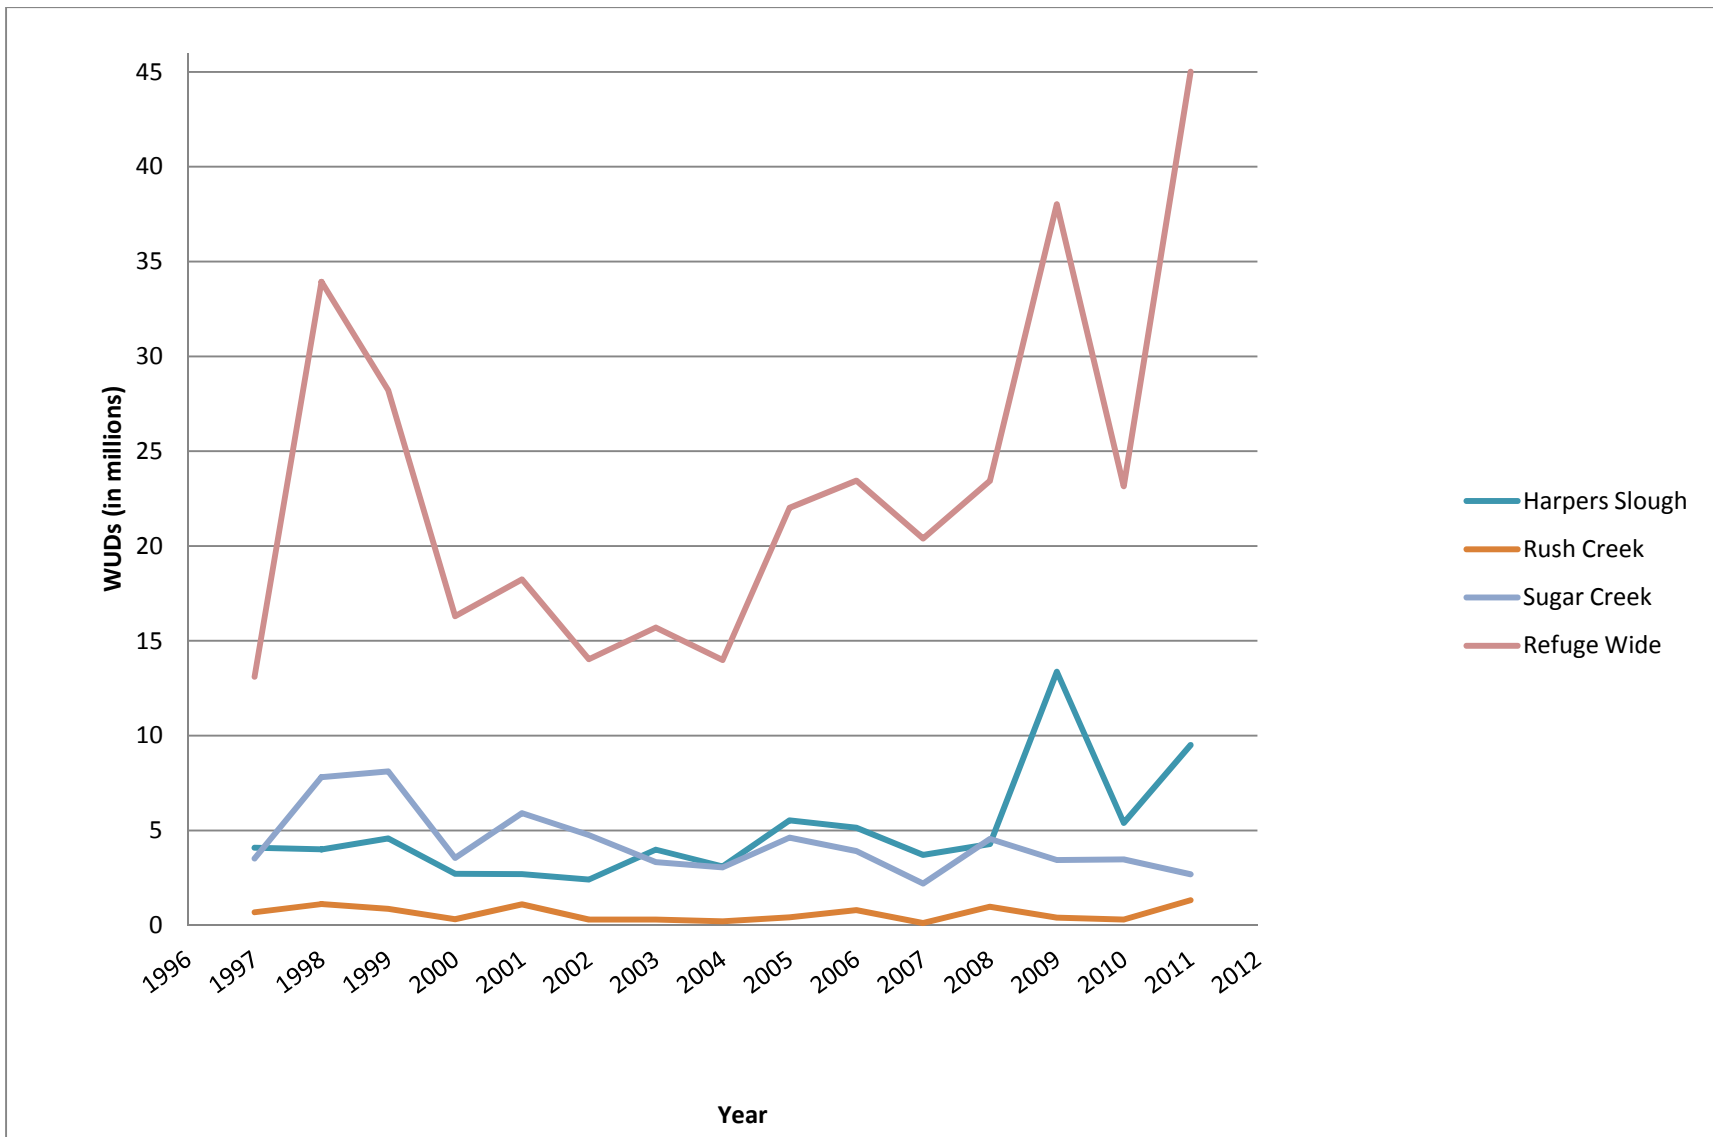
Figure 7. Waterfowl use at the lower Pool 9

The Waterfowl Use Days (WUD) data provided by the USFWS from 1997 to 2011 (see Figure 7) shows a relatively steady waterfowl utilization of the general project area. The data splits the Pool 9 refuge into four units as Big Lake, Rush Creek, Sugar Creek, and Harpers Slough, with the Pool 9 Island located in the Sugar Creek unit (see Figure 8). It should be noted that the Sugar Creek unit has had a slight decline in WUDs between 2008 and 2011, in comparison to the significant increase in WUDs at Harpers Slough during the same period. This difference could be attributed to several factors. One of those may be due to Harpers Slough’s increased vegetative area of influence during that period, and due to the unexpected growth and improvement in the vegetation in this area. This development could be attracting more

waterfowl to this unit than the Sugar Creek Unit does. Another reason may be due to Harpers Slough being a closed area for hunting, while the rockfill island in Sugar Creek unit is open for hunting. This could have impacted waterfowl staging patterns, causing them to use Harpers Slough more during the day than the rockfill island. The data graphed in Figure 7 shows the refuge, as a whole, has seen a relatively steady increase in waterfowl numbers. The Sugar Creek unit should be evaluated and monitored at a closer level to measure the waterfowl utilization of the protected project area with respect to its immediate environment.

Conclusion. The evaluation criterion was not clearly defined in the DPR, but appears to indicate that the terrestrial area of the constructed island was to be measured. Though the project seems to have been somewhat successful in providing migratory waterfowl habitat, the measure for determining success was 10 acres of island habitat and, using GIS tools, only 5.65 acres of island habitat was measured post-project (Table 5). The project measures did not meet the objective of creating 10 acres of island habitat for migratory waterfowl and therefore was determined to be unsuccessful.

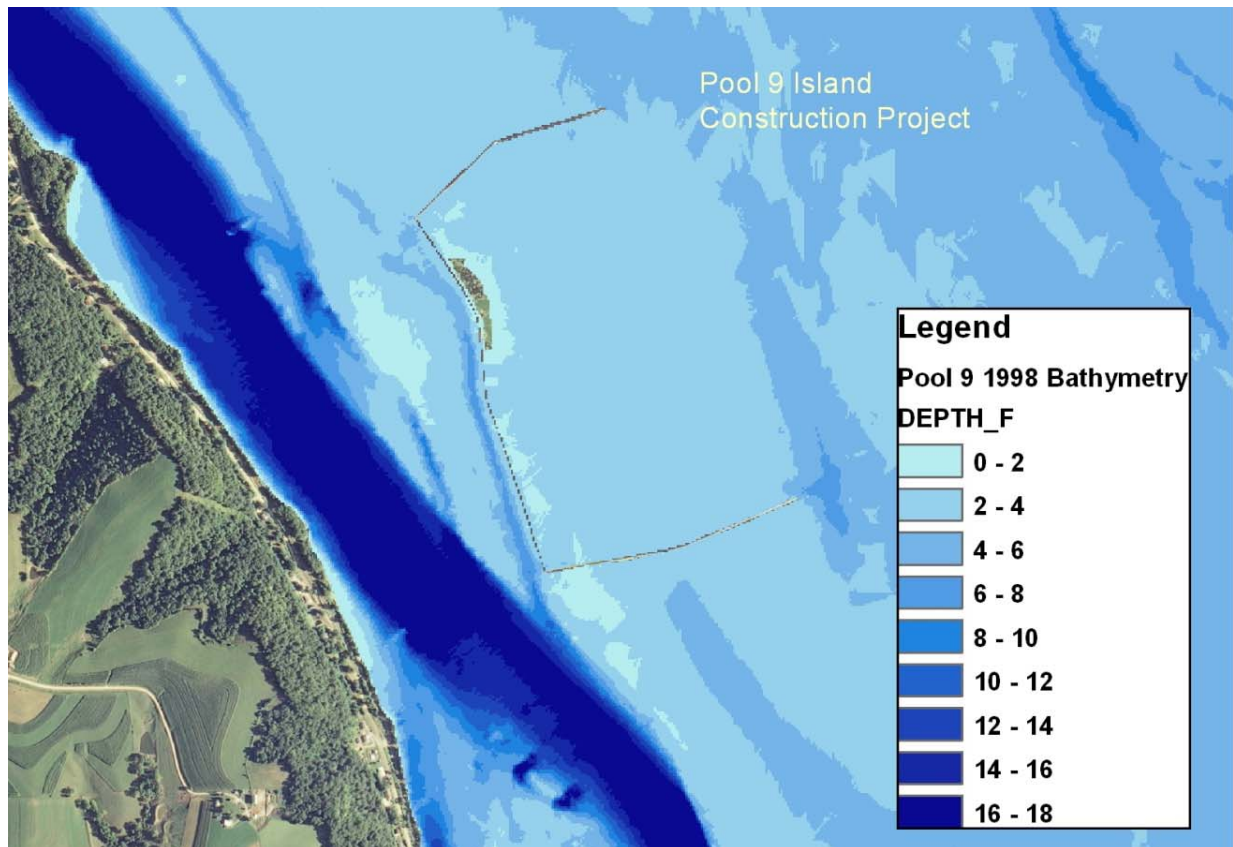
Figure 9. Bathymetry model at the Pool 9 island

Pre- and Post-Project Conditions. Prior to the island construction the average water depth in the area was recorded at 3 feet. The existing deep water habitat (depth of greater than 5 feet) prior to the project construction was considered to be about 5 acres, and was expected to decline to 0 without the project. The shallow areas were unsuitable for fish in the wintertime due to ice formation and possible oxygen deficiencies. The access channels, anticipated to be dredged for the island construction, were considered part of the design with the goal of providing deeper habitat for fish, and were specified to be about 65 feet wide and 6 feet deep. During construction however, the channels along the interior side of islands A and B were dredged to a depth of 4 feet because the contractor considered it to be sufficient for construction access. Furthermore, access to island D was provided through the old slough that existed adjacent to the channel. Bathymetry obtained in 1998 (Figure 9) shows the water depth to be in the 2 to 4 foot range throughout the backwater area protected by the island.

Conclusion. The project measures were not effective in creating the desired 7 acres of deep water fish habitat. The channels dredged during construction of islands A and B were not dredged to the original design depth of 6 feet. The access channels were only dredged to 4 feet and do not meet the design depth requirement of greater than 5 feet for suitable deep water fish habitat. The 1998 bathymetry shows the depth throughout the entire protected region inside the island complex to be between 2-4 feet, which is essentially the same as pre project conditions.

- vi. Lessons Learned & Recommendations: It is recommended that future contracts specify dredging depth when it is critical to the project objective. The contract indicated there would be access dredging but did not have specific depth requirements.
