**Rice Lake  
Habitat Rehabilitation and Enhancement Project  
Project Evaluation Report**

**Environmental Management Program  
for the Upper Mississippi River System**

April 2012

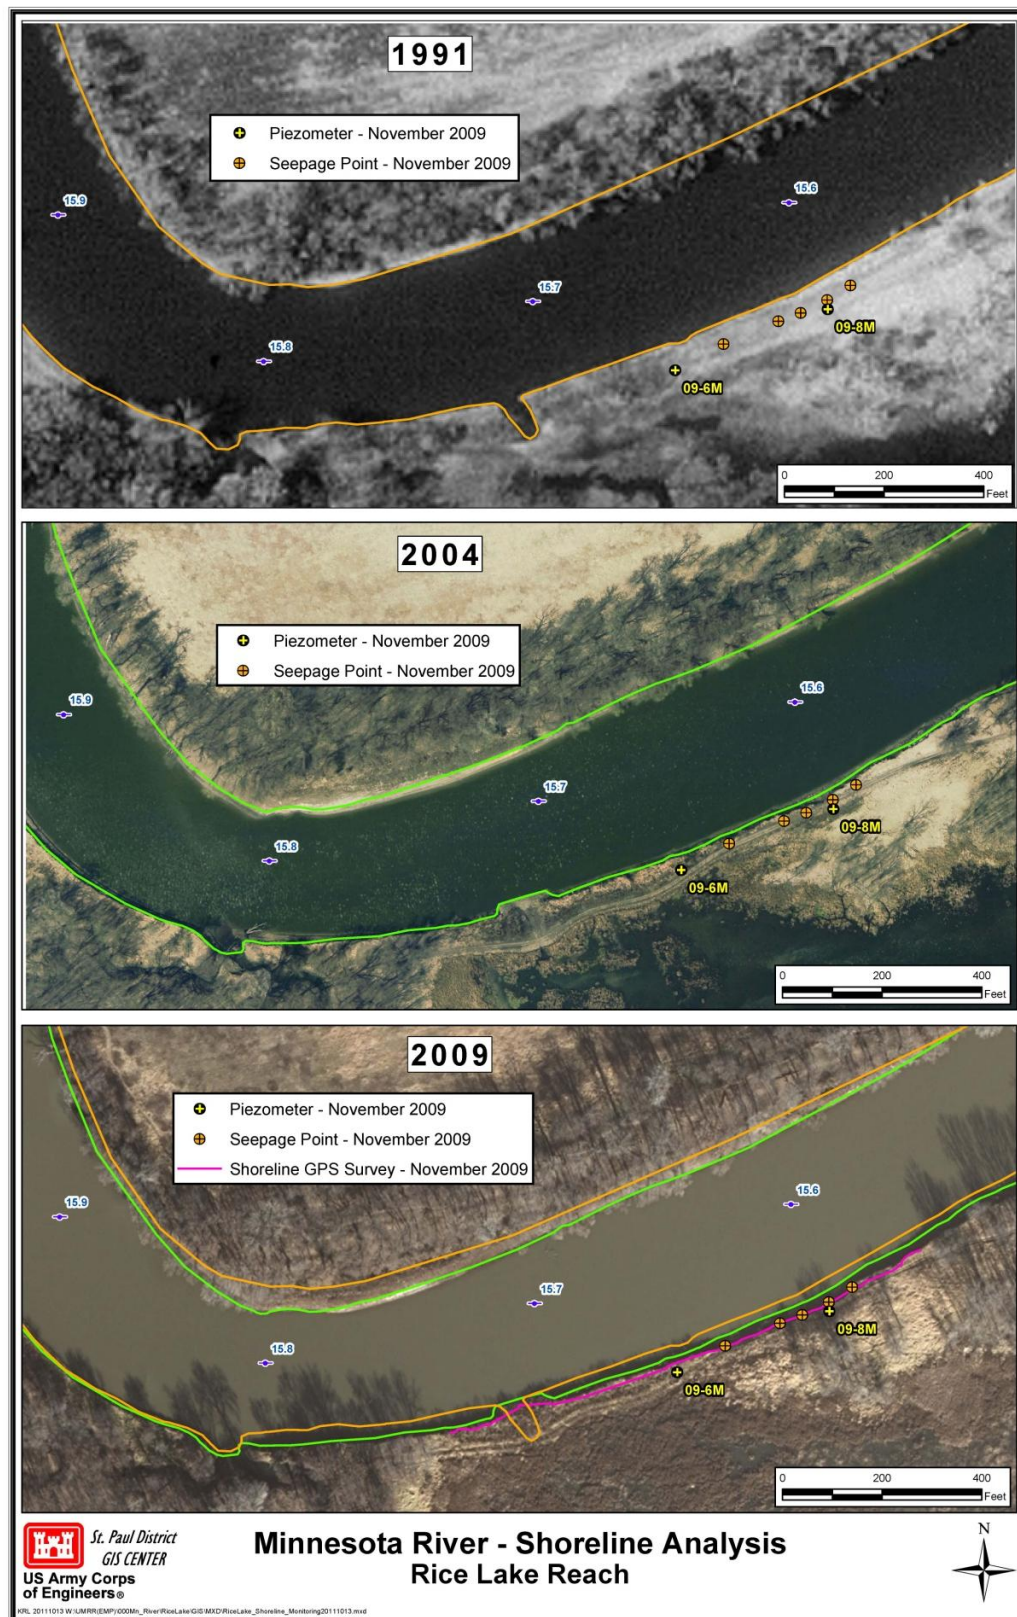
Figure 4 – Analysis of shoreline locations through time

Figure 3). The general pattern showed active shoreline erosion/deposition occurring in the immediate vicinity of bend areas and relatively stable shoreline locations in long straight areas (Figure 4). The analysis only showed that the pattern is relatively consistent throughout the reach and was not meant to quantify erosion/deposition rates or to identify factors contributing of the amount of migration/deposition in any given area.

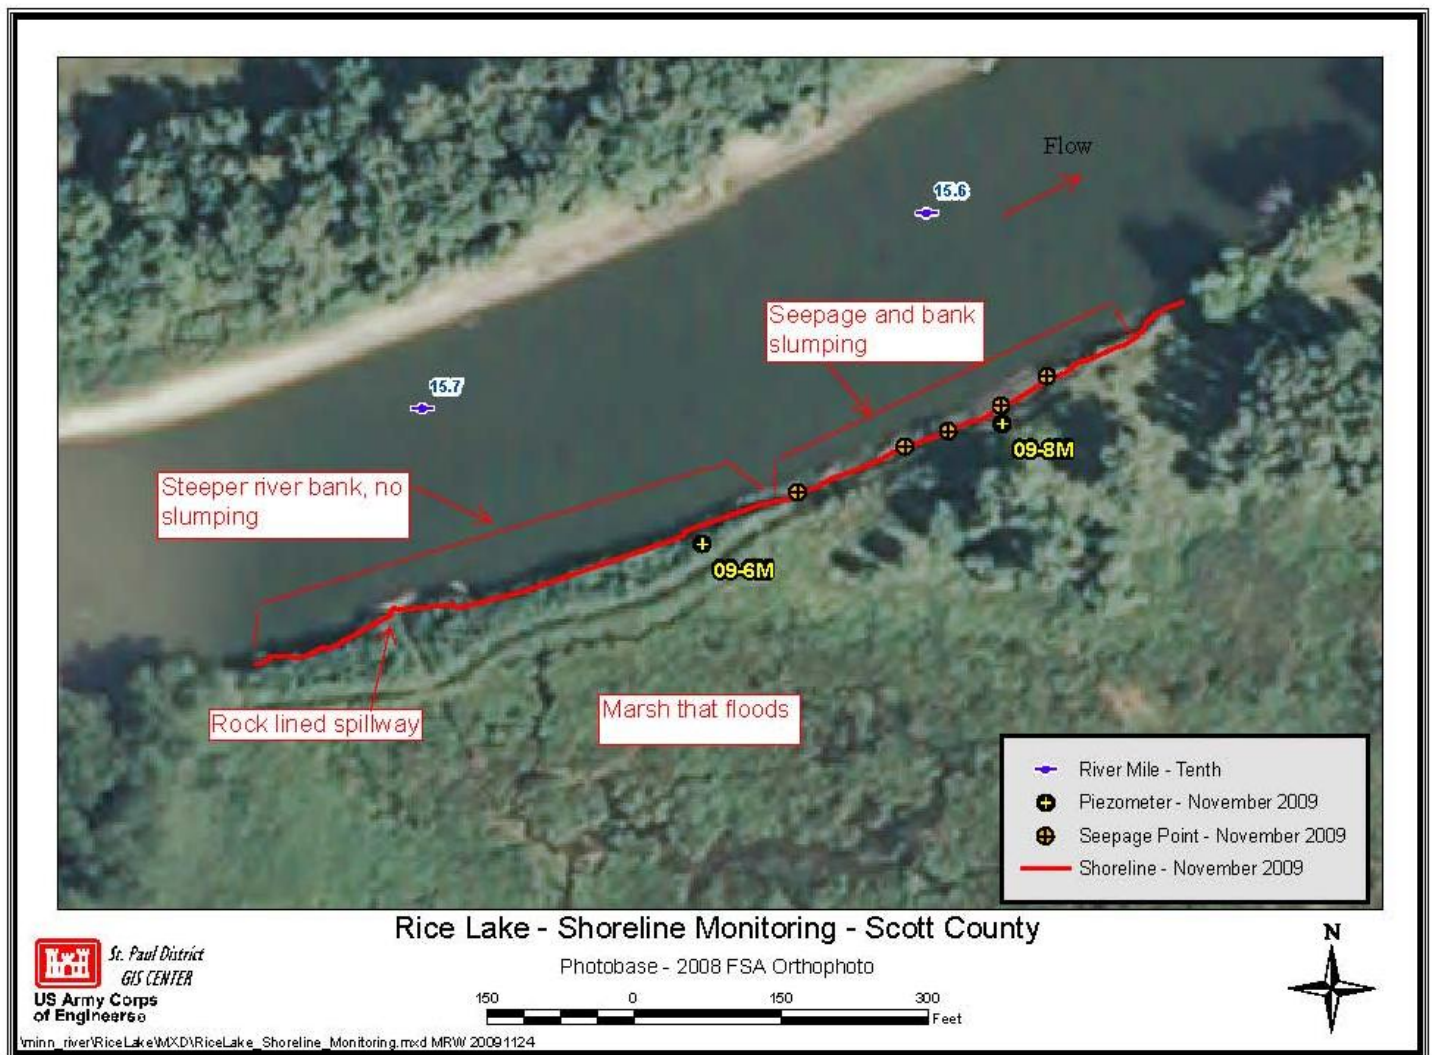
Figure 5 – MN River Bank Seepage Points and Locations

1. Upstream area – 600-feet long with steeper banks including scattered seeps close to the water line with approximately 30-feet of erosion.
2. Downstream area – 350-feet long showing approximately 39-feet of erosion and dominated by seeps and slumping soil units.

Four borings, labeled 09-5M through 09-08M, were drilled along the river bank; two 40-foot deep borings in the downstream area adjacent to the slumping bank and a 20 and 40-foot boring adjacent to the more stable steeper riverbank area. Borings, labeled 09-6M and 09-8M, were conducted along the project location: an upstream area and a downstream area, respectively. Figure 5 shows the seepage points and the locations of the piezometers. A pair of vibrating wire transducer piezometers were nested in each borehole and installed at 10-feet and 35-feet below ground surface (6P shallow(sh) and deep (dp)) and 8P sh and dp). Piezometers 6P sh and dp were installed in the berm foundation in the upstream area near the project overflow spillway where the river bank maintains a more vertical slope, and seepage is less pronounced. Piezometers 8P sh and dp were installed in the downstream area where the river bank has significant seepage, bank slumping, and a higher erosion rate. The borings showed very similar soils dominated by soft silty clay and organic clay. In the upstream area of the project, boring 6M, P had two sandy seams in the upper 5-feet of the soil profile. The downstream location, boring 8M, P had three thin silty sandy seams interbedded in a very soft silty clay layer within the upper 10-feet of the soil profile. Both Dataloggers and manual readings were employed to collect the data. Due to frequent flooding the monitoring period was extended beyond one year to account for lost data during times of flooding (Jorgenson, 2011; Appendix B).

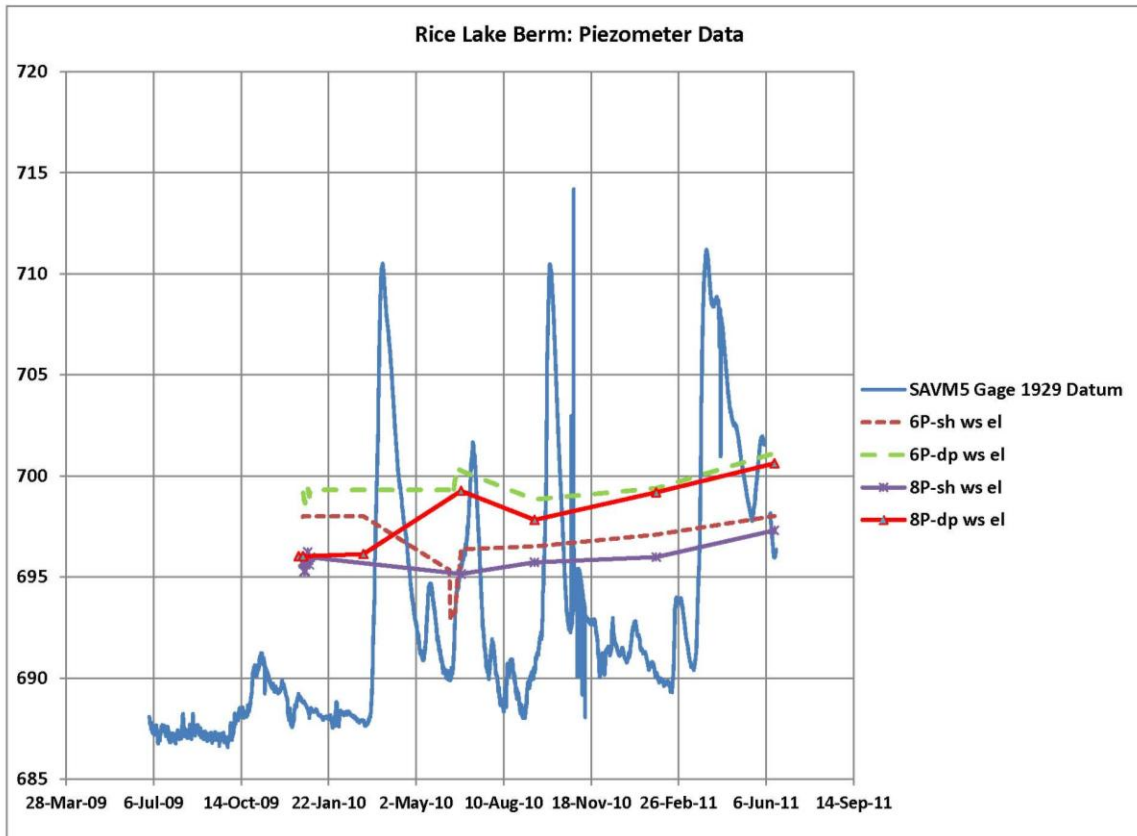
Figure 6 – Piezometer Data

The shallow piezometers (6P-sh ws el and 8P-sh ws el) seem to be influenced by the marsh water levels, showing little change when piezometric levels are 2-5 feet below the berm ground surface when there is no flooding (Jorgenson, 2011; Appendix B). The sandy seeps in the river bank are 3-6 feet below the top of the berm in the slumping area, and 5-8 feet below the top of the berm in the area showing a less pronounced rate of slumping and erosion (Jorgenson, 2011; Appendix B).

- The deep (dp) piezometers showed higher levels than the shallow (sh) piezometers
- Both pairs of piezometers, in the slumping and non-slumping areas showed similar responses to fluctuations in the river level

- Shallow or meteoric groundwater is likely due to the lack of iron staining in the seeps and soils that were sampled
- Additional piezometric data during times when the river level is low is needed and may offer additional insight on the slumping and erosion occurring

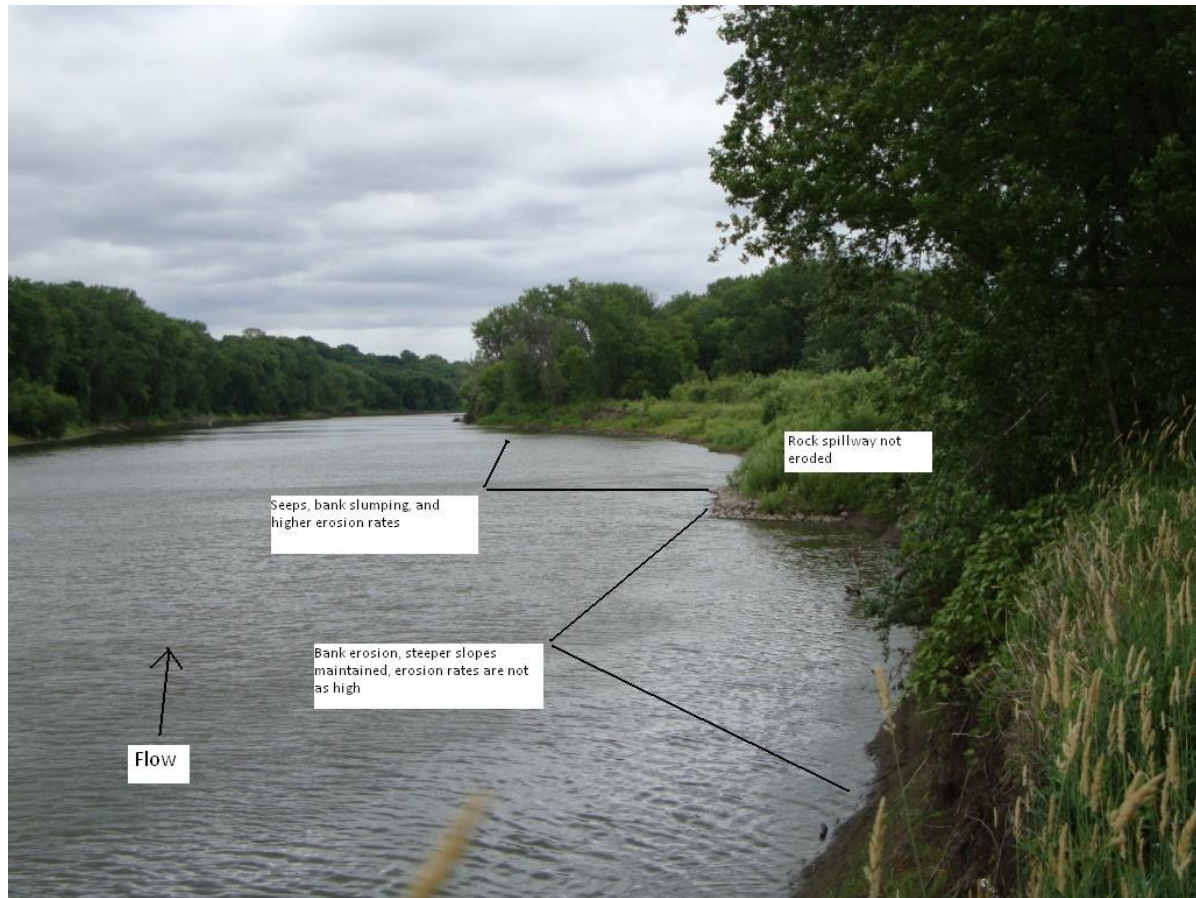
Figure 8 – Minnesota River Upstream and Downstream Areas

As of July 2009, the rock lined overflow spillway appeared to be intact and in good condition; although, vegetation clearing and sedimentation maintenance was needed (Jorgenson, 2011; Appendix B). Water levels within the marsh were found to be managed at a high level by a large beaver dam; typically within 2-3 feet of the top of the berm. As previously discussed in section 5.4.2, the soils along the Minnesota River bank in the project area are composed of a silty clay soil with fine sandy seams (less than 0.1' thick). These sandy seams located in various depths within the soil profile seem to be the source of the visible bank seepage in the slumping soils (Jorgenson, 2011; Appendix B). The slumping tends to be progressive and likely occurs when the river erodes the toe of the slumping soil. The 350-foot downstream portion of the project showed significantly more seepage than the 600-foot upstream area (

Figure 8). The areas along the river bank where seepage is greatest are also the locations with the greatest erosion. In most locations seepage was found to occur approximately 5 to 6 feet below the top of the berm (elevation 700), causing benching and downward soil mass movement/slumping (Jorgenson, 2011; Appendix B). The project area is just downstream of a sharp outside bend, so erosion is not unexpected; however, erosion has been occurring at a higher than expected rate. Typical erosion rates in this reach of the Minnesota River, based on the Design Memorandum and another private report (Wenck Associates, Inc., 2010) appear to be along the lines of 1-foot or less per year vs. the 2-feet or more that have been occurring at this site. Banks showing slope stability problems due to seepage tend to be prone to higher erosion rates, and can be further influenced by site specific field conditions that may alter averages (e.g. river level fluctuations, flooding frequency, hydraulic conditions, and soil conditions, etc.). The piezometric levels shown in the collected data (section 5.4.2) are typical of this environment; however, in combination of the seeps, saturated clay soils, and the velocity of the Minnesota River, these components all work together accelerating the slumping and erosion of the riverbank (Jorgenson, 2011; Appendix B). In addition, the ponded water seeping from the marsh and regional groundwater flowing toward the river provide a persistent source of groundwater for the seeps along the riverbank (Jorgenson, 2011; Appendix B).

The following recommendations and analysis are based on the 2010 USACE piezometer study findings. Riverbank erosion along the outside bend of the project location will continue to occur unless erosion protection is added or river flows are diverted from the river bank. An erosion protection design should include recent river cross sections and a slope stability review to account for the seepage and to assure adequate safety can be met. Although a “top of berm” survey was conducted in 2008, given all the high water events that have occurred in the last 2-3 years it is recommended that a new “top of berm” survey be conducted along the length of the natural levee/berm to verify the existing conditions prior to any remedial work. The top of the berm at the downstream area may now be lower than the rock berm spillway. Recent field observation from the last high water event has shown erosion to occur both parallel and perpendicular to the river bank. Overland flow from the marsh is likely enhancing the rate of erosion already occurring along the riverbank. Repairs to only manage the seepage would be incomplete due to the ongoing erosion along the riverbank; the sandy seams could be discontinuous and complex. Based on field observations it appears that portions of the natural levee (sand and silt deposits forming parallel to the river) may be starting to form landward of the existing eroding bank. Methods to increase the rate of formation of the new natural levee could be used or possibly adding material to the berm could prolong the life of this project (Jorgenson, 2011; Appendix B).

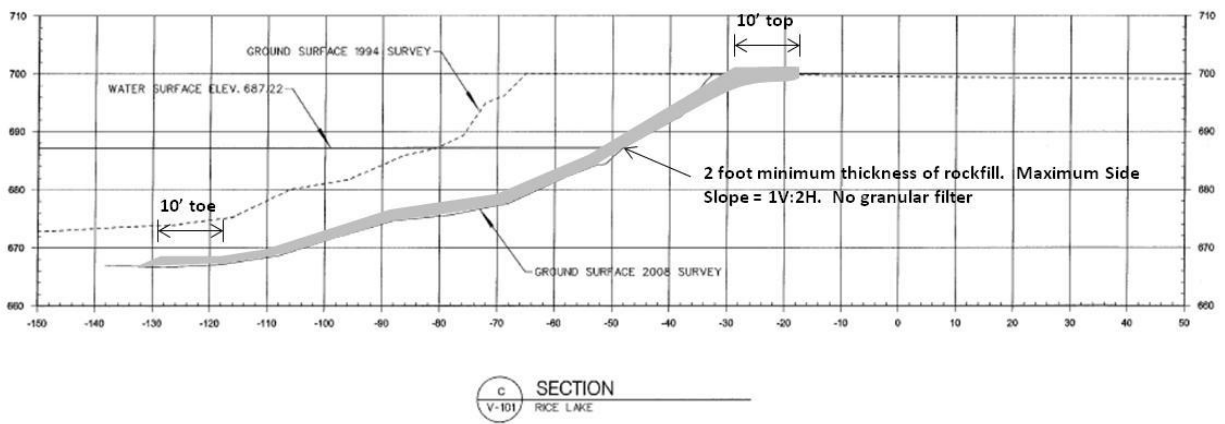
Figure 9 – Preliminary design for a two foot layer of rock fill at the Minnesota River Bank, Cross Section C

Minnesota River at the project location ranges from 29 to 39 feet, which occurred in the timeframe of 1994 to 2008 (Jorgenson, 2011; Appendix B). After several site visits and a piezometer study conducted by the USACE, it was discovered that seeps occurring along the Minnesota River bank at the project location were likely contributing to the progressive erosion rates. Other additional contributing factors, ponding of the marsh by a beaver dam, river velocity and other possible artesian conditions in the area, all work together to enhance the rate of erosion.
