ANDALUSIA REFUGE INSPECTION OF COMPLETED WORKS 2017

Andalusia Refuge Habitat Rehabilitation and Enhancement Project (HREP)

Pool 16, Upper Mississippi River, Miles 462.9-463.0, Rock Island County, IL

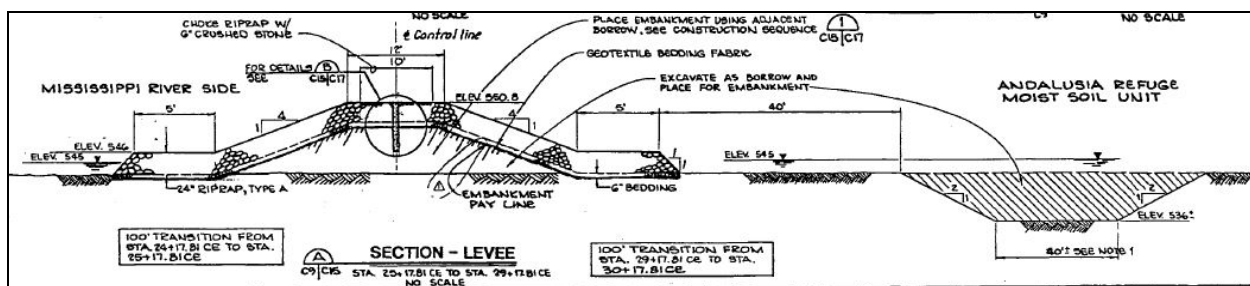
Figure 1. Typical Levee Design Section (Sheet C-15, O&M Manual)

The levee had adequate vegetation cover and has been periodically mowed. Portions of the riverside toe of the levee were undercut, with 2 to 4 feet tall cutbanks. Flooding and wavewash action were speculated as the cause of the levee undercutting. Repairs have been conducted on the levee by the ILDNR due to frequent flooding and overtopping. As-built elevations of the perimeter levee range from 551.8 to 552.8 feet MSL. One chronic breach area is present just downstream (approximate Station 41+00) of the Dead Slough Access Channel. This area has been repaired several times, but is currently a depression in the levee approximately 10 feet wide and 2 feet deep.

- Repair perimeter levee depression and wavewash damage.
- Reinstall refurbished KSB pump.

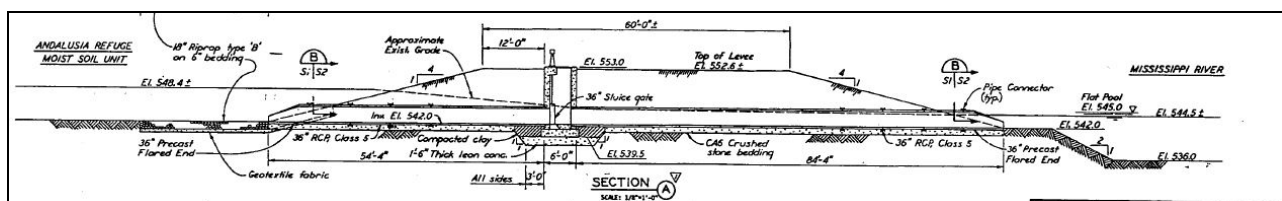
Figure 2: Water Control Structure Design Section (Sheet S-1, O&M Manual)

The water control structure is operational and has been used in the recent past. However, it is affected by the sedimentation occurring in Dead Slough and requires periodic cleaning out. The invert elevation of the control structure conduit is 542. Survey transects conducted in 2014 indicated the bed elevation of Dead Slough near the area of the water control structure ranged from 542 to 544 feet MSL.

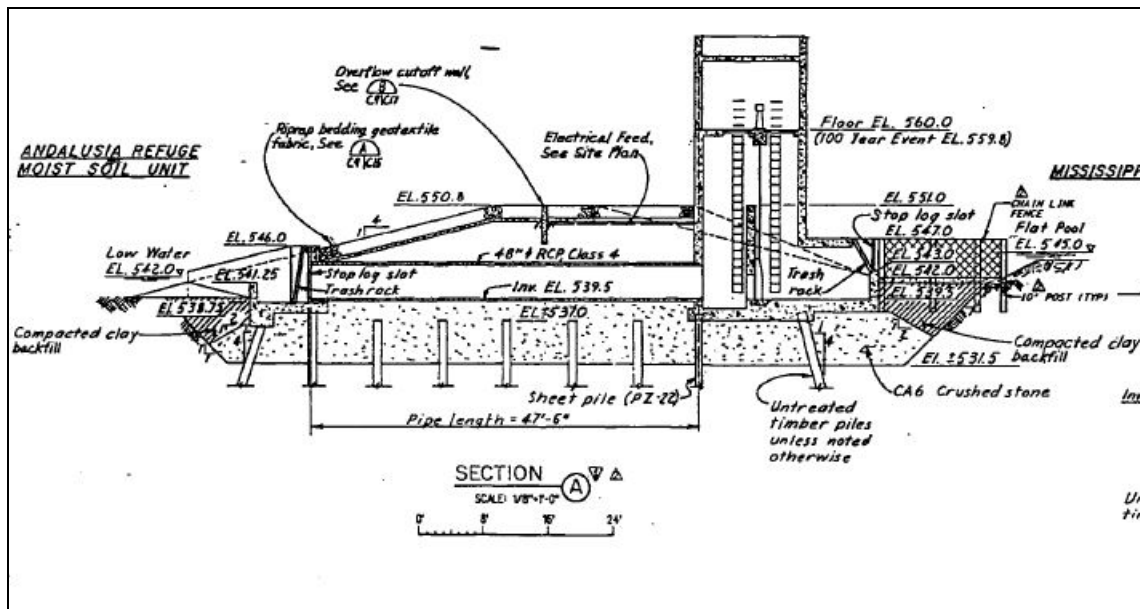
Figure 3: Pump Station Design Section (Sheet S-3, O&M Manual)

The pump station is operational at the time of this report. Repair of the inflow pump occurred in 2016 and 2017, with the pump available for use in June 2017. The German made KSB outflow pump is repaired but not installed yet. Due to the lack of an overhead crane on the pump station building, additional coordination in terms of renting a crane is required for pump repairs. The sponsor noted issues with excess heat in the electric panel, possibly due to poor insulation characteristics of the building. Historically there have been issues with excess vegetation and

debris accumulating on the pump station intakes. Periodic dredging near the intakes is also required.

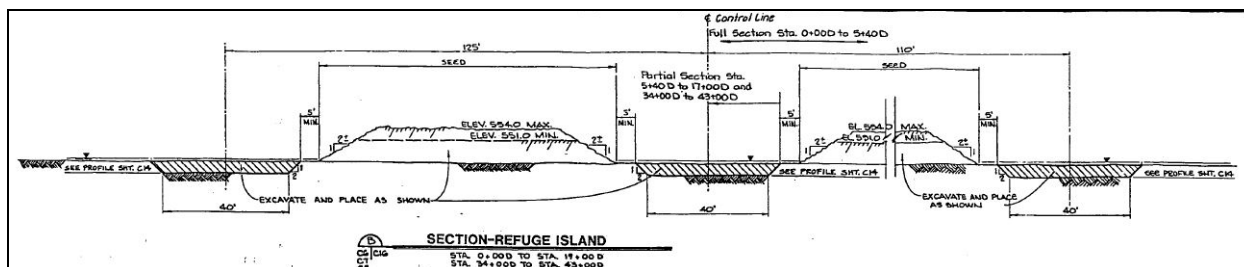
Figure 4: Channels and Islands Design Section (Sheet C-16, O&M Manual)

Based on survey transects conducted in 2014, at least one foot of sedimentation has occurred within the MSMU drainage channels since construction. Due to frequent flooding, water level management in the MSMU has proven difficult. The nesting islands contained goose nests initially, but since then have been overtaken by willow trees. No waterfowl surveys have been conducted, but the refuge manager reports significant waterfowl usage during the migration season.

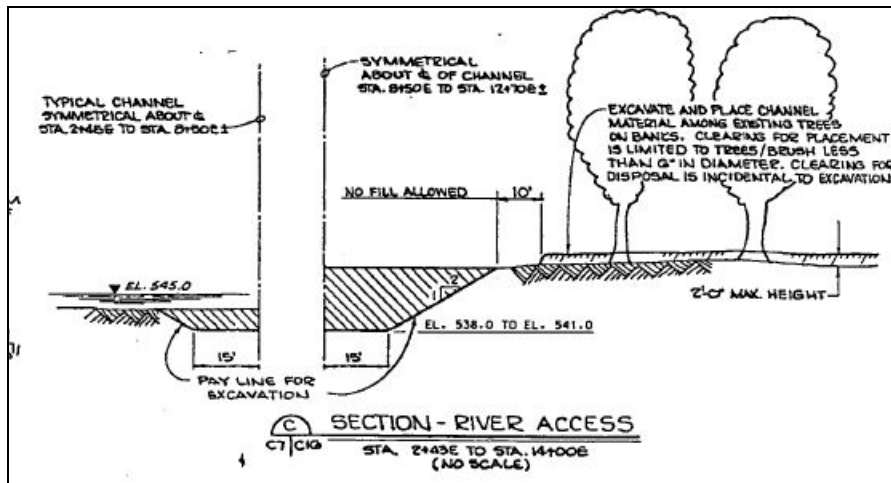
Figure 5: Access Channel Design Section (Sheet C-16, O&M Manual)

The access channel is currently infilled with sediment. At the time of the site inspection, portions of the bed of the access channel were visible, due to low water condition. The access channel has been dredged in the past, but no dredging has occurred in the past 10 years.

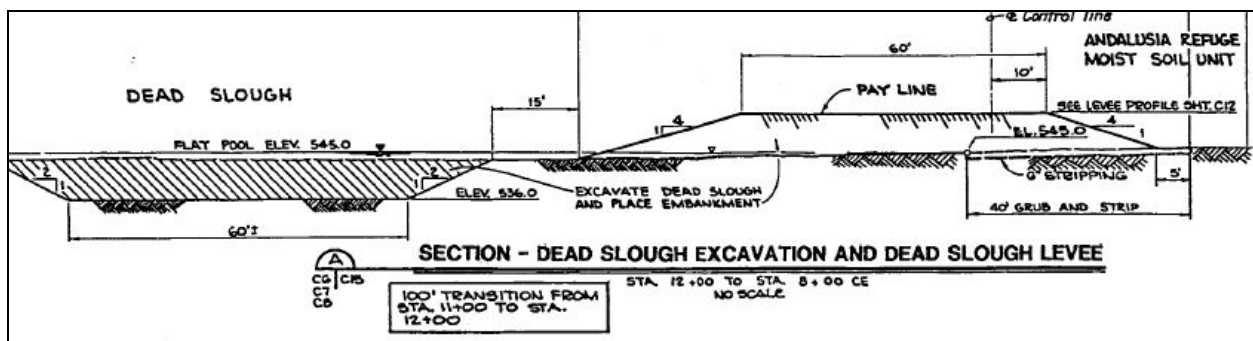
Figure 6: Dead Slough Aquatic Habitat Design Section (Sheet C-15, O&M Manual)

Deep aquatic habitat was dredged to elevation 536, nine feet below the flat pool elevation. Based on survey transects conducted in 2014 approximately six feet of sedimentation has occurred since construction.

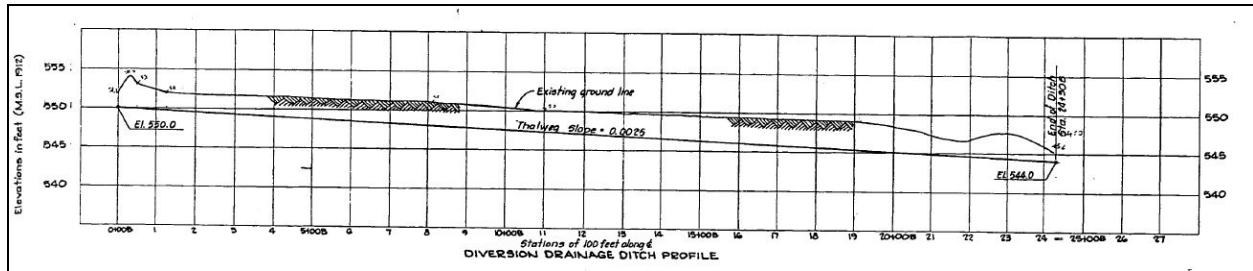
Figure 7: Drainage Ditch Design Profile (Sheet C-13, O&M Manual)

The diversion channel is periodically infilled with sand and gravel, and has been excavated over 20 times since project construction.

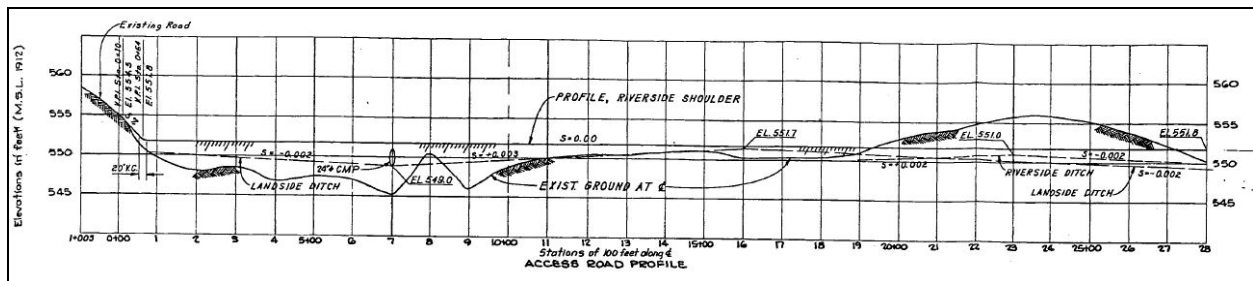
Figure 8: Access Road Design Profile (Sheet C-13, O&M Manual)

The 3,600 foot long access road into the Refuge needs continual maintenance to stay open. Runoff from the adjacent bluff brings significant sediment onto the road, and has filled in the roads drainage network.

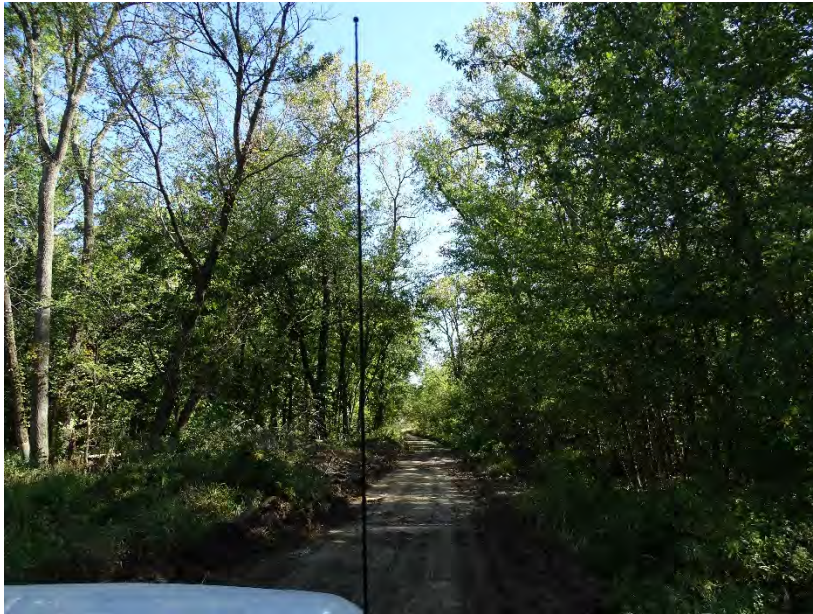
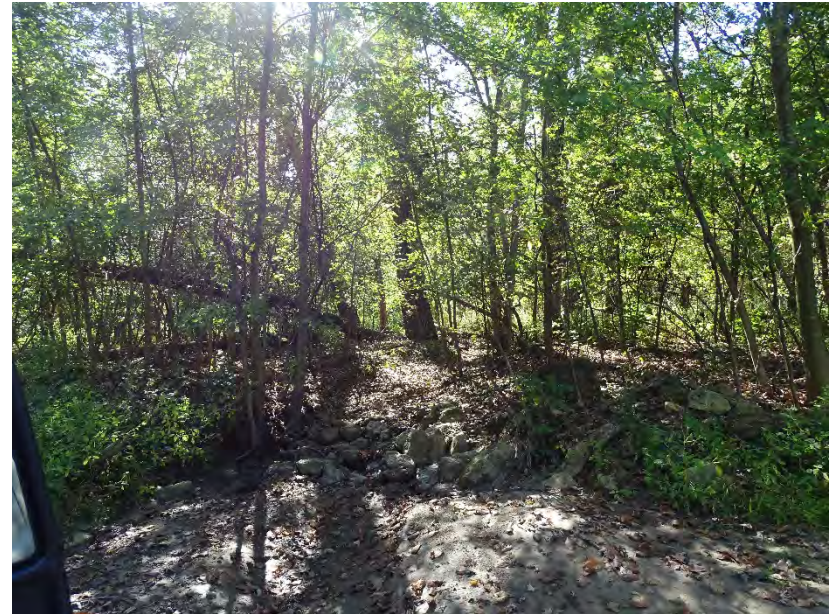
Access Road to HREP (need to be cleared of mud post flood)

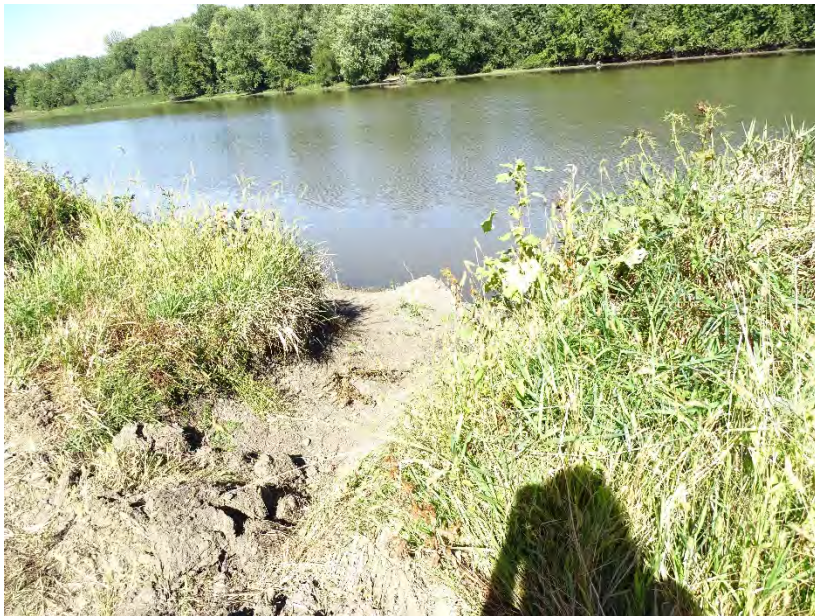
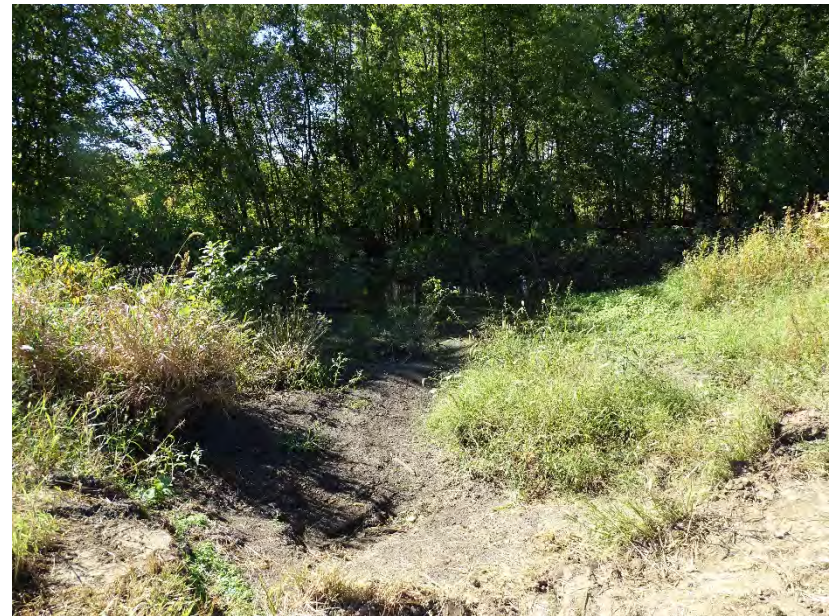
Erosion across Dead Slough Levee

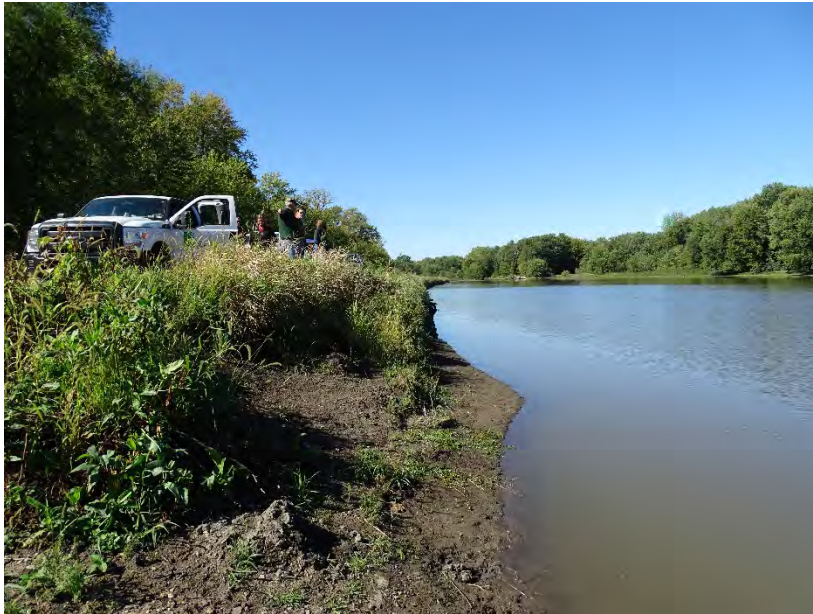
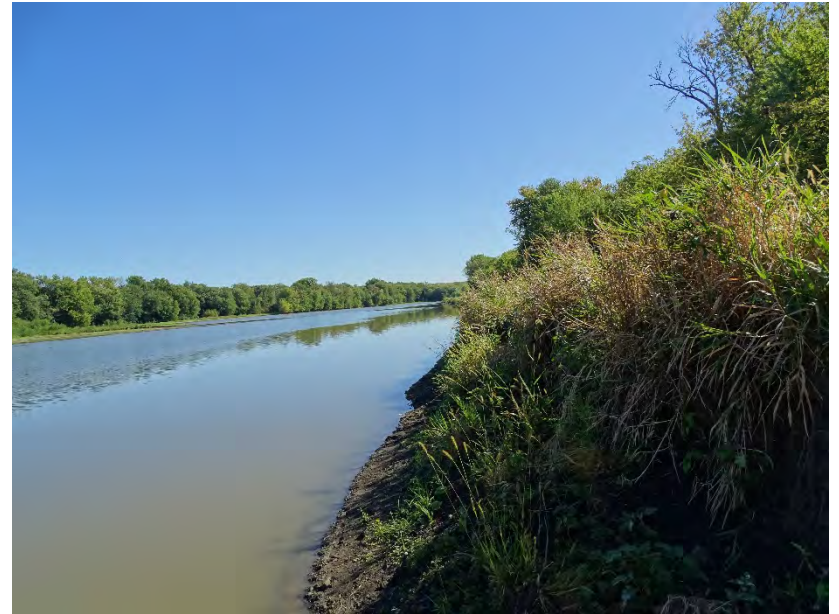
Erosion on riverside of Dead Slough Levee

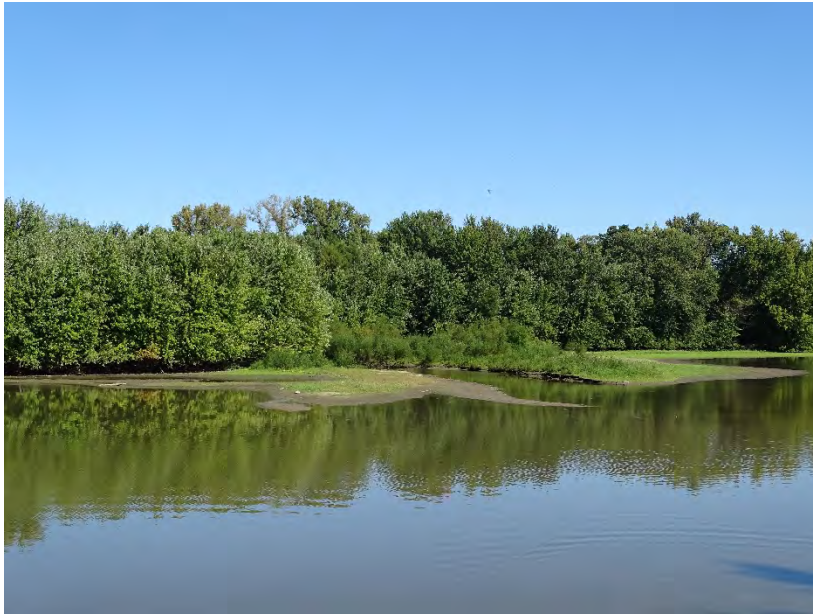
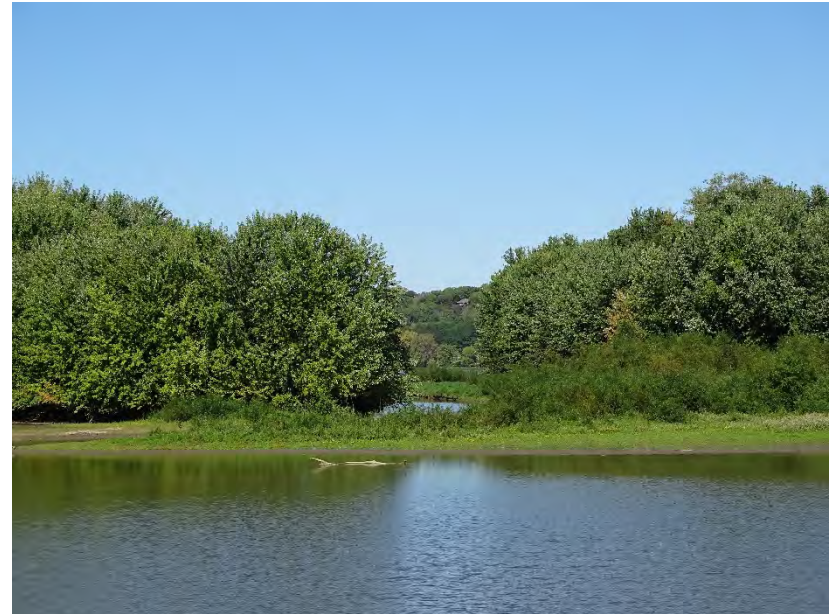
Dead Slough Lentic-Lotic Access Channel (two views)
