**UPPER MISSISSIPPI RIVER SYSTEM  
ENVIRONMENTAL MANAGEMENT PROGRAM  
POST-CONSTRUCTION PERFORMANCE EVALUATION REPORT (PER4F)**

**ANDALUSIA REFUGE REHABILITATION AND ENHANCEMENT**

**POOL 16, MISSISSIPPI RIVER MILES 462-463  
ROCK ISLAND COUNTY, ILLINOIS**

**AUGUST 1997**

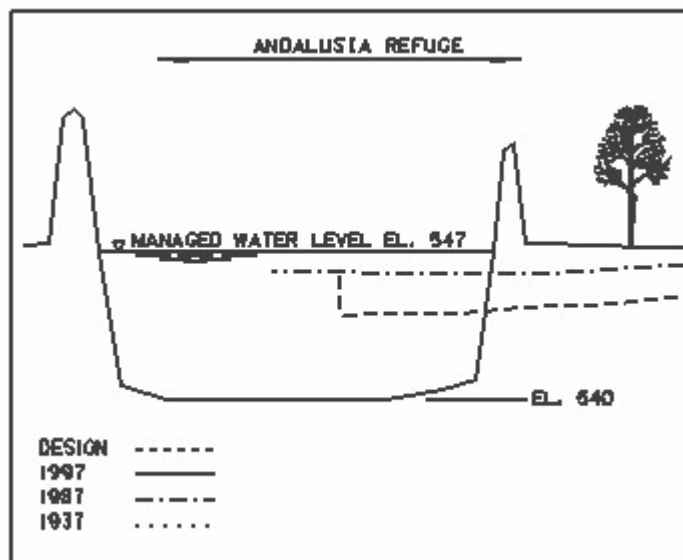
**FIGURE 5-3. Typical transect in refuge area with water surface at December-April management level.**

Transects within the MSMU were surveyed in January 1997 with the MSMU at increased water levels in order to determine the reliable resting and feeding water area. As illustrated in Figure 5-3 below, the tree symbol indicates the tree line, which will be used to monitor vegetative encroachment.

(b) Increase reliable resting and feeding water area. The Year 50 Target with Alternative will be changed from 200 acres to reflect the as-constructed 50-acre area of the MSMU. Transects within the MSMU should be surveyed early in the year (January or February) with the MSMU at increased water levels. Changes in vegetation (i.e., timber to shrub to grass) will be noted to better monitor vegetative encroachment within the MSMU.

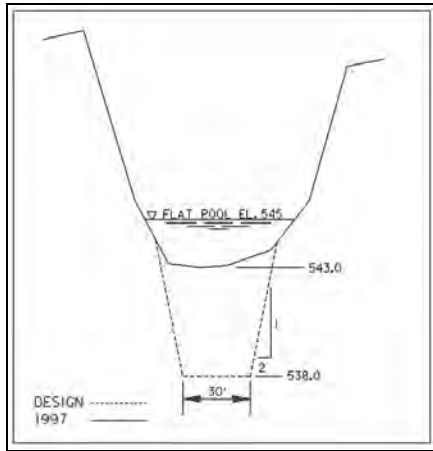
(1) Monitoring Results. As shown above and in Appendix A, Table A-1, the year 50 target with alternative is restoration of 180 square feet of lentic-lotic habitat access. In January 1997, the average cross-sectional area of the lentic-lotic habitat access channel was approximately 178 SF. The 1993 Flood Damage Assessment Report noted the lentic-lotic access channel had silted in considerably, from initial elevations of 536 -541 to 544 in some places. The channel was re-excavated to elevation 538 in March 1994 by Corps labor forces. As shown below in Figures 6-4 and 6-5 and on plate 5, the channel elevation near the mouth of the lentic-lotic access channel was approximately 2 feet below flat pool (elevation 545 feet MSL).

**FIGURE 6-4. Transect D1**  
**Near mouth of lentic-lotic access channel**  
**Cross-sectional area = 104.8 SF**  
**Depth = 2'**

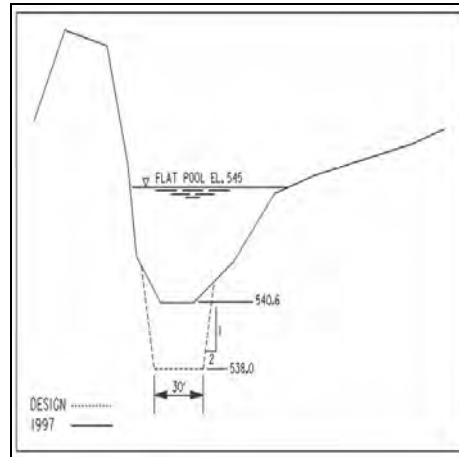
**FIGURE 6-5. Transect D2**  
**Upstream end lentic-lotic access channel**  
**Cross-sectional area = 250.2 SF**  
**Depth = 4.4'**

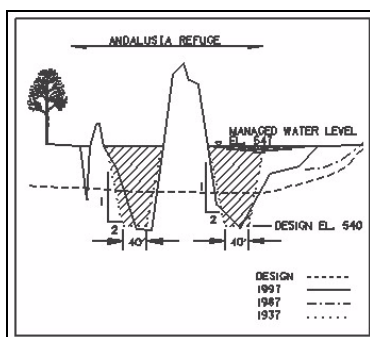
FIGURE 6-6. Transect C.

The sedimentation transects of the refuge area were obtained in January 1997. As shown below in Figures 6-6 through 6-8, sedimentation in the refuge area is noticeably less than Dead Slough or the lentic-lotic access channel.
