**UPPER MISSISSIPPI RIVER SYSTEM  
ENVIRONMENTAL MANAGEMENT PROGRAM  
POST-CONSTRUCTION PERFORMANCE  
EVALUATION REPORT – YEAR 8 (2000)**

**ANDALUSIA REFUGE  
HABITAT REHABILITATION  
AND ENHANCEMENT**

**JUNE 2001**

**POOL 16  
MISSISSIPPI RIVER MILES 462.0 – 463.0  
ROCK ISLAND COUNTY, ILLINOIS**

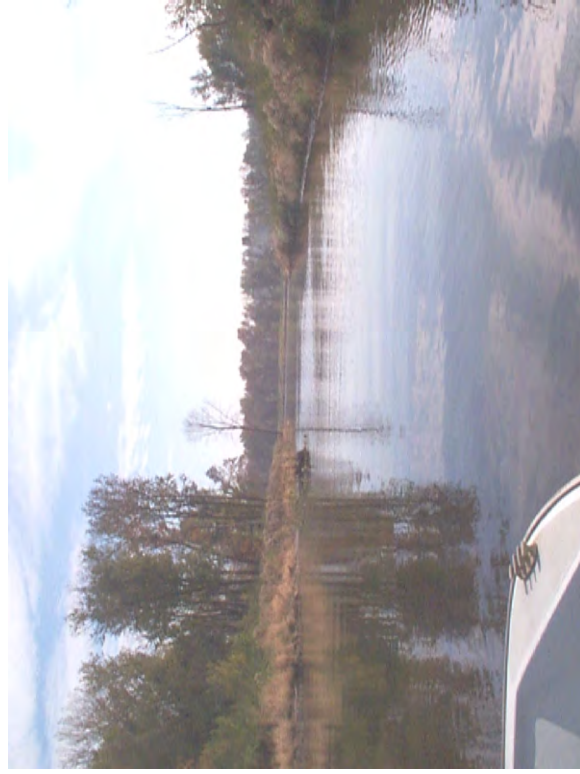
However, a hydraulic study was conducted in October 1997 to determine the cause of the high sedimentation rate at the entrance to the lentic-lotic habitat access channel. The results of the study indicated that bank sloughing was the primary cause of excessive sedimentation near the channel entrance. Field reconnaissance revealed unstable banks with numerous slope failures. Existing bank slopes of 1H:1V and steeper were observed where the design slope was 2H:1V.

Entrance to Access Channel

In addition, the 1997 hydraulic study proposed remedial solutions to alleviate the high sedimentation rate. In order to maintain an access depth of 3.5 feet, it was recommended that the bank slopes near the entrance to the lentic-lotic habitat access channel be graded to the design slope of 2H:1V (preferably 3H:1V) and then protected with vegetation. In addition, the access channel should be excavated to a depth of 3.5 feet below flat pool with the dredged material placed at least 50 feet beyond the crest of the downstream bank. Placement of dredged material on the downstream shore of Scisco Island was also stated as being acceptable. The other option was to relocate the access channel. The current entrance to the access channel is located near the downstream end of Scisco Island where sediment deposition is greatest. The lowest bottom elevation within Scisco Chute (elevation 536 feet MSL) is located approximately 2,400 feet upstream of the existing channel entrance. This would be the ideal location for the access channel. The report from this study is located in Appendix F.

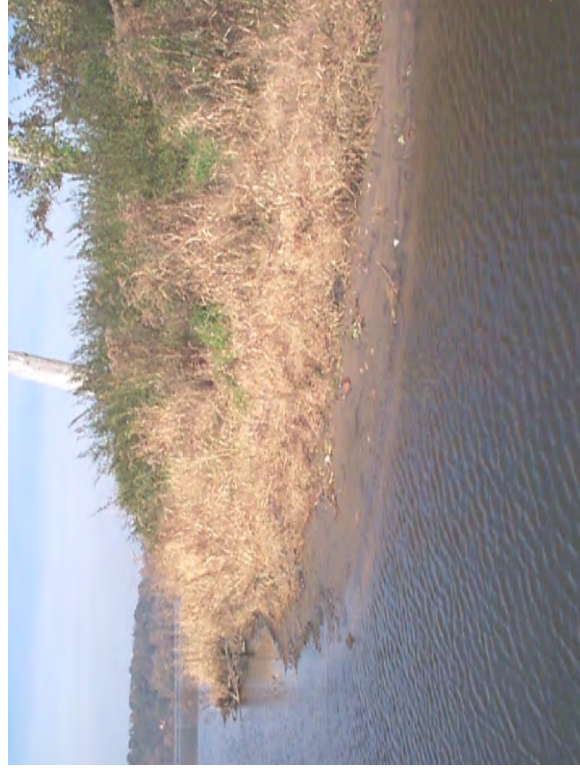
Upstream Bank at Entrance to Access Channel

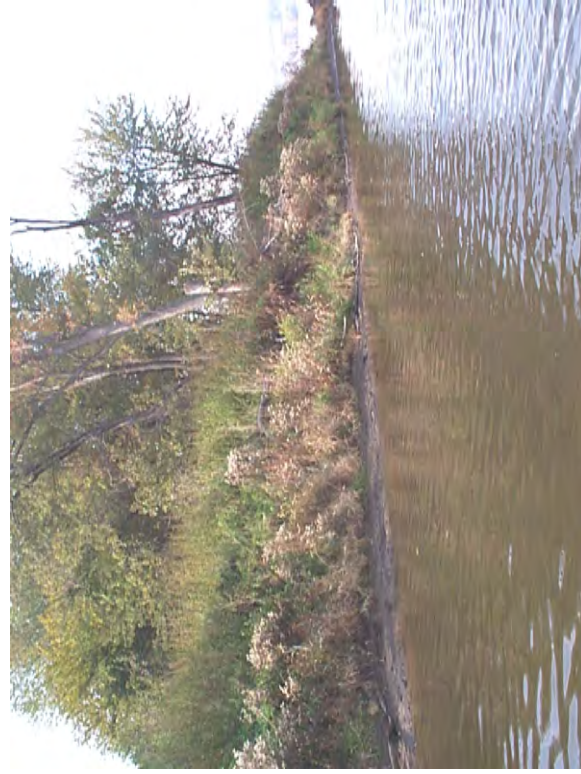
Downstream Bank at Entrance to Access Channel

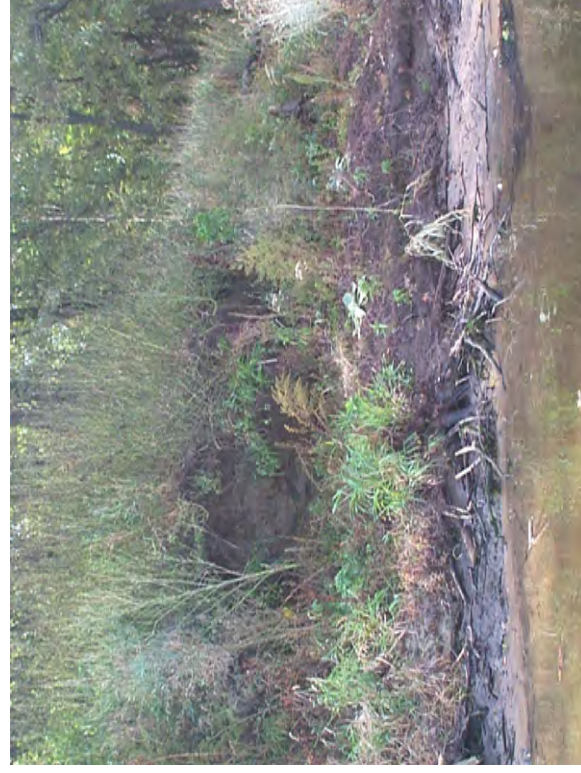
Bank Sloughing at Entrance to Access Channel

In response to these recommendations, Corps labor forces excavated a portion of Scisco Chute and the access channel in 1998 to elevation 540 feet MSL or 5 feet below flat pool. Also, the banks were sloped back and vegetation was planted. After additional sediment deposition occurred, the access channel was visited in the summer of 1999. At this time, a second channel connecting the navigation channel to Dead Slough was discovered further downstream. More than likely, flow is entering Dead Slough through the access channel and exiting through the second channel. If this is the case, then the access channel is unable to naturally “flush” itself out.

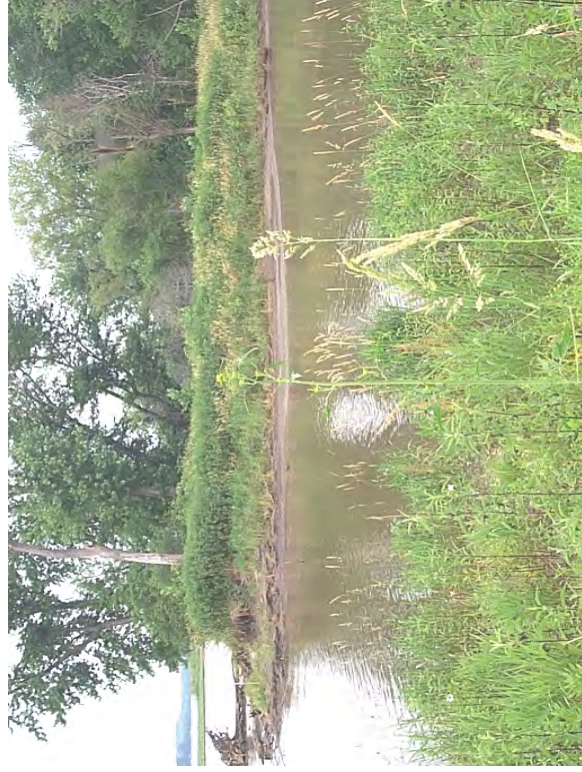
1999: Excessive Sedimentation is still a concern at the entrance to the access channel. Re-visit to the site discovers exit channel downstream of project.

Andalusia Slough Entrance (access channel entrance)

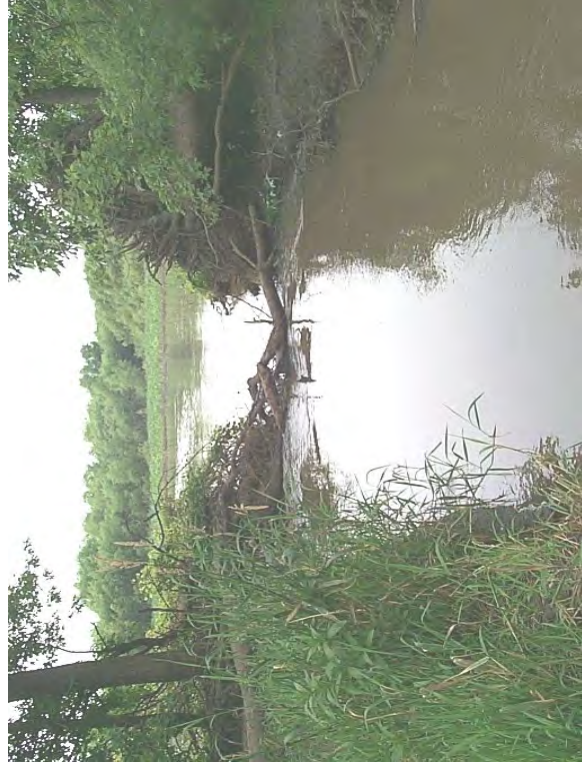
Andalusia Slough Exit (scoured, unplanned)

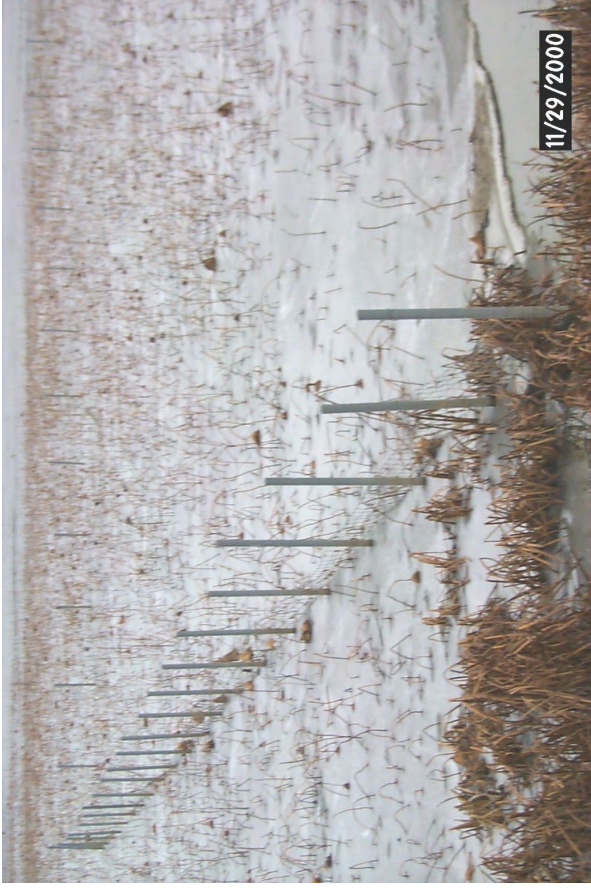
Perimeter fence on river side of levee installed by Illinois DNR

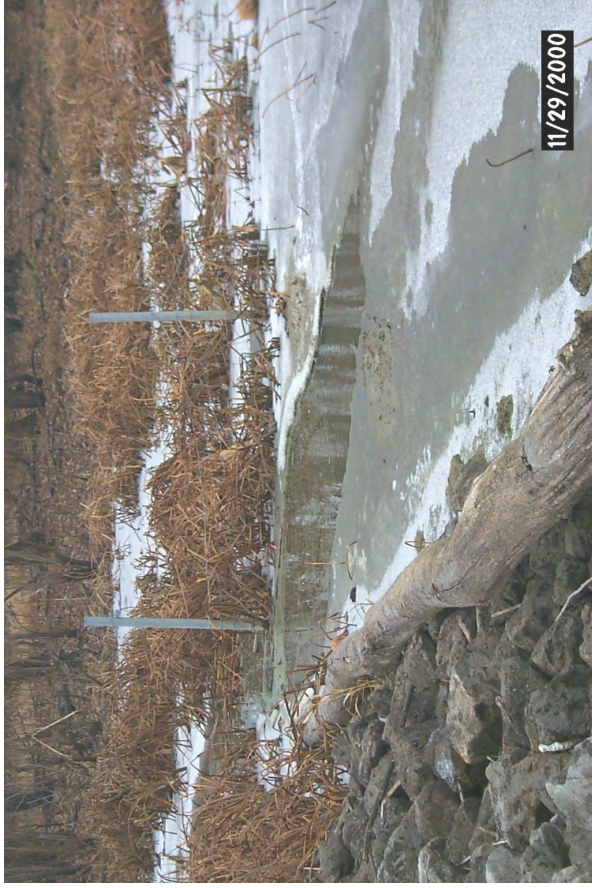
Perimeter fence at work holding back debris and vegetation

(e) Pump Station. The 1997 report states that the fence systems at the pump station were not functioning as intended and were destroyed by ice, and that vegetative growth on the riverside of the levee had filled back in from shore to shore. The trash rack fence was designed for those years when there is an excess of floating or dead vegetation outside of the MSMU, river levels are low, and fall pumping is required. The ILDNR installed the outer perimeter fence for additional protection. In the 1998 and 1999 reports, it was noted that the outer perimeter fence still had not been repaired or removed. However, it is believed that this fence was indeed repaired in 1998 after Corps labor forces corrected a problem with the sluice gate. Annual maintenance should be performed on both fences prior to freezing conditions in the channel.
