**UPPER MISSISSIPPI RIVER SYSTEM  
ENVIRONMENTAL MANAGEMENT PROGRAM  
POST-CONSTRUCTION PERFORMANCE  
EVALUATION REPORT – YEAR 9 (2001)**

**ANDALUSIA REFUGE  
HABITAT REHABILITATION  
AND ENHANCEMENT**

**APRIL 2002**

**POOL 16  
MISSISSIPPI RIVER MILES 462.0 – 463.0  
ROCK ISLAND COUNTY, ILLINOIS**

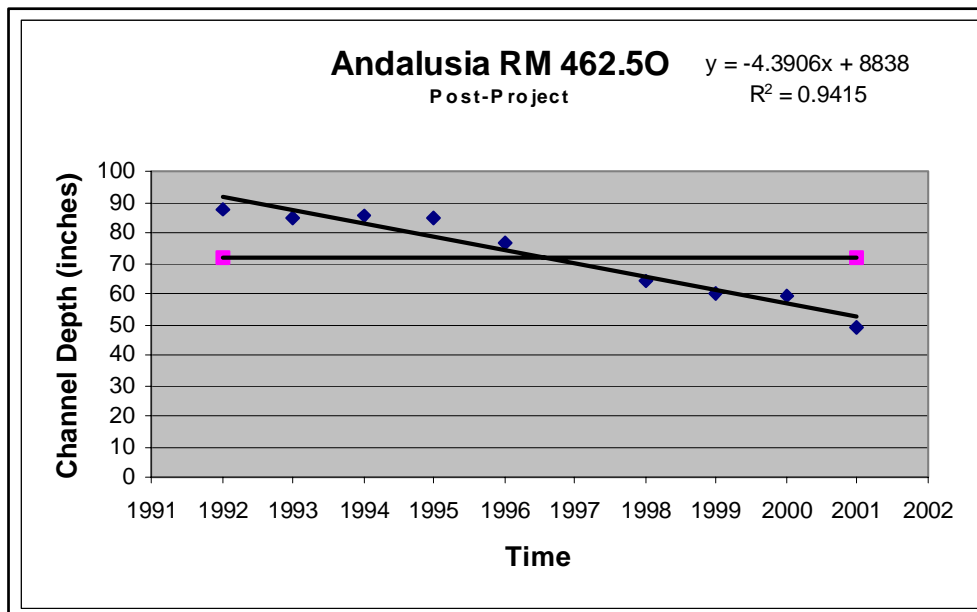
Figure E-3. Sedimentation Rates at Station W-M462.5O

The design bottom elevation of 536 feet MSL for deep aquatic habitat was based on an ideal water depth of 6 feet, a low-flow regulation of 1 foot below flat pool, and sediment deposition of 2 feet over a project life of 50 years. The 2 feet of sediment accumulation is equivalent to an annual sedimentation rate of 0.5 inch per year. The average sedimentation rate was found to be more than 4 inches per year. This high rate of sediment deposition may be the result of the area being inundated during the 2001 Flood. In the future, it is anticipated that the average sedimentation rates will gradually decrease from year to year, as seen previously, until the slough has stabilized.

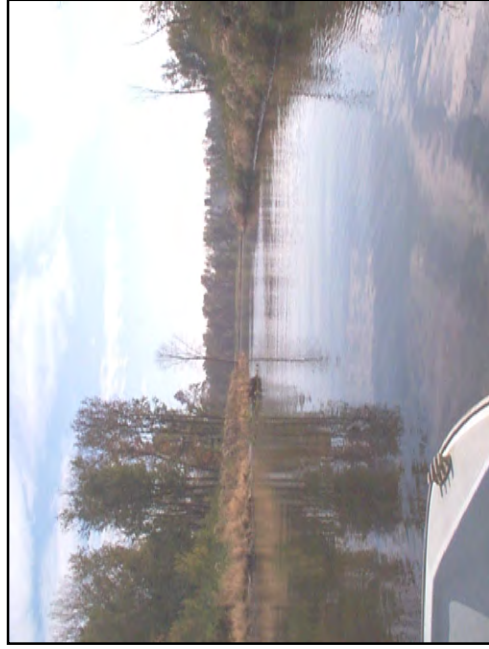
Entrance to Access Channel

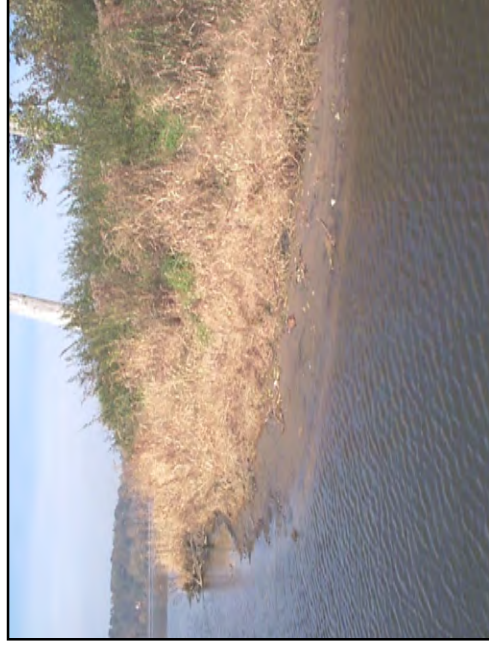
However, a hydraulic study was conducted in October 1997 to determine the cause of the high sedimentation rate at the entrance to the lentic-lotic habitat access channel. The results of the study indicated that bank sloughing was the primary cause of excessive sedimentation near the channel entrance. Field reconnaissance revealed unstable banks with numerous slope failures. Existing bank slopes of 1H:1V and steeper were observed where the design slope was 2H:1V.

U/S Bank at Entrance to Access Channel

The 1997 hydraulic study proposed remedial solutions to alleviate the high sedimentation rate. In order to maintain an access depth of 3.5 feet, it was recommended that the bank slopes near the entrance to the lentic-lotic habitat access channel be graded to the design slope of 2H:1V (preferably 3H:1V) and then protected with vegetation. In addition, it was recommended that the access channel be excavated to a depth of 3.5 feet below flat pool with the dredged material placed at least 50 feet beyond the crest of the downstream bank. Placement of dredged material on the downstream shore of Scisco Island was also stated as being acceptable. The other option was to relocate the access channel. The current entrance to the access channel is located near the downstream end of Scisco Island where sediment deposition is greatest. The lowest bottom elevation within Scisco Chute (elevation 536 feet MSL) is located approximately 2,400 feet upstream of the existing channel entrance. This would be the ideal location for the access channel. The report from this study is located in Appendix F.

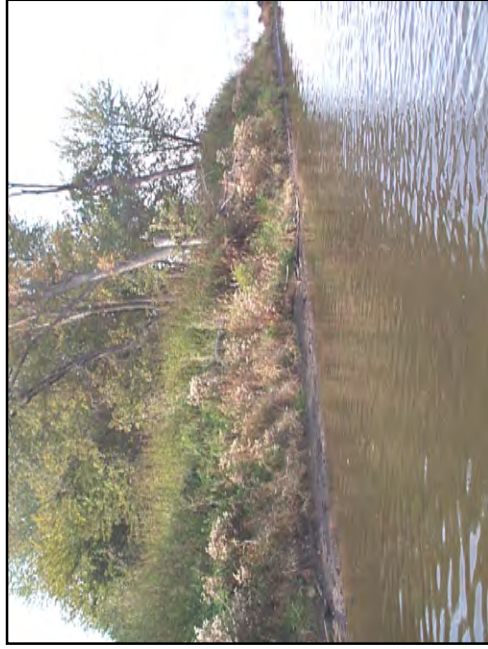
D/S Bank at Entrance to Access Channel

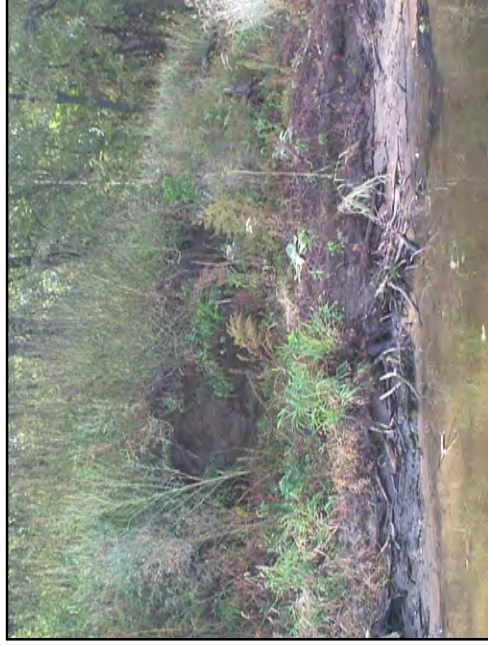
Sloughing at Entrance to Access Channel

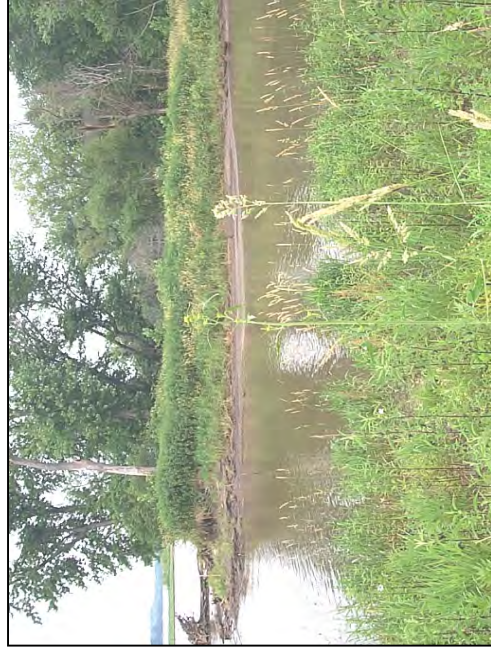
1999: Excessive Sedimentation is still a concern at the entrance to the access channel. Re-visit to the site discovers exit channel downstream of project.

Andalusia Slough Entrance (access channel)

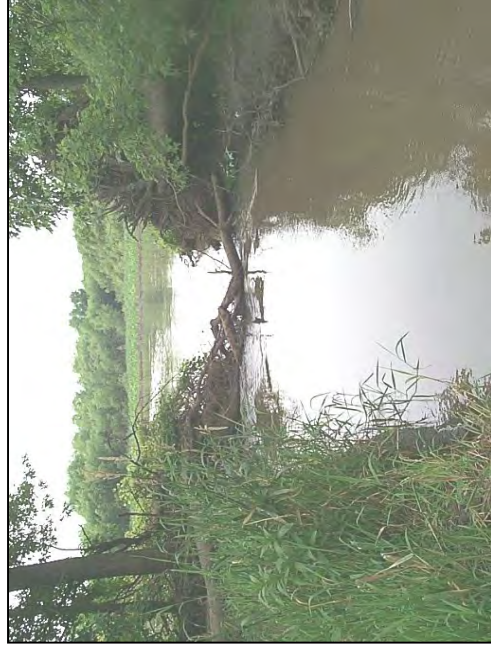
Andalusia Slough Exit (new channel)

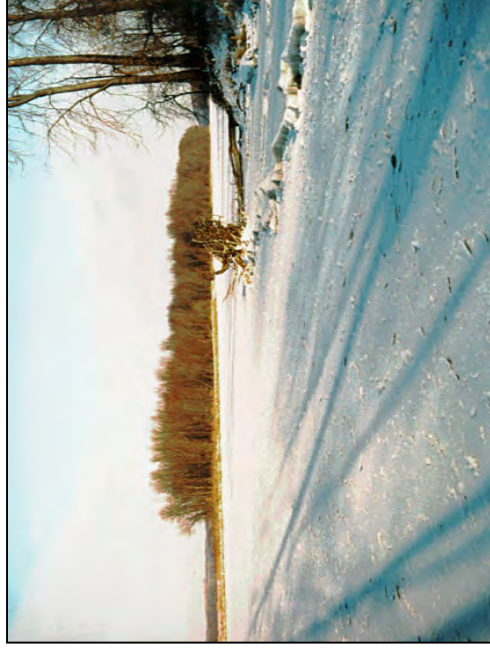
entrance channel had nearly silted in. Table 6-2 summarizes the lentic-lotic habitat access channel depths observed since project completion.

Access Channel Entrance
