**POST-CONSTRUCTION PERFORMANCE
EVALUATION REPORT – YEAR 10 (2002)
FOR**

**ANDALUSIA REFUGE
HABITAT REHABILITATION
AND ENHANCEMENT PROJECT**

**UPPER MISSISSIPPI RIVER SYSTEM
ENVIRONMENTAL MANAGEMENT PROGRAM**

**POOL 16
MISSISSIPPI RIVER MILES 462.0-463.0
ROCK ISLAND COUNTY, ILLINOIS**

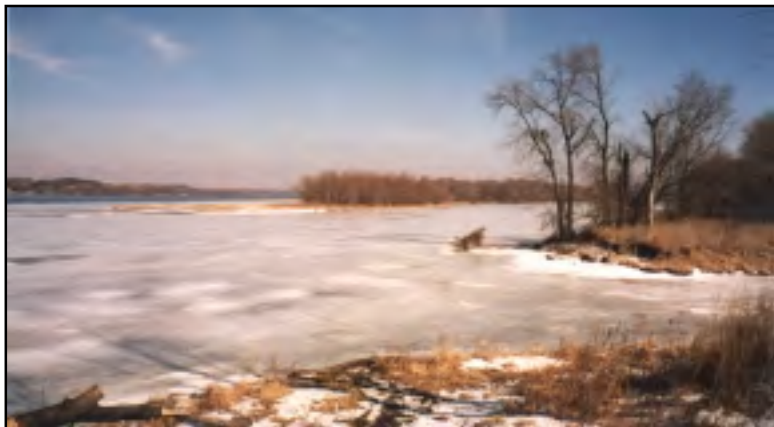
Looking Upstream at Scisco Chute and Access Channel

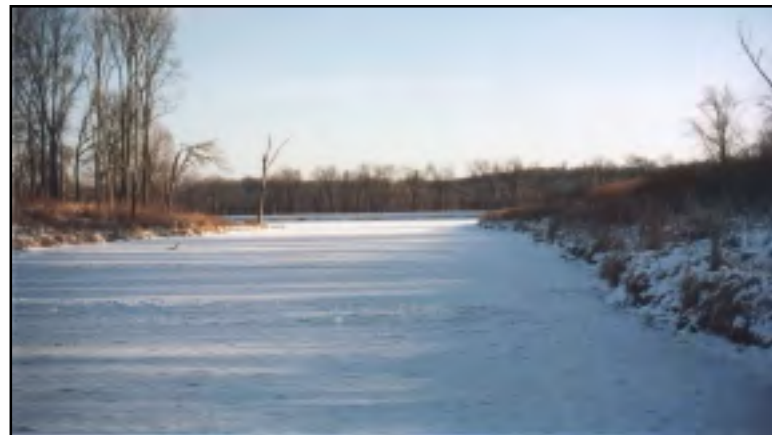
Lentic-Lotic Habitat Access Channel

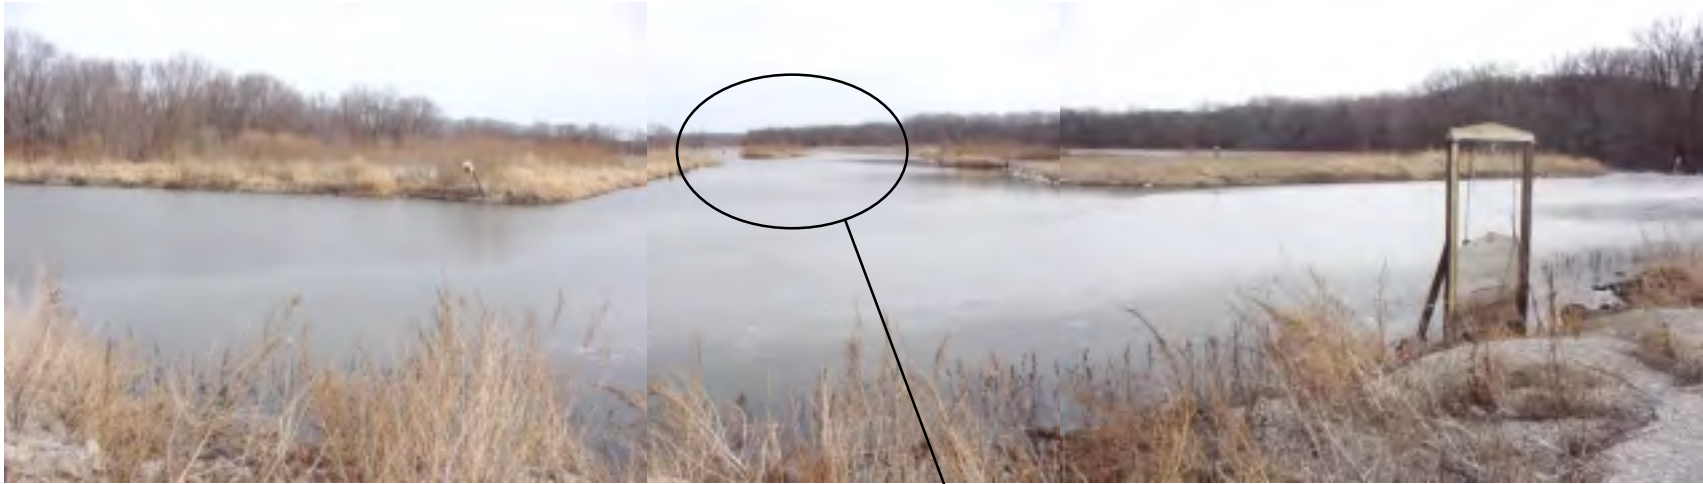
Standing on top of perimeter levee near pump station looking east towards moist soil management unit (MSMU)

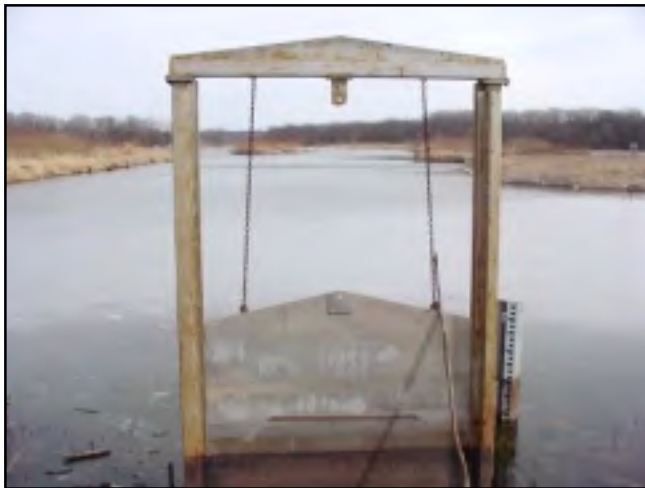
Water control structure for pump station

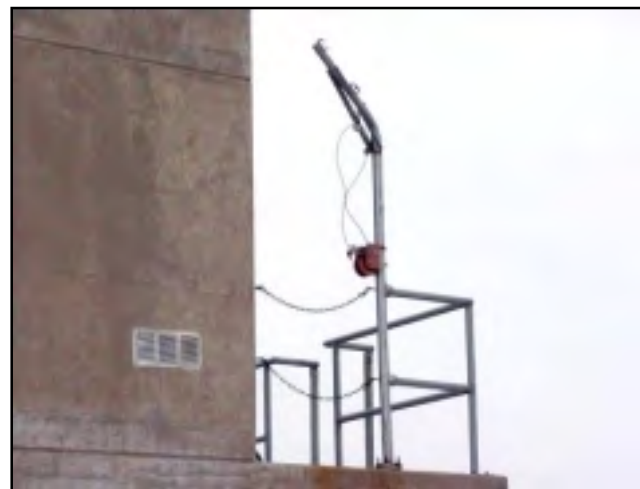
Manual hoist & jib crane mounted to handrail

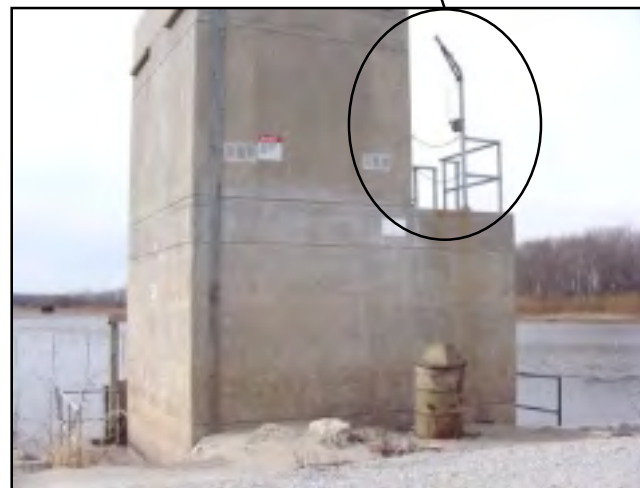
On levee looking at pump station

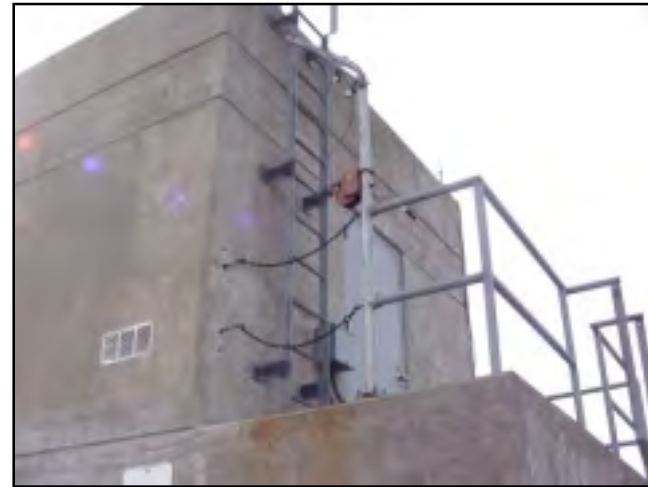
Manual hoist and jib crane mounted to handrail

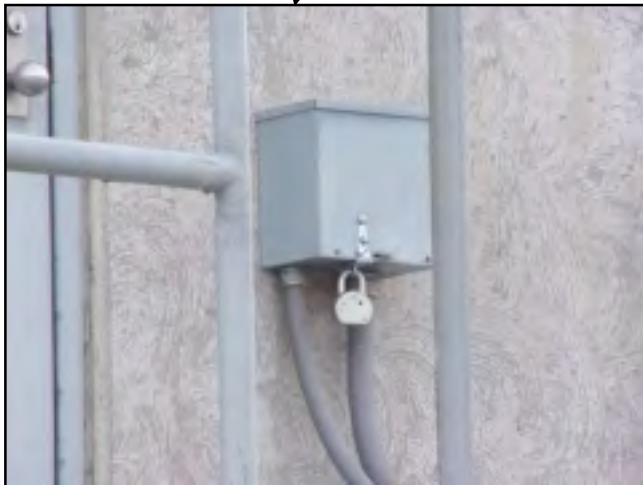
Security measure for the utility box

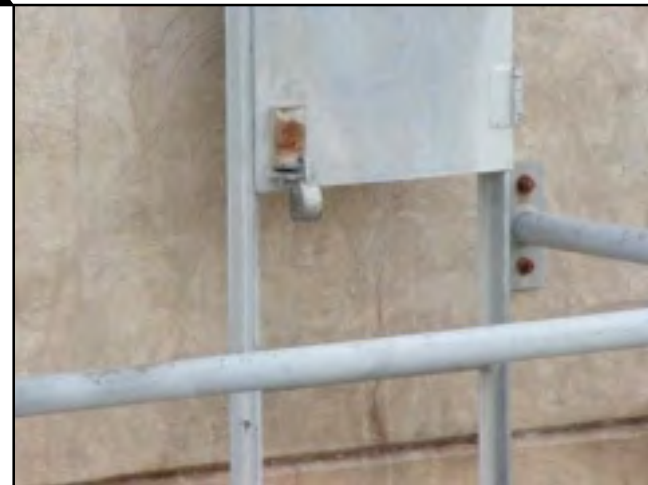
Security measure for the access ladder
