**POST-CONSTRUCTION
PERFORMANCE EVALUATION REPORT**

**ANDALUSIA REFUGE
HABITAT REHABILITATION AND ENHANCEMENT PROJECT**

**US Army Corps
of Engineers** ®
Rock Island District

**POOL 16
RIVER MILES 462.0-463.0
ROCK ISLAND COUNTY, ILLINOIS**

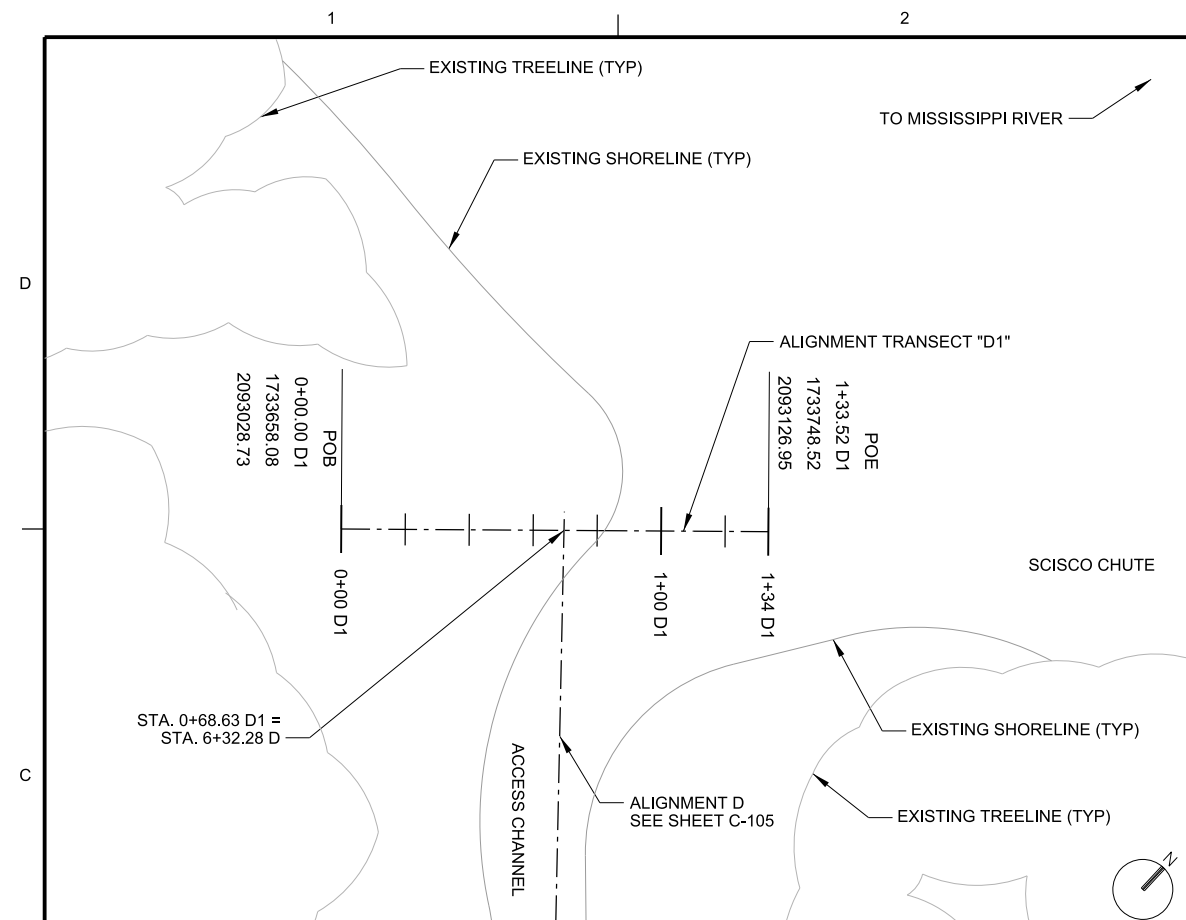
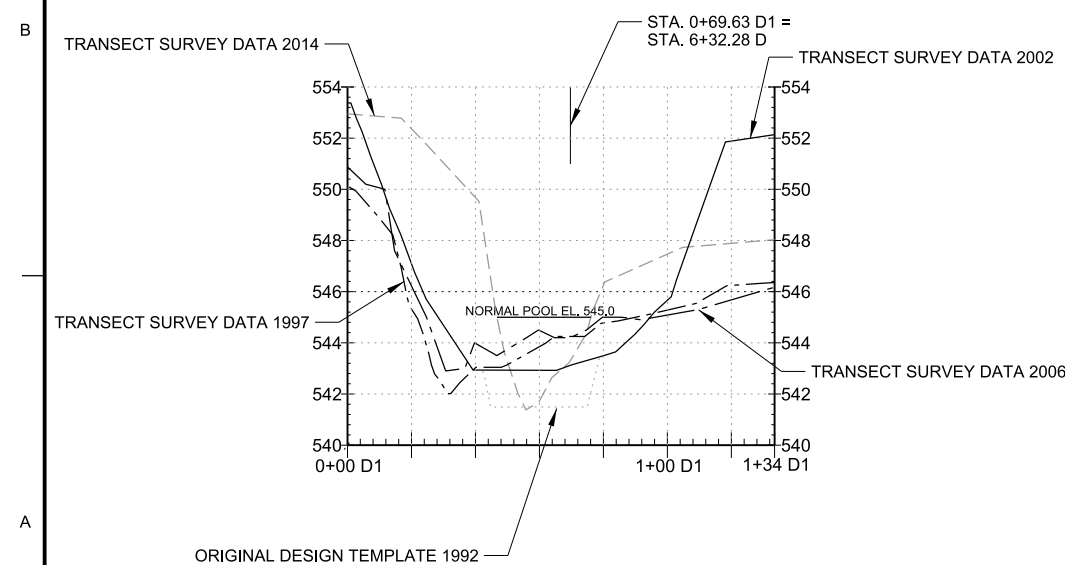
C1 **TRANSECT "D1" PLAN**
SCALE : 1"=30'-0"

Pre- and Post-Project Conditions. Prior to project construction, 100 percent of Dead Slough was composed of submergent vegetation, and the maximum depth was 1.5 feet below flat pool (545 feet MSL). As part of the HREP construction, approximately 85,000 cubic yards of materials were mechanically dredged from Dead Slough. Sedimentation transects A, C and E intersect these dredge cuts. Surveys of these transects have been conducted in 1996, 2006 and 2014. The as-built volume of deep aquatic habitat (1992) was 55.8 acre/feet. In 1996 the volume had decreased to 34 acre/feet. The 2006 survey indicated a further reduction to 3.8 acre/feet. As of 2014, there is no deep aquatic habitat remaining in Dead Slough. Sedimentation transects are included in Appendix B.

Conclusion. The project measures were unsuccessful in providing the ability to maintain deep aquatic habitat. Sedimentation rates, either progressively or in punctuated events (flooding) appear higher than anticipated in the DPR. No further surveying of sedimentation transects is recommended.

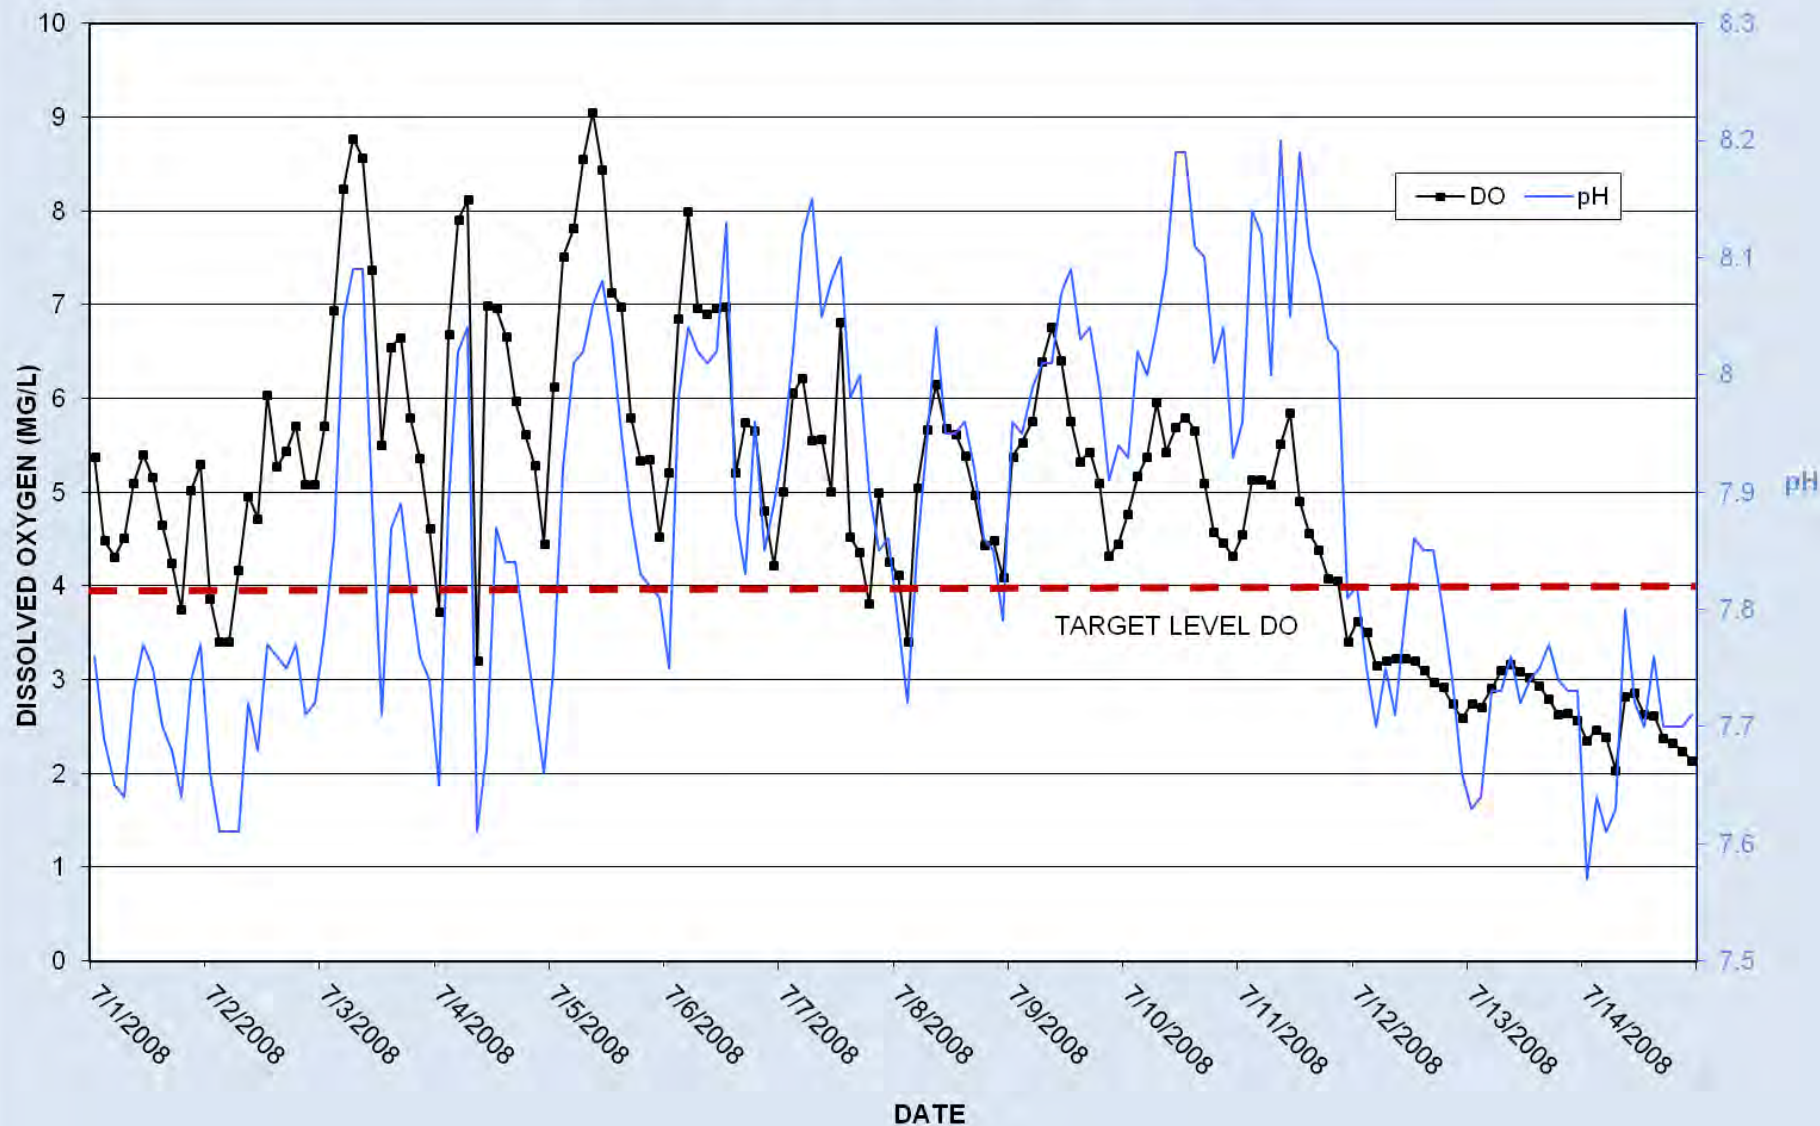
Figure 1. Worst Case Deployment during Current Monitoring Period, July 1st to 15th, 2008

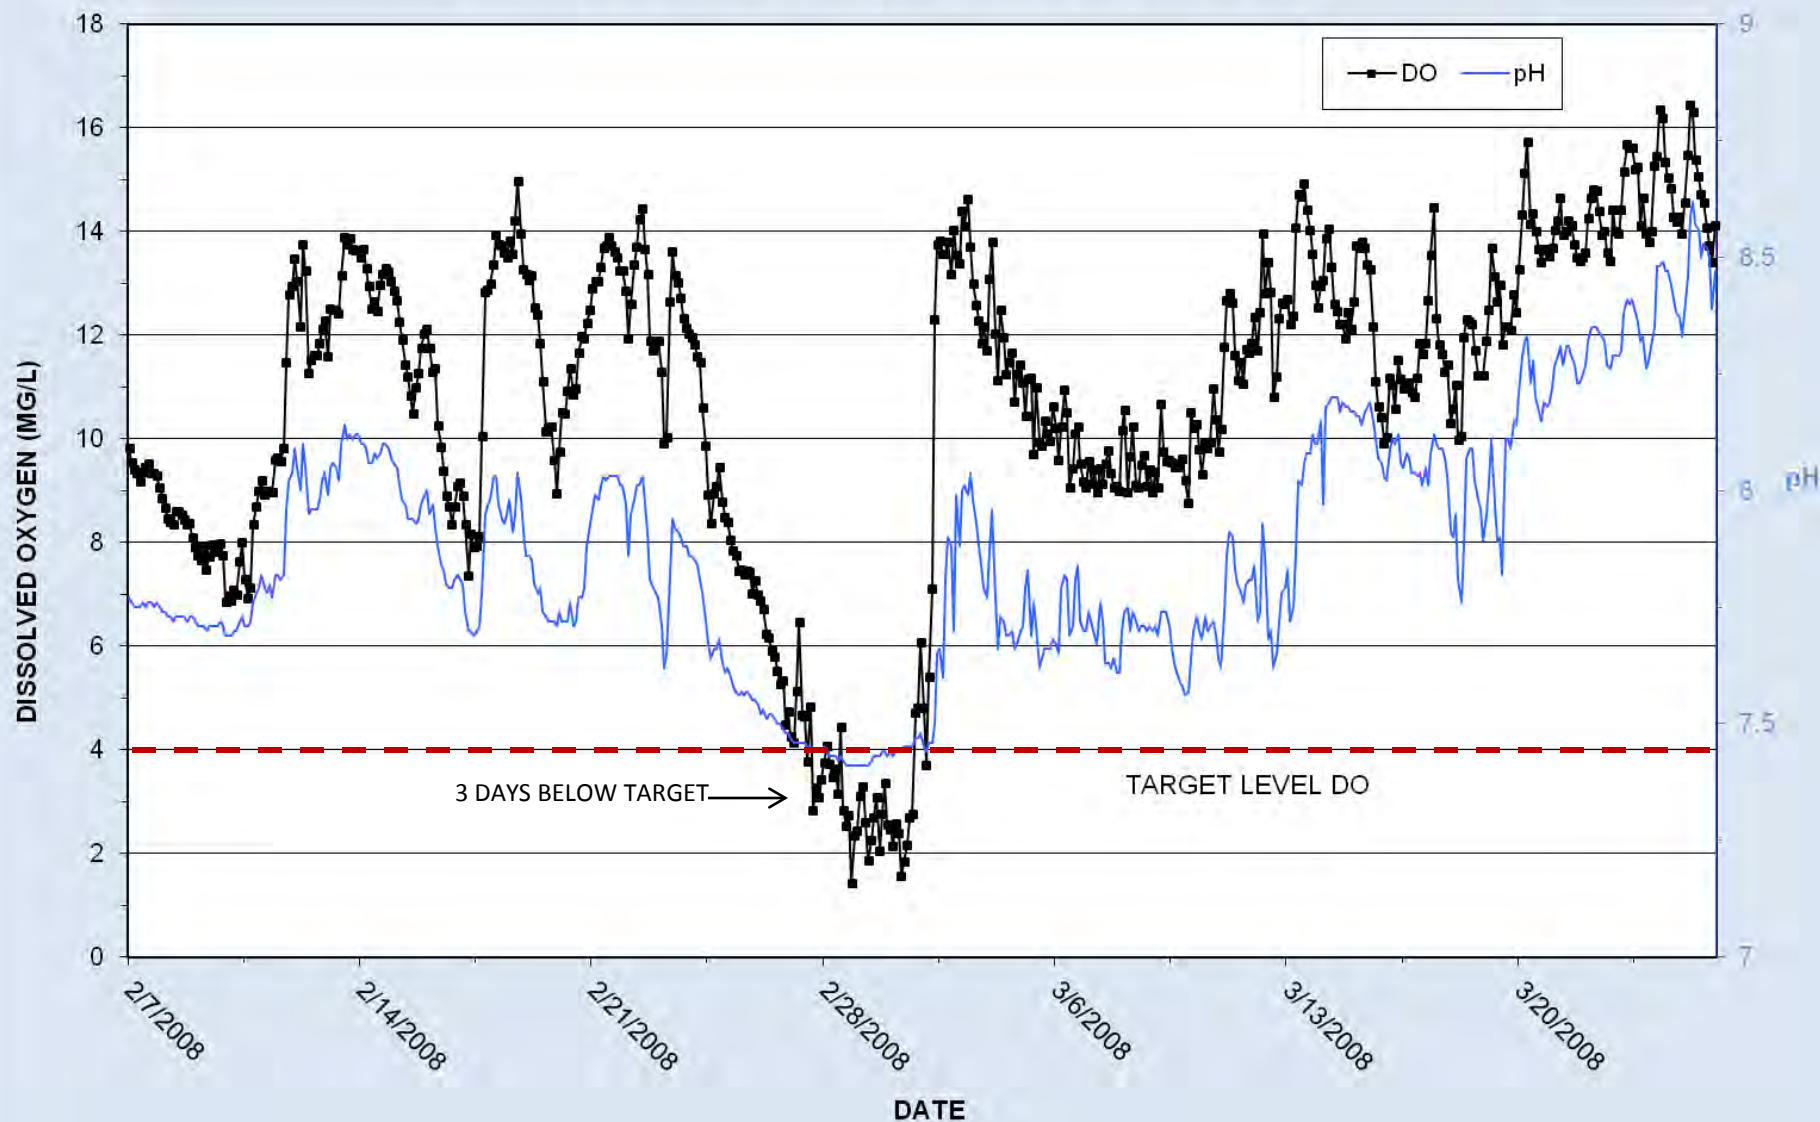
2008. Results of DO monitoring during this deployment are displayed in Figure 3. A probable explanation for the prolonged low DO concentration lies in the field observations for that winter at the sampling site, which noted ice and snow cover since mid-December of 2007. Chlorophyll-a analysis performed on February 7th at the monitoring site revealed a very low value of 1.6 mg/m³. A flow velocity measurement taken on February 7th, 2008, showed only 0.21 cm/s in Dead Slough. With little water inflow, no light penetration, and a low amount of photosynthetic organisms in the surface water, there was little opportunity for oxygenated water to flow into the site or for photosynthesis to occur to produce oxygen.

Figure 3. Worst case winter deployment during current monitoring period, February 7th to March 26th, 2008.

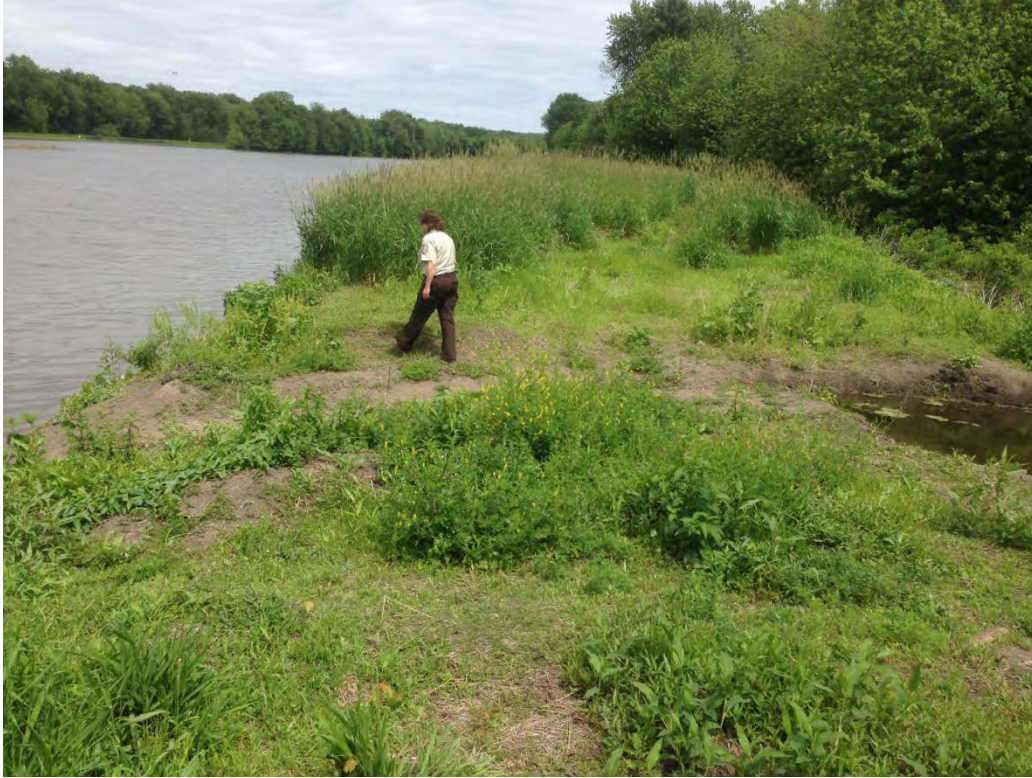
- () Settlement, sloughs, or loss of section. WAS PARTIALLY REPAIRED THEN SPRUNG
- () Seepage, saturated areas, sand boils. 2013 WASHED OUT AGAIN & NEED'S
- () Wave-wash, scouring. SOME REPAIR
- () Overtopping erosion. OVERTOPPED SPRING 2013 & 2014 BY PUMP HOUSE
- () Vegetative cover (mowing). ONCE IN 2013 NEED'S REPAIRED
- () Displaced/missing riprap. OK
- () Burrowing animals. OK
- () Unauthorized grazing or traffic. SOME BUT VERY LITTLE
- () Encroachments. NONE

Photo 2: Perimeter Levee damage, prior to repair, looking west.

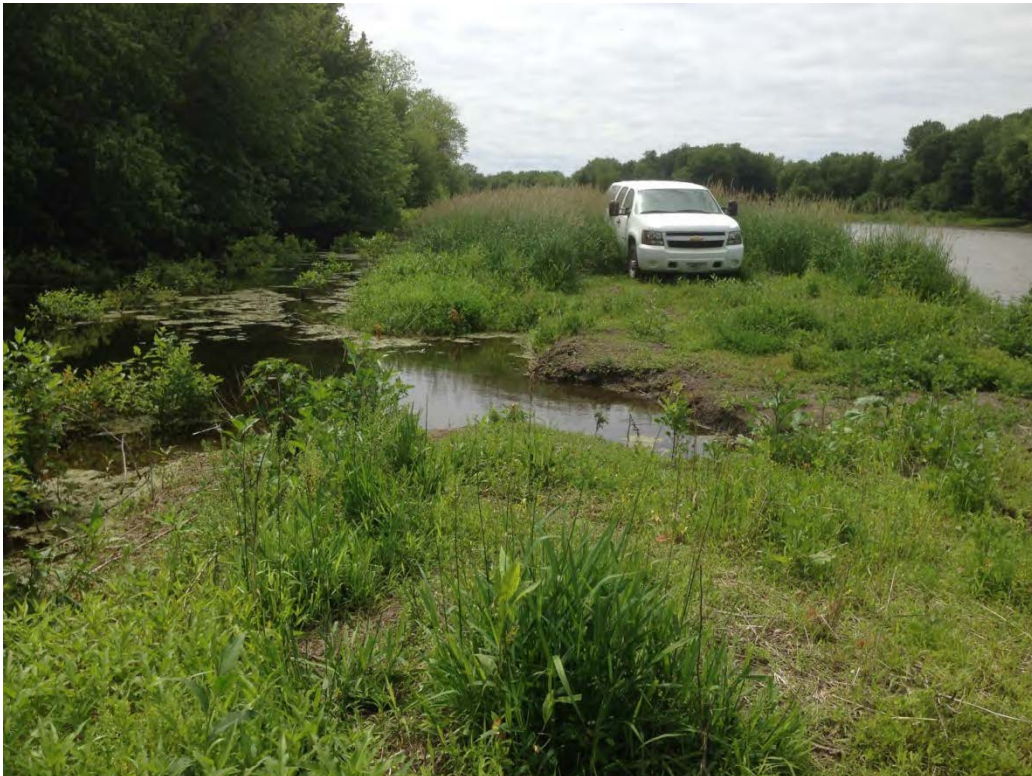
Photo 1: Perimeter Levee damage, prior to repair, looking east.

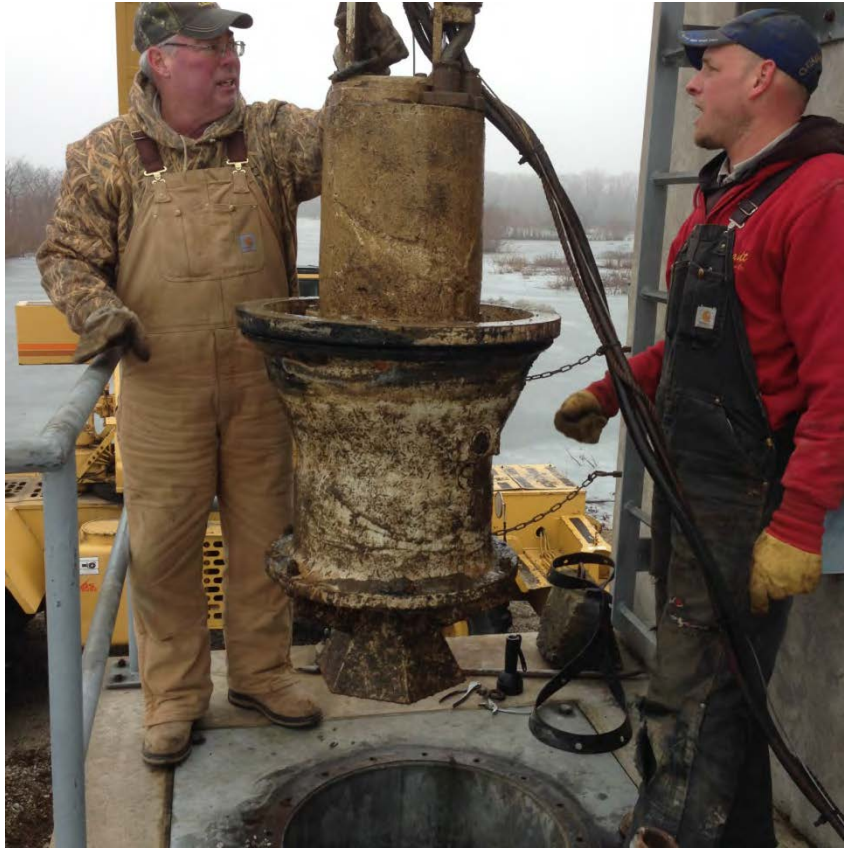
- () Building. OK
- () Gates. OK
- () Pumps. REFUGE DRAIN PUMP TO BE PULLED FOR REPAIR IN 2016
- () Control Panel. OK
- () Trash Racks. OK

Photo 3: Pump removal for repair, winter 2016.

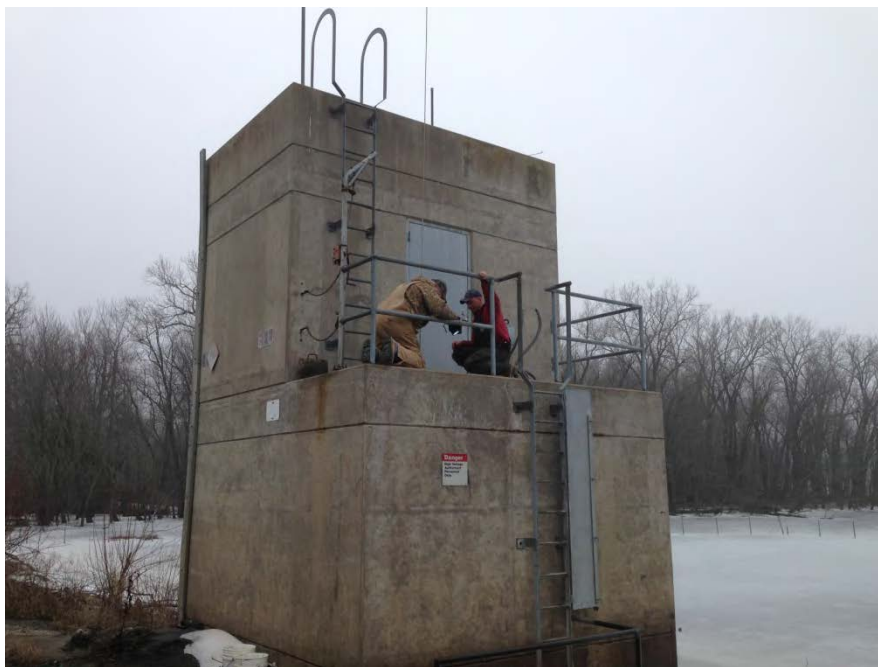
Photo 4: Pumphouse, winter 2016, preparing for pump removal.
