## **BANNER MARSH INSPECTION OF COMPLETED WORKS 2017**

Banner Marsh Habitat Rehabilitation and Enhancement Project (HREP)

LaGrange Pool, Illinois River, Miles 138-144, Fulton and Peoria Counties, Illinois

**IX. DATE OF FIELD VISIT:** June 26, 2017, Warm, overcast, mid 70's °F

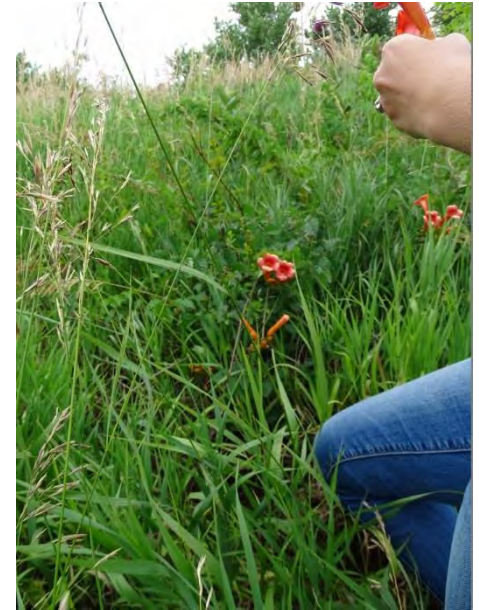
Vine on Levee

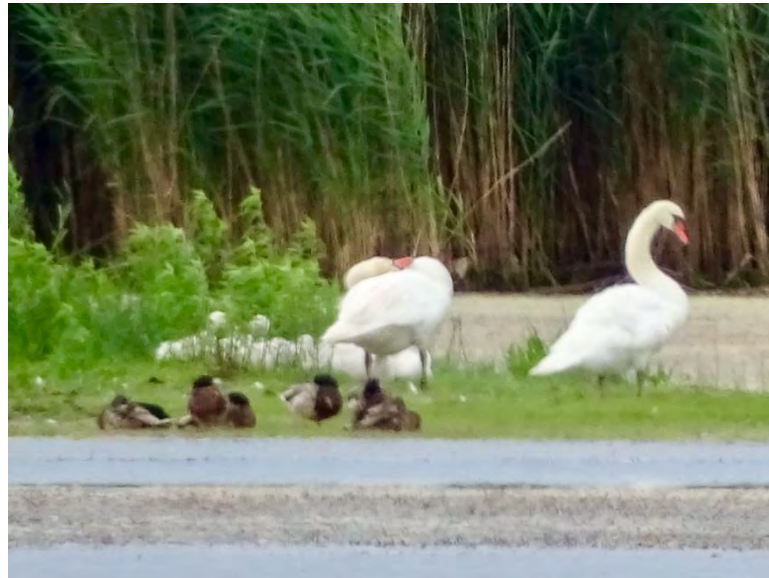
Mute swans have become an issue at the site. They impact wetlands through degradation of submerged aquatic vegetation communities. These invasive swans are a concern because they damage other wildlife and discourage goose nesting. One option to manage nuisance birds is herding dogs.

Mute Swans

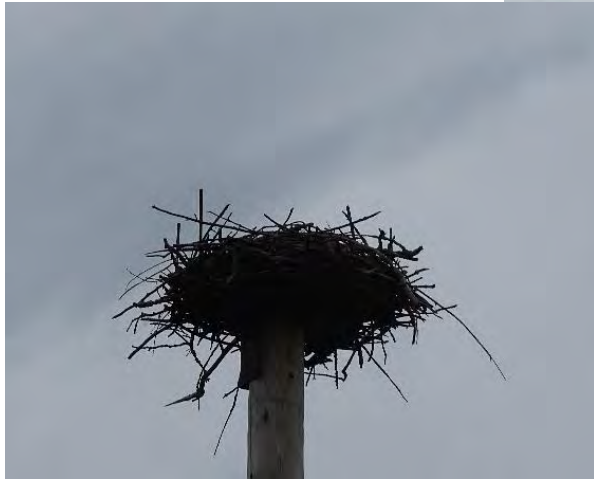
Osprey nest

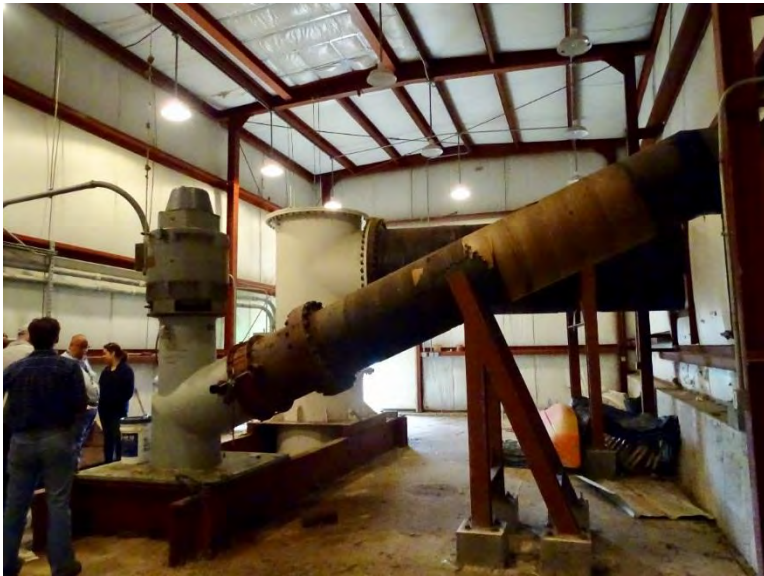
The pump station is designed for the 48" pump to be the primary pump and the 24" pump to be the backup pump when the marsh is at high water. However, the system does not operate as designed. The mercury floats and electronics are damaged and malfunctioning on the 48" pump. The pump is working but must be operated manually. The labor cost to operate it manually are prohibitively expensive except in emergency situations. The Illinois Department of Natural Resources (ILDNR) has spoken with a local electrician/pump contractor who stated that the damaged electrical components could be replaced for approximately \$20,000, and this would allow the pump to operate as designed. The contractor also stated that the mercury floats could be replaced with a more reliable laser system to determine water surface elevation.

Condensation has been an issue in the pump station in the past and the ILDNR confirmed that it is still in issue, especially during the humid summer months. According to the 2014 PER, the pump station was designed to keep water levels between 429 and 431. The ILDNR is currently operating the pumps to keep water levels in the marsh between 436 and 437. At this elevation there is no extra capacity for water storage, but it is the minimum elevation required to keep the site roads from being submerged. They stated that if they were able to get the 48" pump operating as designed, they would like to lower the marsh water levels by 8-12 inches. There were no concerns with the sump in regards to sediment or debris.

Interior of Pump Station

- Additional invasive species management in the prairie planting area
- Replace/repair electronics and floats for the 48 inch pump

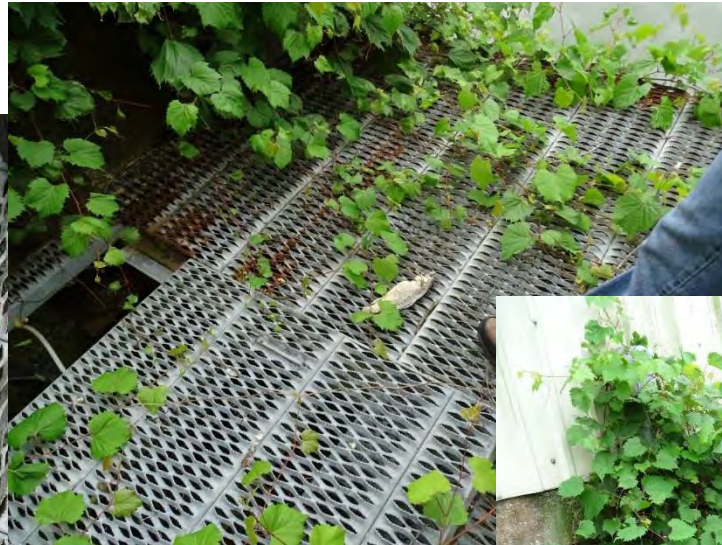
Vegetation encroaching  
on intake structure
