**UPPER MISSISSIPPI RIVER SYSTEM  
ENVIRONMENTAL MANAGEMENT PROGRAM  
POST-CONSTRUCTION INITIAL PERFORMANCE  
EVALUATION REPORT (IPER4F)**

**BAY ISLAND HABITAT REHABILITATION  
AND ENHANCEMENT PROJECT**

**DECEMBER 1999**

• **POOL 22**  
**MISSISSIPPI RIVER MILES 311-312**  
**MARION COUNTY, MISSOURI**

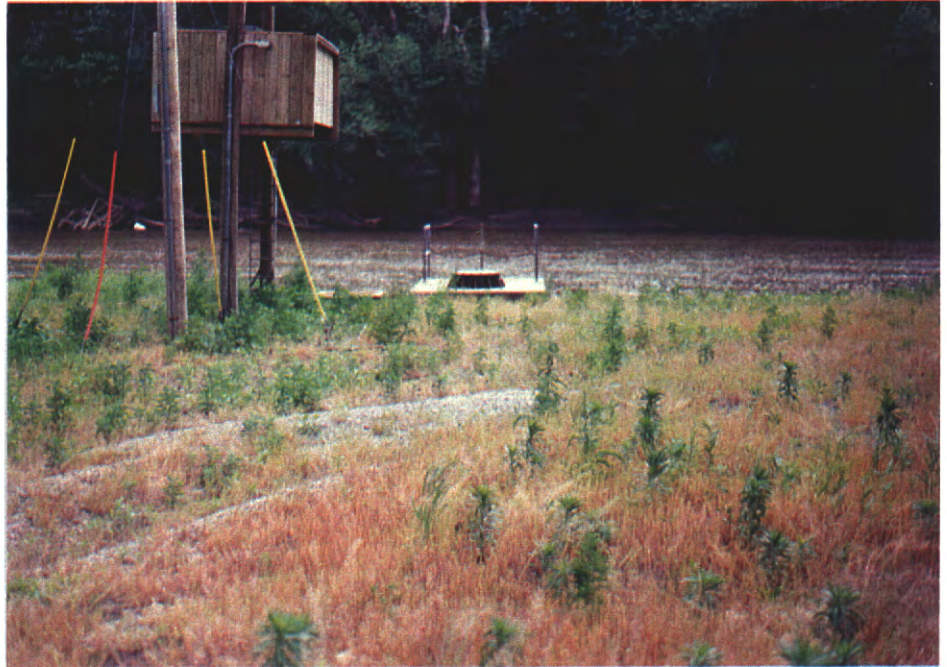
(b) Pump Station. The pump station consists of a 6,000-gpm submersible propeller-type pump. This pump has the capacity to fill in the NWMU in 15 days and both units in 23 days. The pump station, located on the south end of the project, pumps water from Ziegler Chute. The pump is housed in a vandal-resistant cast-in-place building. The intake entrance is equipped with a trash rack. Underground single-phase electrical power is provided to the site. All necessary electrical equipment is located on an overhead platform (see photos 1 and 2, page 13).

Photo 1. Pump station and electrical control equipment platform.

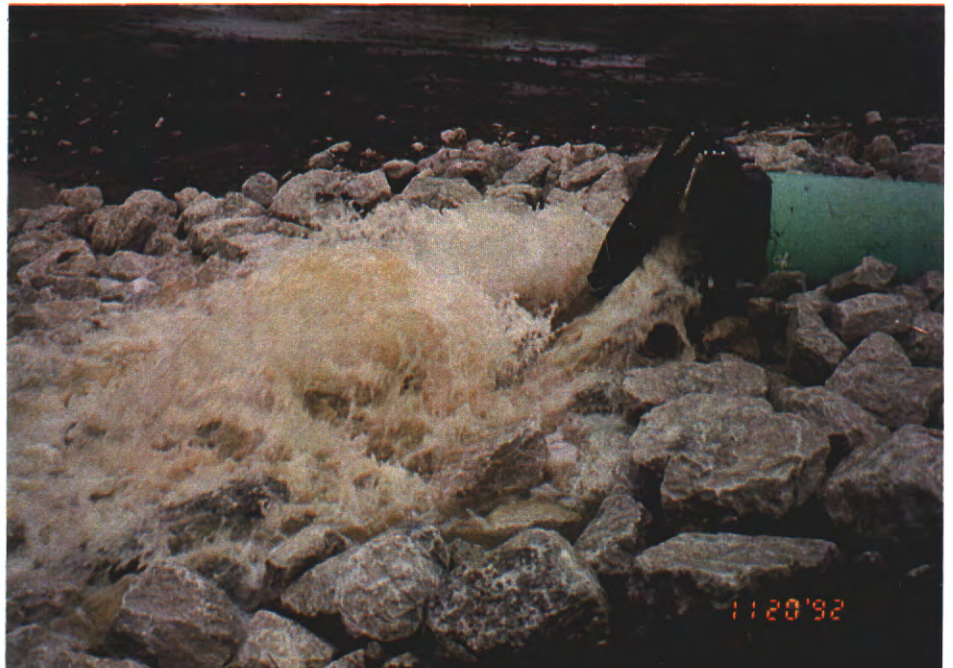
Photo 2. Pump station outfall.

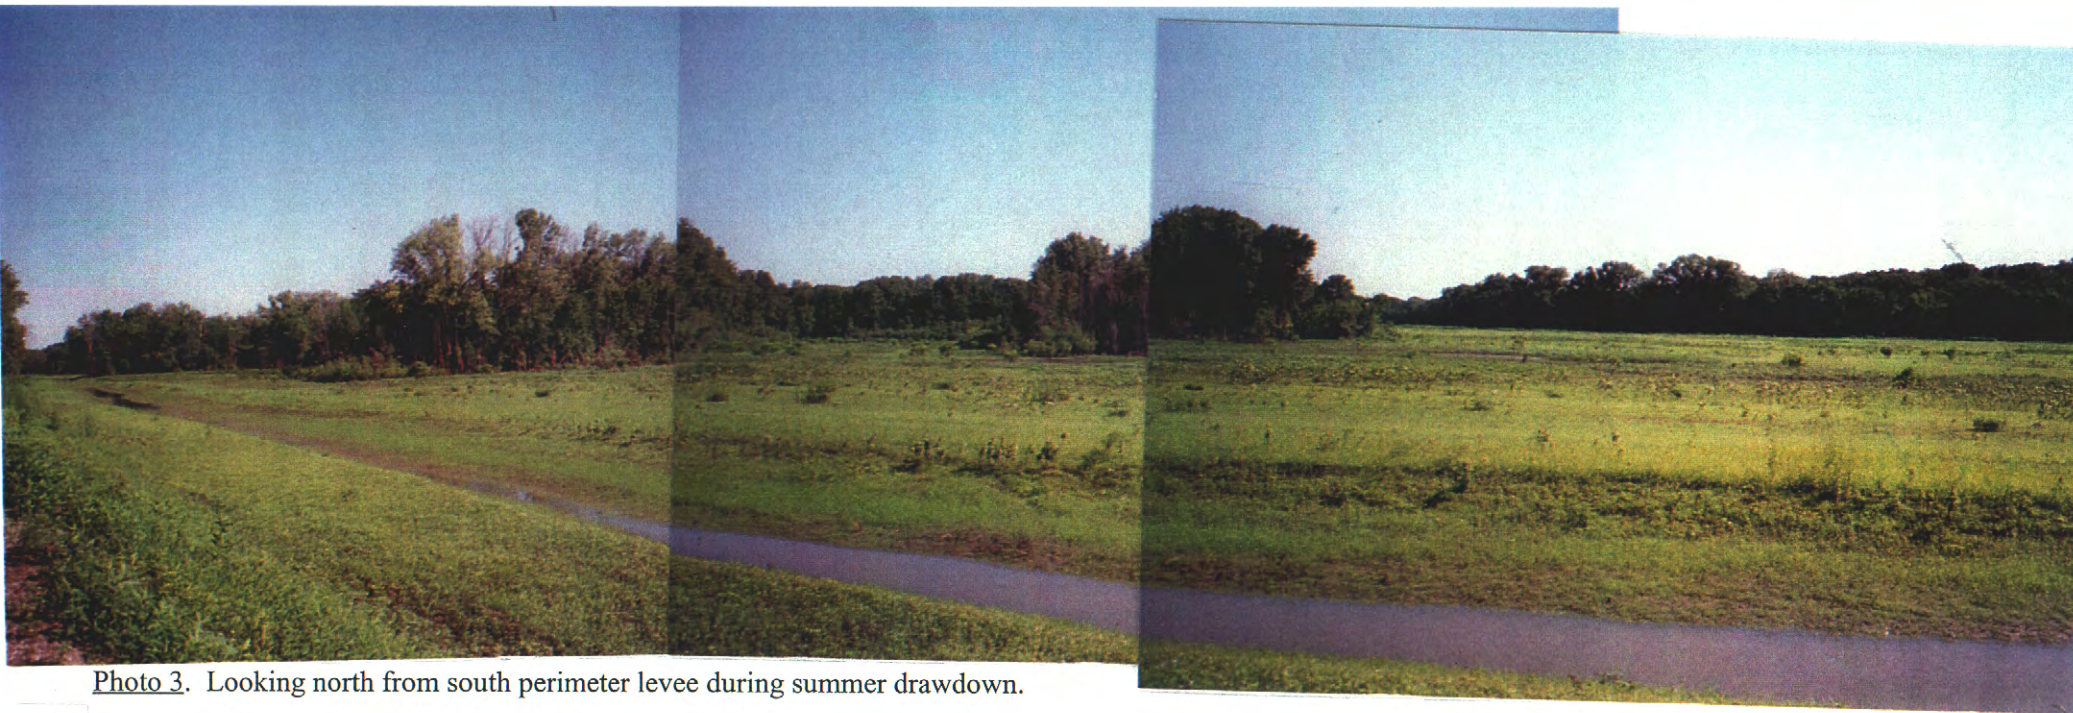
Photo 3. Looking north from south perimeter levee during summer drawdown.

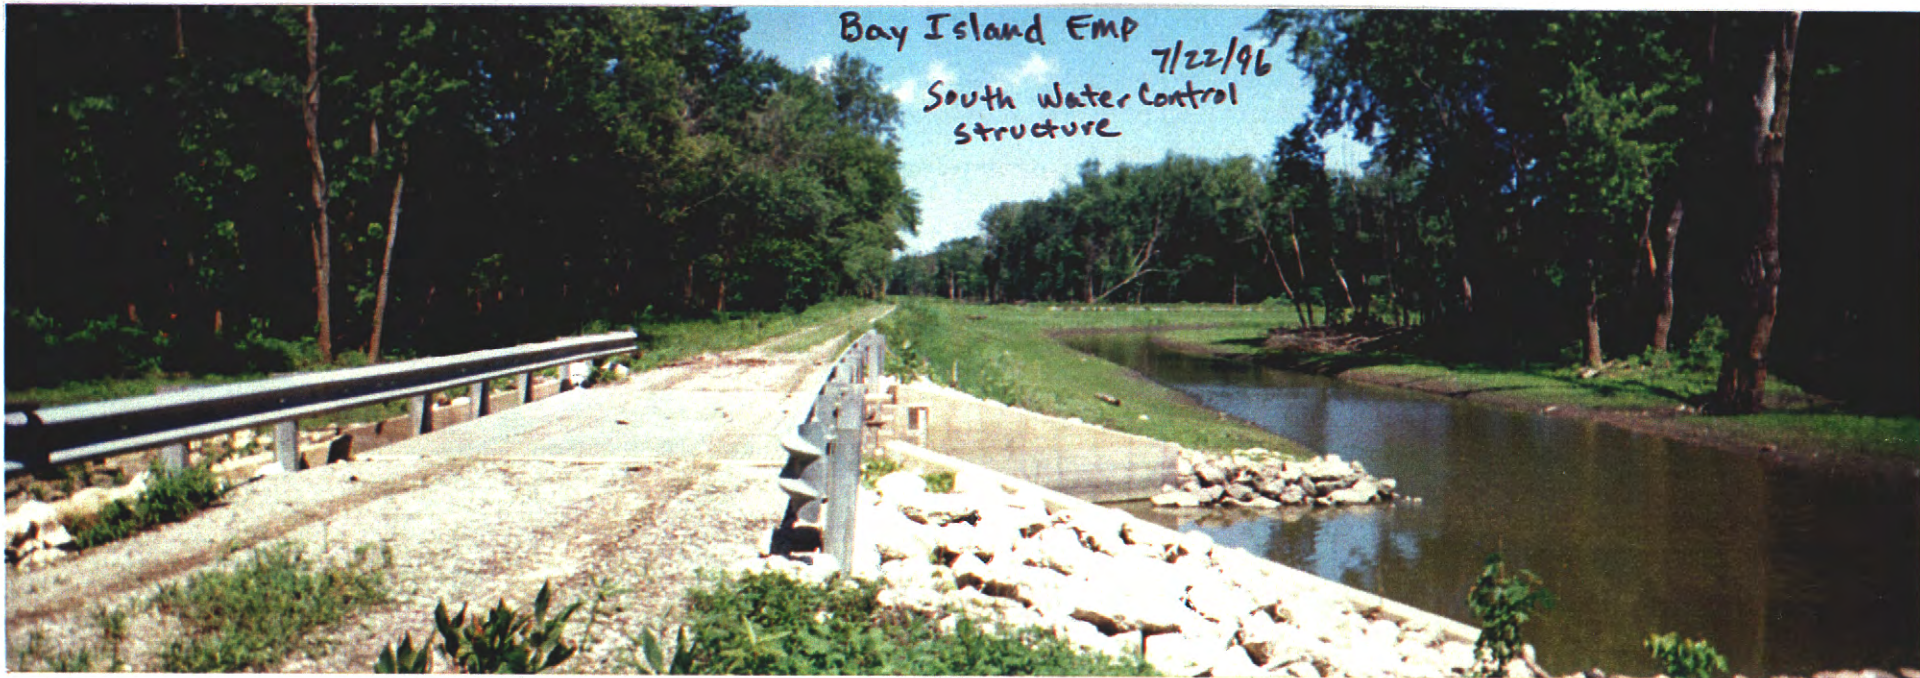
Photo 4. Perimeter levee and south water control structure.

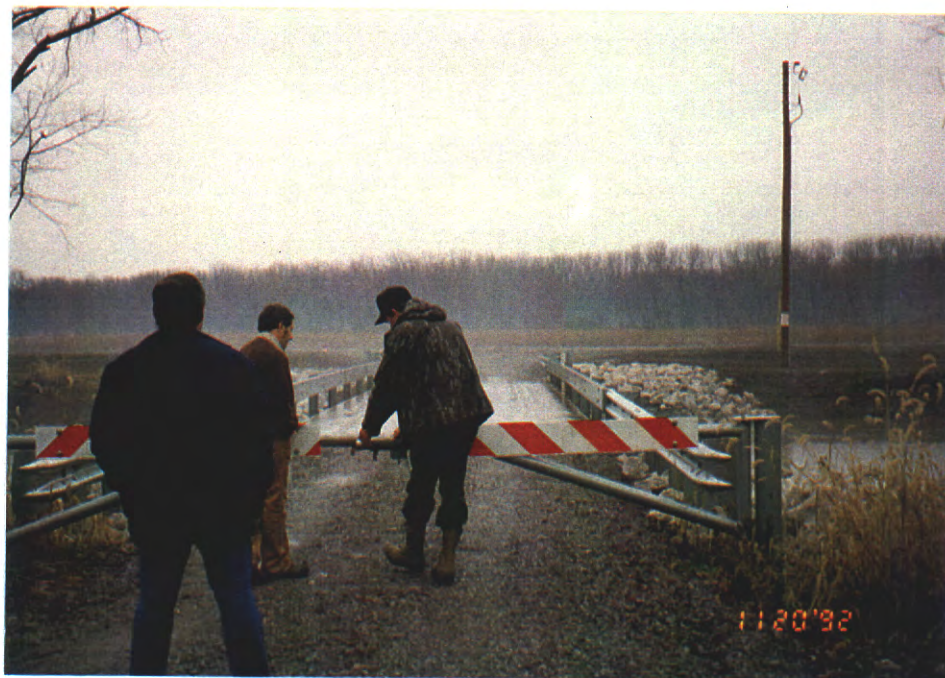
Photo 5. Site access bridge.

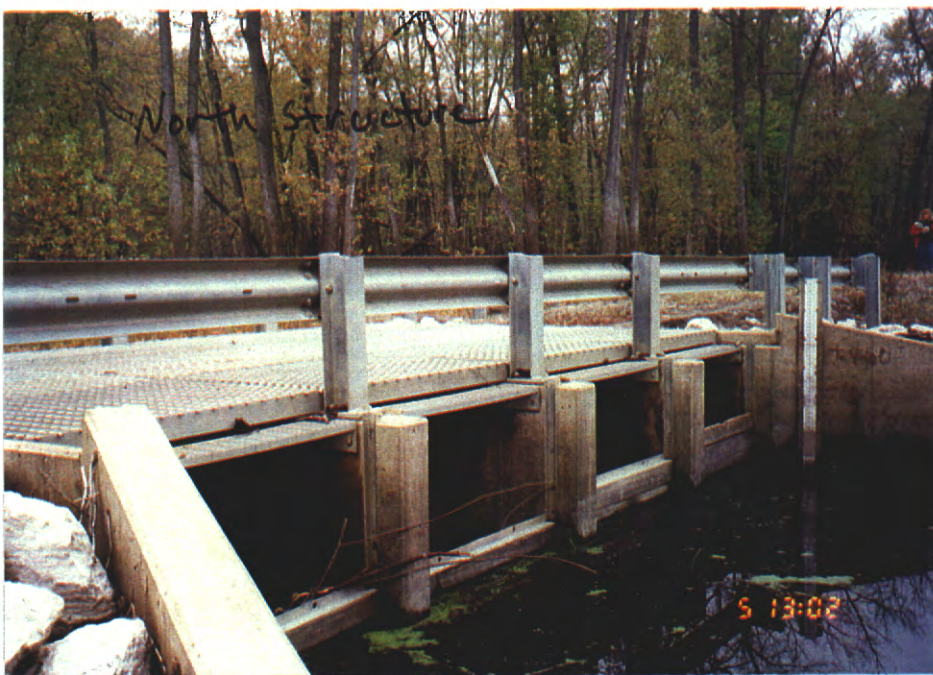
Photo 6. Perimeter water control structure with stop logs in place.

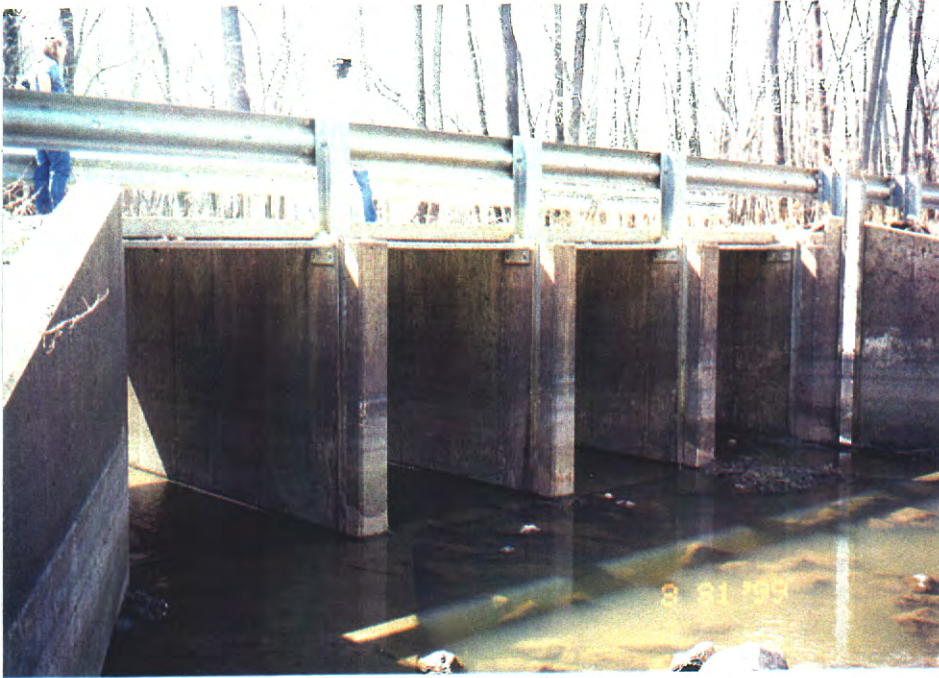
Photo 7. Perimeter water control structure with stop logs removed.

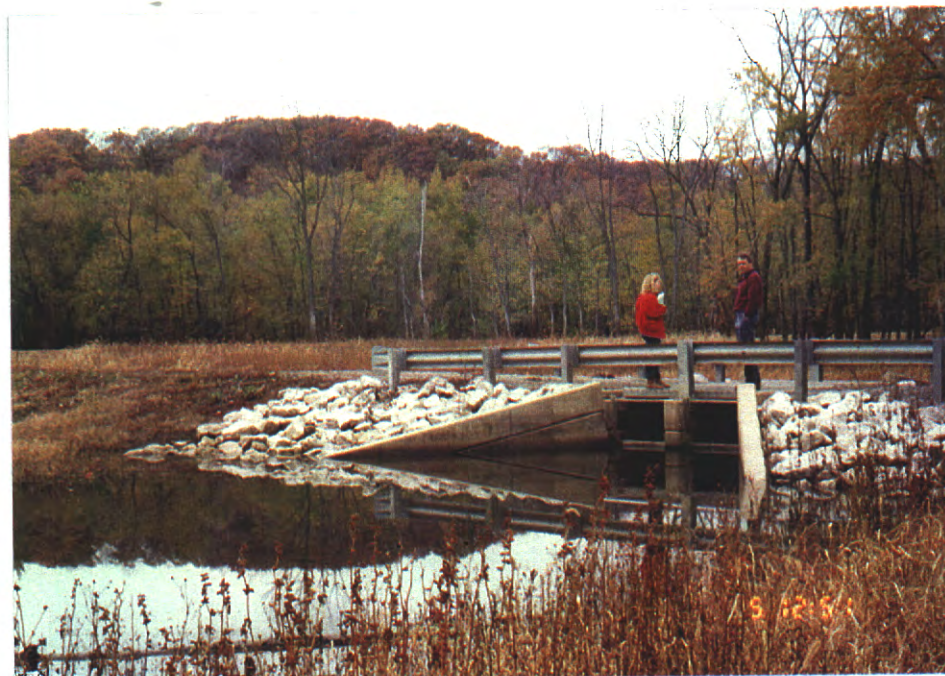
Photo 8. Intermediate (interior) water control structure (2-bay stop logs)

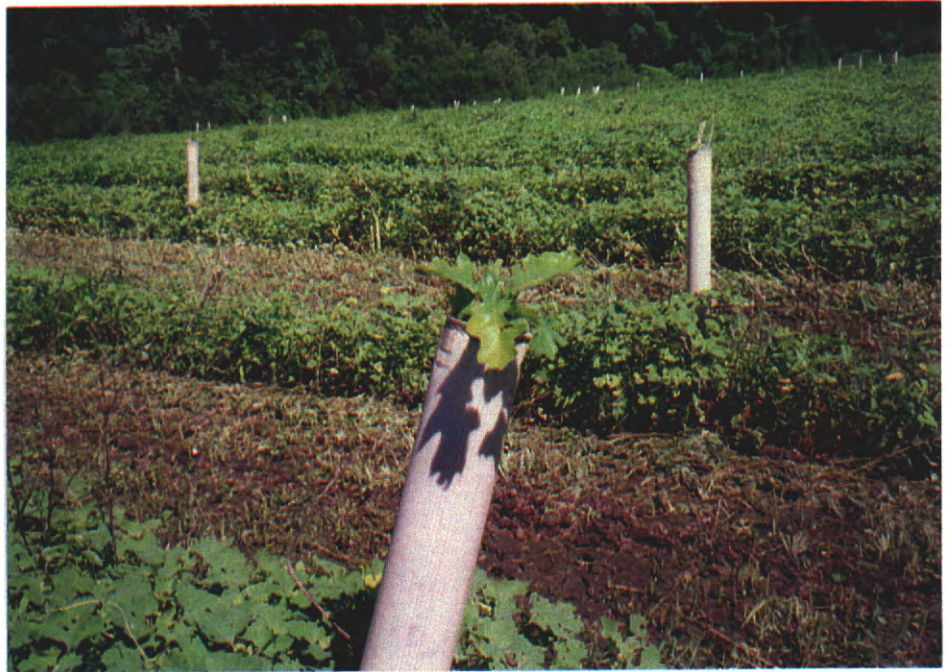
Photo 9. Bare-root tree seedlings with tree shelter protection.

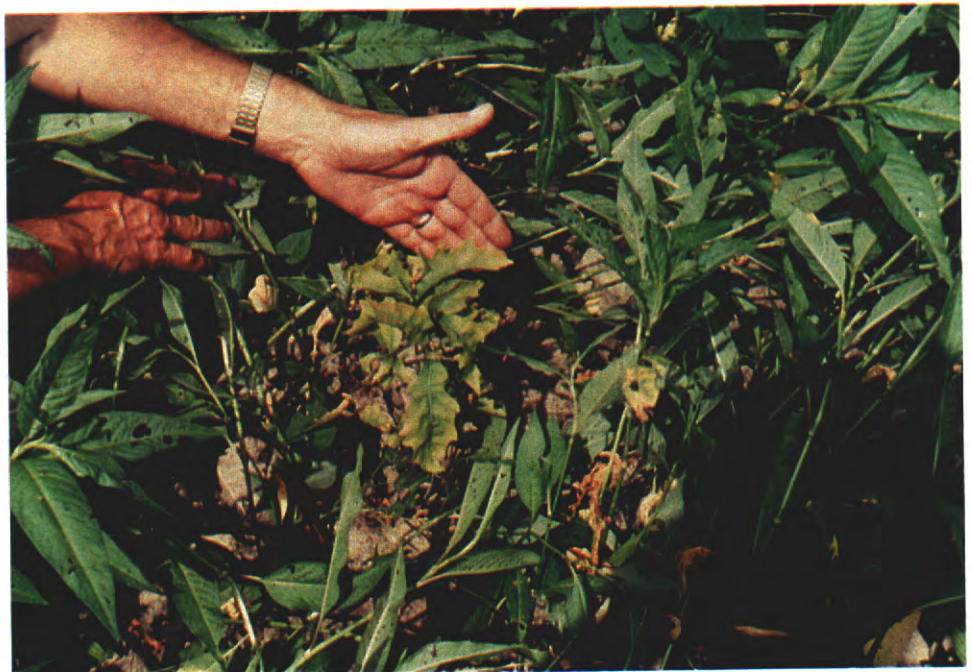
Photo 10. Seedling sprouted from acorn.

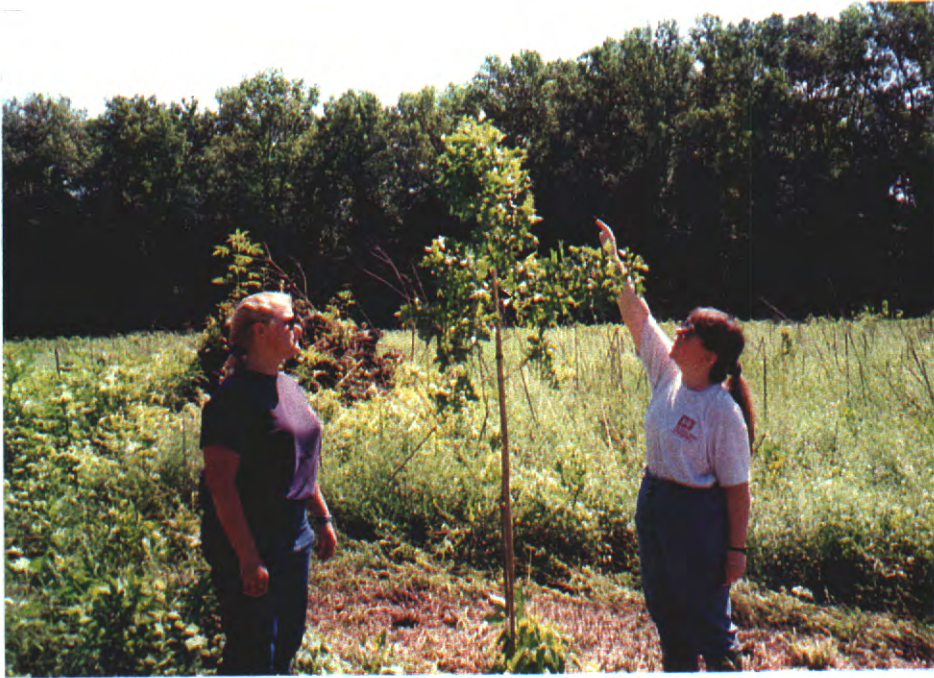
Photo 11. Container-grown tree stock.
