## MEMORANDUM FOR RECORD:

SUBJECT: Bay Island HREP, 10-Year Performance Evaluation Report, 2003

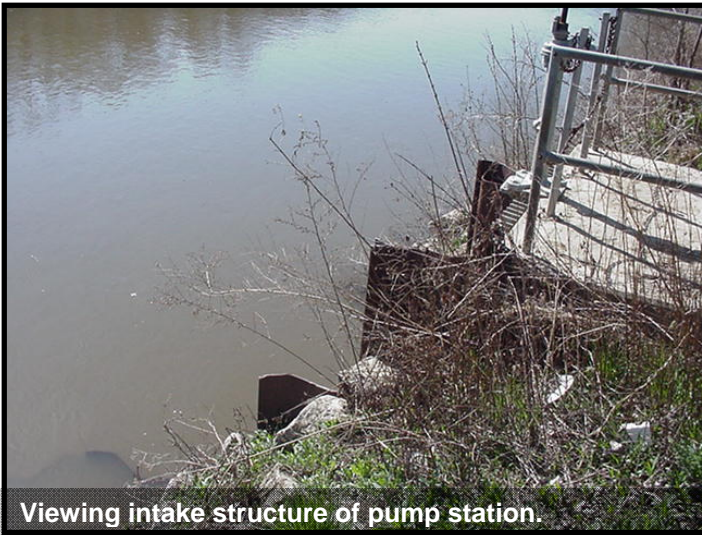
Viewing intake structure of pump station.

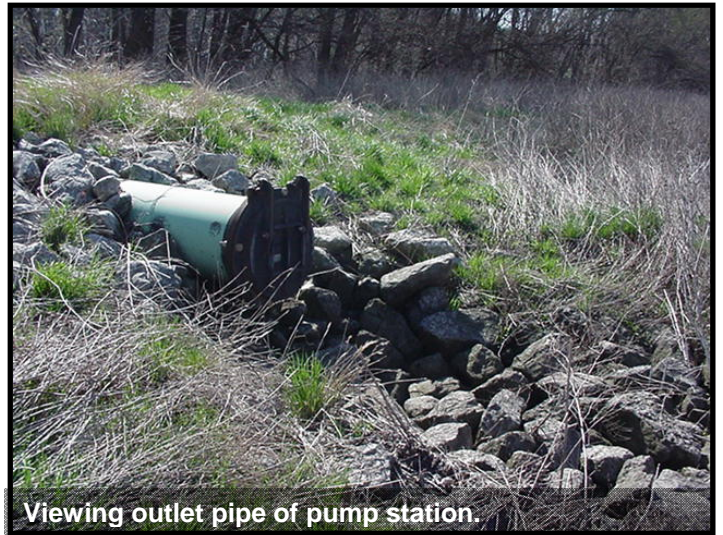
Viewing outlet pipe of pump station.

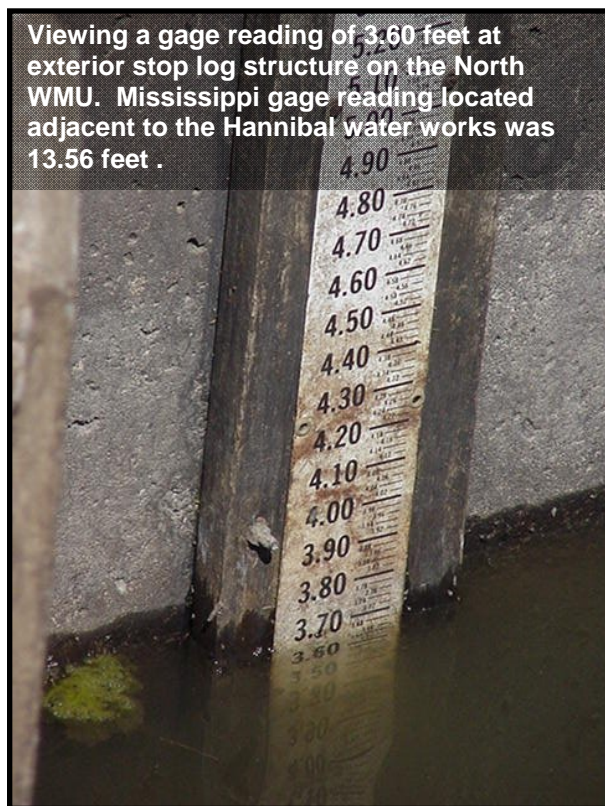
Viewing a gage reading of 3.60 feet at exterior stop log structure on the North WMU. Mississippi gage reading located adjacent to the Hannibal water works was 13.56 feet .

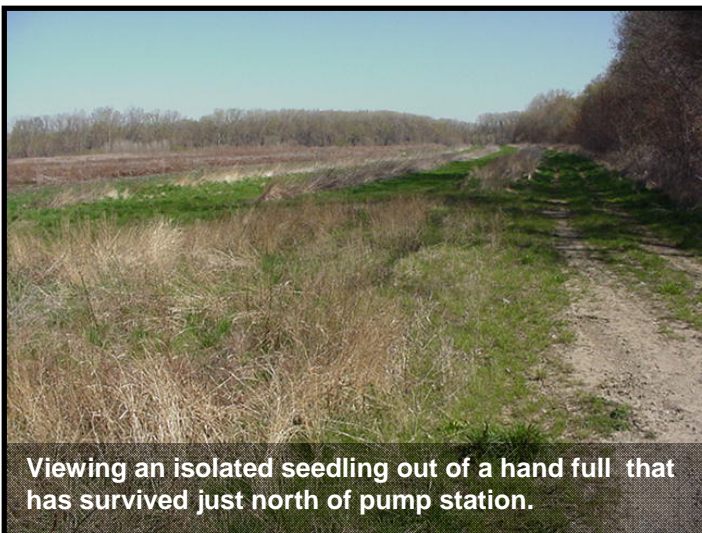
Viewing an isolated seedling out of a hand full that has survived just north of pump station.

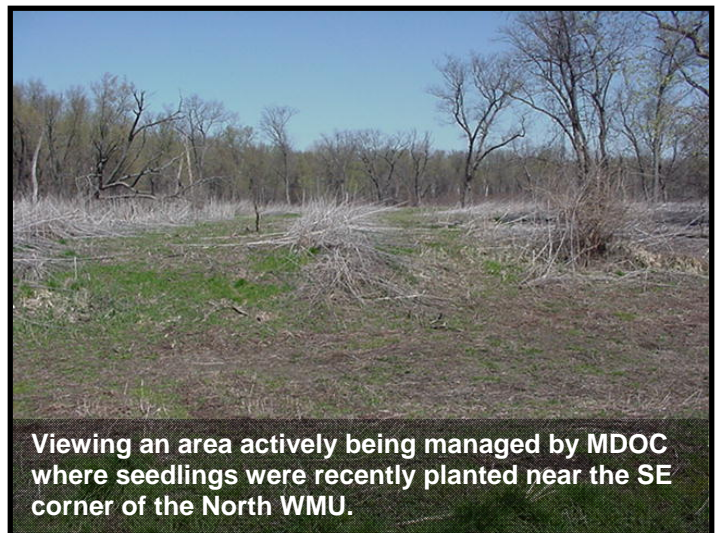
Viewing an area actively being managed by MDOC where seedlings were recently planted near the SE corner of the North WMU.

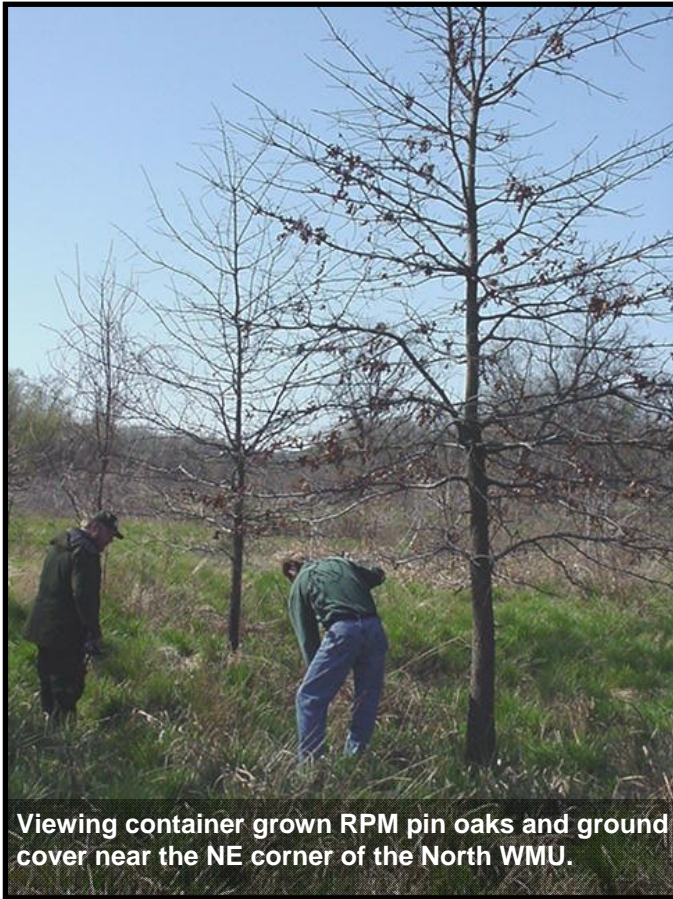
Viewing container grown RPM pin oaks and ground cover near the NE corner of the North WMU.

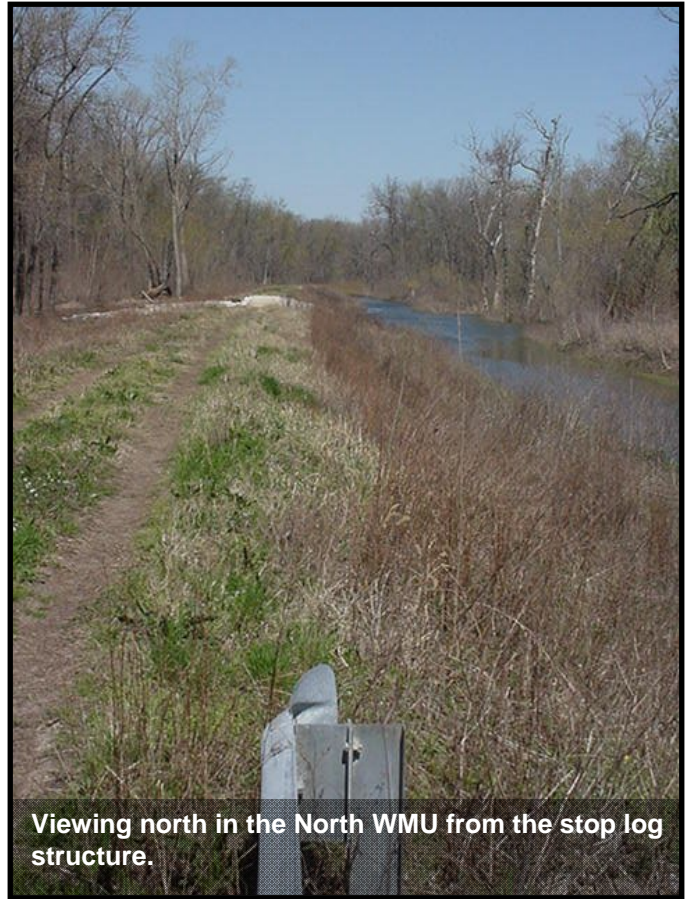
Viewing north in the North WMU from the stop log structure.

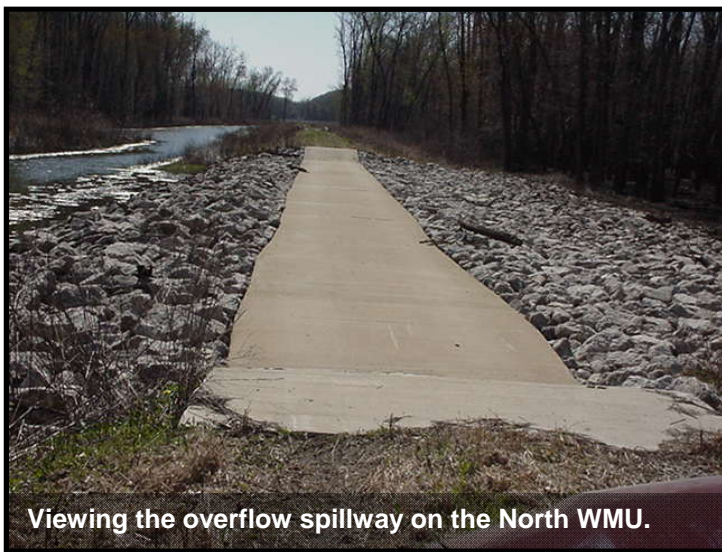
Viewing the overflow spillway on the North WMU.

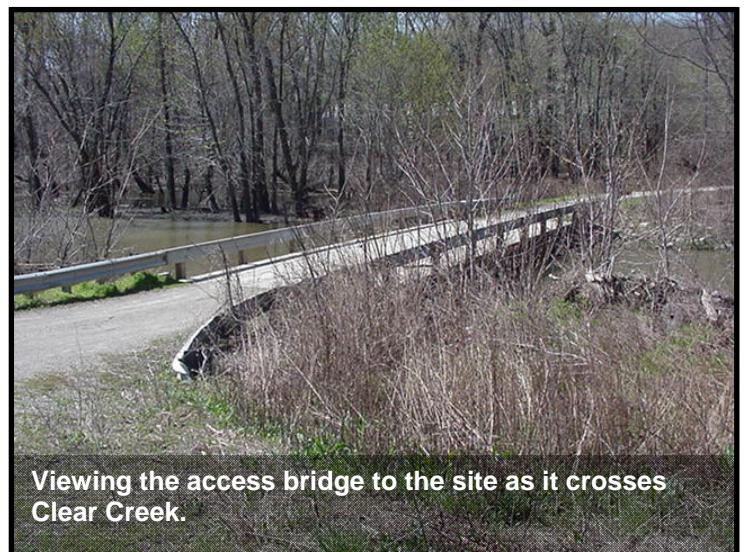
Viewing the access bridge to the site as it crosses Clear Creek.
