PROJECT: Bay Island Habitat Rehabilitation and Enhancement Project (HREP)

LOCATION: Pool 22 Upper Mississippi River Miles 311.0-312.0
Marion County, MO

DATE OF FIELD VISIT: 27 SEPT 2011

Environmental Management Program, Inspection of Completed Works: Trip Report
 Site Visit Photos and Captions

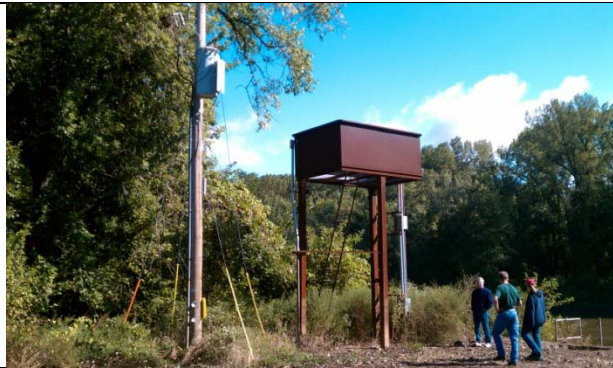
Pump Controller Tower

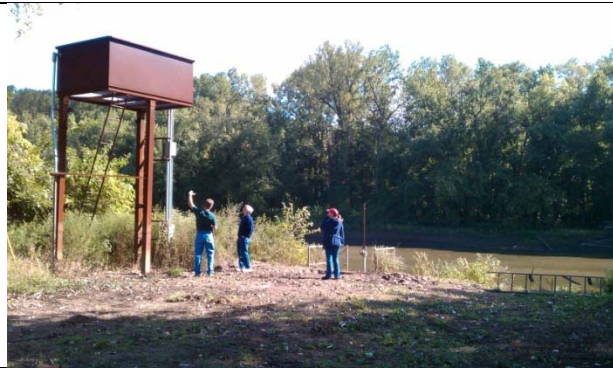
Pump Controller Tower

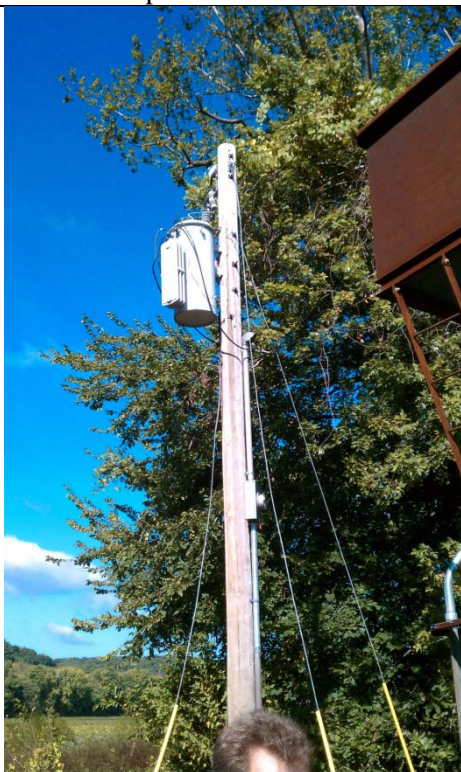
Utility Transformer & Meter Pole

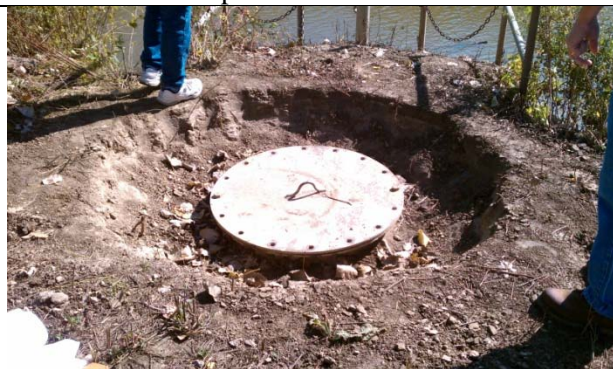
Pump Discharge Pipe

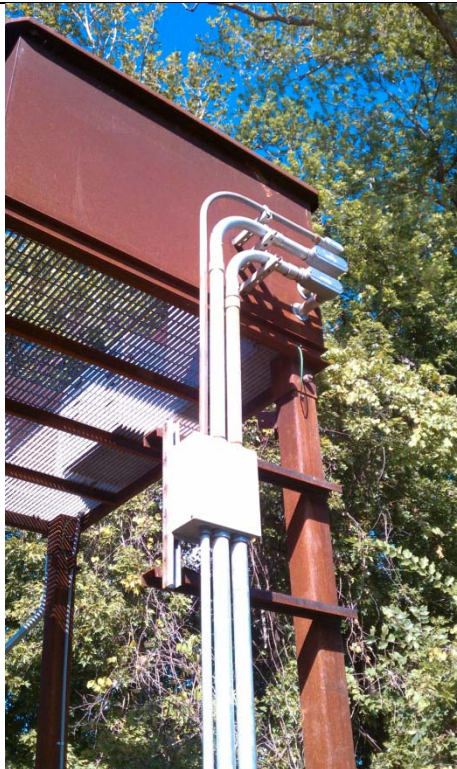
Pump Power & Monitor Conduits

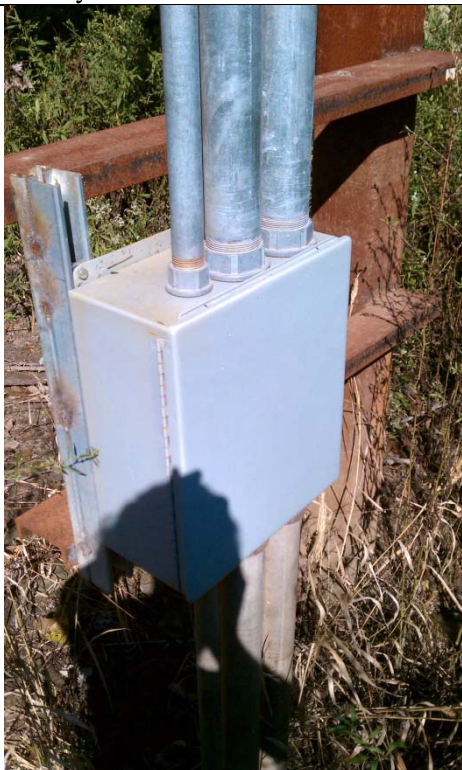
Pump Junction Box

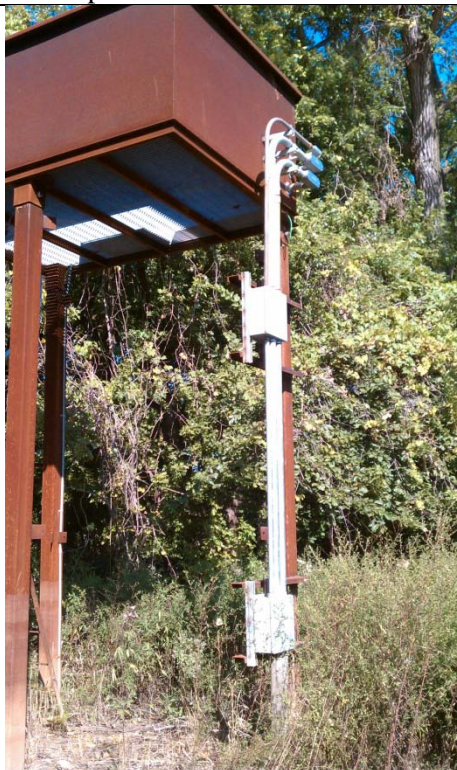
Pump Conduits

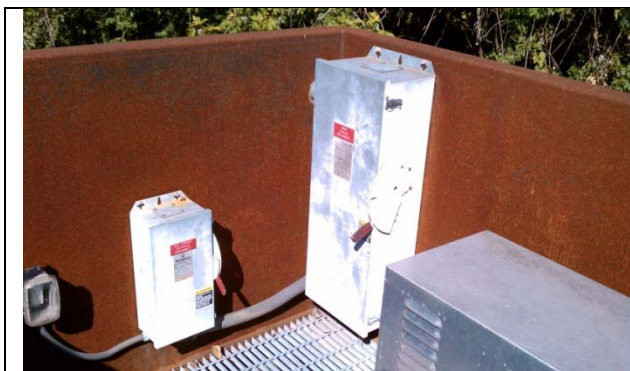
Main Disconnect & Receptacle Transformer

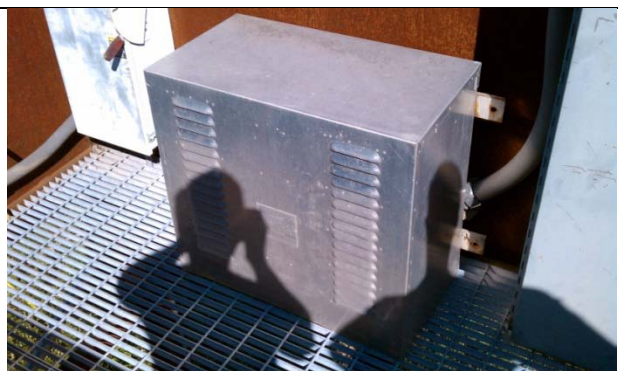
Phase Converter

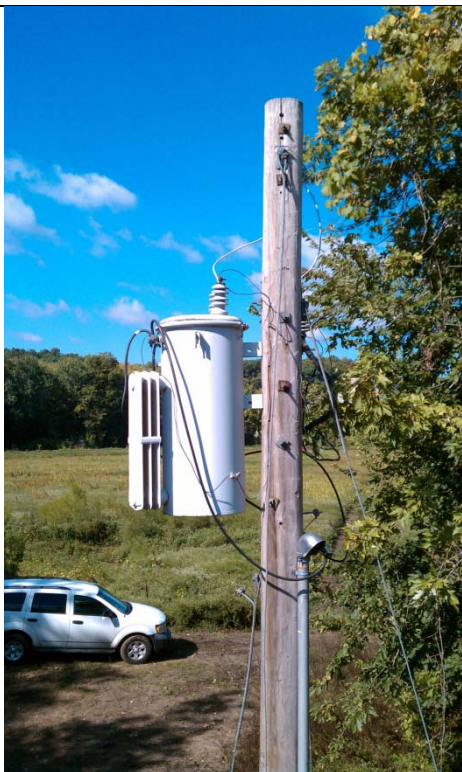
Utility Transformer

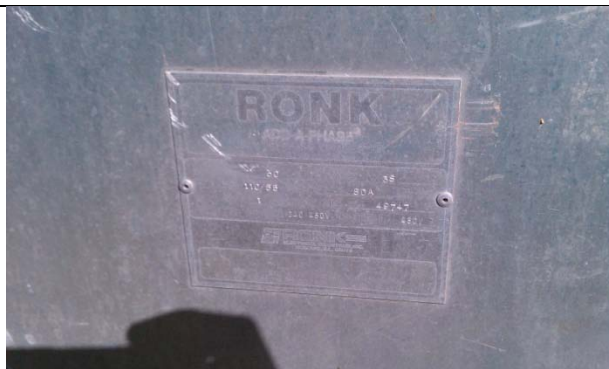
Phase Converter Nameplate

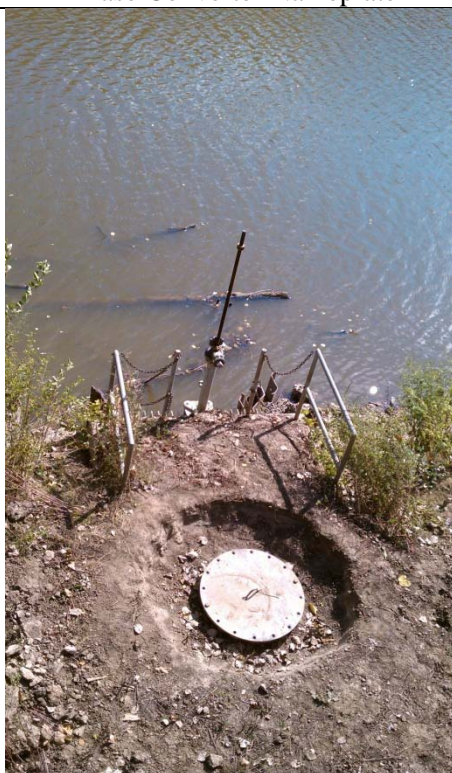
Pump Discharge Pipe

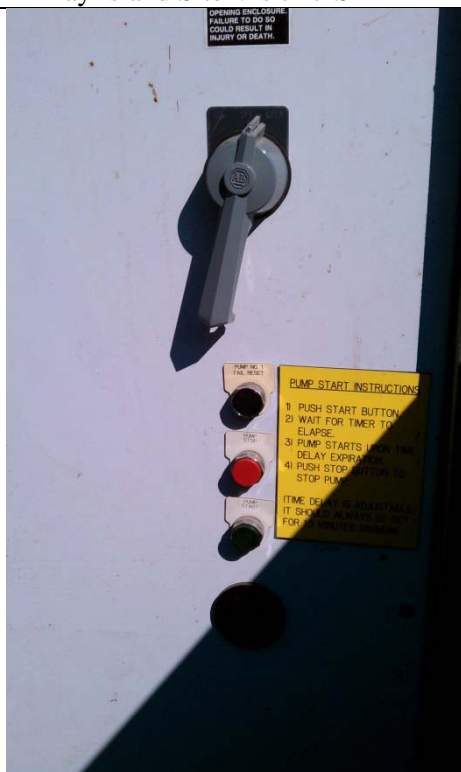
Pump Controller

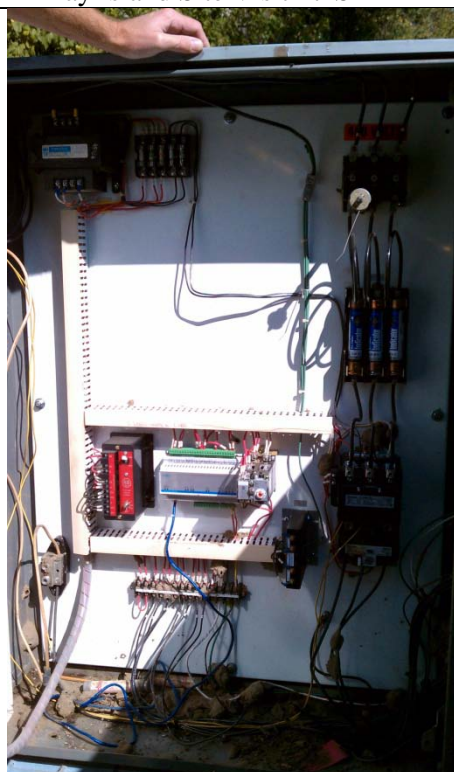
Pump Controller

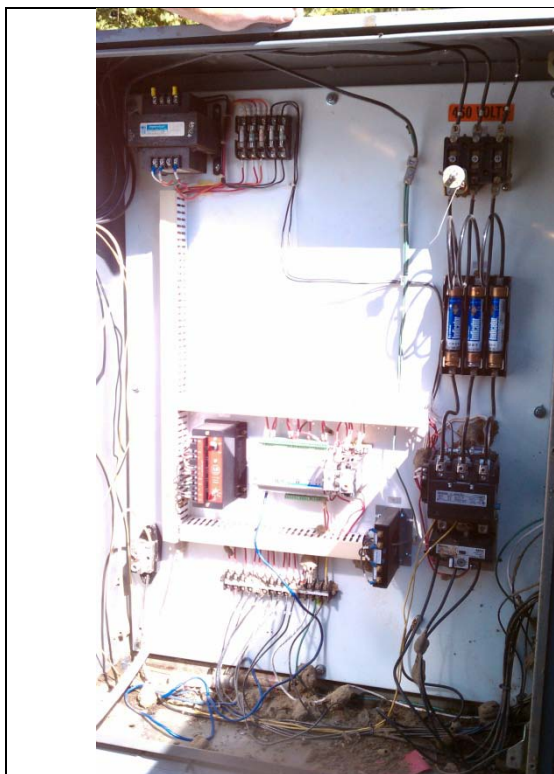
Pump Controller

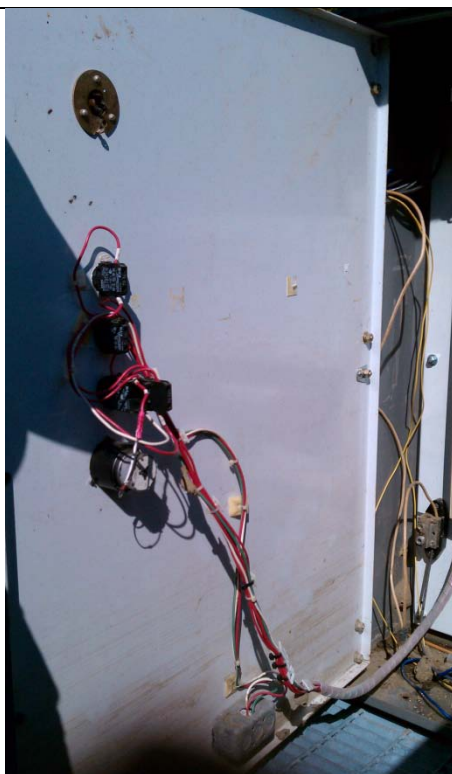
Pump Controller

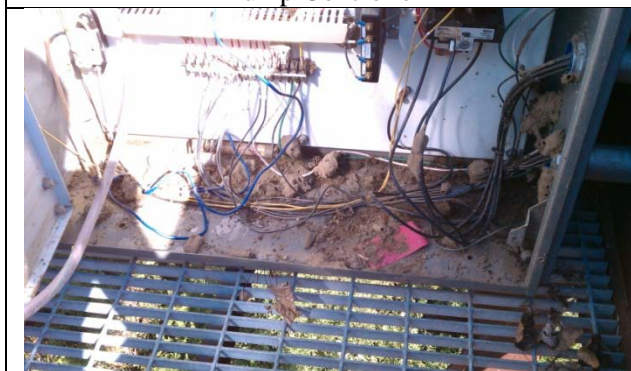
Mud Daubers in Controller

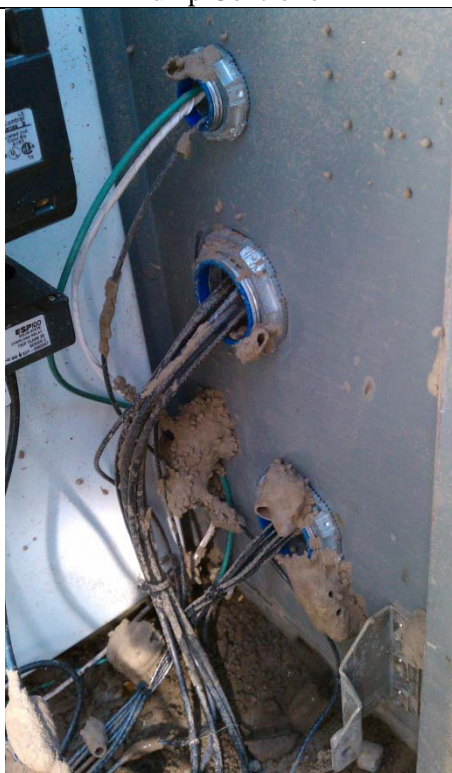
Mud Daubers in Controller

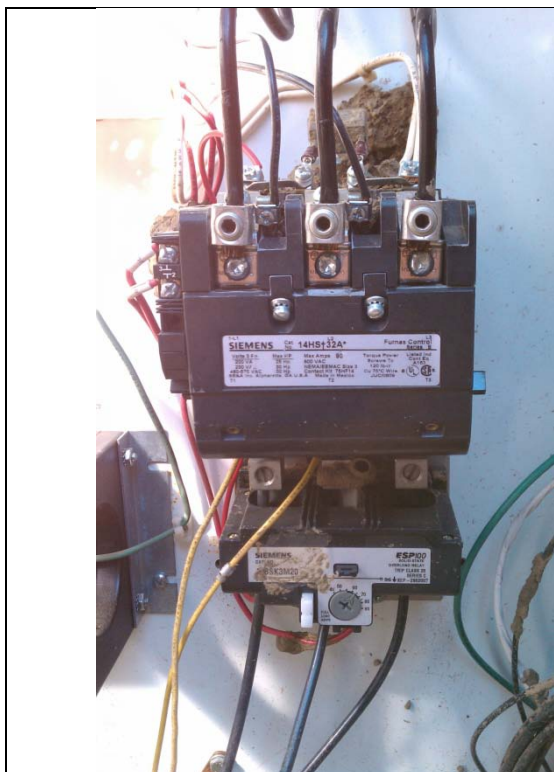
Mud Daubers in Controller Contactor

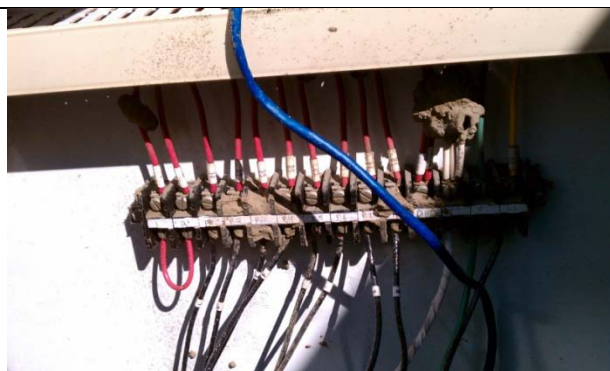
Mud Daubers in Controller in Terminal Board

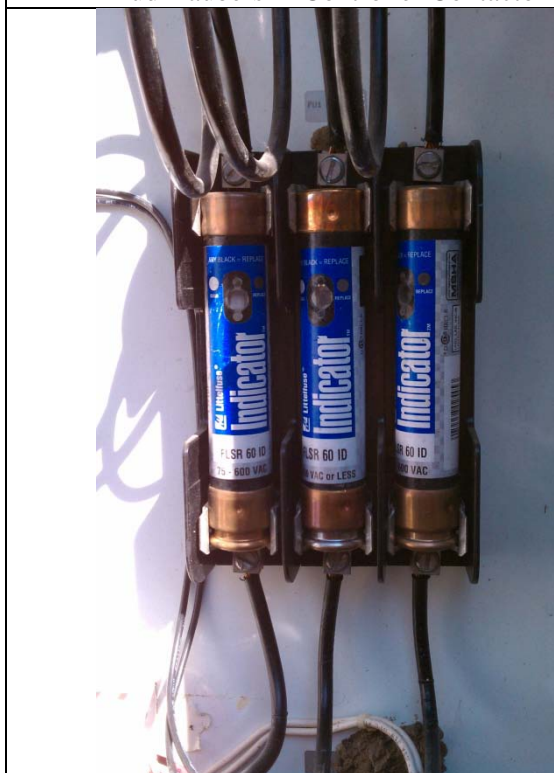
Pump Controller Main Fuses

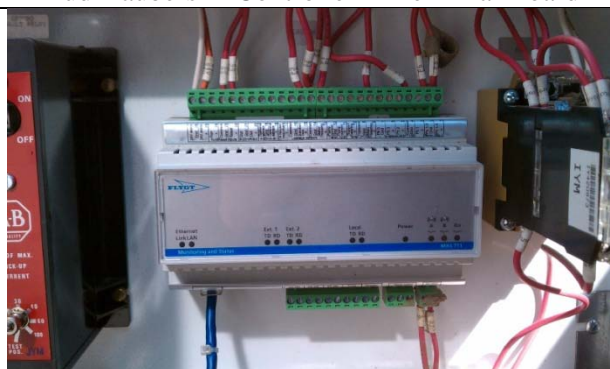
Pump Fault Detector

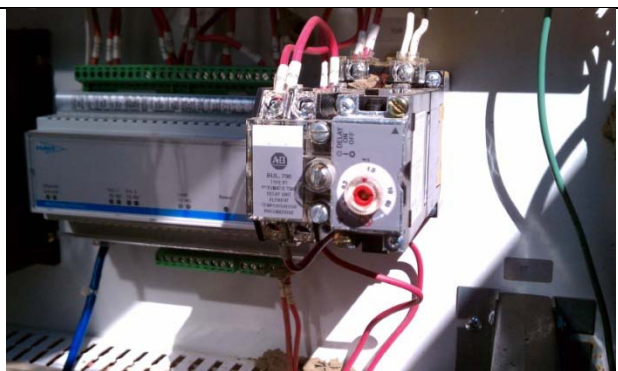
Pump Controller Heater & Thermostat

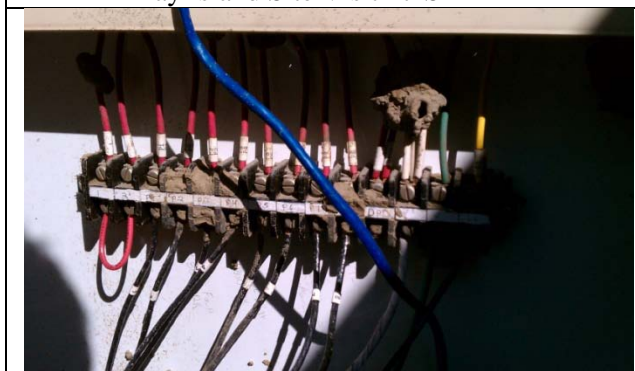
Mud Daubers in Controller in Terminal Board

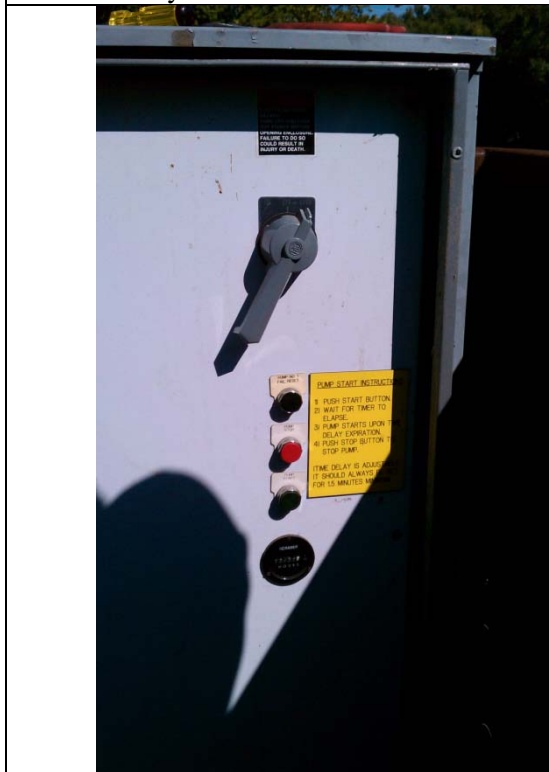
Pump Controller Main Controls
