BAY ISLAND INSPECTION OF COMPLETED WORKS 2022

Bay Island Habitat Rehabilitation and Enhancement Project (HREP)

Pool 22, Mississippi River Miles 311.0 - 312.0, Marion County, MO

V. DATE OF FIELD VISIT: June 17, 2022, warm, humid, sunny, low 80's °F

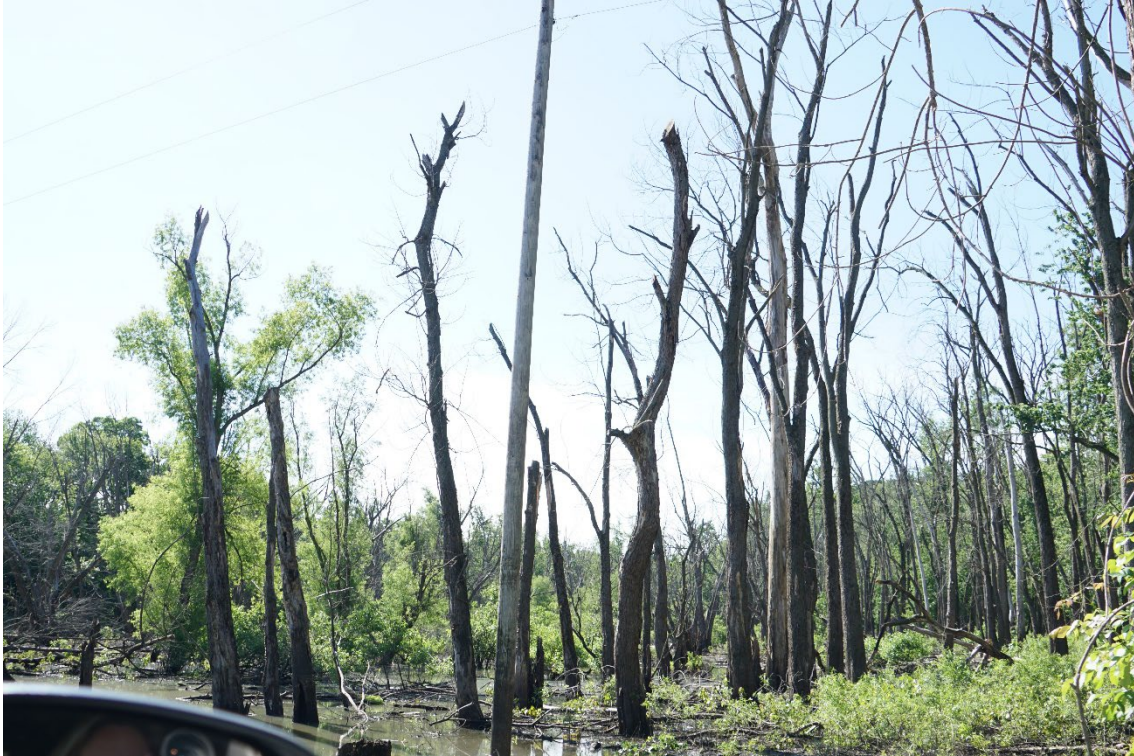
Many dead trees are seen in the interior due to water being too high for too long. Site habitat seems to be transitioning from forested to scrub shrub/wetland habitat.

Photograph 1: Dead Interior Trees

1. Thin RPM trees
2. Determine actions to be taken to reduce leaf litter debris at pump station
3. Replace stop log structures with gates
4. Fix screw gate
5. Repair erosion between borrow pit and levee (break through)
6. Supplemental planting effort in South Wetland Management Unit.

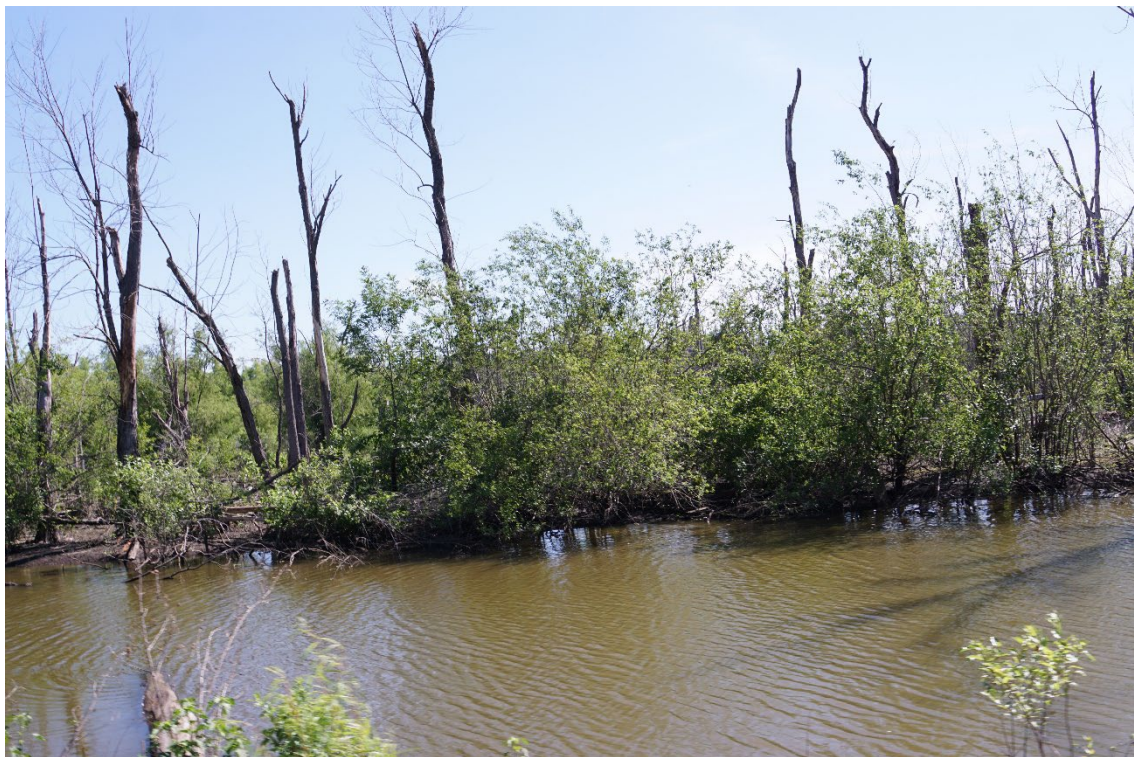
Photograph 2: Dead Interior Trees

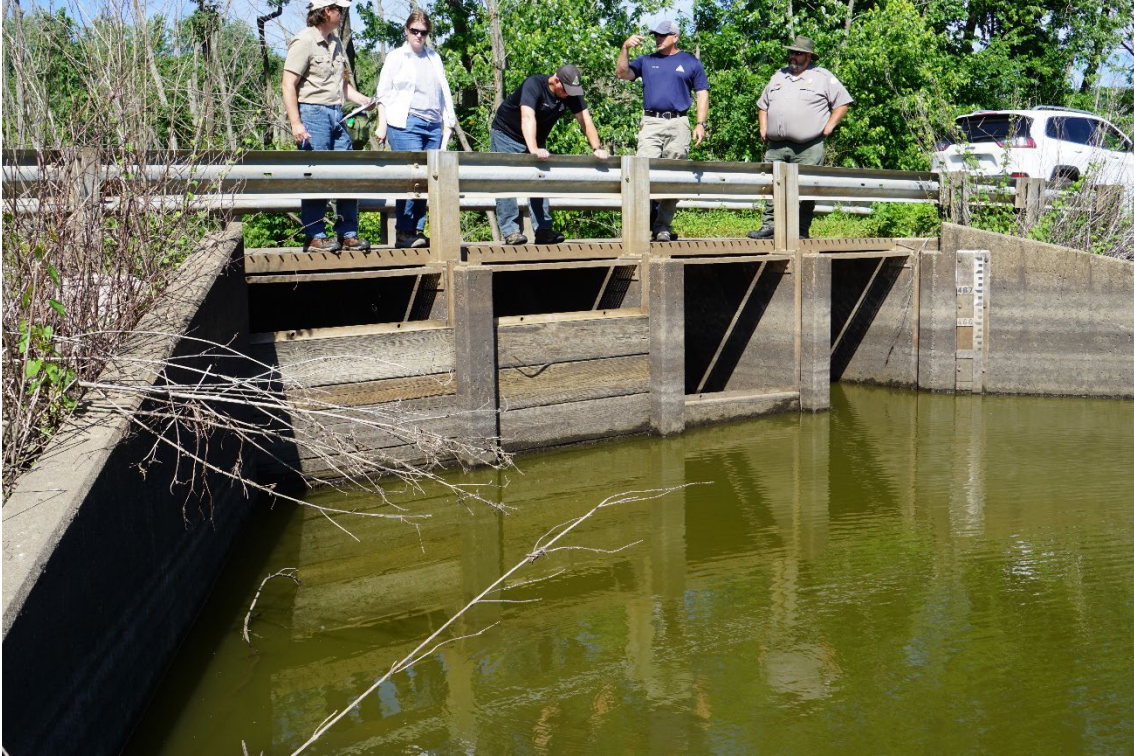
Water Control Structure South Perimeter Levee: The condition of the WCS South Perimeter Levee is similar to the North Perimeter Levee. Like the North Perimeter Levee, operating the stoplogs is a three-person job. It was open in the spring to let the water out, but there is no funding to replace the structure and make it easier to operate. As mentioned above, there is an area on the intermediate levee that consistently breaches, sending water towards the South Perimeter Levee. No damage to the South Perimeter Levee has been observed.

Additionally, beavers have in the past filled the WCS requiring them to be cleared out by MDC staff.

Photograph 3: South Stoplog Structure

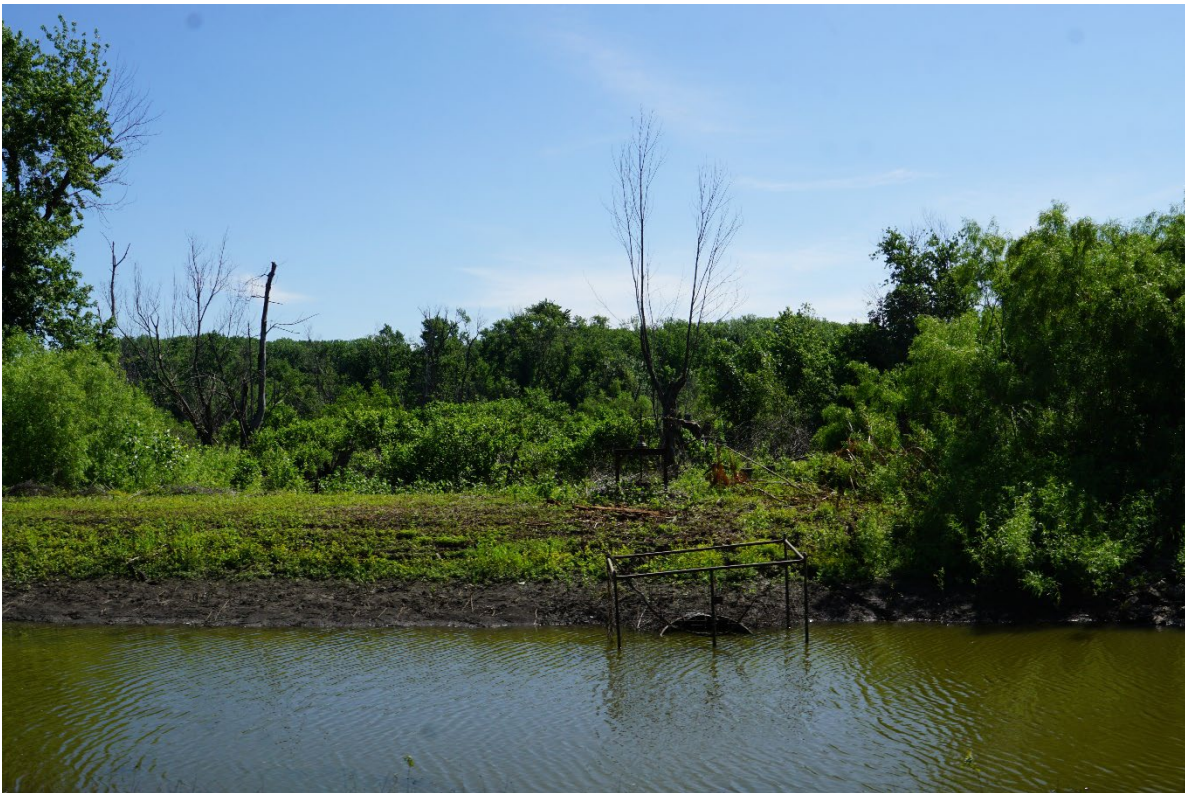
Screw Gate: The gate is completely inoperable. The screw turns but the gate will not raise or lower. It is likely stripped and needs repaired, but there is currently no money to do so. As built shows the gate on the edge of the levee. However, it is actually in the center.

Photograph 4: Broken Screw Gate

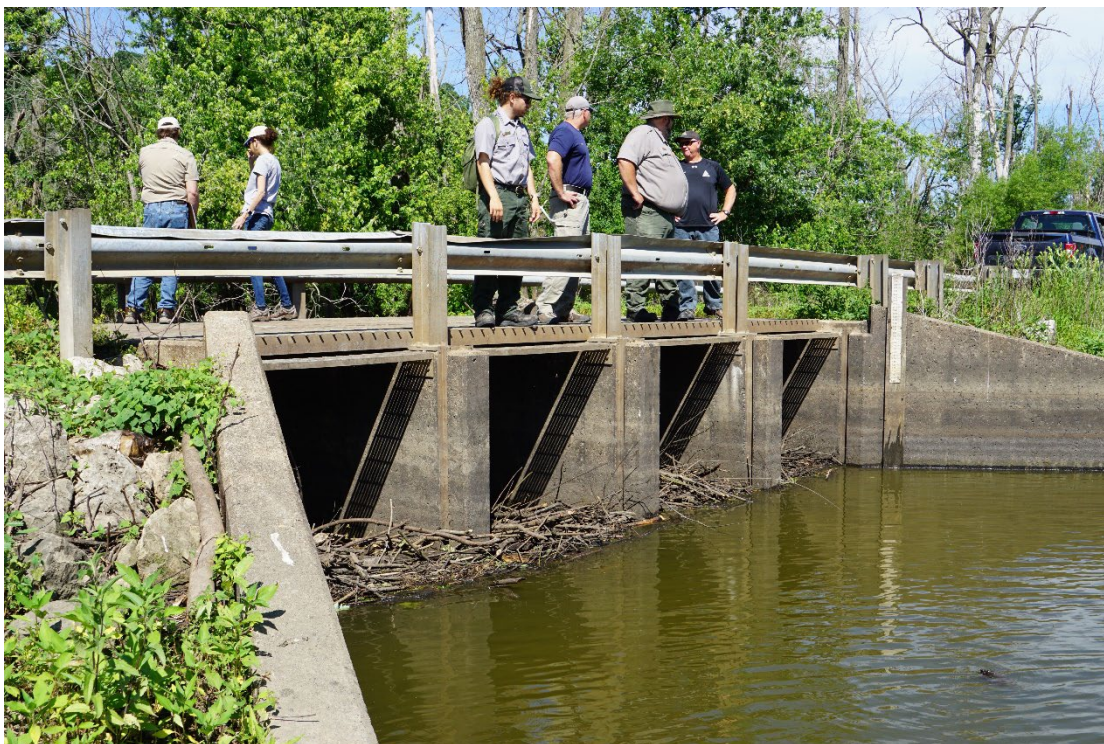
Water Control Structure North Perimeter Levee: The WCS along the North Perimeter levee is in good condition and has not been modified since the 2017 site inspection. The rip-rap is largely still in place. There is no erosion adjacent to the structure, and only minimal concrete structural degradation adjacent to the grate decks above the stoplogs. It is also clogged with woody debris from beaver activity.

The main issue indicated by the sponsor with the WCS is the stoplogs. The structures require two to three people to operate which is difficult given current staffing levels. The low guardrails and the awkward angle for insertion and removal of the lifting hooks also leads to safety concerns. The Missouri Department of Conservation (MDC) plans to change to gates that can be operated by one person pending funding. Images of the stoplogs can be viewed in Attachment A. These give a clearer indication of the difficult angle necessary to manipulate the structure and the safety concerns that may arise.

Photograph 5: North Stoplog Structure

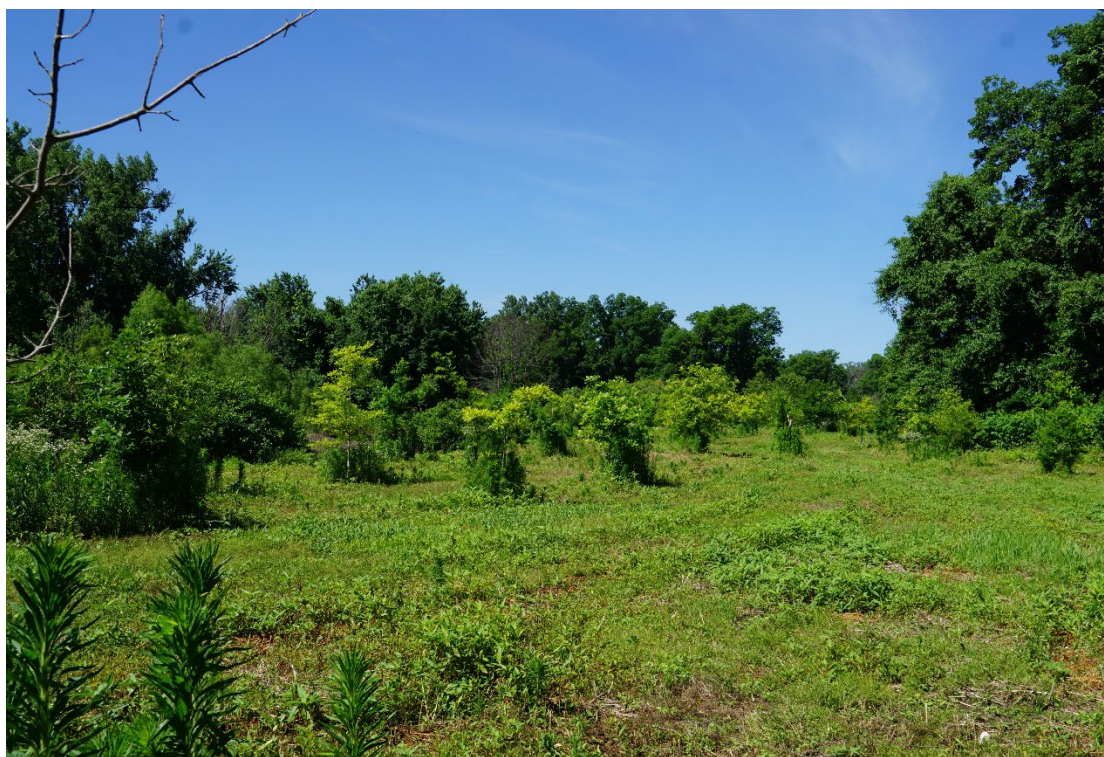
Ameren Mitigation Plot: Formerly used as a food plot, this area was planted with trees and shrubs in 2015 and has since flooded approximately 5 times. Mowing is done approximately 2-3 times a year. The plot is currently on year six of ten, set to be let alone in 2026. Most plantings have endured to the 2-year critical threshold, after which continued survival of tree species increases. However, the aggressive mowing of the site has negatively impacted some of the trees; many had to be righted and re-set into the soil during the 2017 site inspection. Tree species included northern pecan, swamp white oak, overcup oak, bur oak, pin oak, persimmon, elderberry, swamp privet, gray dogwood, spicebush, silky dogwood, buttonbush, bald cypress, river birch, and hickory. A handful of trees had strong stump sprouts from strong roots even if the main stem were dead. Mowing has eradicated the original plantings of scrub-shrub species; none were observed during the inspection. Monitoring for a period of 10 years is required to

ensure containerized trees and shrubs do not fall below the 60% survival rate; otherwise, supplemental planting will be required to at least 80% of original planting density. As a result, many scrub-shrub species were supplementally planted in 2019.

Photograph 6: Ameren Mitigation Tree And Shrub Planting Area (12 Acres)

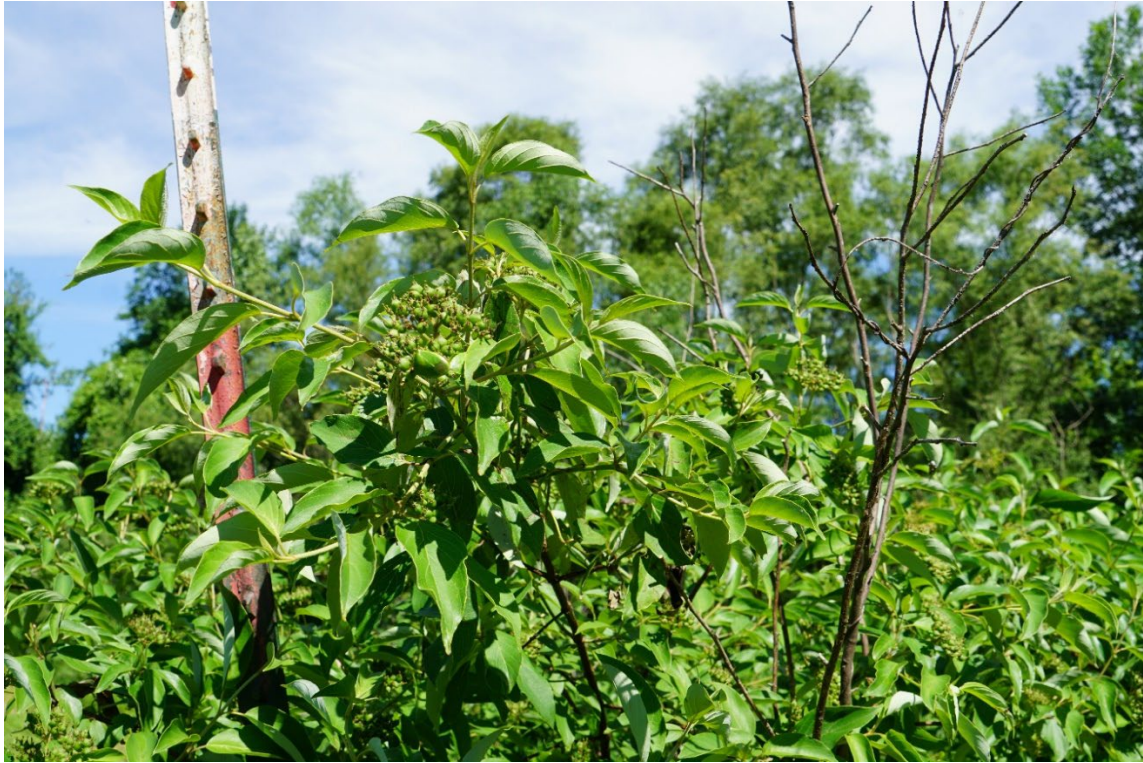
Photograph 7: Ameren Shrub Planting Progress

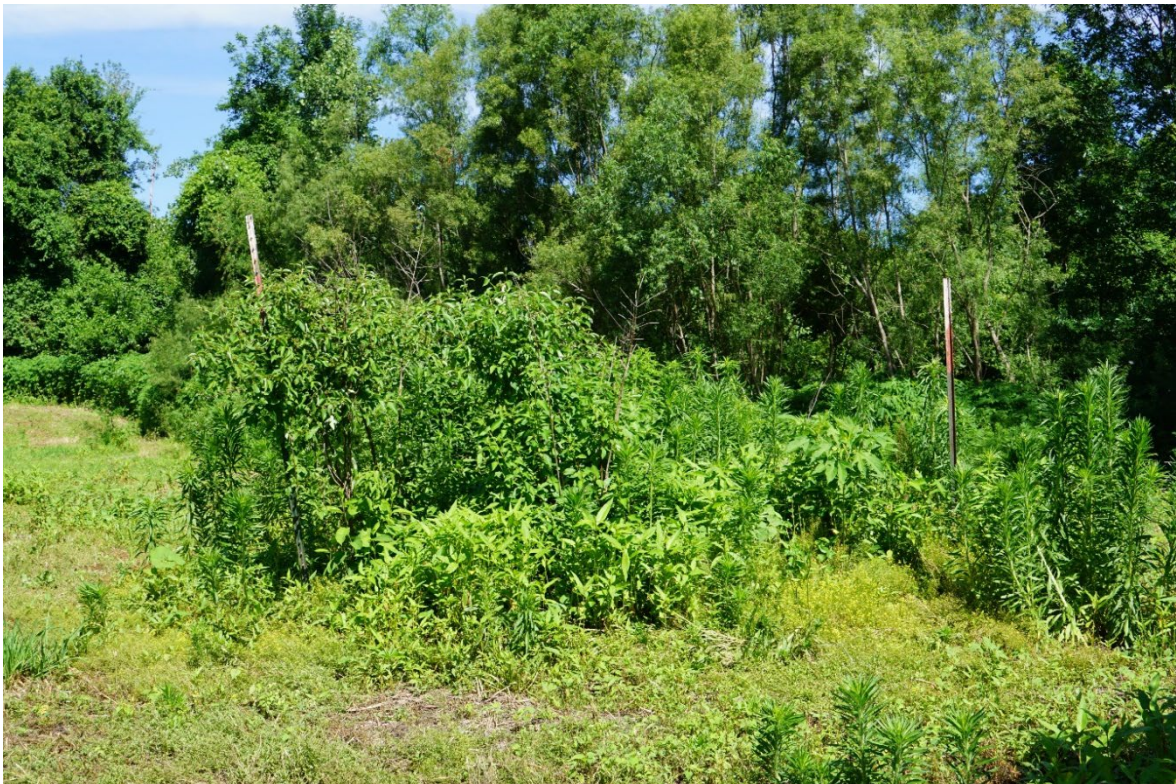
Photograph 8: Ameren Shrub Planting Progress

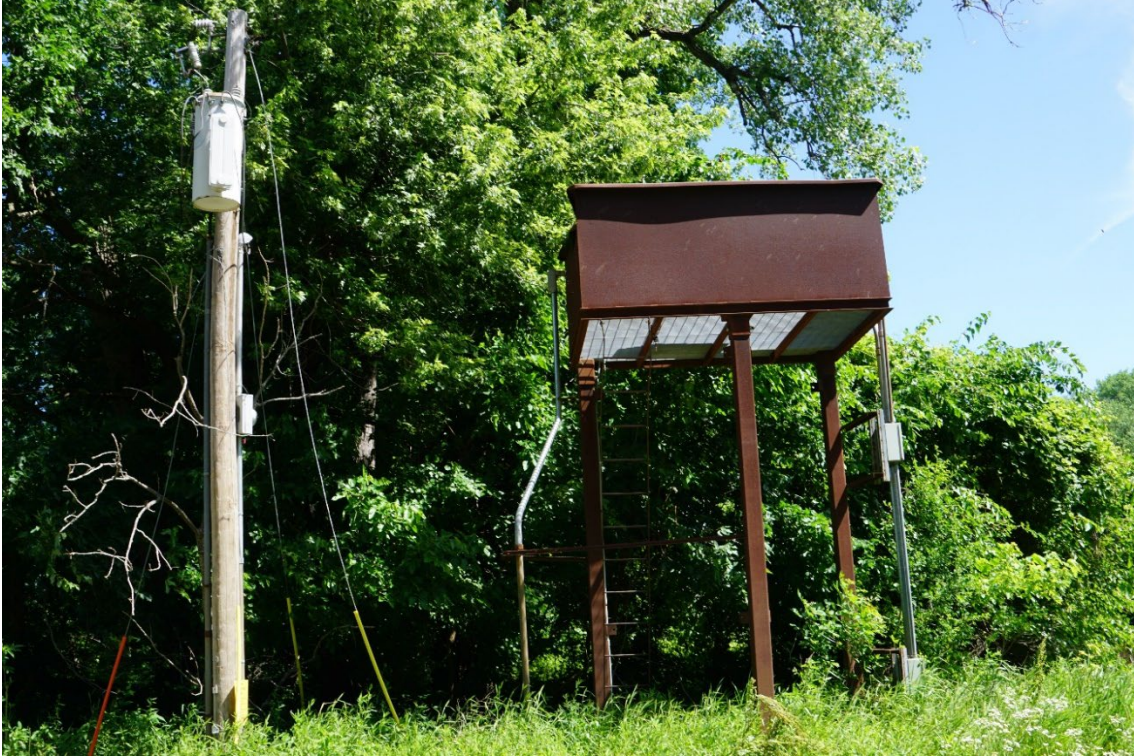
Pump Station: No concerns were noted in regard to the pump station structure. Regular maintenance is occurring since the pump station is used at least once a year. The only issue the project sponsor brought to USACE representatives' attention was that leaf litter during the fall clogs the pump, causing it to shut down. The sponsor noted the pump is working efficiently to bring water into the project area. However, getting water out of the project area during extended high-water events has been a concern. Routinely long-duration high stages of the Mississippi River prevent adequate drawdown of the HREP, which is leading to tree stress and death. Since the purpose of the pump station is to only bring water in, aside from the water control structures, there is no way to remove water from the HREP.

Photograph 9: Pump Station

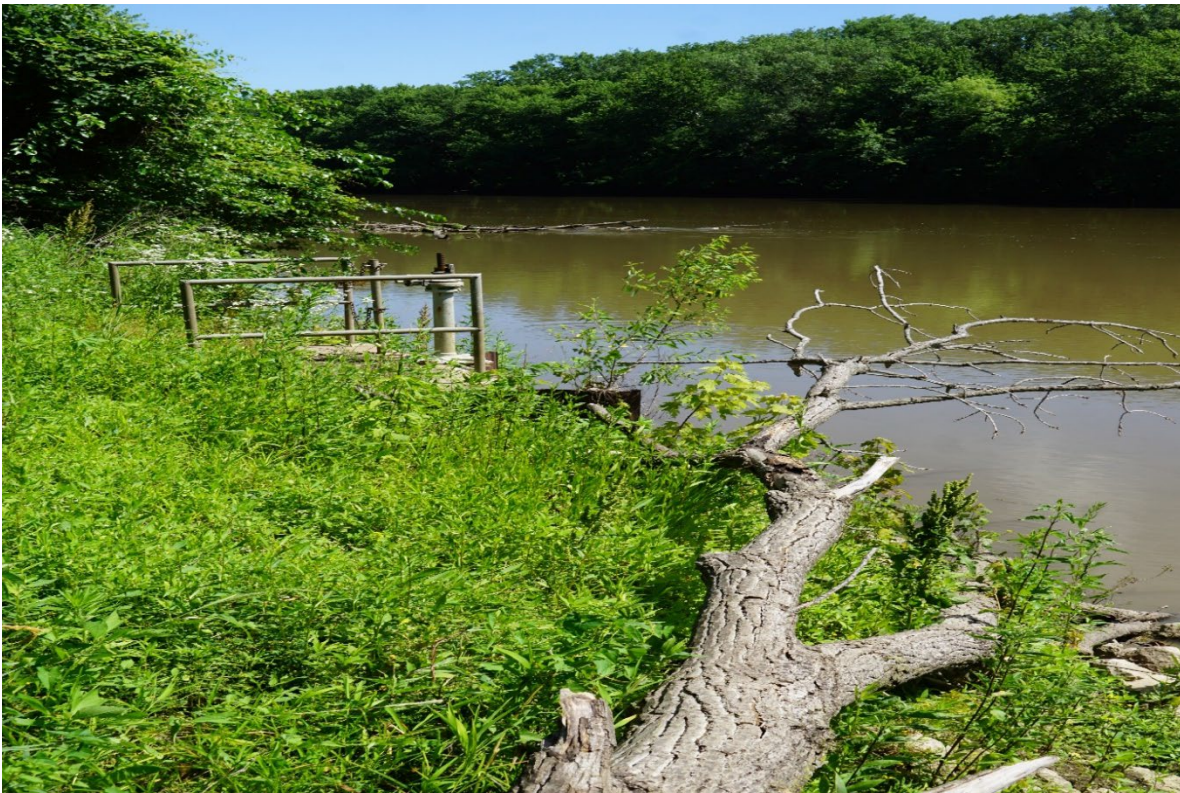
Photograph 10: Pump By The River

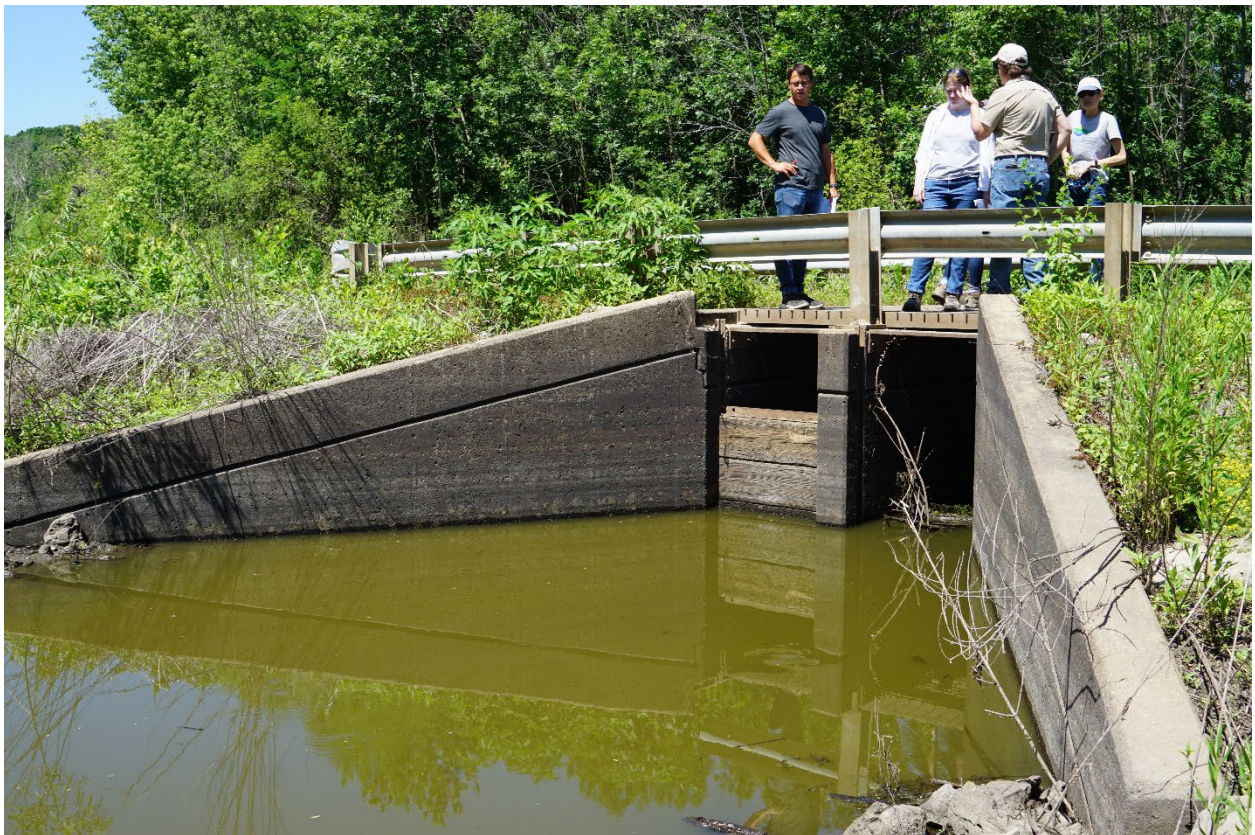
Water Control Structure Intermediate Levee: The screw gate on the intermediate levee separating the North and South Wildlife Management Units needs repaired. In addition, protective cages are set up on either side of this WCS to protect from beaver damage. The structure resembles a cage and surrounds the area at risk. The sponsor did not know when it

Photograph 12: Intermediate Levee Stoplogs
