**BAY ISLAND
INSPECTION OF COMPLETED WORKS
2017**

PROJECT: Bay Island Habitat Rehabilitation and Enhancement Project

LOCATION: Pool 22, Mississippi River Miles (RM) 311.0 - 312.0, Marion County, MO

DATE OF FIELD VISIT: June 20, 2017, warm, sunny, mid 80's °F

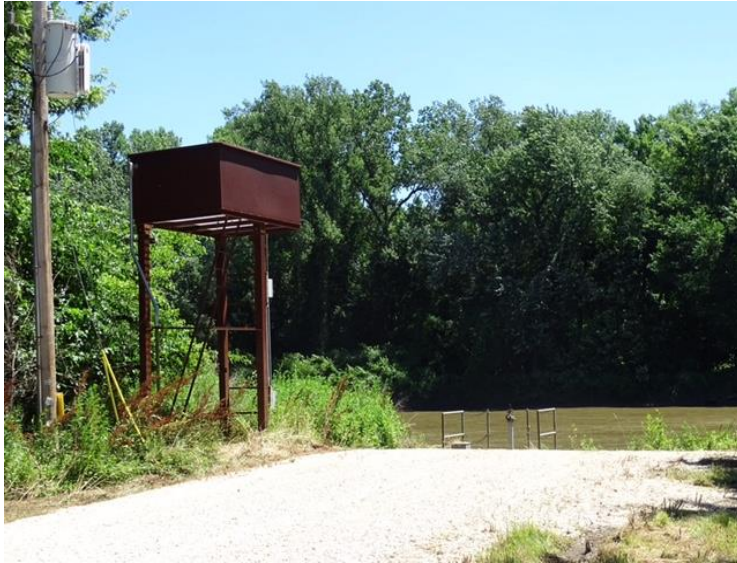
No concerns were noted in regards to the pump station structure. Regular maintenance is occurring. The only issue brought to USACE representatives' attention by the project sponsor was that leaf litter during the fall clogs the pump, causing it to shut down. The sponsor also noted the pump is working efficiently to bring water into the project area. However, getting water out of the project area during extended high water events has been a concern. Routinely long duration high stages of the Mississippi River prevent adequate drawdown of the HREP, which is leading to tree stress and death. Besides the water control structures, there is no other way to remove water from the HREP. The pump station only brings water in.

Pump station structure

1. Thin pin oak stand.
2. Determine actions to be taken to reduce leaf litter debris at pump station.
3. Replace stop log structures with gates.
4. Fix screw gate.
5. Repair erosion between borrow pit and levee (break through).

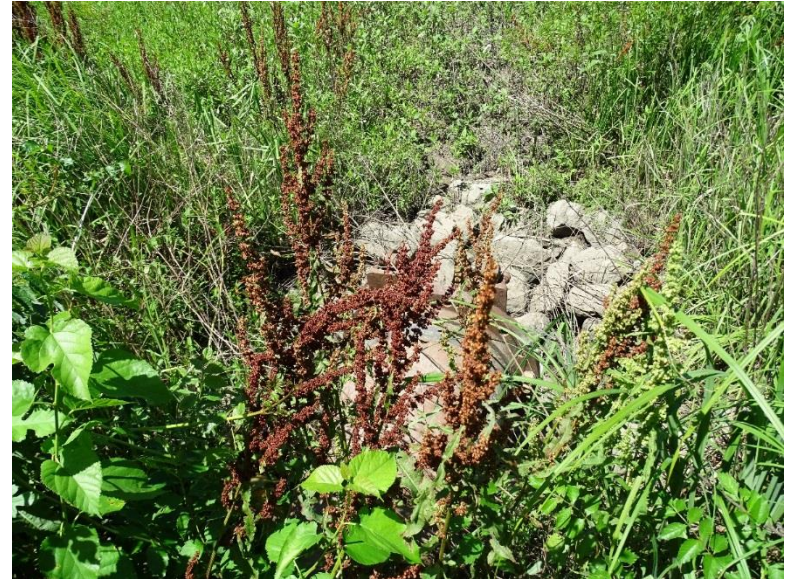
Pump station outlet

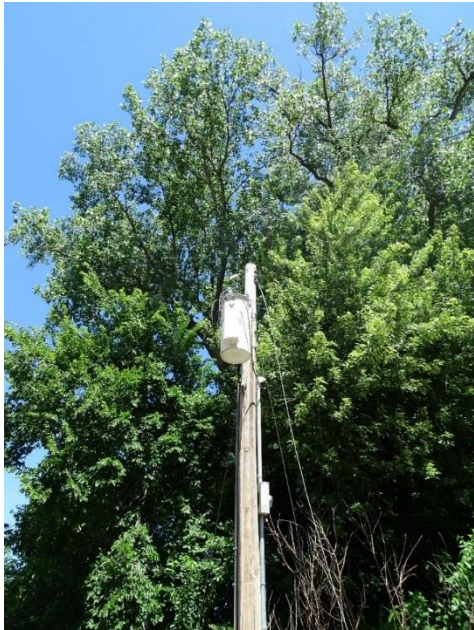
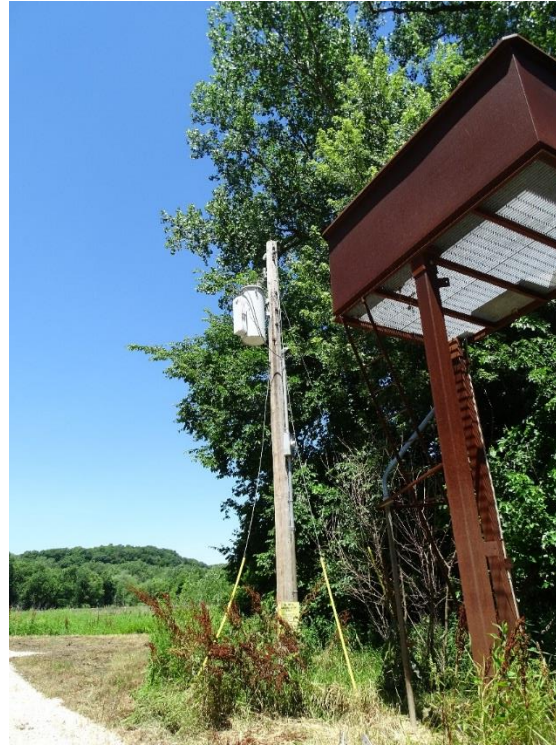
Pump station electrical

Maintenance to the site has required some repairs to the pump station electrical control box, but in general, water levels are able to be raised to mimic natural riverine wetland processes.

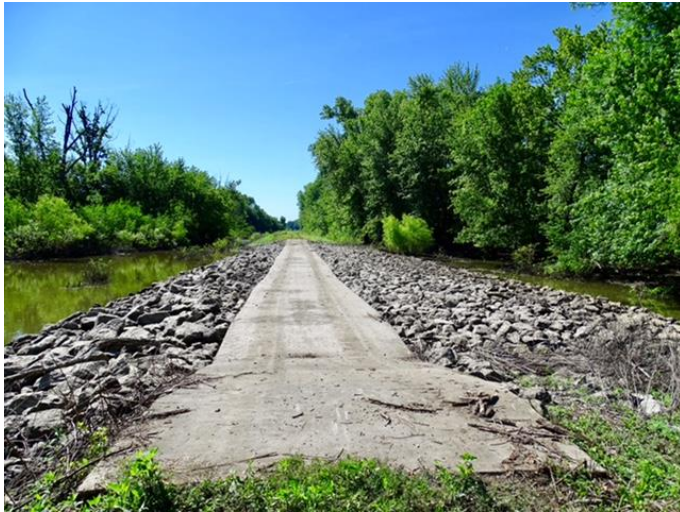
The North Spillway is well maintained. There is no erosion, and unwanted vegetation is managed well in the riprap. Following flood events sediment needs to be scraped off. The South Spillway is in the same condition as the North Spillway. The condition of both spillways and riprap can be viewed in Attachment A.

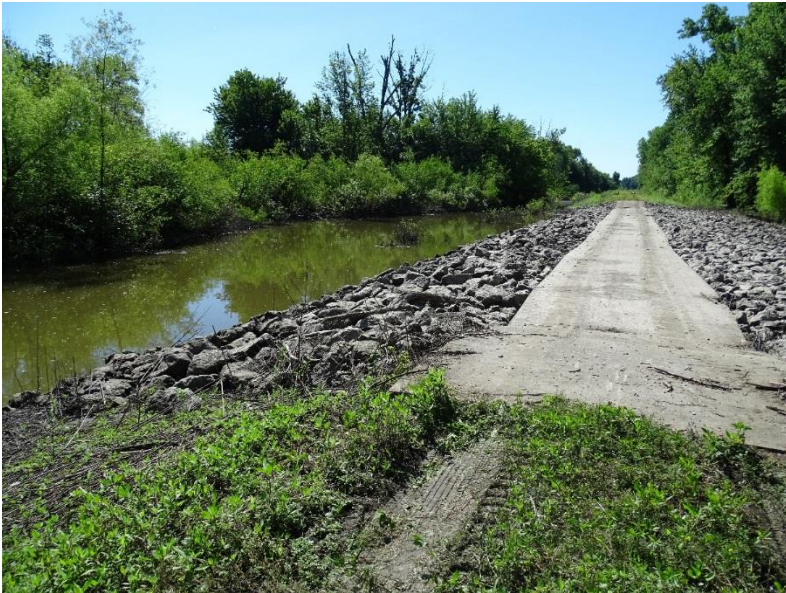
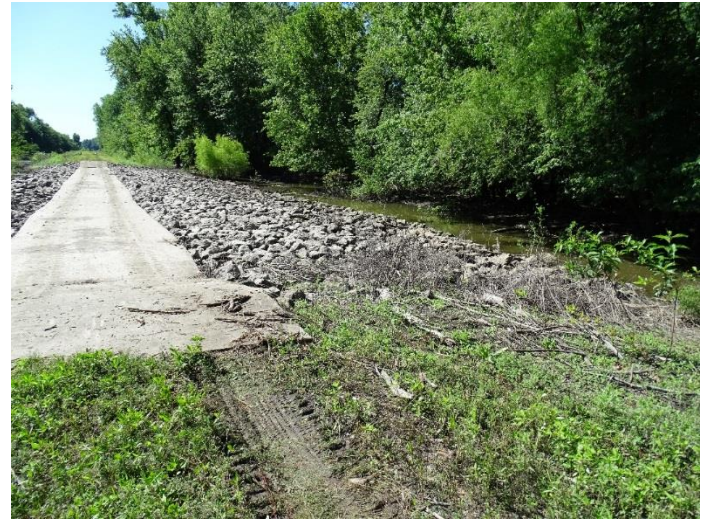
North Spillway riprap in good condition

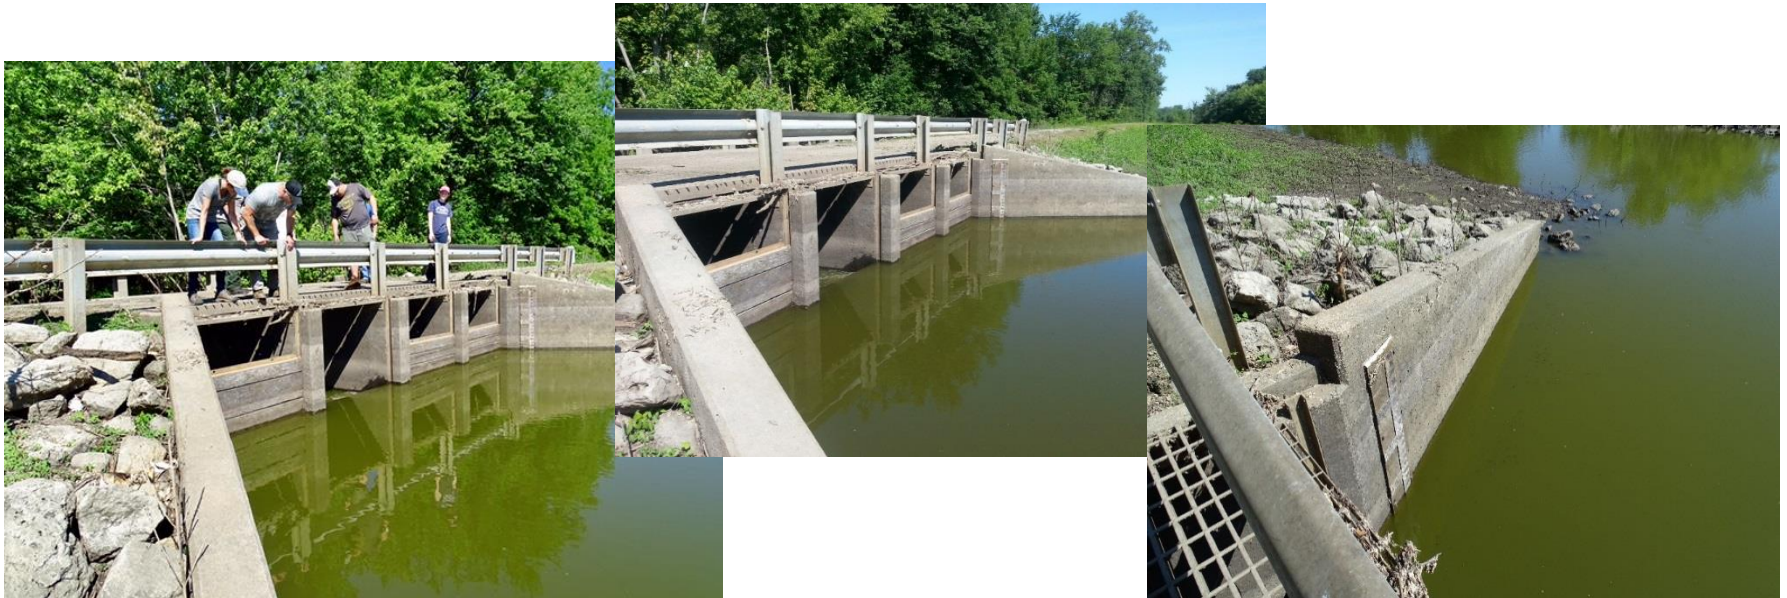
The main issue indicated by the sponsor with the water control structures is the stoplogs. The structures require two people to operate which is difficult given current staffing levels. The low guardrails and the awkward angle for insertion and removal of the lifting hooks also leads to safety concerns. Missouri Department of Conservation (MDC) plans to change to gates that can be operated by one person pending funding. Images of the stoplogs can be viewed in Attachment A. These give a clearer indication of the difficult angle necessary to manipulate the structure and the safety concerns that may arise.

The stoplogs require two individuals to operate which is difficult to staff. The low guardrails and the awkward angle for insertion and removal of the lifting hooks may lead to safety concerns. The MODOC is hoping to modify the structures to ease the operation for water level management to one individual. This would occur pending the availability of funding.

Sponsor recommends not using stoplogs in future designs as they are extremely difficult to manage. A structure that can be manipulated with one person is more practical for local staff to manage.

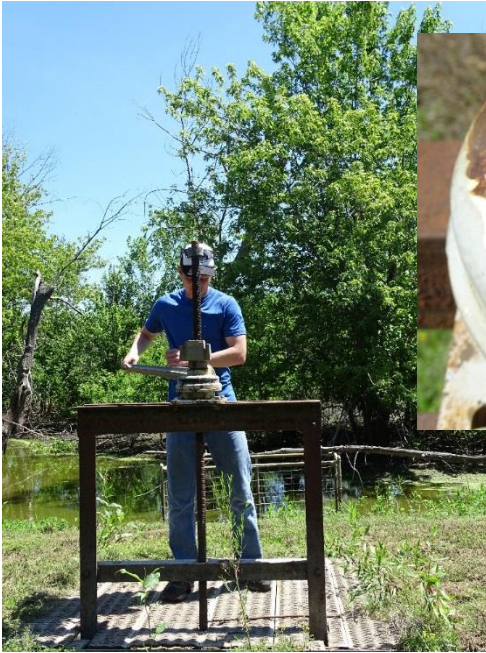
The gate is not operable. The screw turns but the gate will not raise or lower. It is likely stripped and needs repaired. As-built shows the gate on the edge of the levee. However, it is actually in the center.

Gate, not operable

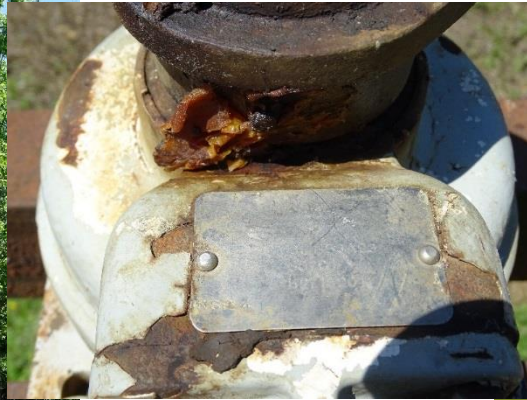
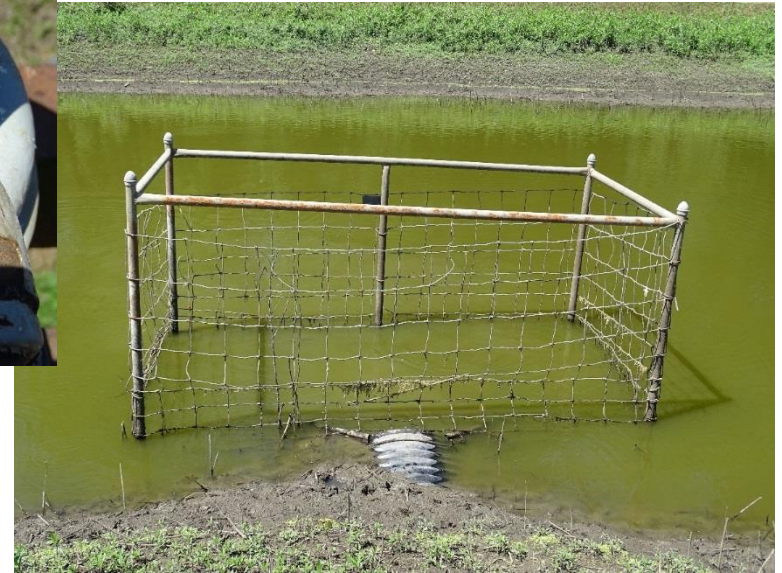
Beaver Deterrent

Additionally, beavers have in the past filled the water control structures requiring them to be cleared out by MDC staff.

The screw gate on the intermediate levee separating the North and South WMUs needs repaired. In addition, protective cages are set up on either side of this water control structure to protect from beaver damage. The structure resembles a cage and surrounds the area at risk. According to the As-builts this was part of the original design.

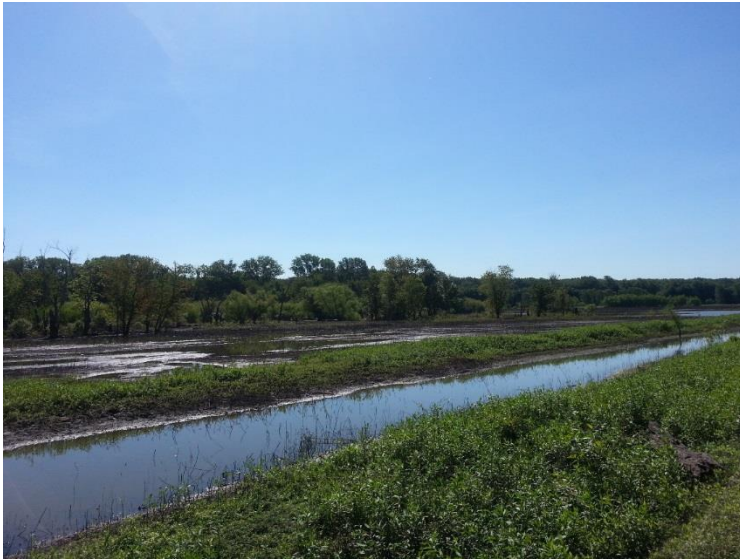
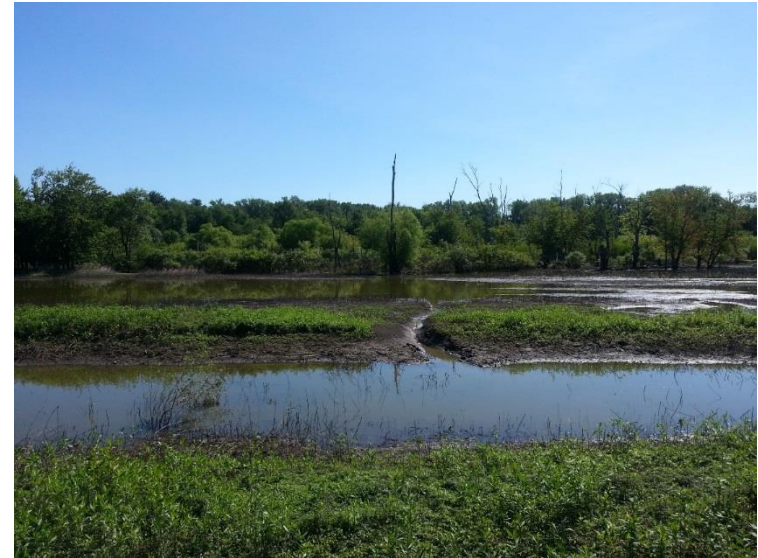
Near the south water control structure, break through commonly occurs between the borrow pit and the ditch by the levee.

Break through

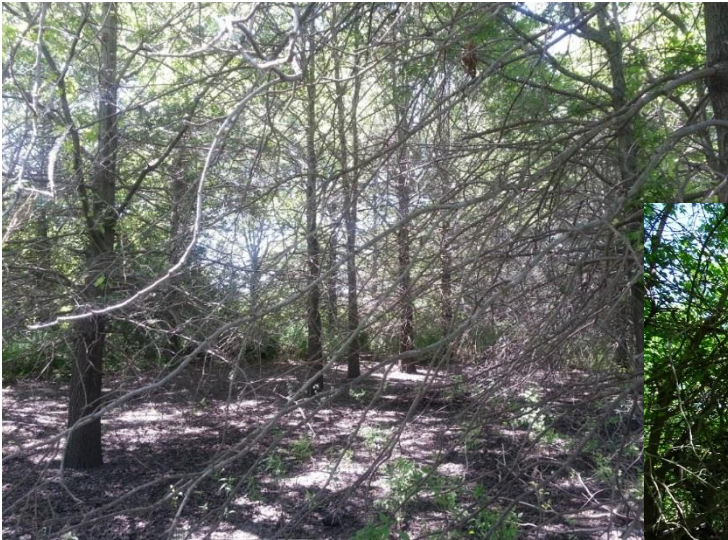
The tree plantings are all showing general signs of stress. The pin oak planting has had a high rate of survival of over 80%. However, 50% of these trees are stressed and have a reduction in crown development.

Pin Oaks in need of thinning

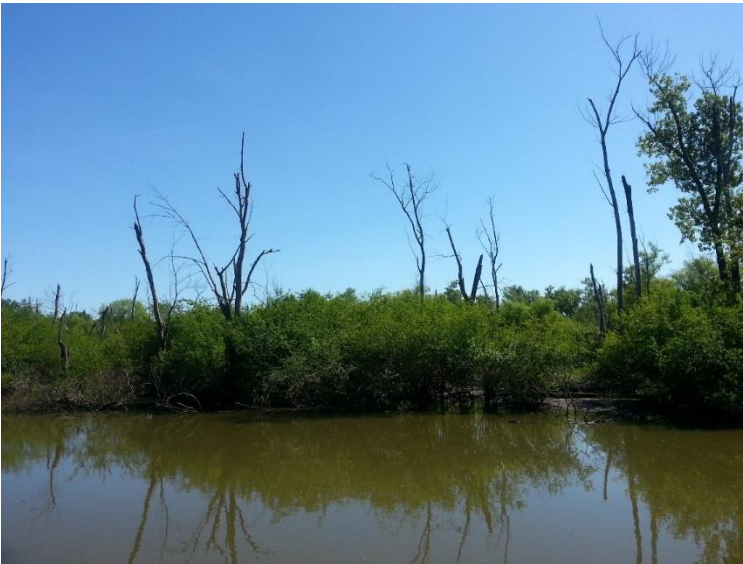
Many of the RPM trees planted at the Northeast end of the project are 7-10 inches in diameter with good canopy cover. Several appeared to have grown from stump sprouting. Others showed stress most likely due to crowding. These conditions can be viewed in Attachment A. Scattered pecans are present and in good condition. USACE foresters anticipate thinning the stand in fall 2017 with the MDC staff to ensure success of the best trees. Invasive plants include giant ragweed, reed canary grass, honeysuckle bush, and bur cucumber.

Trees showing stress most likely due to flooding.

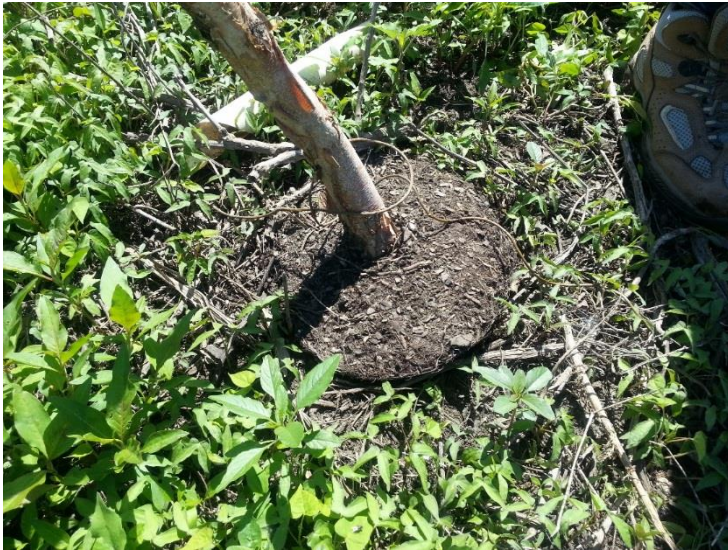
This plot was planted in 2015 and has since flooded approximately 3 times. Most plantings have endured to the 2-year critical threshold, after which continued survival of tree species increases. However, aggressive mowing and windthrow on the site has negatively impacted some of the trees; many had to be righted and re-set into the soil during the site inspection. Tree species included northern pecan, swamp white oak, overcup oak, bur oak, persimmon, river birch and sycamore. A handful of trees exhibited stump sprouting. Ameren is required to monitor for a period of 10 years to ensure containerized trees and shrubs do not fall below the 60% survival rate; otherwise, supplemental planting will be required to achieve at least 80% stocking. The site is under heavy vegetation control by mowing and spraying. This has provided excellent growing conditions for the planted trees. However, minor residual damage and tree loss has occurred.

Trees falling or growing at an angle due to flooding
