## **UMRR BERTOM MCCARTNEY LAKES HREP INSPECTION OF COMPLETED WORKS**

Bertom and McCartney Lakes HREP

Mississippi River  
Pool 11  
River Miles 599 - 603  
Grant County  
Wisconsin

## X. DATE OF FIELD VISIT: August 11, 2016

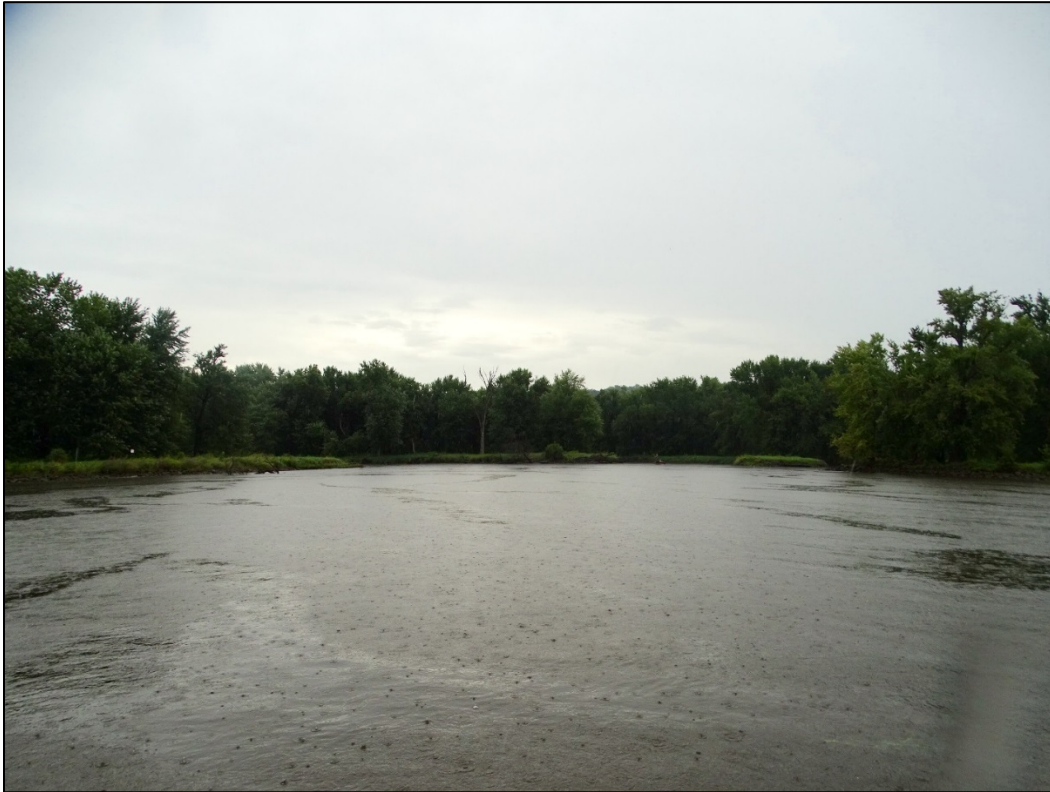
Photo 1: Closure Structure.

The rock closure structure is always submerged (Photo 1, Attachment A). The tie-ins to the upstream and downstream end of the project were visible. Erosion on the downstream end tie in had been noted on previous inspections, but due to water levels and heavy rain, it could not be observed during the site inspection (Photo 2). In the interior (eastern) side of the structure, one of the boats hit a rock, which likely had come from the structure itself. The purpose of this structure was to limit the amount of bedload entering the project area. There is bed load (sand) evident the in the left (control) channel (Photo 3). One tool to analyze the success of this structure could be to compare pre- and post- aerial photography of the Bertom portion of the project to see if sand entry has lessened post project.

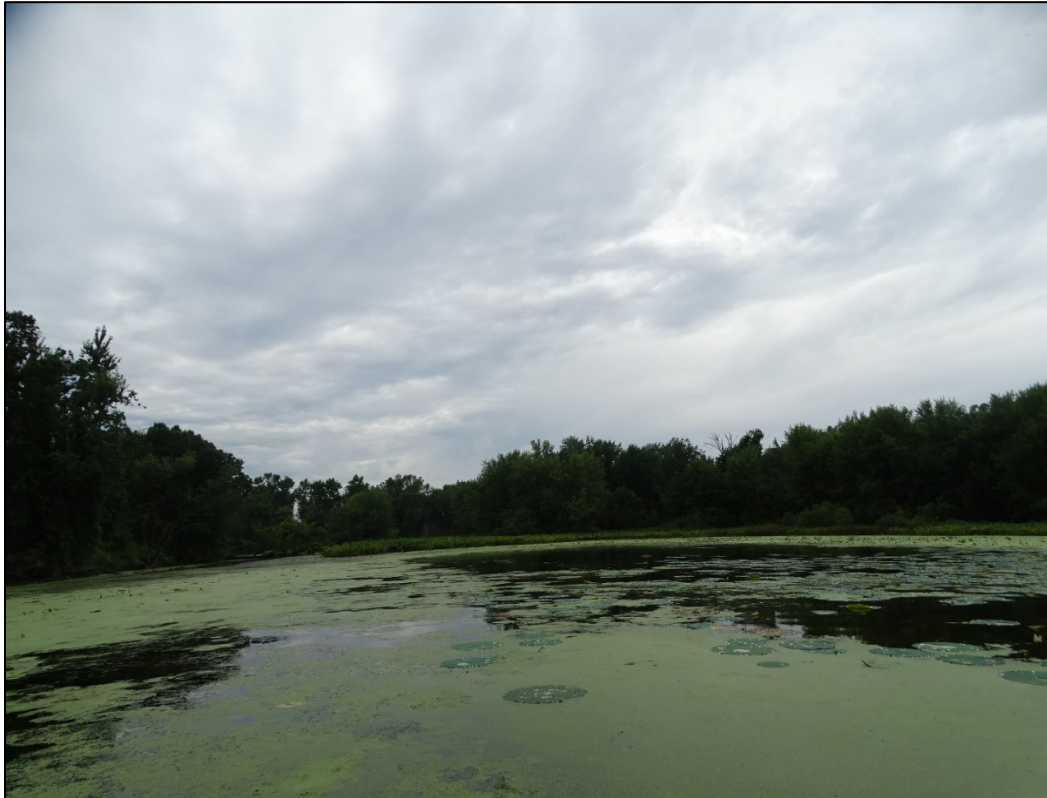
Photo 3. Dredge Cut STA 59+92.

A small sand bar near STA 59+92 has helped prevent additional infilling of the adjacent dredge cut (see photos 4 and 5 Attachment A and Site Plan, in Attachment B). Willows are beginning to establish on the sand bar. This dredge cut has seen channel sloughing; however, infilling around the edges has allowed aquatic vegetation to establish. This littoral zone makes the adjacent deeper water more desirable fish habitat. This dredge cut has a better, more diverse fish population than other parts of the project per conversations with the WI DNR.

Rebuilding peninsulas of berms at entrance to dredge cuts could reduce current velocities in overwintering areas.

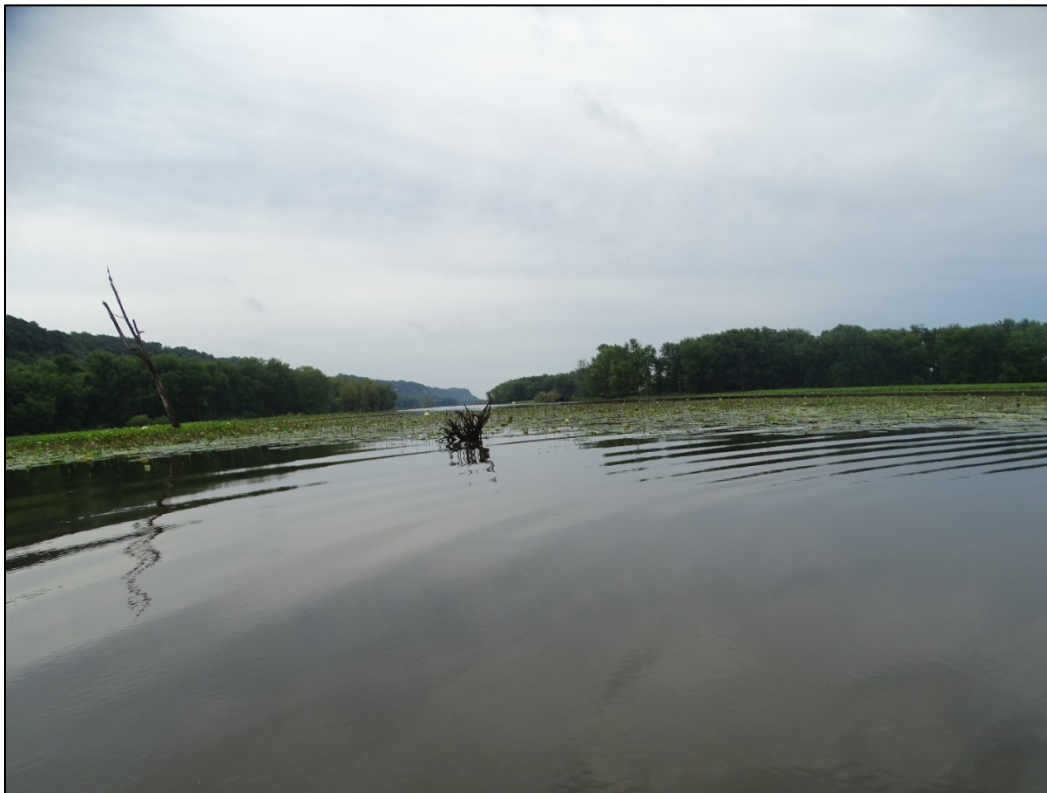
Photo 4. Dredge Cut STA 83+92

The “Spring” dredge cut section (STA 83+92 to STA 95+91) is considered a good fisheries habitat, with groundwater springs from the adjacent bluff helping to stabilize winter temperatures (Photo 6).

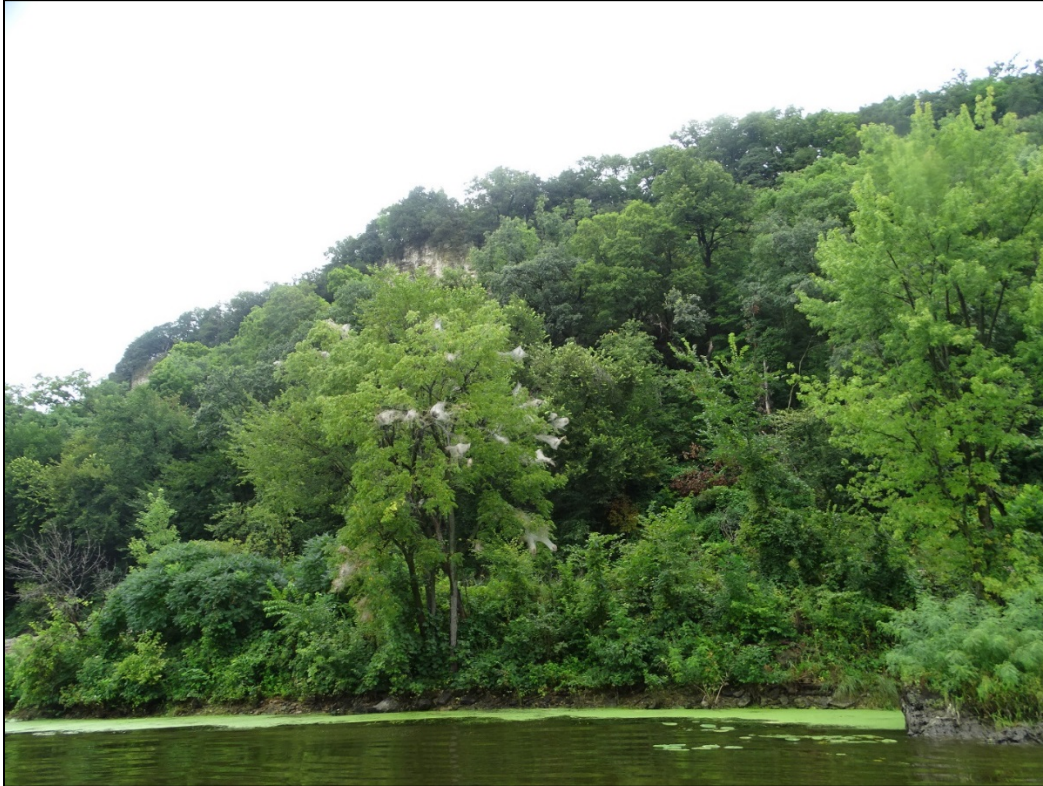
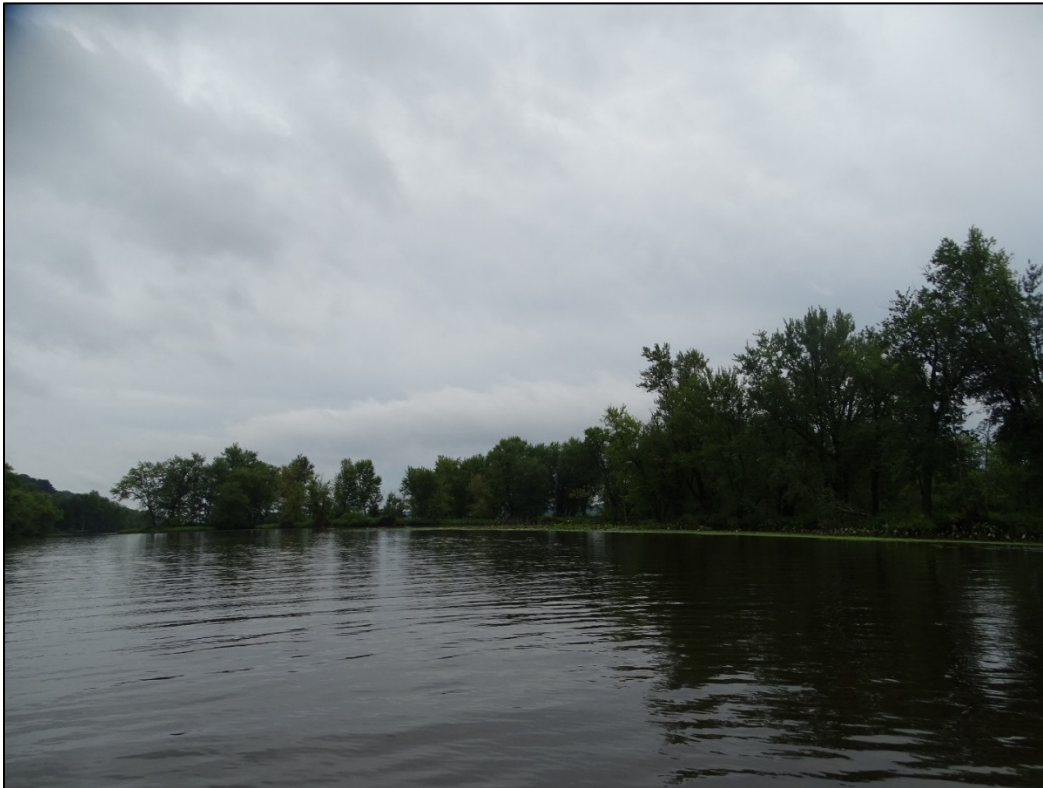
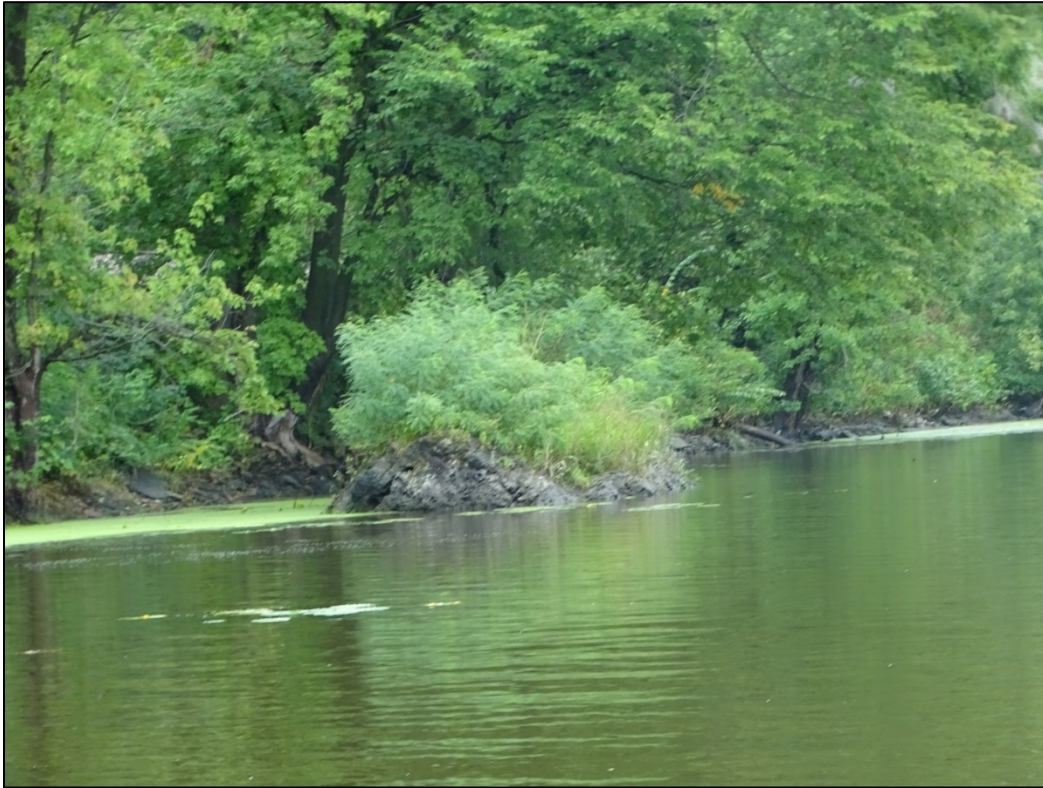
Groundwater springs were observed in the “Rock” dredge cut (STA 101+89 to STA 113+86). The adjacent peninsula to the south has been eroded, allowing channel quality to degrade for fish habitat (Photos 7, 8, & 9).

Photo 5. Dredge Cut STA 101+89 to STA 113+86): “Rock”

Photo 6. Dredge Cut STA 101+89 to STA 113+86): “Rock”

Photo 7. Dredge Cut STA 101+89 to STA 113+86): “Rock” namesake

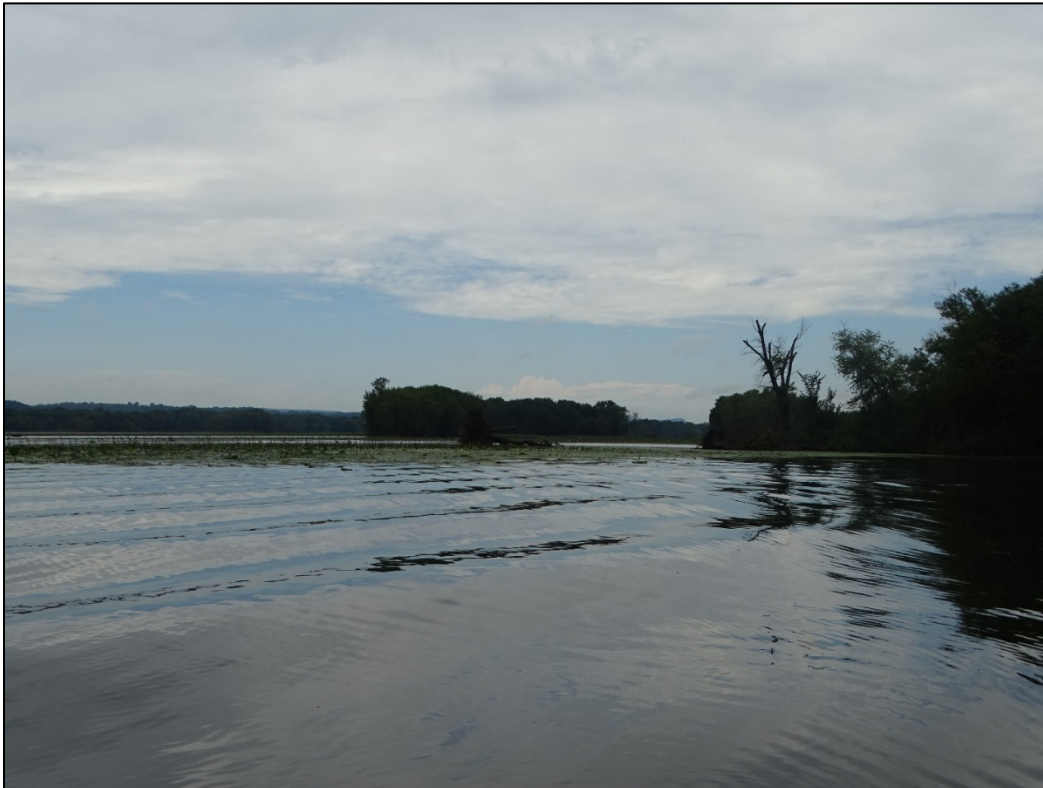
The furthest east dredge cuts (STA 125+84 to STA 143+78, dredged areas I, J, K) are not optimum for fish habitat. Two peninsulas that protected the cuts from the south have eroded, thereby degrading the habitat (Photo 10).

Photo 8. Dredge Cut STA 125+84 to STA 143+78.

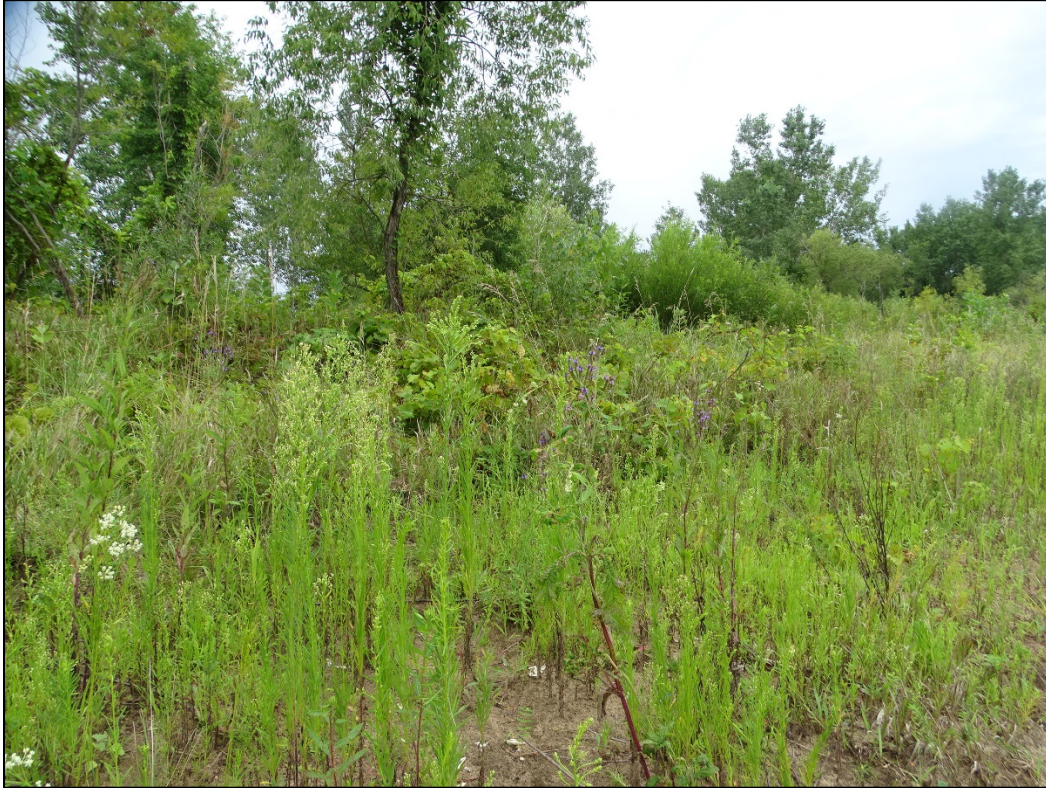
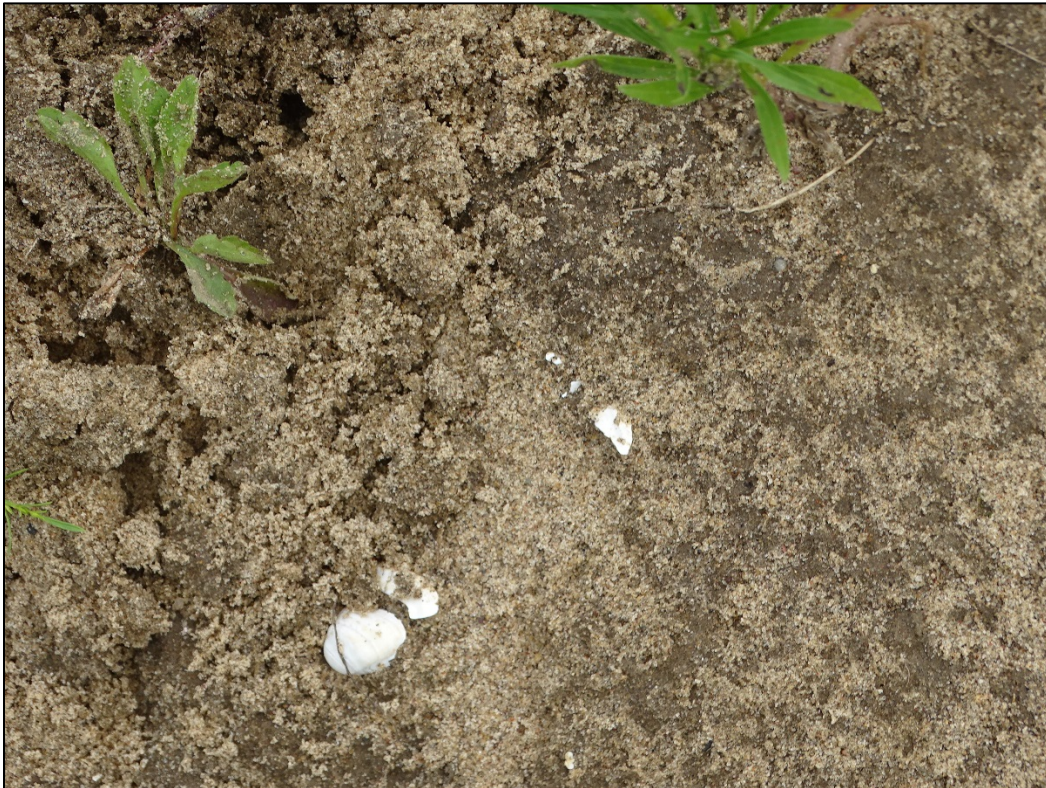
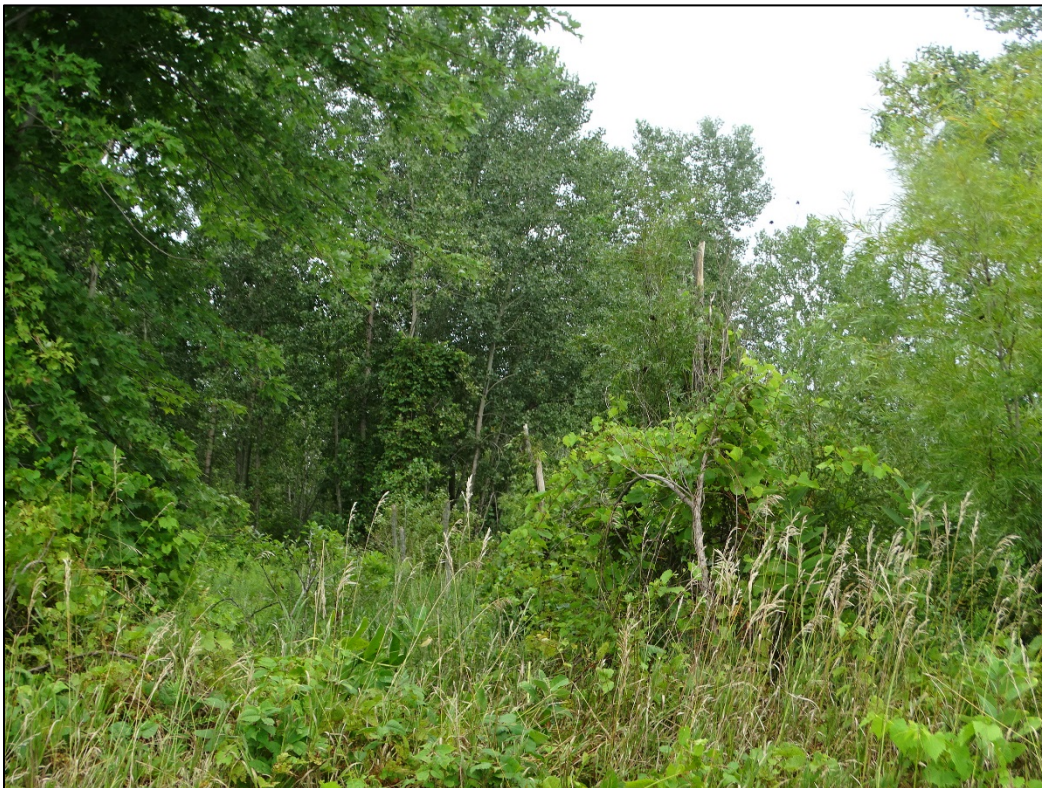
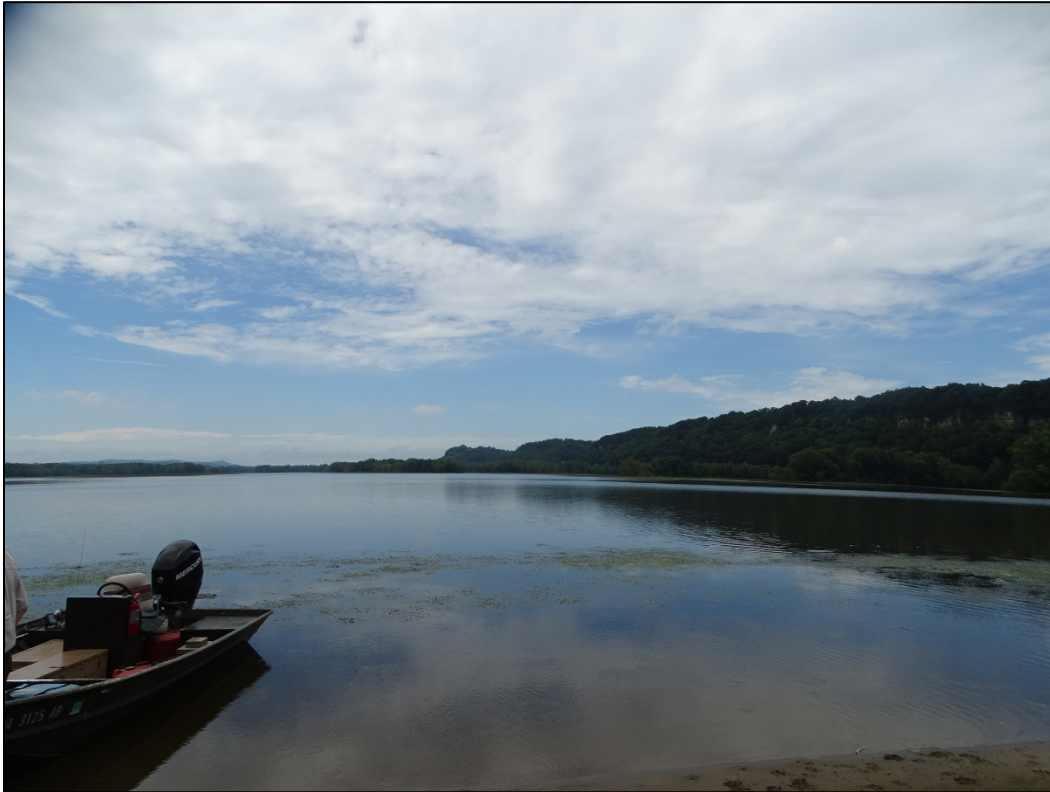
The dredged material placement site (Bertom Island) contains an isolated wetland created by a low central area. Wavewash and erosion is occurring on the upstream side of the placement site and will likely break through to the wetland over time (Photos 11, 12, 13, 14, 15, 16, 17, and 18). The placement site vegetation includes cottonwood, cedar, willows and silver maple, as well as

Photo 9. Shoreline of Dredged Material Placement Site

Photo 10. Shore of Dredged Material Placement Site.

Photo 12. Upper shore of Dredged Material Placement Site.

Photo 13. Upstream of Dredged Material Placement Site.

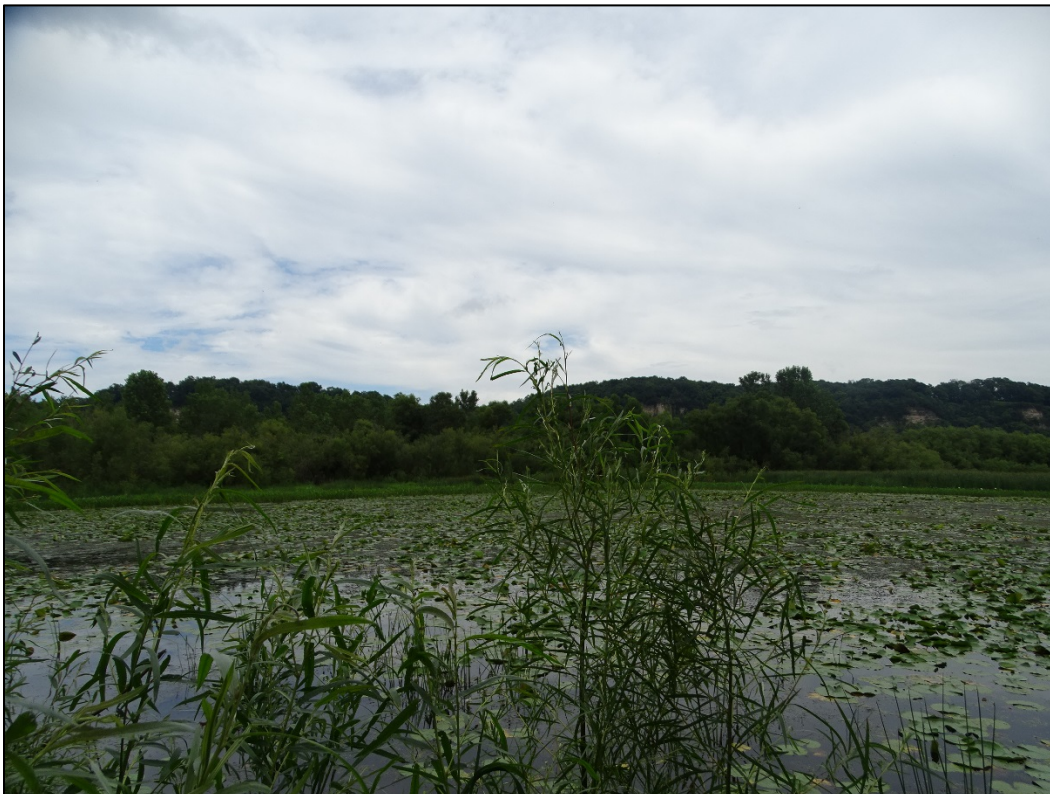
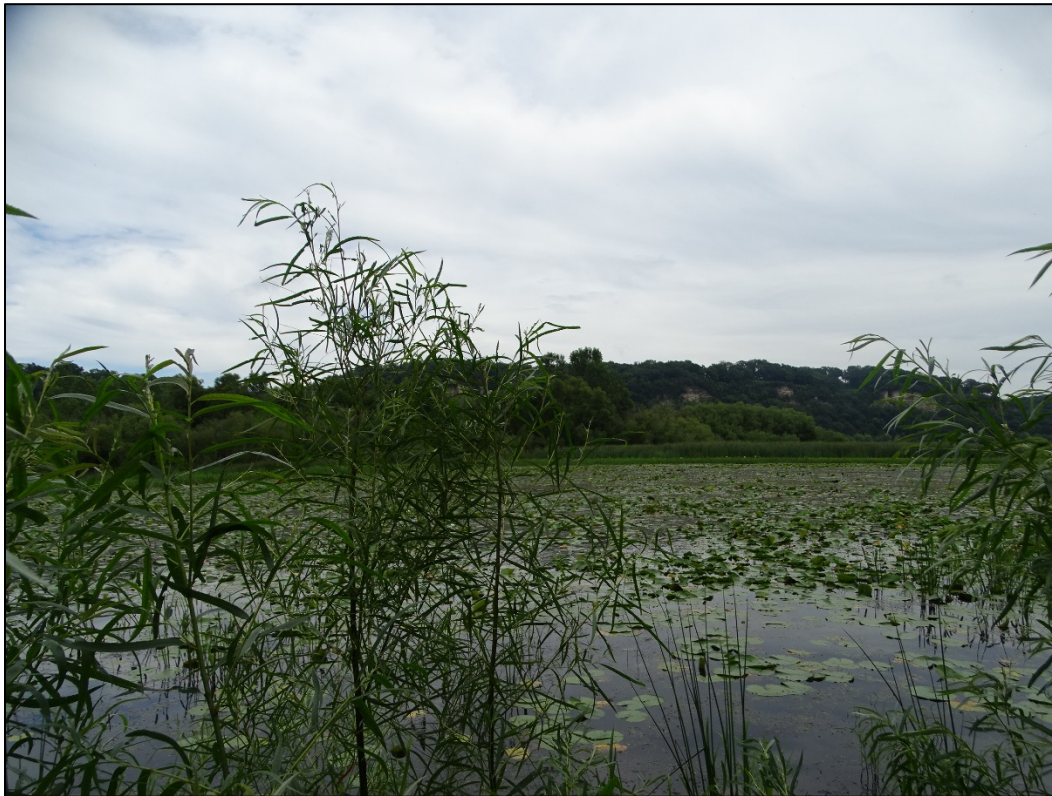
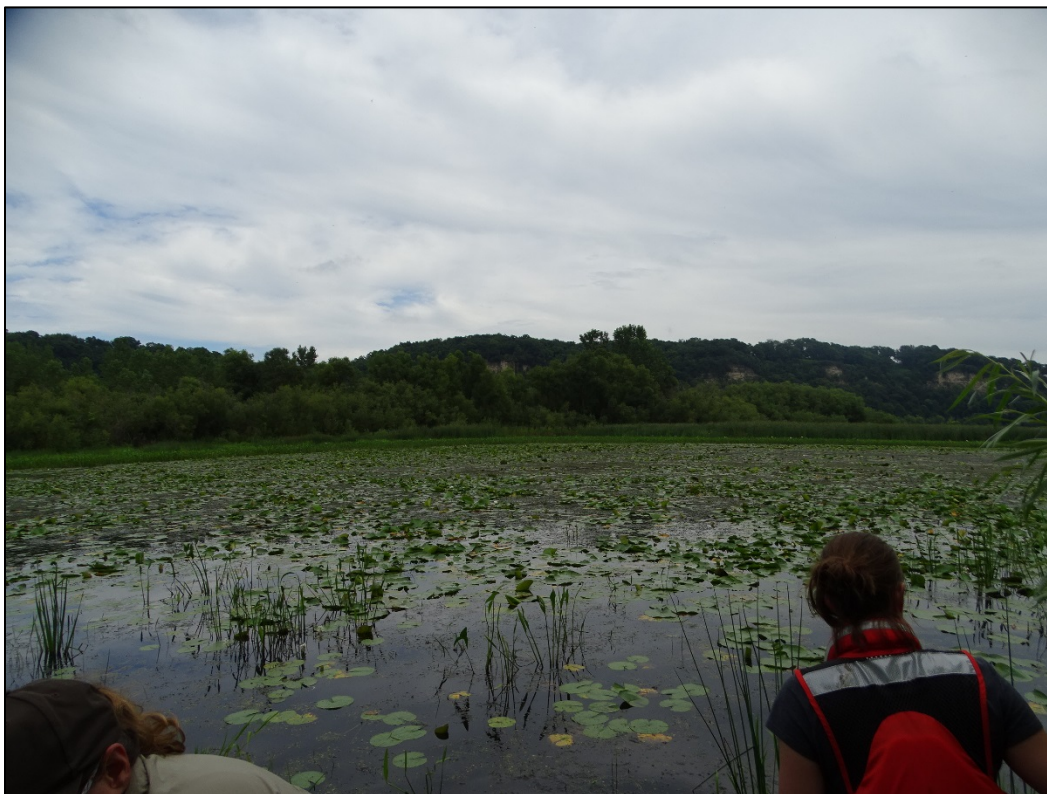
Photo 14. Interior wetland in Dredged Material Placement Site.

Photo 15. Interior wetland in Dredged Material Placement Site.

Photo 16. Interior wetland in Dredged Material Placement Site.

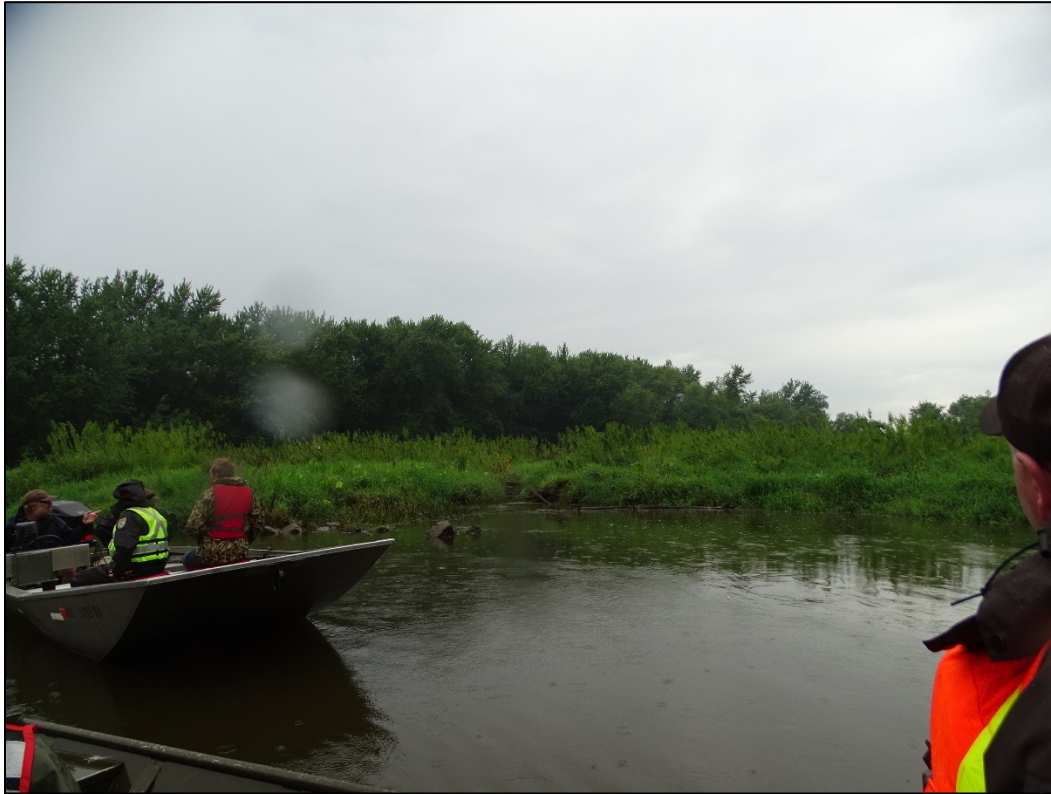
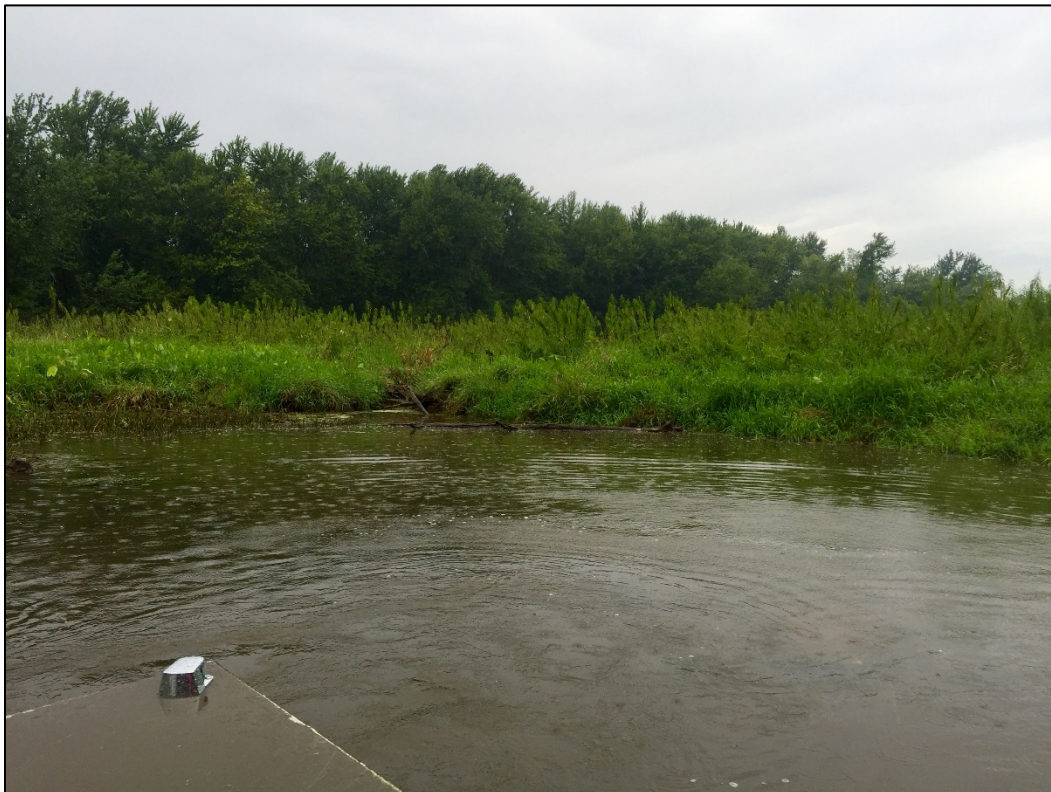
A large scour hole was noted at the end of the rock channel. Depths of up to 29 feet were read using the depth finder past the rock, as compared to depths of 6 to 7 feet in the rock channel itself.

- The rock channel remains stable in depth, as would be expected. Immediately downstream, the channel depth is deeply cut. While this could be used as a design benefit in some situations, it also causes the sediment and materials from the scouring to move downstream, potentially impacting other cuts. Careful consideration should be made to evaluate downstream impacts of a rock channel.

Photo 17. End of Rock Habitat Channel.

Photo 18. Erosion at end of Rock Habitat Channel.

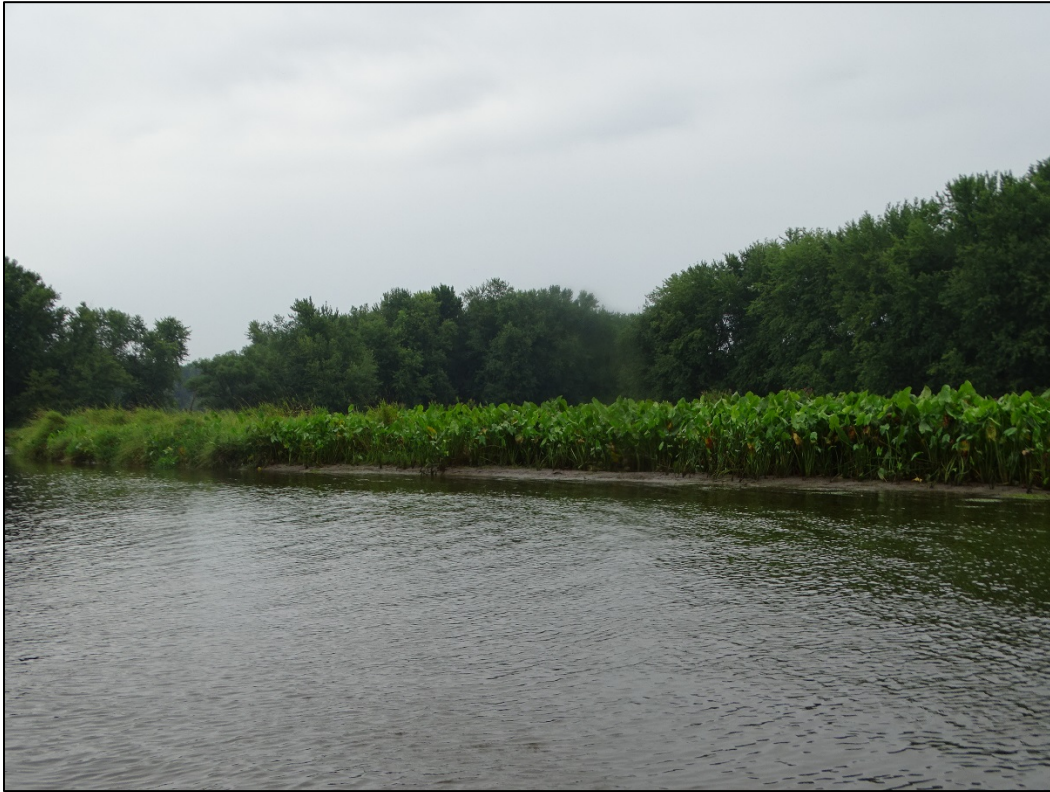
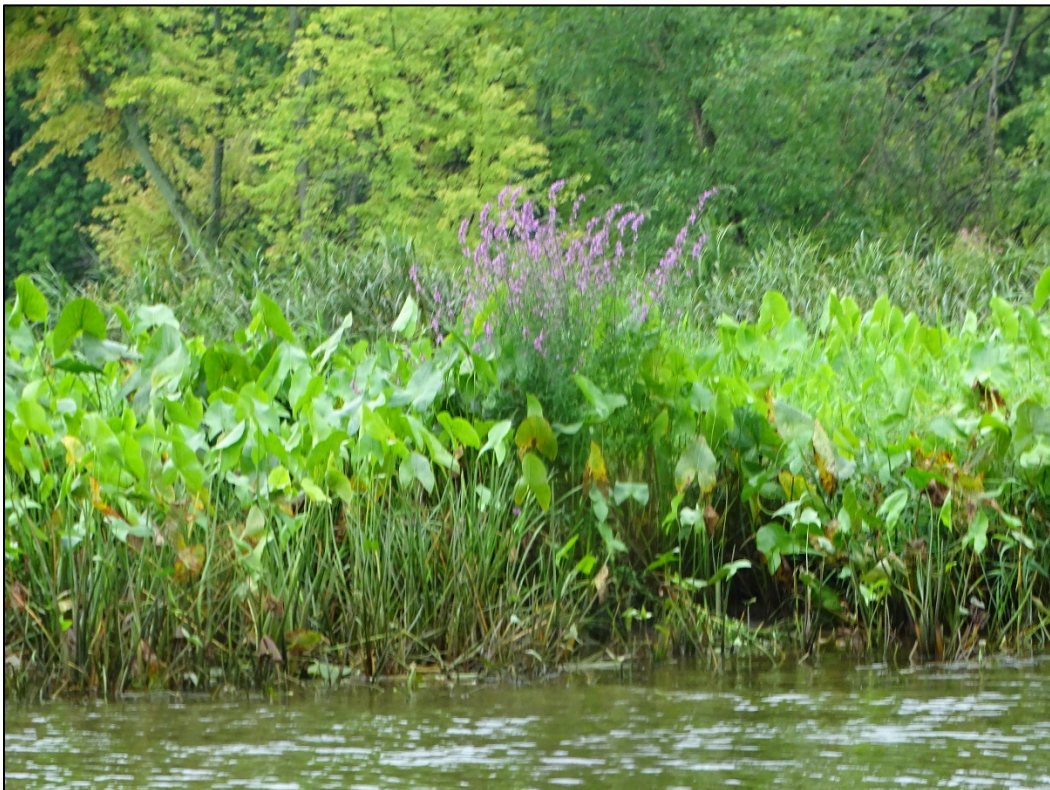
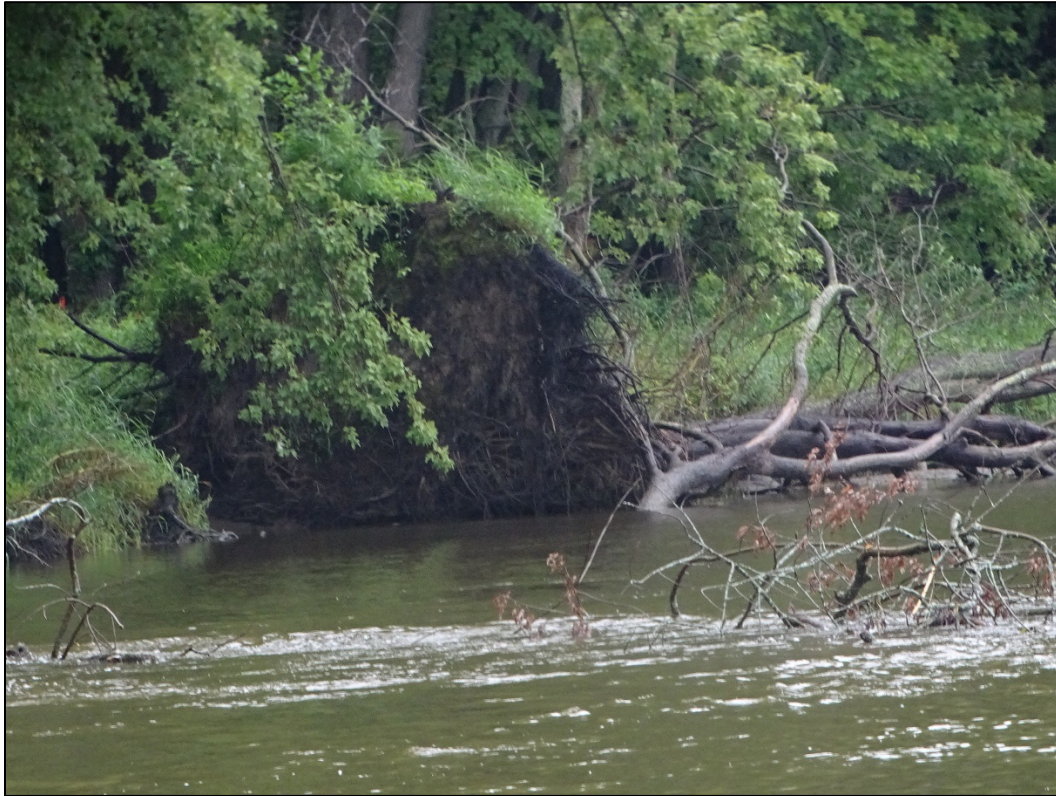
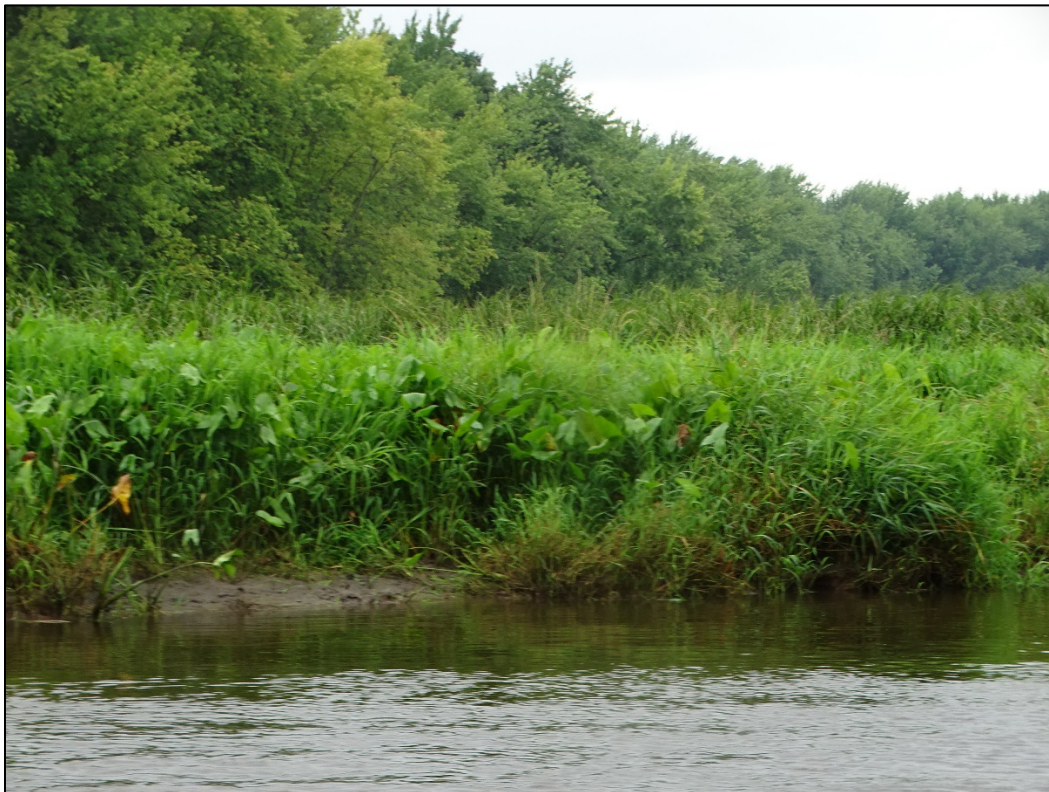
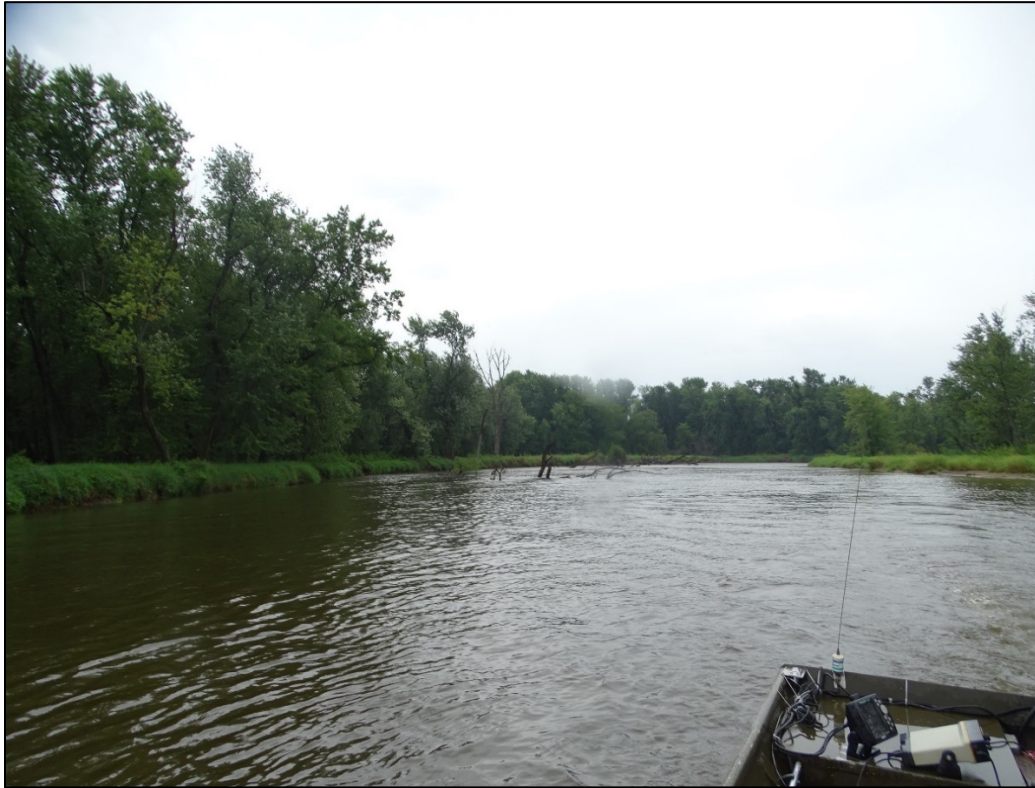
The control channel west of the habitat channel has become wider and shallower over time. Erosion noted on the north bank, with treefall. Logjams observed in the control channel entrance (Photos 21, 22, 23, 24 and 25).

Photo 19. Control Channel.

Photo 20. Arrowhead on bank of Control Channel.

Photo 21. Treefall in Control Channel.

Photo 22. Bank of Control Channel.

Photo 23. Logs in Control Channel.

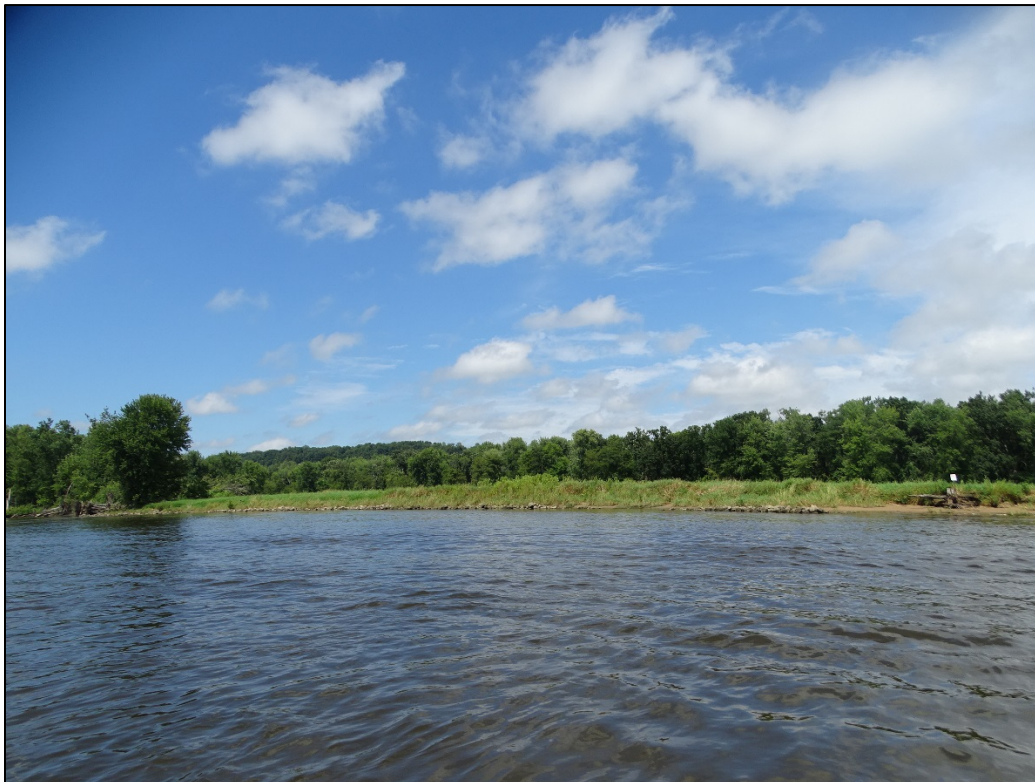
Location 1) Deep erosion was noted on the left descending bank of the main channel (Photo 26) at RM 601.6 (N 42.681322°, W 90.9095°). Rock has been placed here, but erosion continues upstream. Depths of over 25 feet were observed off shore.

Photo 24. Main channel LDB, erosion area at N 42.681322°, W 90.9095°.

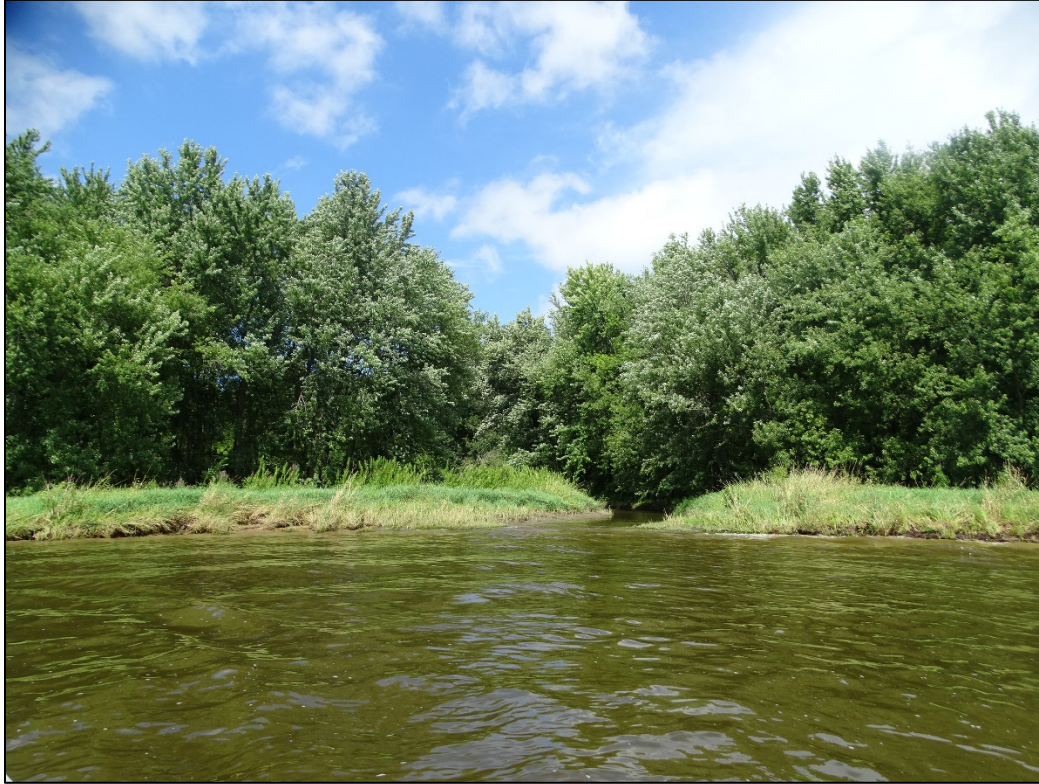
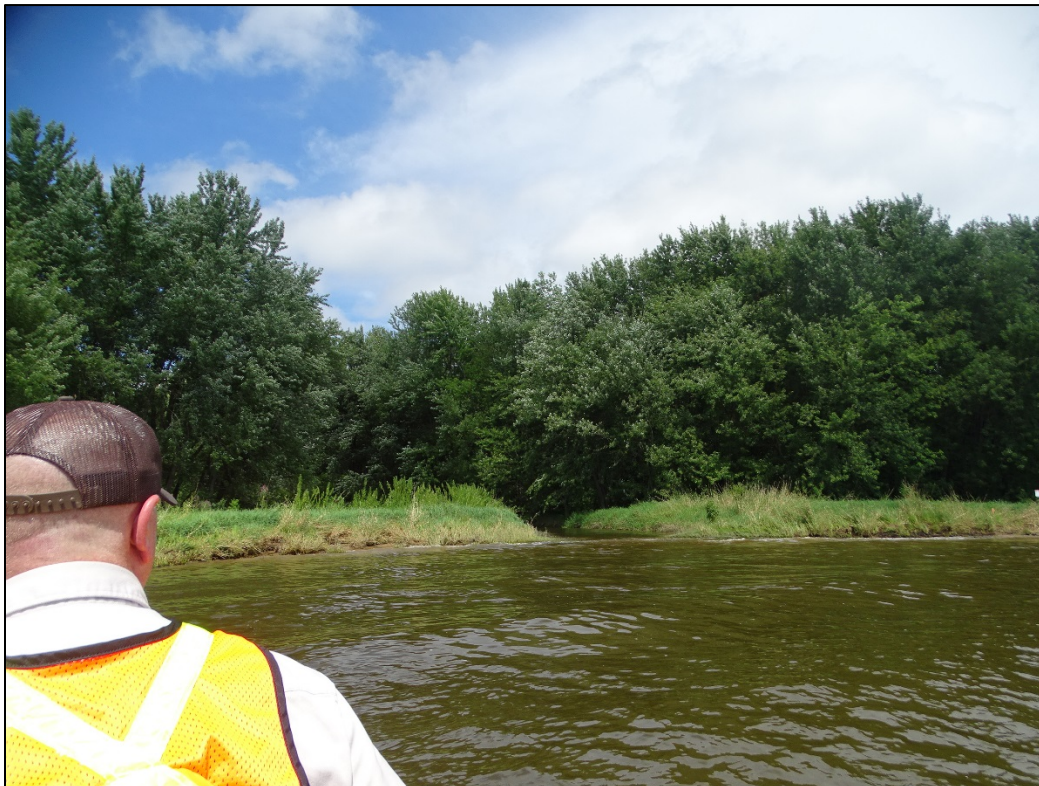
Location 2) No erosion protection riprap observed at cut-through channel at RM 601.3 (N 42.680480°, W 90.905088°) (Photos 27 and 28). No significant erosion observed.

Photo 25. Main channel LDB, erosion area at N 42.680480°, W 90.905088°

Photo 26. Main Channel LDB, side channel at N 42.680480°, W 90.905088°.

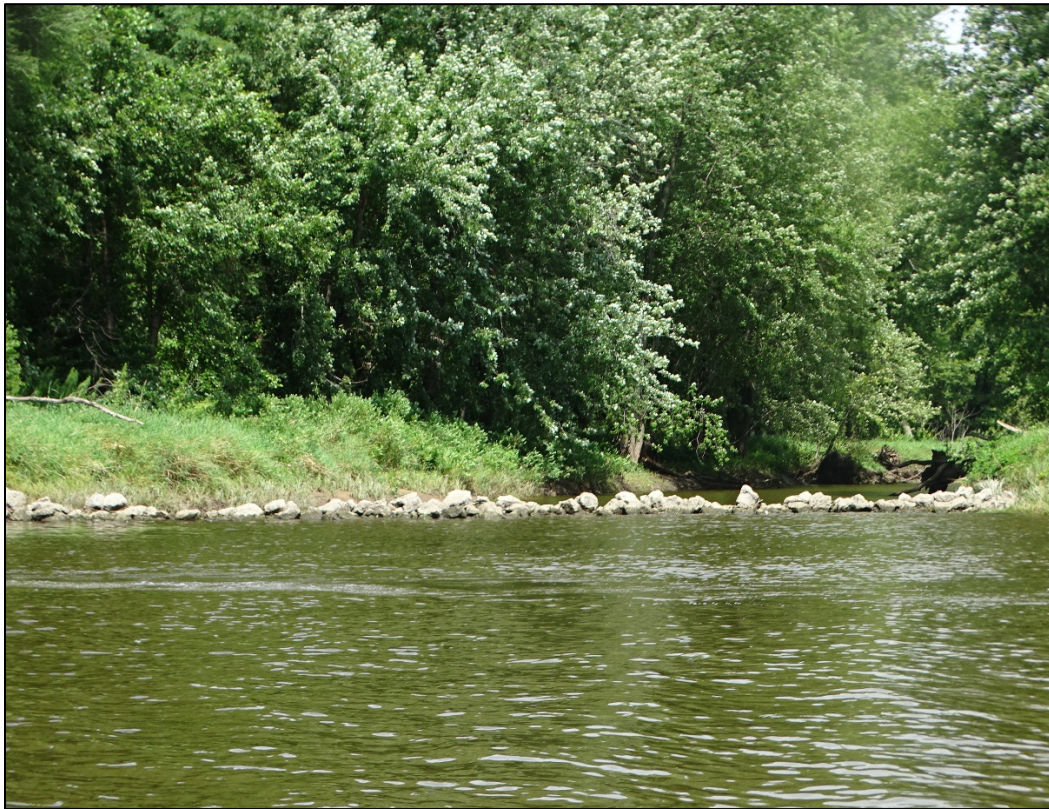
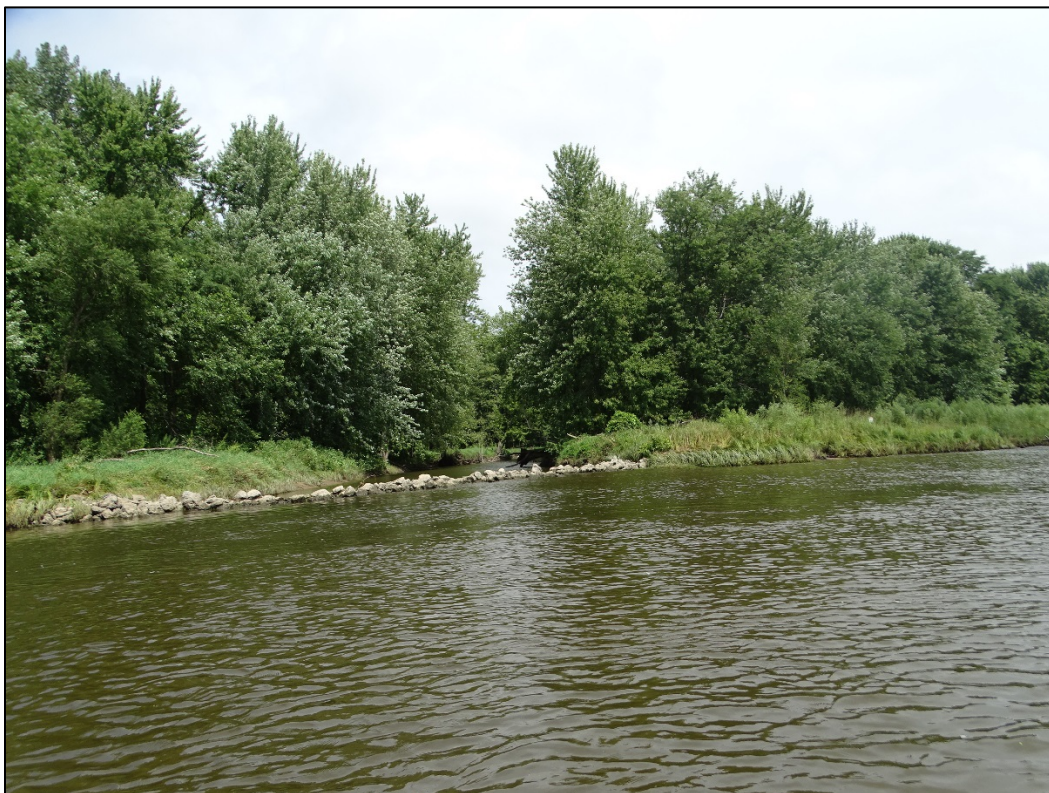
Location 3) Control structure present on channel at RM 601.2 (N 42.680294, W 90.901646), appears to be performing as designed (Photos 29 and 30).

Photo 27. Control structure at N 42.680294, W 90.901646.

Photo 28. Control structure present at N 42.680294, W 90.901646.
