**UPPER MISSISSIPPI RIVER SYSTEM
ENVIRONMENTAL MANAGEMENT PROGRAM
POST-CONSTRUCTION PERFORMANCE
EVALUATION REPORT (PER5D)**

**BIG TIMBER REFUGE
REHABILITATION
AND ENHANCEMENT**

OCTOBER 1995

**POOL 17
UPPER MISSISSIPPI RIVER
MILE 443-445
LOUISA COUNTY, IOWA**

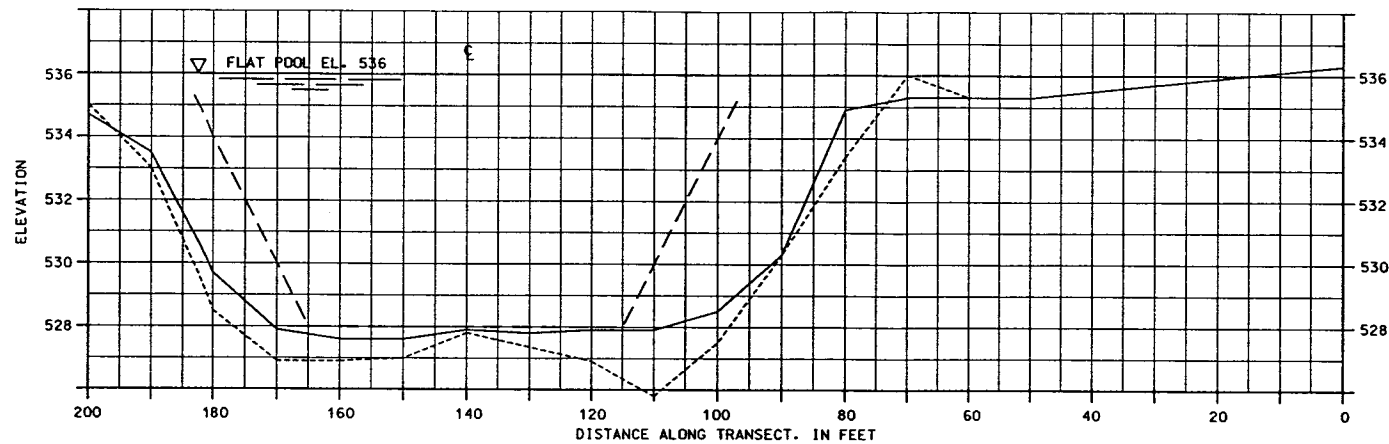
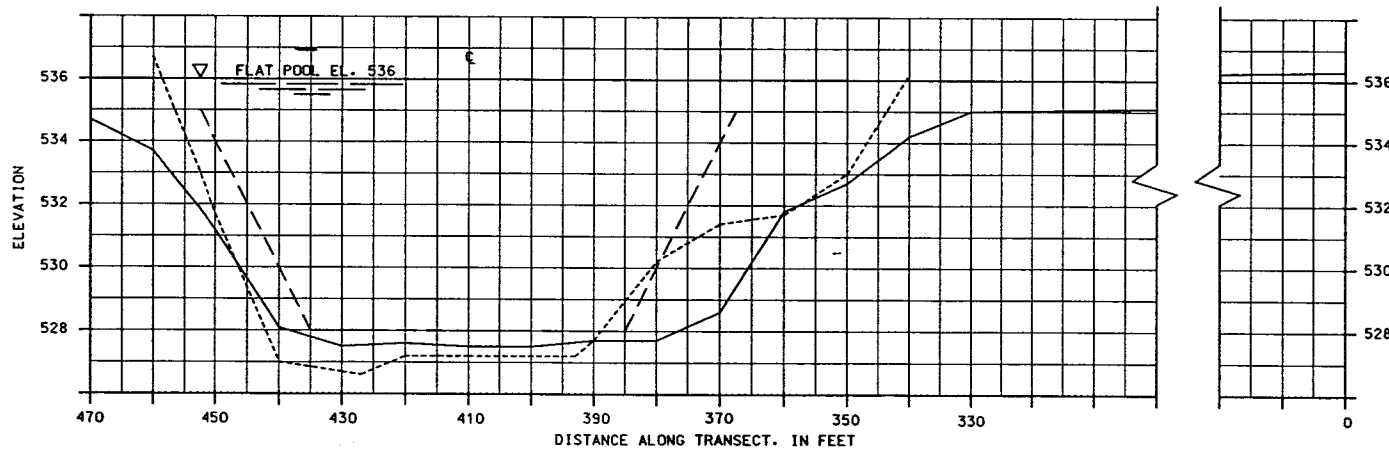
SEDIMENTATION TRANSECT S-M443.7F to S-M443.6G (STA. 0+00)

(1) Monitoring Results. Dredged channel sedimentation transects for Round Pond, Timber Chute, Willow Chute, and Big Denny are shown on plates 4 through 8. As shown in Appendix A, Table A-1, the Big Timber project was designed to include 100 acre-feet of deep aquatic habitat at year 50. Changes in project scope between the DPR and construction eliminated the deep dredging in Big and Little Denny described in the DPR. As built, about 78 acre-feet of deep aquatic habitat was constructed (see Appendix D, Table D-1). At year 4, nearly 70 acre-feet of deep water habitat remains available. According to the Corps of Engineers Great Flood of 1993 Damage Assessment for the Big

Timber project, soundings indicated that sedimentation was generally less than 4 inches but up to 2 feet in the reach known as Timber Chute. During the June 1995 USFWS Site Manager's project inspection, bank sloughing (approximately 3 feet) was observed throughout the east bank of Timber Chute (see Appendix C). The trees placed in the water for additional fish structure have remained in place. Aquatic vegetation, such as pondweed (*Potamogeton* sp.), has begun to inhabit the deep aquatic habitat.

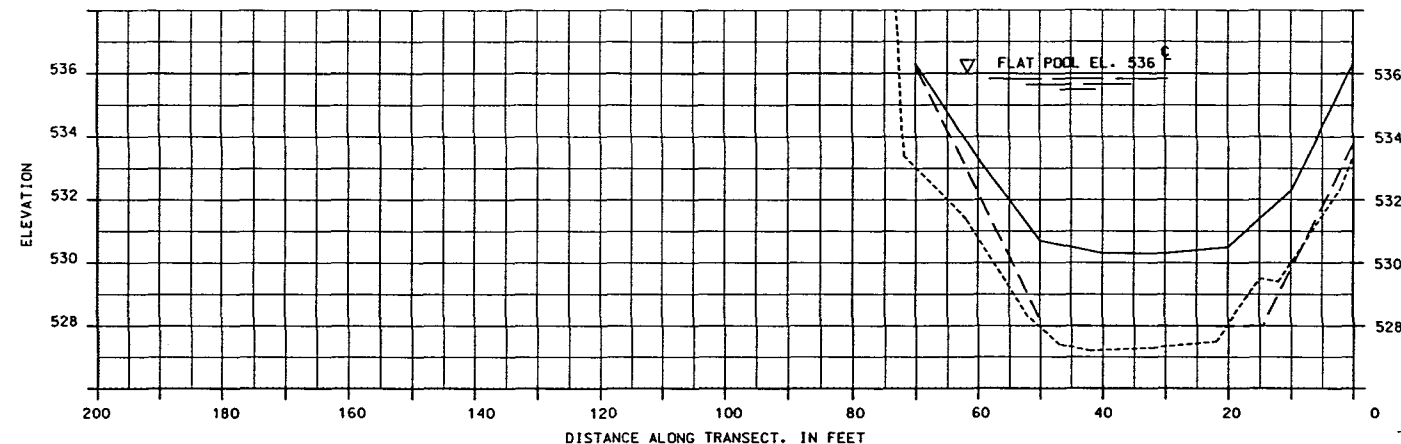
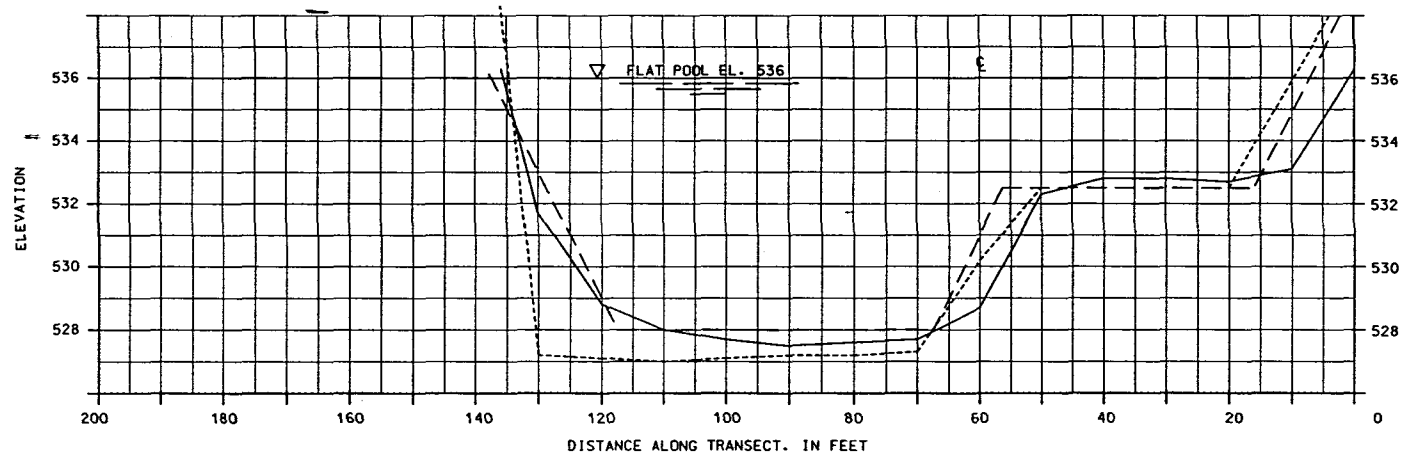
SEDIMENTATION TRANSECT S-M443.7J to S-M443.6J (STA. 0+00)

(1) **Monitoring Results.** Dredged channel sedimentation transects for Round Pond, Timber Chute, and Willow Chute are shown on plates 4 through 8. As shown in Appendix A, Table A-1, the Big Timber project was designed to have 500 square feet of year-round habitat access (cross-sectional area) at year 50. As built, a minimum of 523 square feet cross-sectional area of year-round habitat access was created in Round Pond and Willow Chute, and 381 square feet cross-sectional area of year-round habitat access was created in Timber Chute (see Appendix D, Table D-1). At year 4, a minimum of 427 square feet of year-round habitat access is available in Round Pond and Willow Chute. Timber Chute has 168 square feet of year-round habitat access available at year 4. During the June 1995 USFWS Site Manager's project inspection, bank sloughing (approximately 3 feet) was observed throughout the east bank of Timber Chute (see Appendix C).

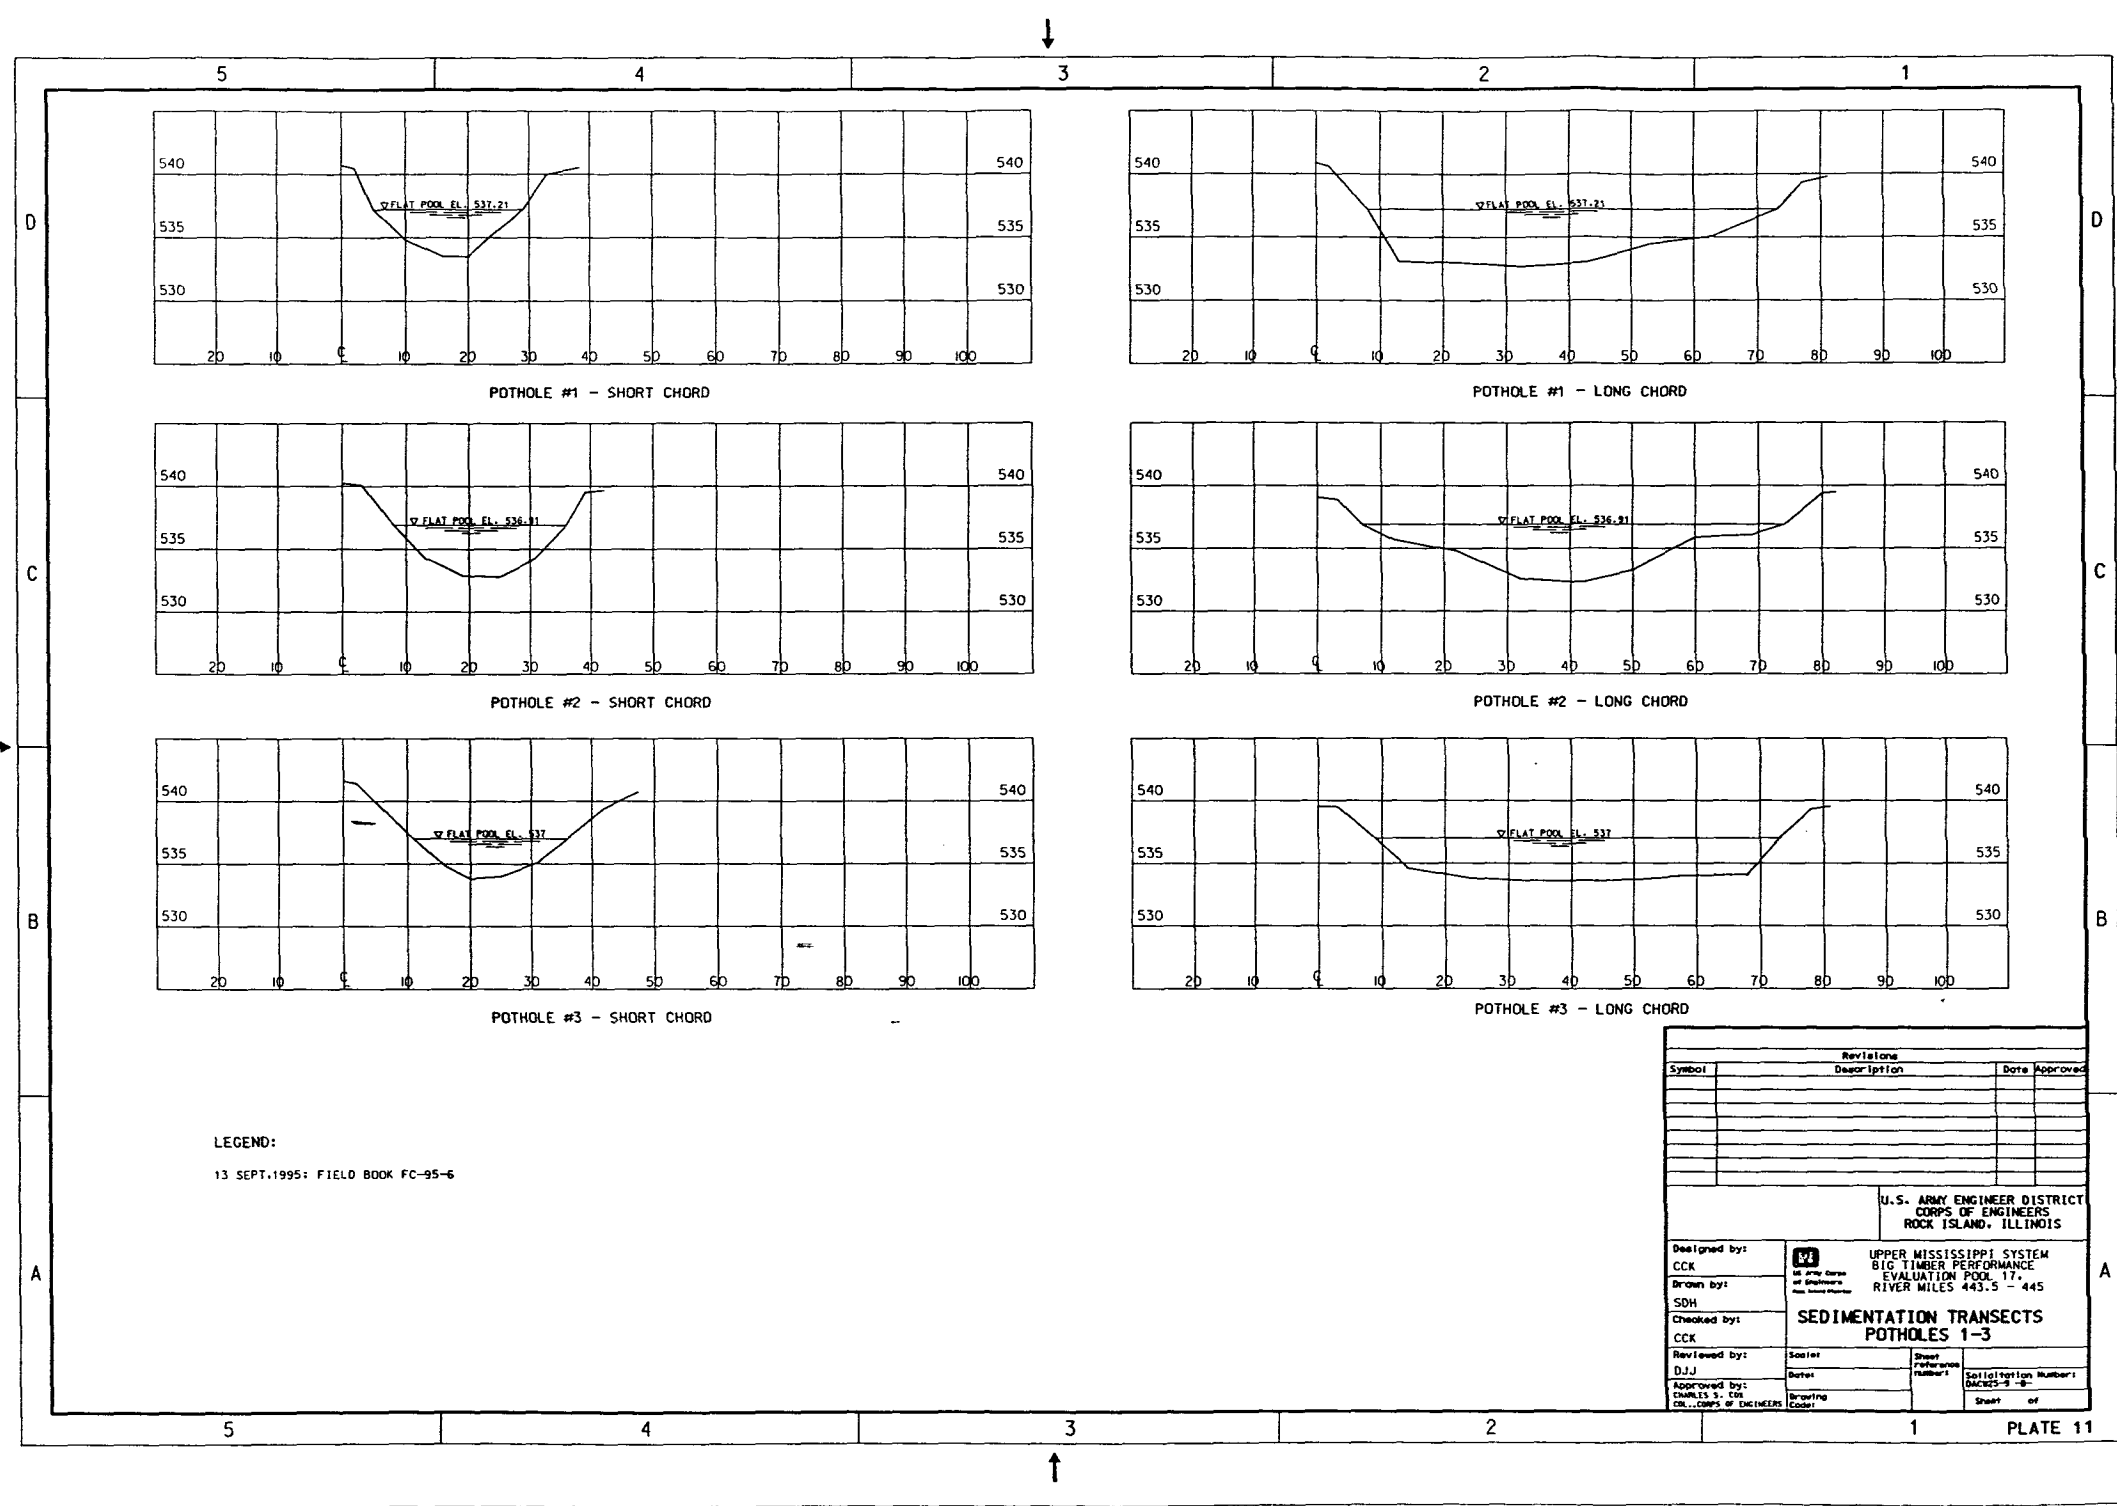
Sheet number: 11
Sedimentation Number: DMCES-9-8
Sheet of: 11

(1) **Monitoring Results.** Pothole sedimentation transects are shown on plates 11 through 14. As shown in Appendix A, Table A-1, the Big Timber project was designed to include 10 isolated resting, feeding, and brooding pools (a.k.a. potholes) at year 50. Following construction in the fall of 1991, the USFWS summarized pothole depths and dimensions, shown in Table 7-2, along with Corps 1995 survey data. The Corps Great Flood of 1993 Damage Assessment (93DA) states that, although no soundings of the potholes were obtained, an accumulation similar to that noted on the surface of the dredged material placement site (approximately 4 to 6 inches of new sediment) could be expected in the potholes. While the potholes provide excellent habitat for waterfowl broods, extensive surveys of the potholes to determine waterfowl use have not been completed. With-project conditions are beginning to show positive waterfowl use for the overall Big Timber site, which may be attributed to the project. Waterfowl production (fledged) for the area is shown in Table 7-3.
