**CHAUTAUQUA REFUGE  
HABITAT REHABILITATION AND ENHANCEMENT PROJECT  
INSPECTION OF COMPLETED WORKS  
2017**

Chautauqua Refuge Habitat Rehabilitation and Enhancement Project (HREP)

Illinois River, Miles 124-130, Mason County, Illinois

September 6, 2017. Temperatures were in the 70s, and skies were mostly sunny. No precipitation occurred. Water elevation in Havana were approximately 430.03 ft

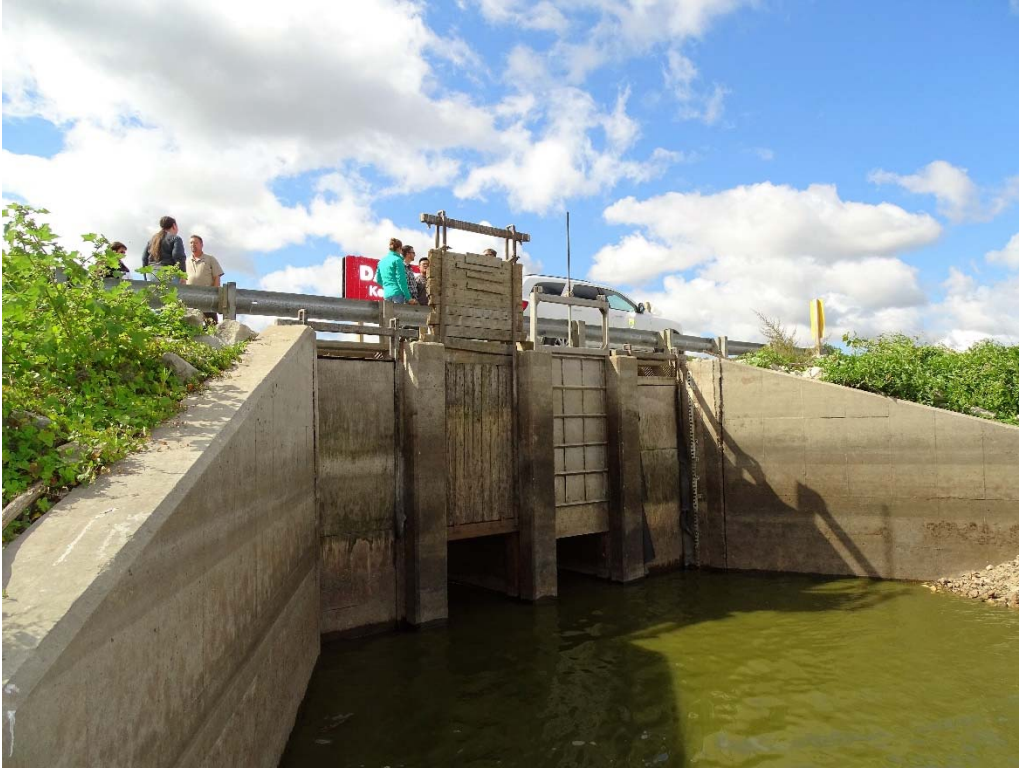
Erosion of rock and material is also noted along the downstream water control structure. Minor modifications to the water control structure gate has occurred due to difficulties with operating stoplog structures. These changes help the service better control water levels through this structure.

Figure 2: Water Control Structure

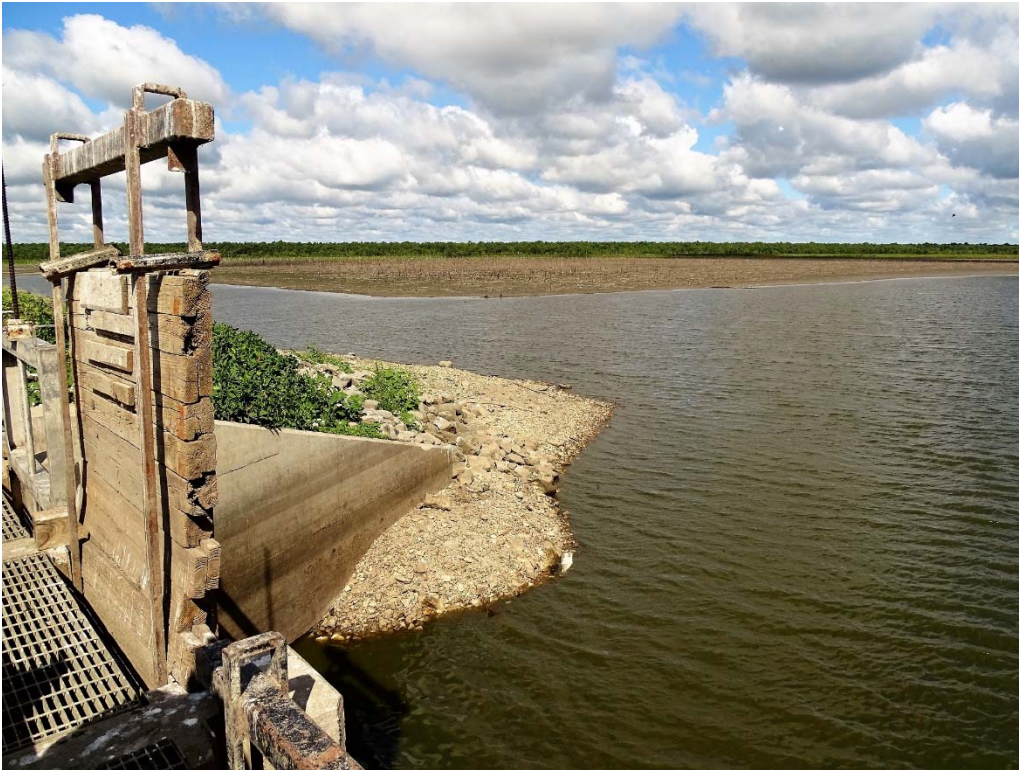
Significant willow growth was occurring in the lower lake and along the levee toe. Water was held high for 3 years to kill off the trees. The trees were removed and stockpiled and should be burned in the next year. Aerial spraying for new growth was planned for this fall.

Figure 3: Lower Lake

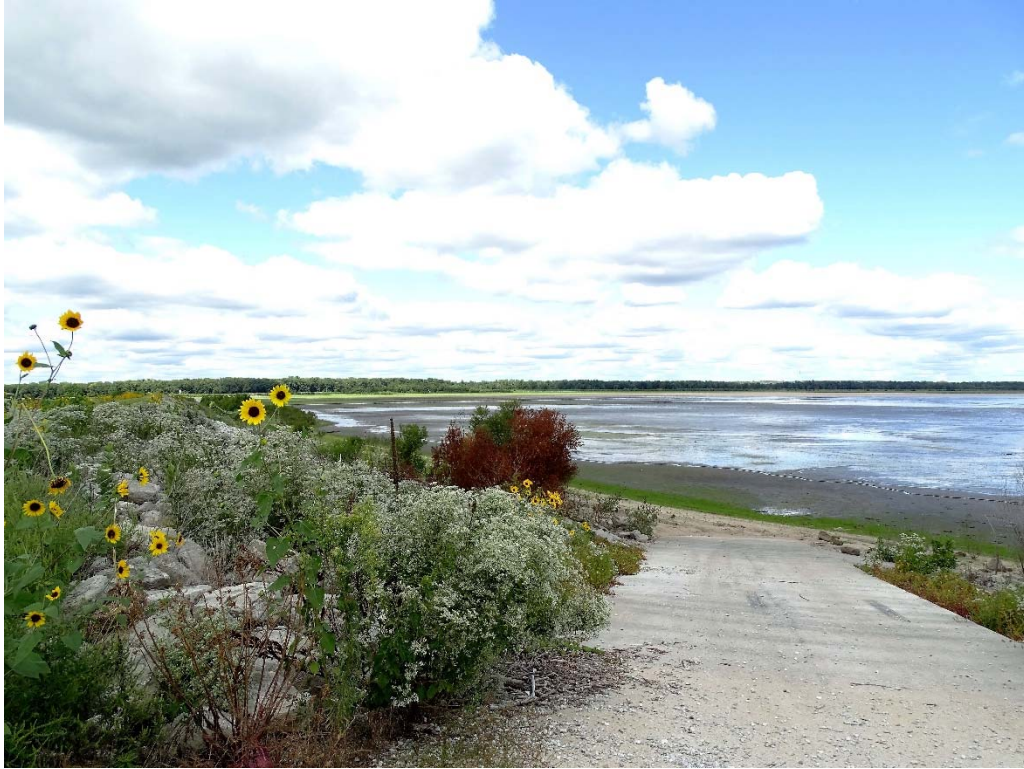
The Upper Lake is managed by an interior gate/lift/pump system, and has had high water for several years. Water had recently dropped as noted during the site inspection, exposing mudflats critical for shorebird habitat.

*Figure 4: Upper Lake*

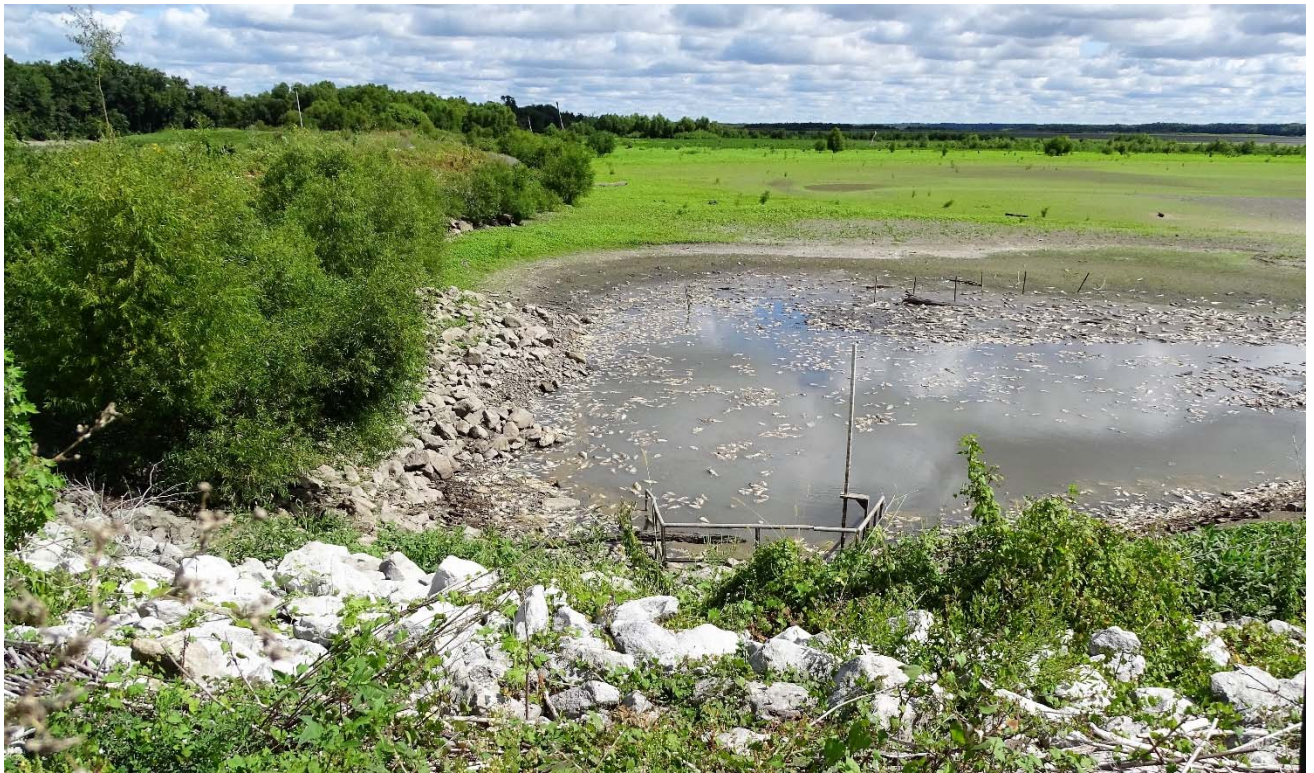
Even though the upper and lower units are no longer being managed to directly benefit fisheries, they do provide a minor indirect benefit to Illinois River aquatic habitat and native fish species by creating a death trap for Asian carp that enter the pools during high water events. A noticeable number of carcasses were present in the remaining puddles at the lower ends of both pools at the time of the site visit.

*Figure 5: Carp in Upper Lake (near pump station)*

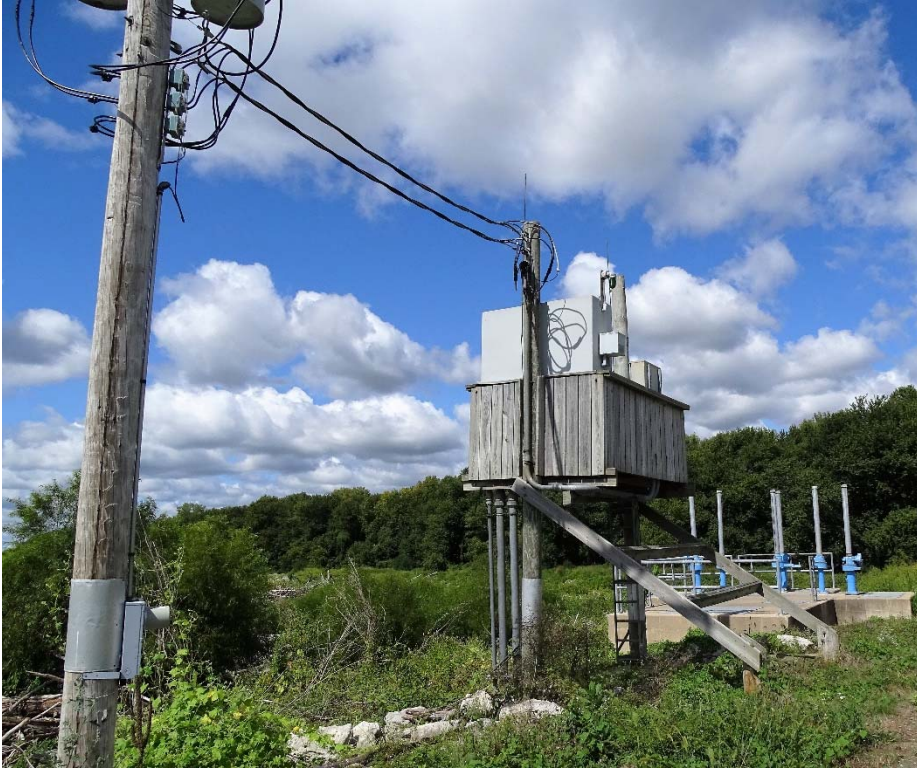
As noted in previous performance evaluation reports, higher river elevations make it difficult to use the pump station, and in general water is controlled by opening gates at the pump station itself. A permitted confined space is associated with the pumps station and gates. FWS are not allowed to enter these permitted spaces and recommended future projects do not include these.

Figure 6: Pump Station

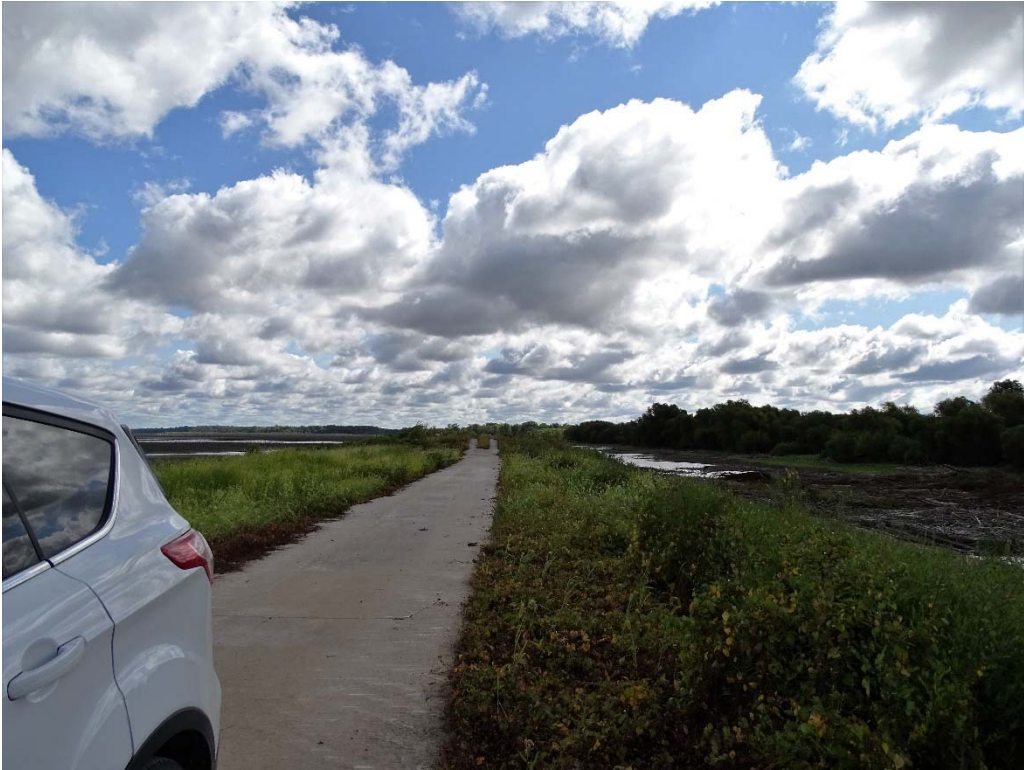
The spillways were constructed of gabion baskets. The FWS coated the roadway with concrete to make driving over it easier. The baskets are holding up well.

Figure 7: Spillway

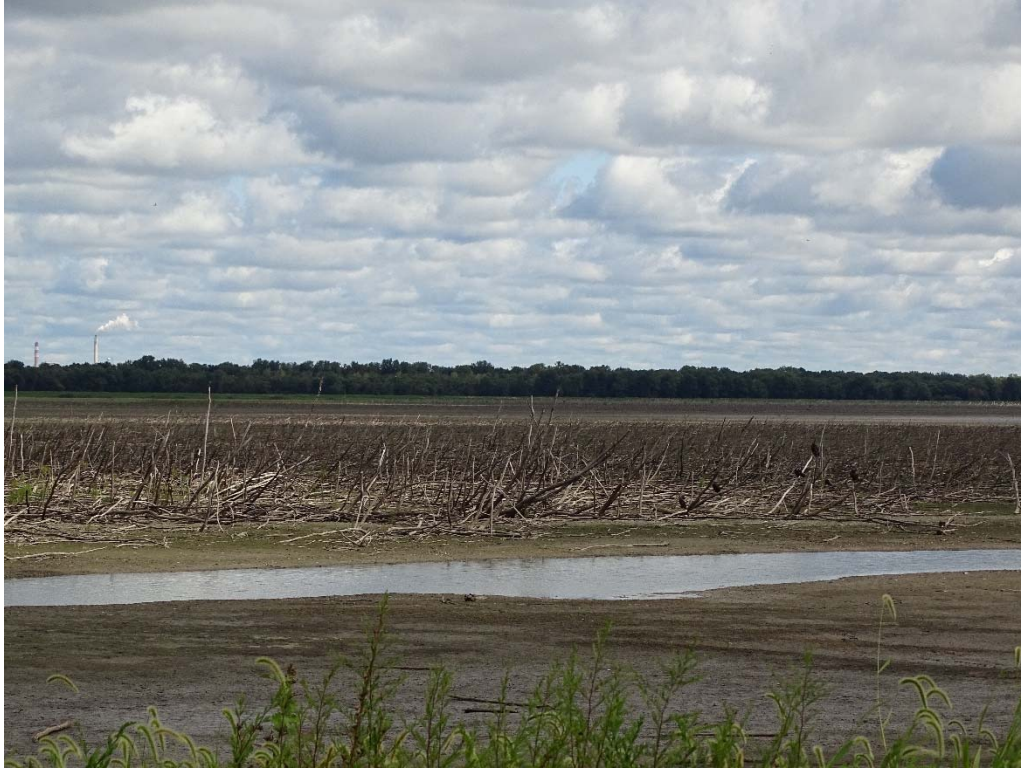
*Figure 8: Willows*

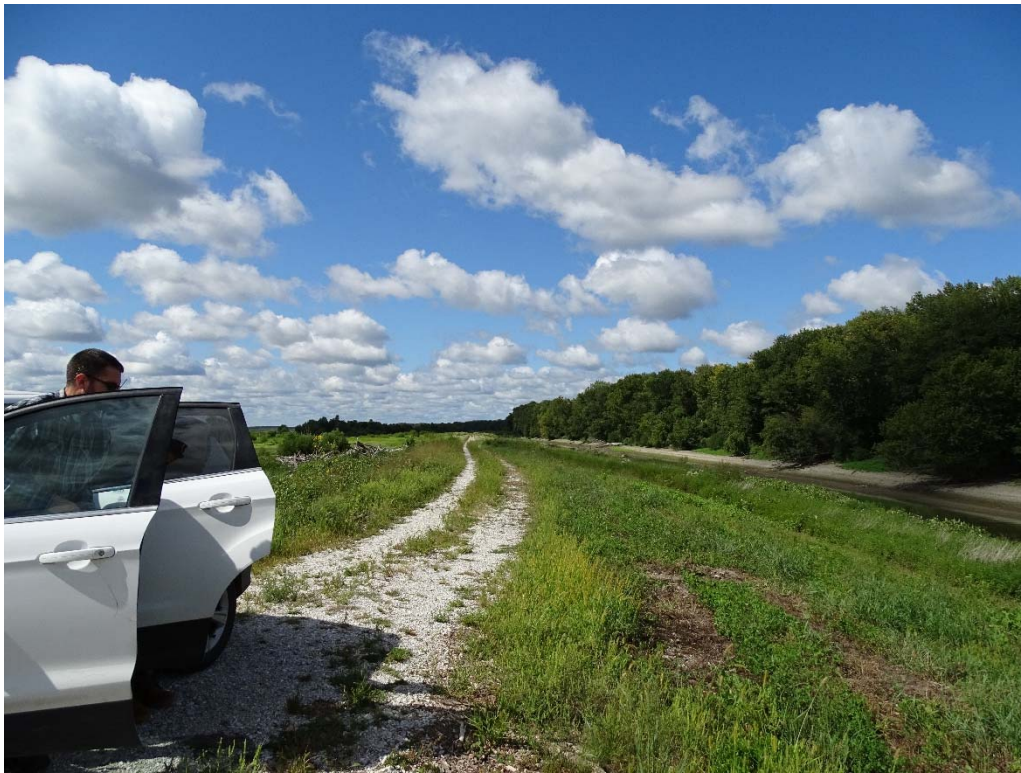
Wave wash erosion occurs near the interior top of the levee before the water levels even out. The FWS repairs these areas, and reseeds as much as possible. Since the interior water is not able to drop quickly, it is difficult to establish good turf vegetation along the toe of the levee. The Corps sent the service some other seed mixes to try, ones that are used on flood control levels. The FWS places riprap when possible. The roadstone on top of the levee washes away during overtopping events. This is pulled back and replenished once the levee dries and funding is available.

*Figure 9: Levee Roadstone (Typical)*

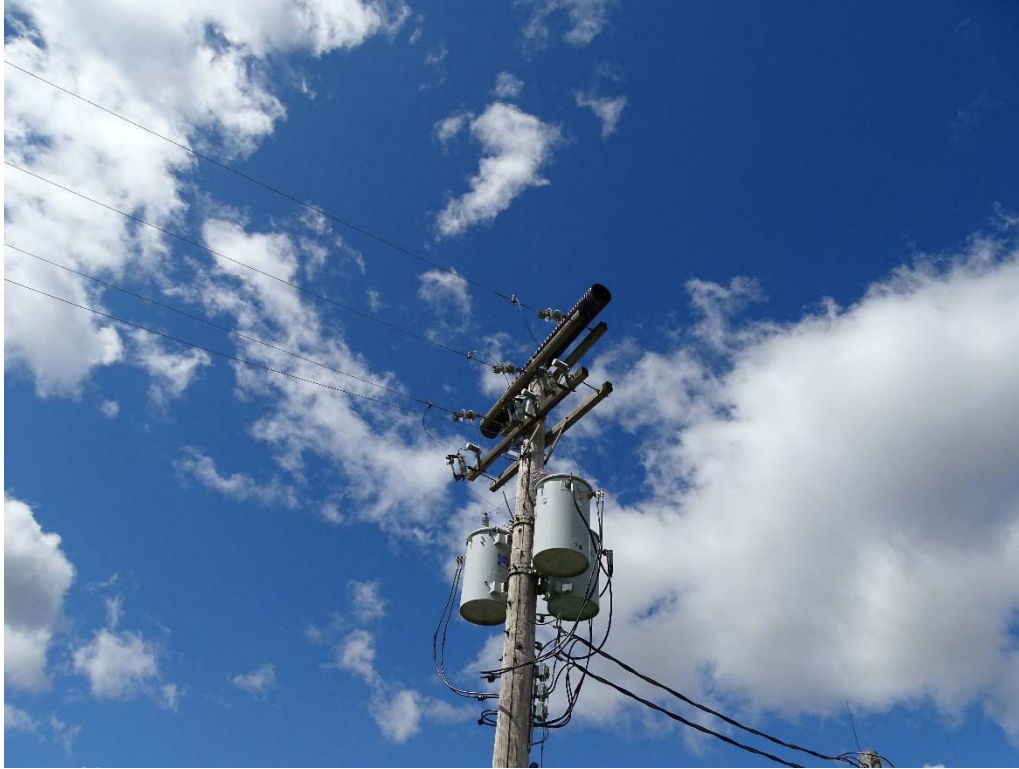
*Figure 10: Nesting Deflectors*

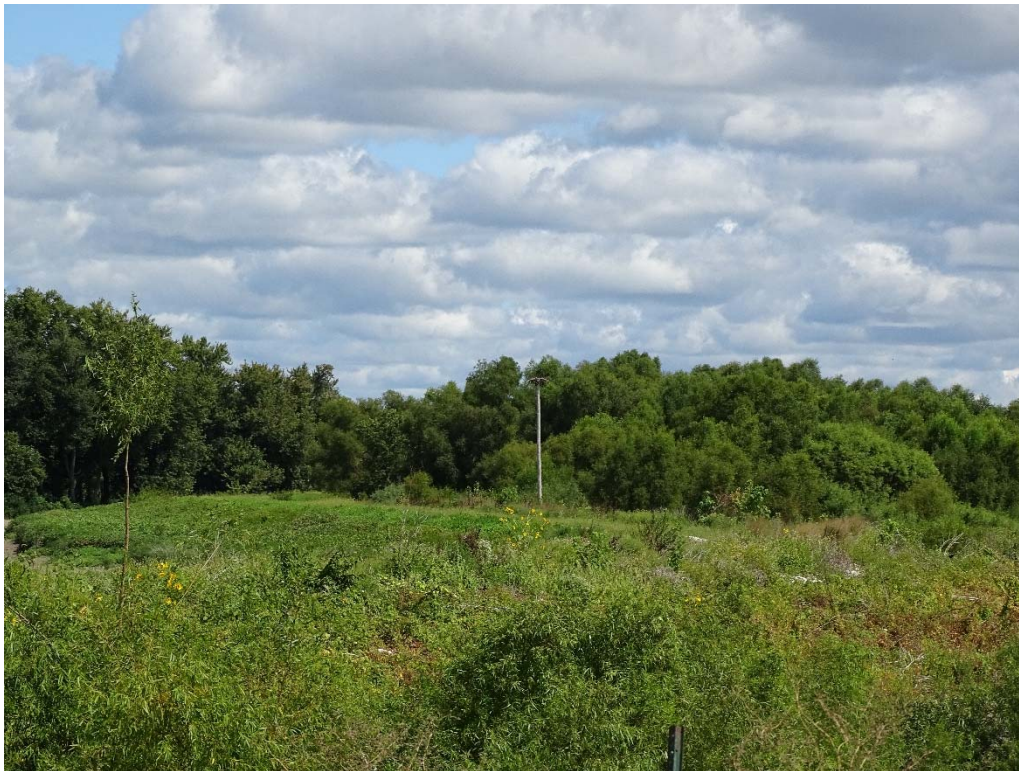
The small stand of canopy trees near the southwest corner of the upper pool, decimated by repeated high water events since the beginning of project construction in the 1990s, is now completely gone. During previous PER site inspections a few standing dead trees persisted, and for a time these provided nesting habitat for bald eagles. While the trees once used as nest sites within the upper pool are now gone, the refuge and surrounding river floodplain forests continue to provide feeding, roosting, and nesting areas for bald eagles, and the number of nesting pairs of eagles in the Illinois River valley and the rest of the state continues to increase. With respect to other raptor species of concern, Refuge staff recently modified the tops of the pump station power poles to prevent nesting attempts by osprey and provided alternative artificial nesting structures nearby adjacent to the perimeter levee, which have been used by the ospreys.

*Figure 11: Artificial Nests*

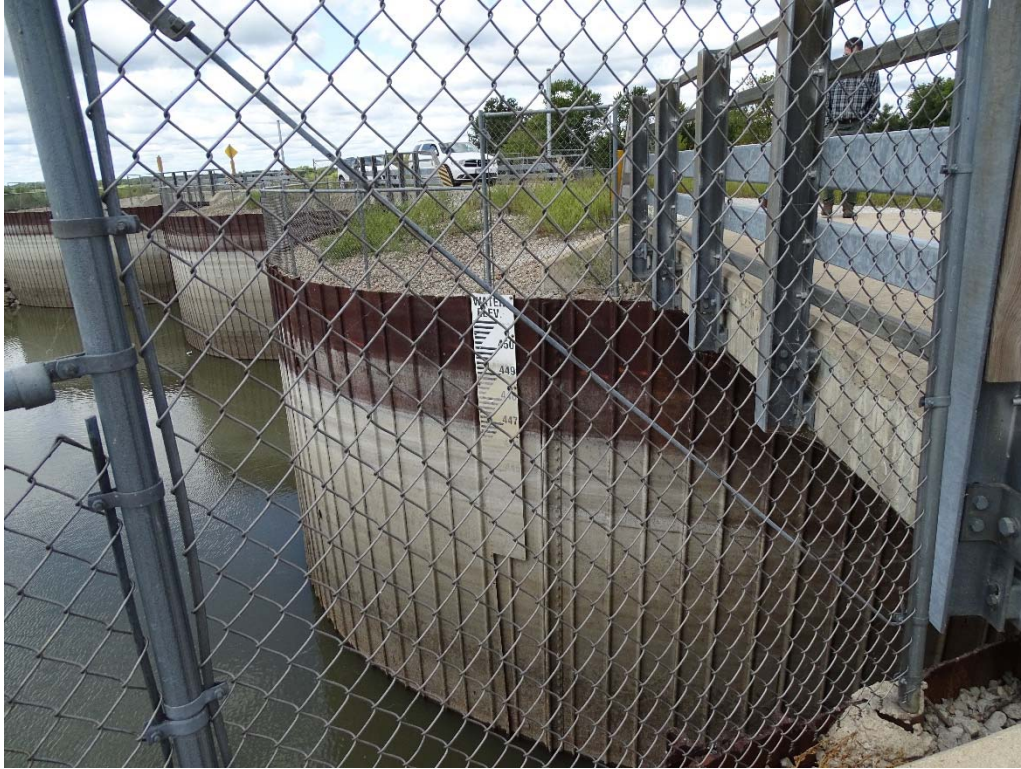
This water control continues to work well. Some vandalism of bolts has occurred (people remove them and throw them into the water). Debris, some from beavers, was noted in the gate openings. These are challenging to remove as there is no land access, and the logs need to be removed from a boat or a person in waders when the water is low.

Figure 12: Cellular Structures

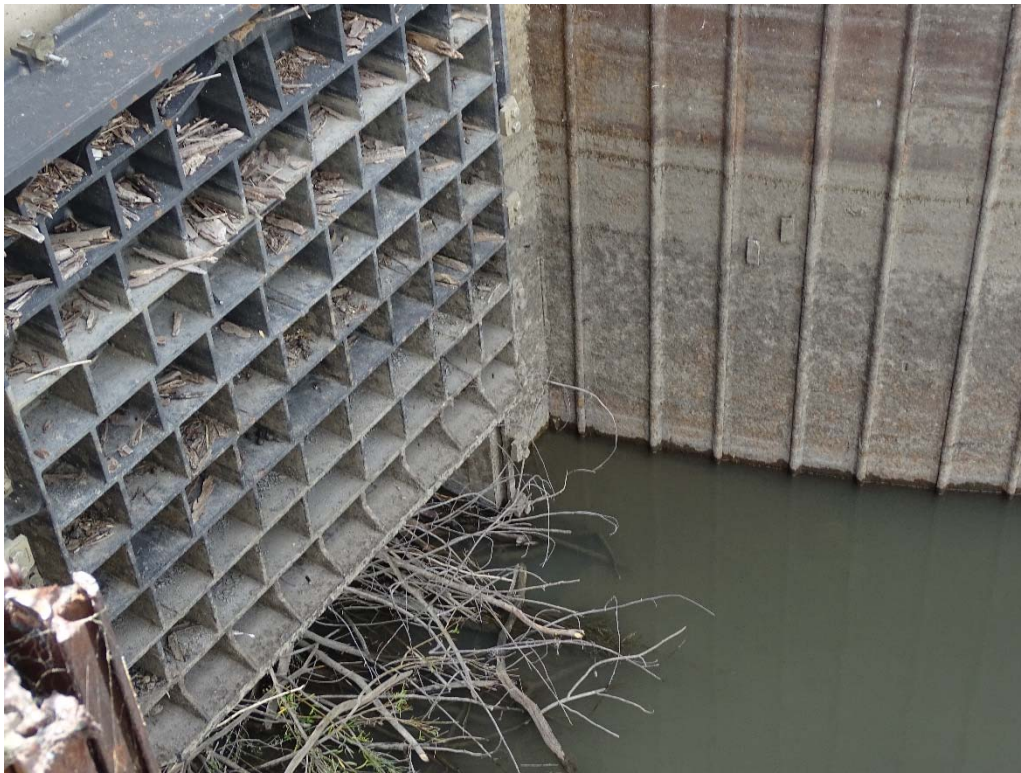
Figure 13: Beaver Intrusion on Cellular Structure
