## **COTTONWOOD ISLAND INSPECTION OF COMPLETED WORKS 2017**

Cottonwood Island Habitat Rehabilitation and Enhancement Project (HREP)

Pool 21, Upper Mississippi River, Miles 328.5 - 331.0, Lewis County, Missouri

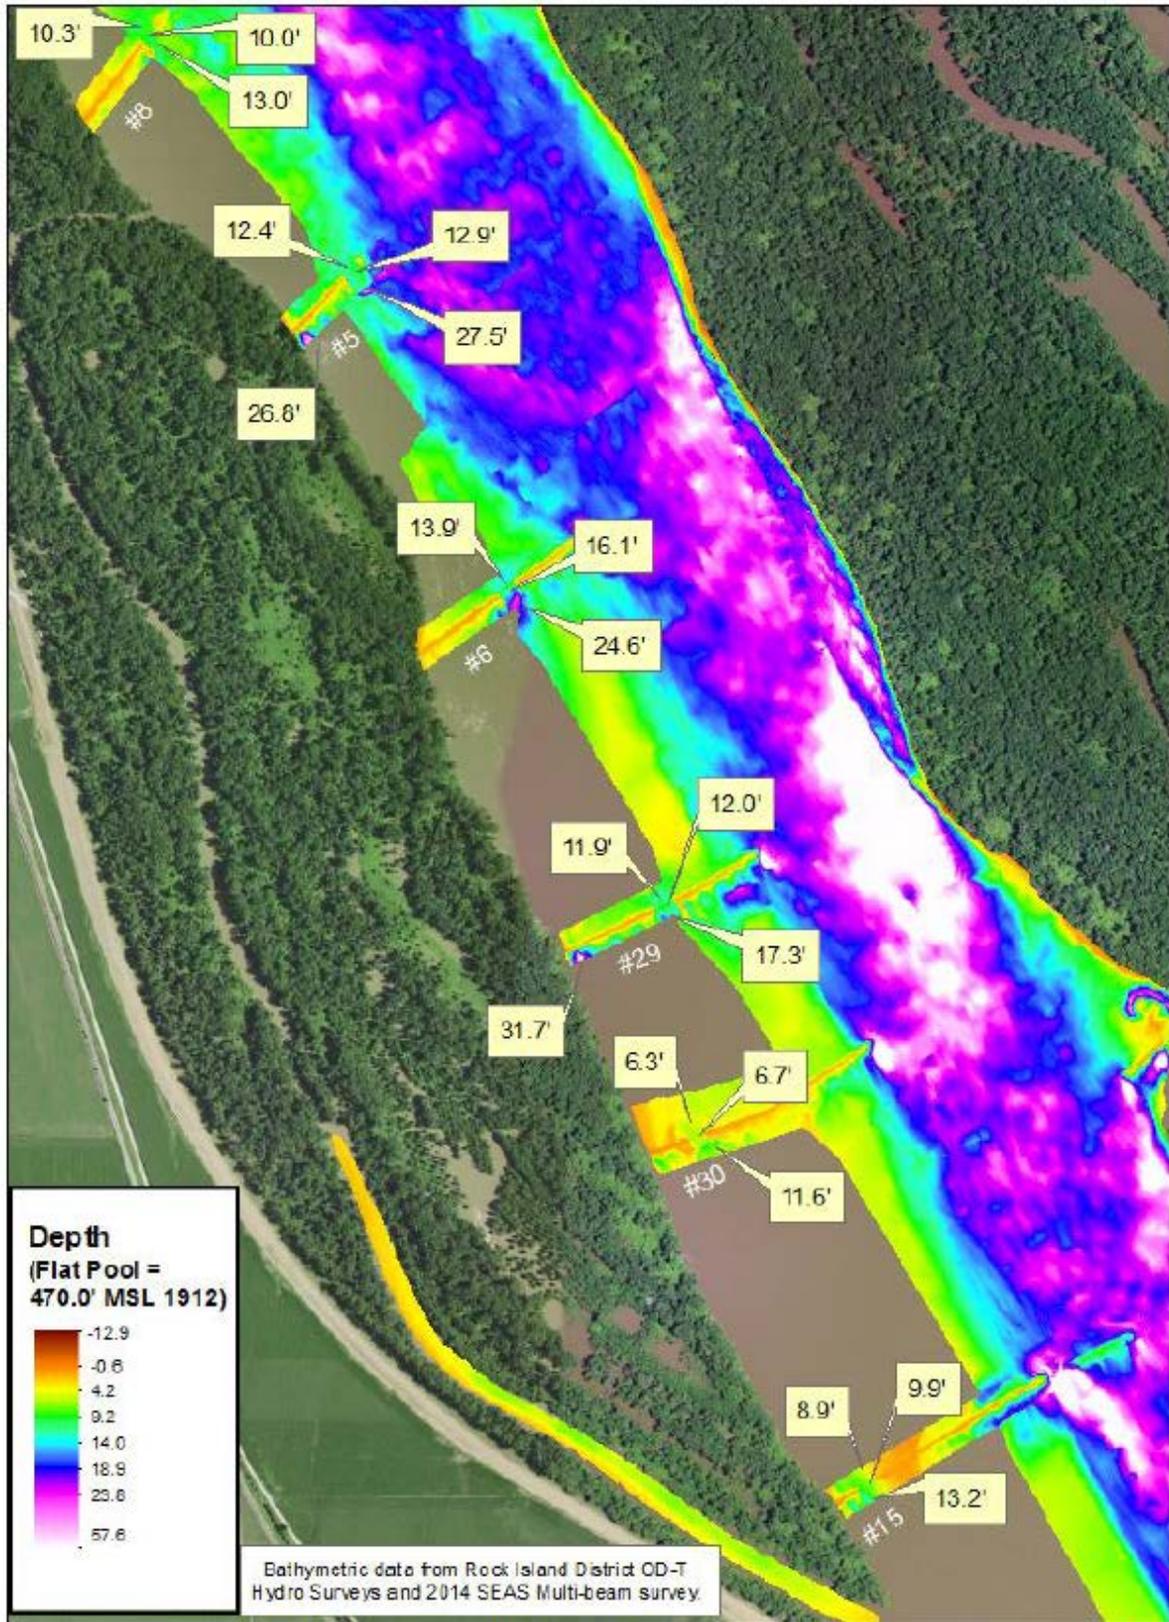
Figure 1: Depths near wing dams from SEAS Multi-beam survey

The SEAS Multi-beam data was also used to determine the depths downstream of the notches. The depths 100 feet upstream of the notch, at the notch and 100 feet downstream of the notch from the 2014 survey can be seen in Figure 1. On the day of the inspection, the depths were found using a depth finder on a boat. The pool stage during the inspection was 12.88' (471.14' MSL 1912) which is 1.14 feet higher than flat pool. A comparison between the 2014 and 2017 depths downstream of the notch are shown in Table 5. The locations of the channel depths may not be in the exact same location since there were not specific coordinates.

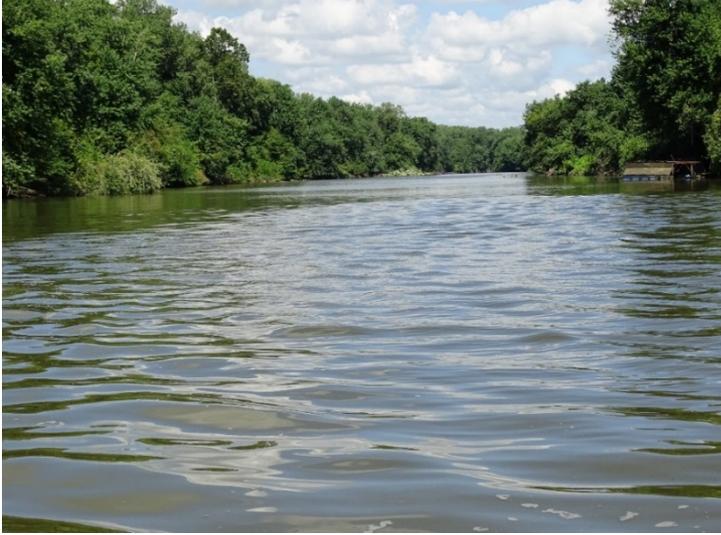
Downstream entrance to dredge cut

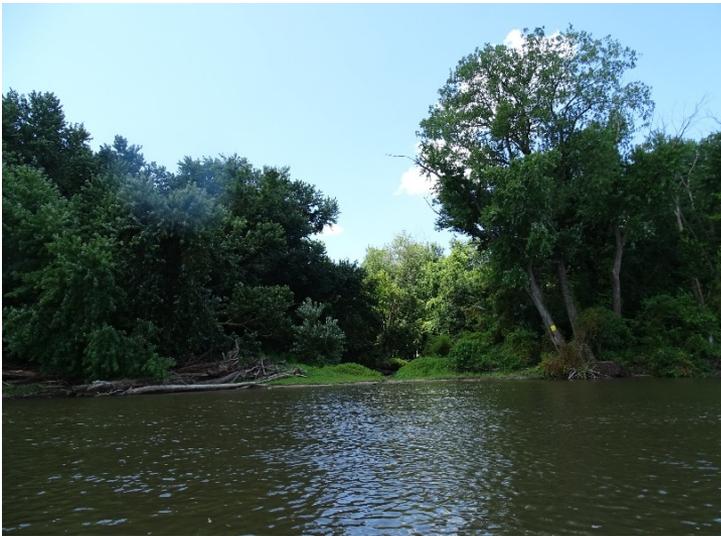
**Chute Restoration:** The dredged channel has successfully been providing overwintering habitat for fish. However, it has filled in from its designed depth of 9 feet to between approximately 7 and 8 feet at the upstream area and 4 feet at the entrance to the chute (based upon depthfinder readings and pool stage on the day of the site visit).

Upstream channel inlet,  
located upstream of the  
causeway, connecting the  
main channel was silted in

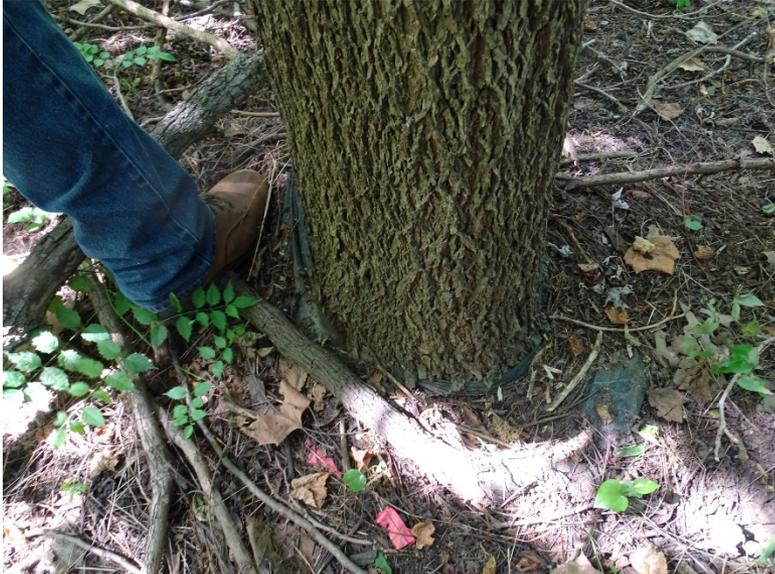
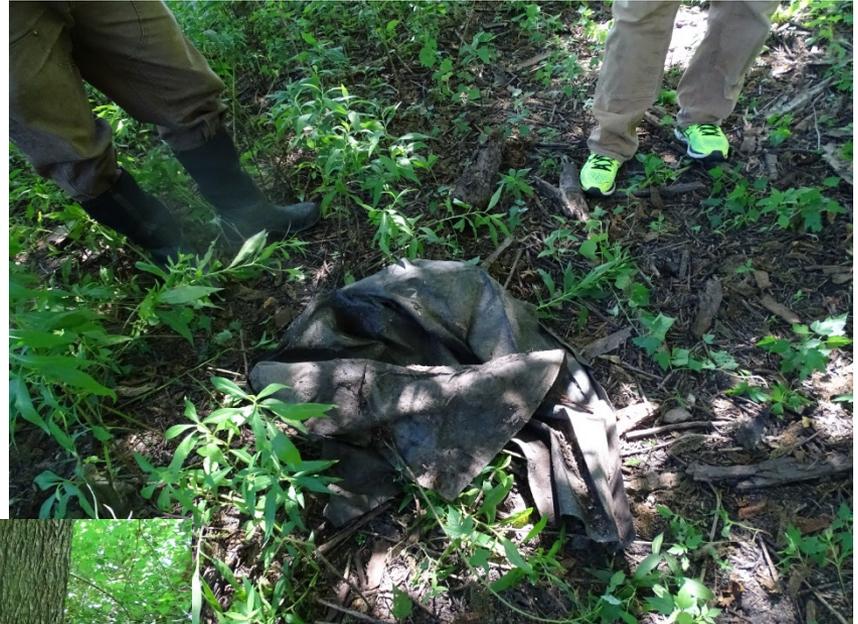
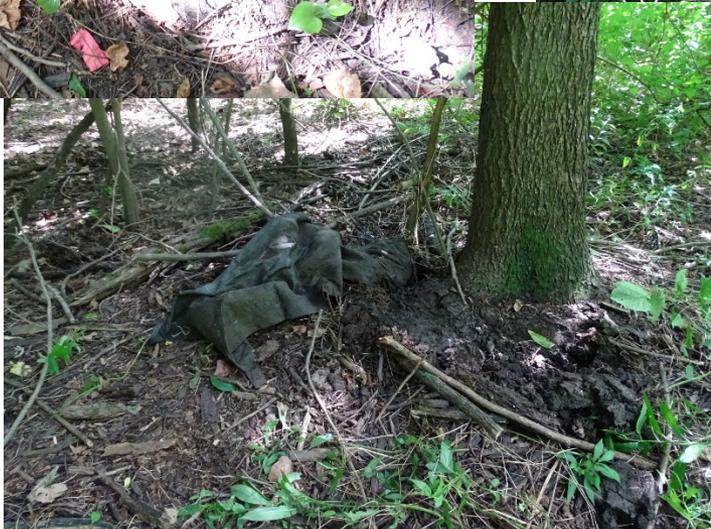
**Mast Tree Plantings:** The tree plantings have developed well. During implementation of the project, weed protection mats were placed around the base of all of the planted trees. These mats were supposed to break down within 5 years but have survived to the present and are choking out many of the trees observed during the site visit. Tree cages were placed around trees in another portion of the site. These cages fill with sediment and in some instances cause rotting and restrict growth. This project also designed tree plantings to be done on berms. These raised portions have been known to cause issues with the way tree roots develop, but at Cottonwood this does not appear to have limited tree growth. Many healthy mast-producing trees were observed, including pin oak, bur oak, swamp white oak, pecan, and sycamore. These have been successfully established and some have grown to over 40 feet tall. Other trees noted on site, both planted and volunteer, were silver maple, American elm, Green ash, honey locus, hackberry, black willow, boxelder, and red mulberry.

Weed barrier mat has the potential to last much longer than expected and can choke and effectively girdle trees if left in place too long. In wet areas tree cages tend to fill with sediment which can result in rotting of the roots and base of the tree.

Weed barrier mats were expected to break down in 5 years but have survived to the present. In some cases these are girdling trees.

- Removing weed barrier mat from around base of trees
- Remove tree cages from around trees in planting area
- Repair scour damage on causeway and add riprap to channel to avoid future erosion

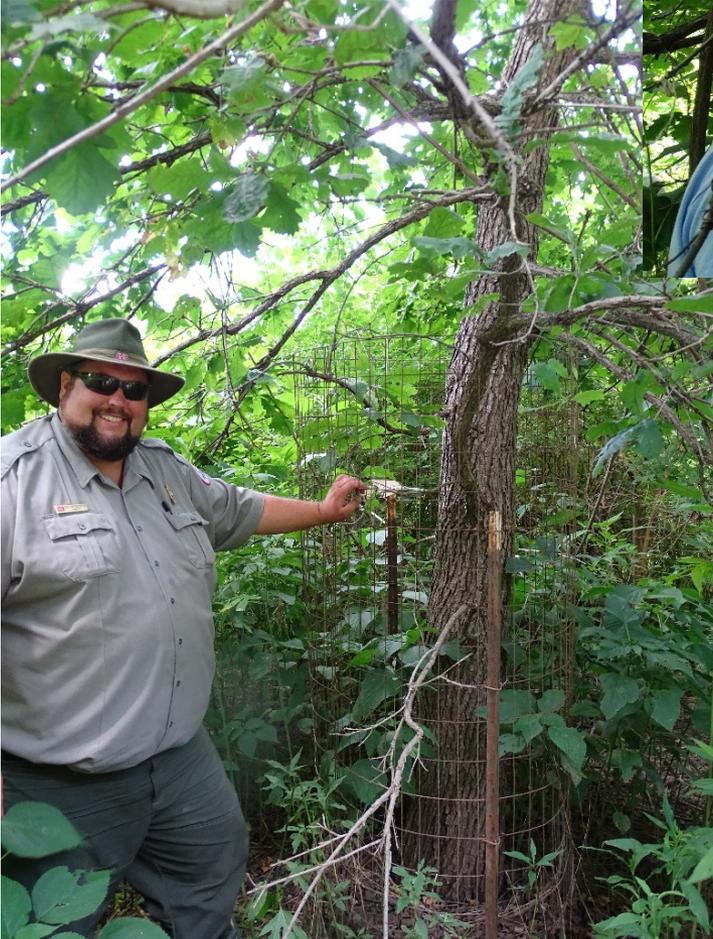
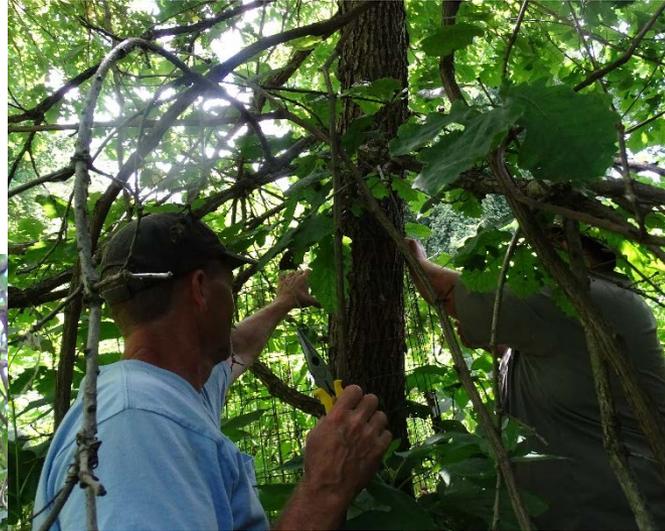
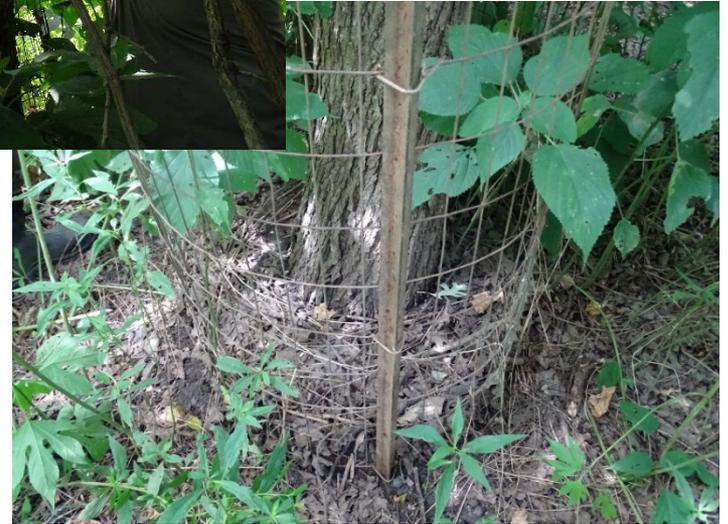
Tree cages were implemented on portions of the tree plantings. These often fill with sediment and sometimes restrict growth as seen in the above images.

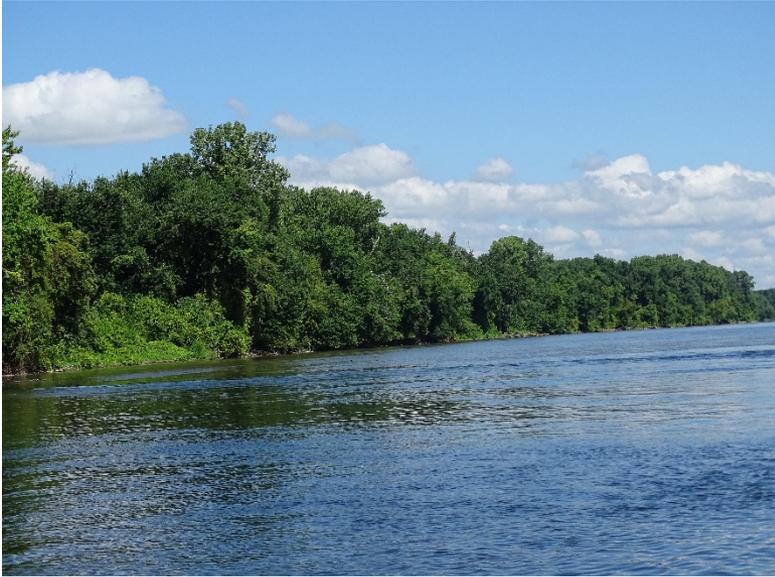
Water surface indicating  
wing dam notches

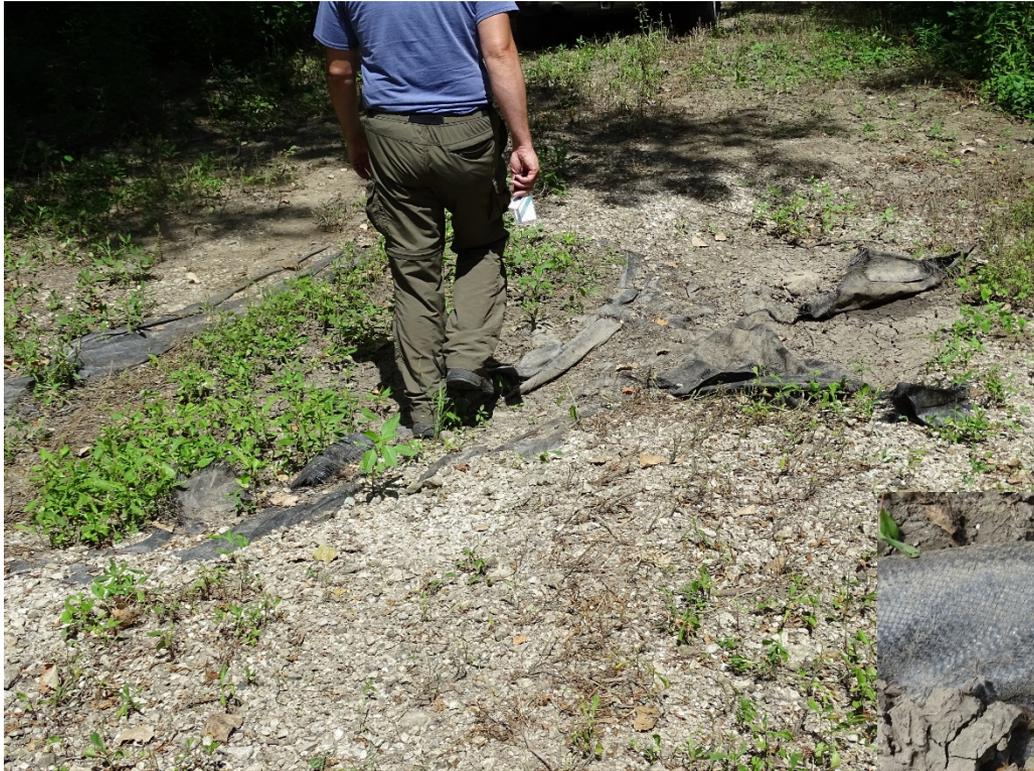
**Causeway:** The causeway has experienced some scour damage just past the channel on the east side. Water is redirecting around the impervious material of the causeway and washing away the material gravel placed there for vehicle access. It has been filled in by the sponsor in the past with gravel but continues to remain an issue after high water events. There is a small amount of riprap at the northeast portion of the causeway, but to avoid erosion this would need to extend farther up the bank and tie into high ground.

Scour damage is occurring just east of the causeway as water is redirecting to that area during high water events.

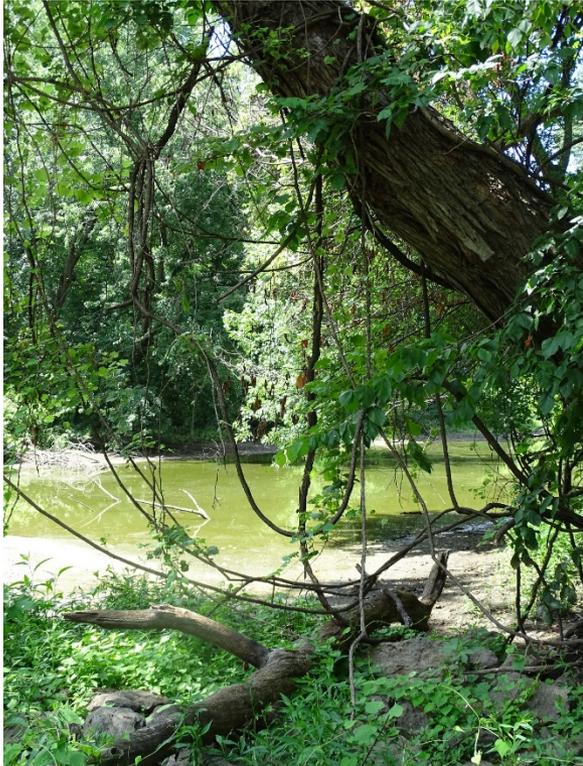
Riprap on the north side of the causeway does not tie into existing high ground currently.
