**FOX ISLAND DIVISION
INSPECTION OF COMPLETED WORKS
2020**

Fox Island Division Habitat Rehabilitation and Enhancement Project (HREP)

Pool 20, Upper Mississippi River, Miles 353.6 – 358.5, Clark, Missouri

IX. DATE OF FIELD VISIT: July 23, 2020

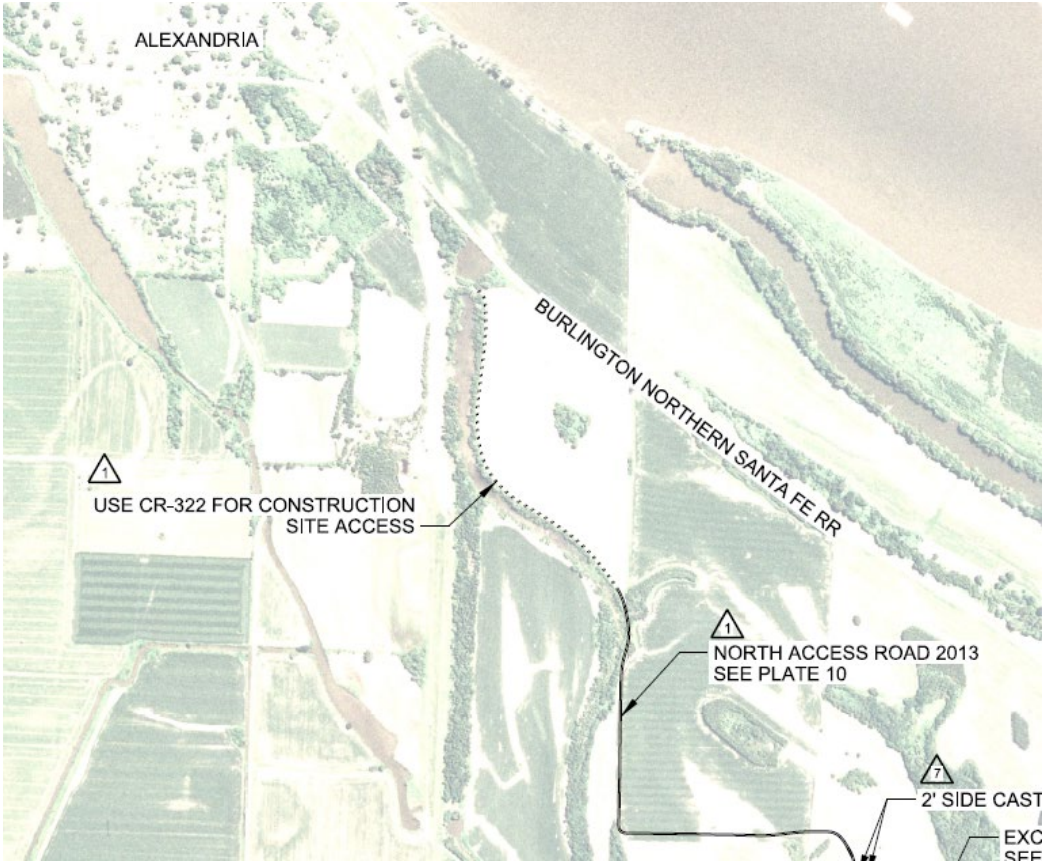
Site access to operate and maintain the project is challenging. The access road leading the project has been frequently submerged over the past several years, and no repairs to the road have been completed to improve site access. When the Mississippi River stage at Gregory Landing is above 17 feet, the access road is not passable. Despite these challenges, the site appears well maintained with little damage observed.

Access Road

Access to the site is extremely difficult. If the roads could have aggregate placed on top, or could be elevated, management of the interior would be significantly increased.

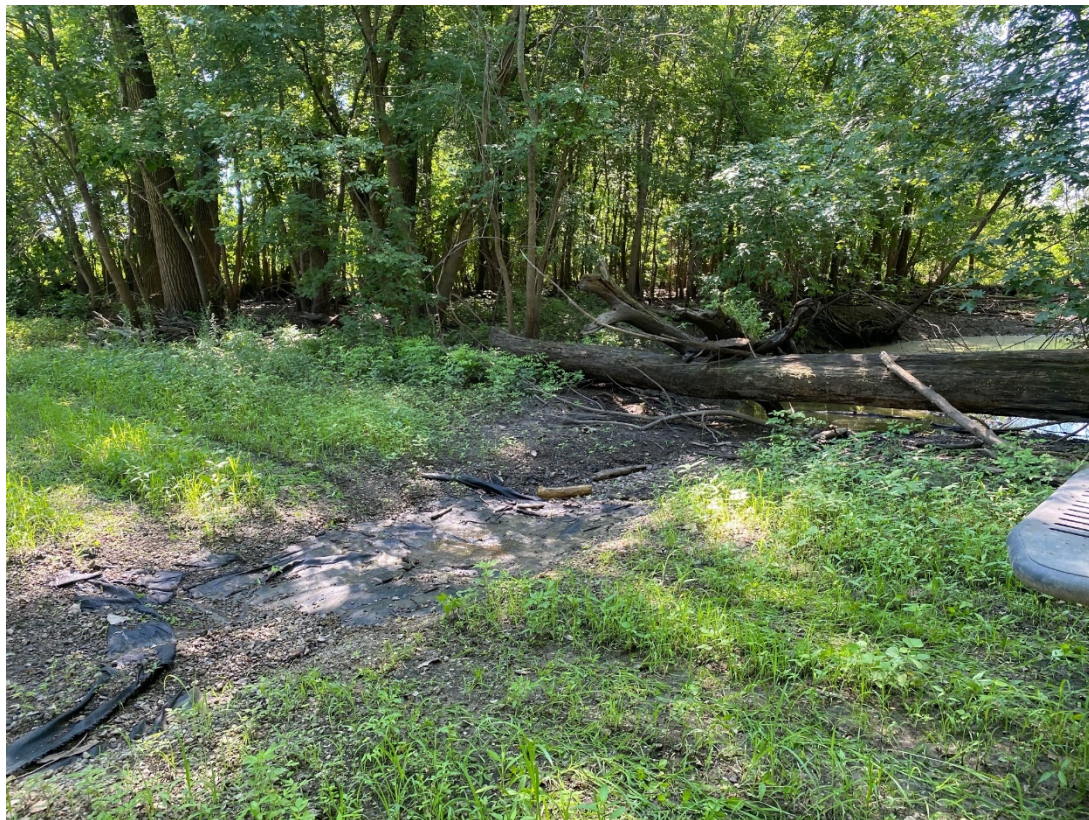
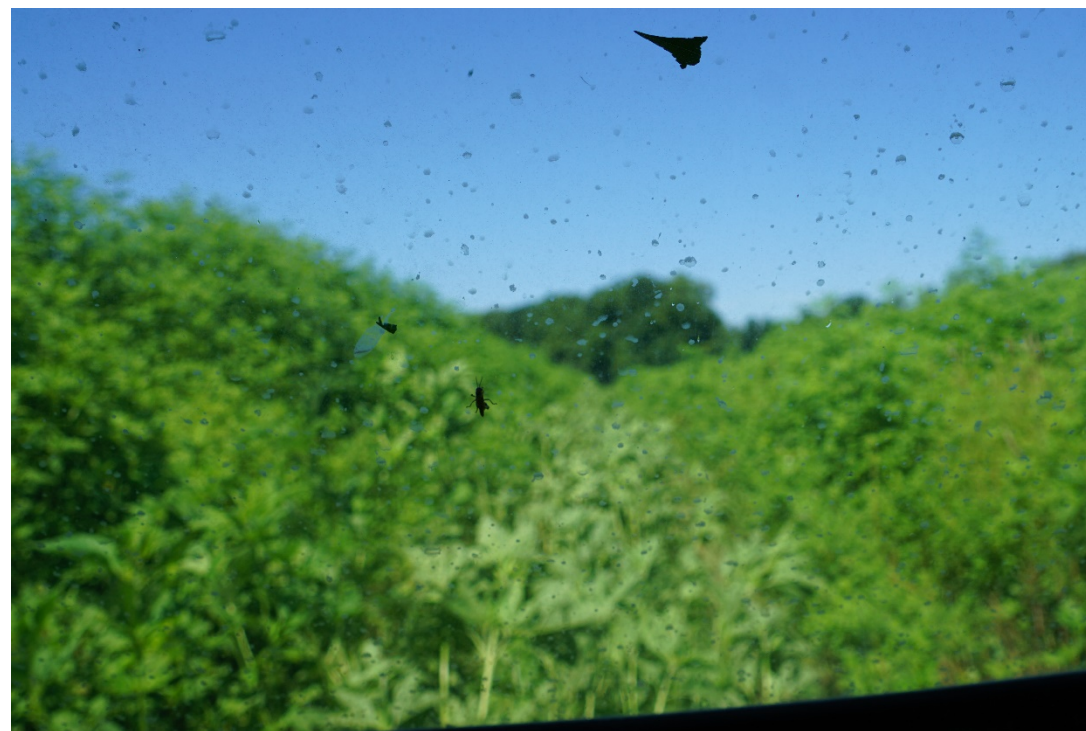
Access Road

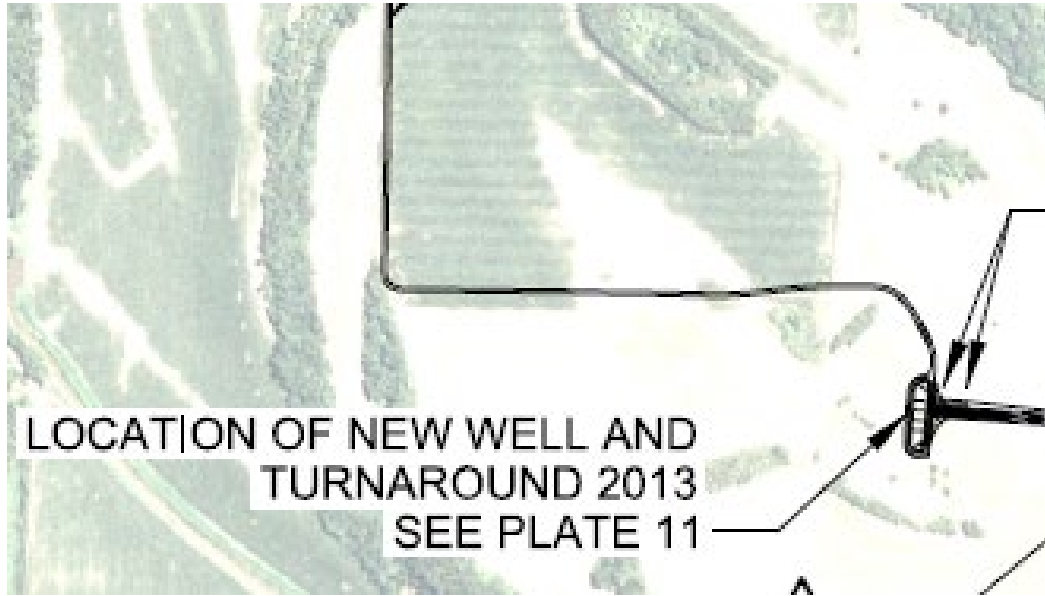
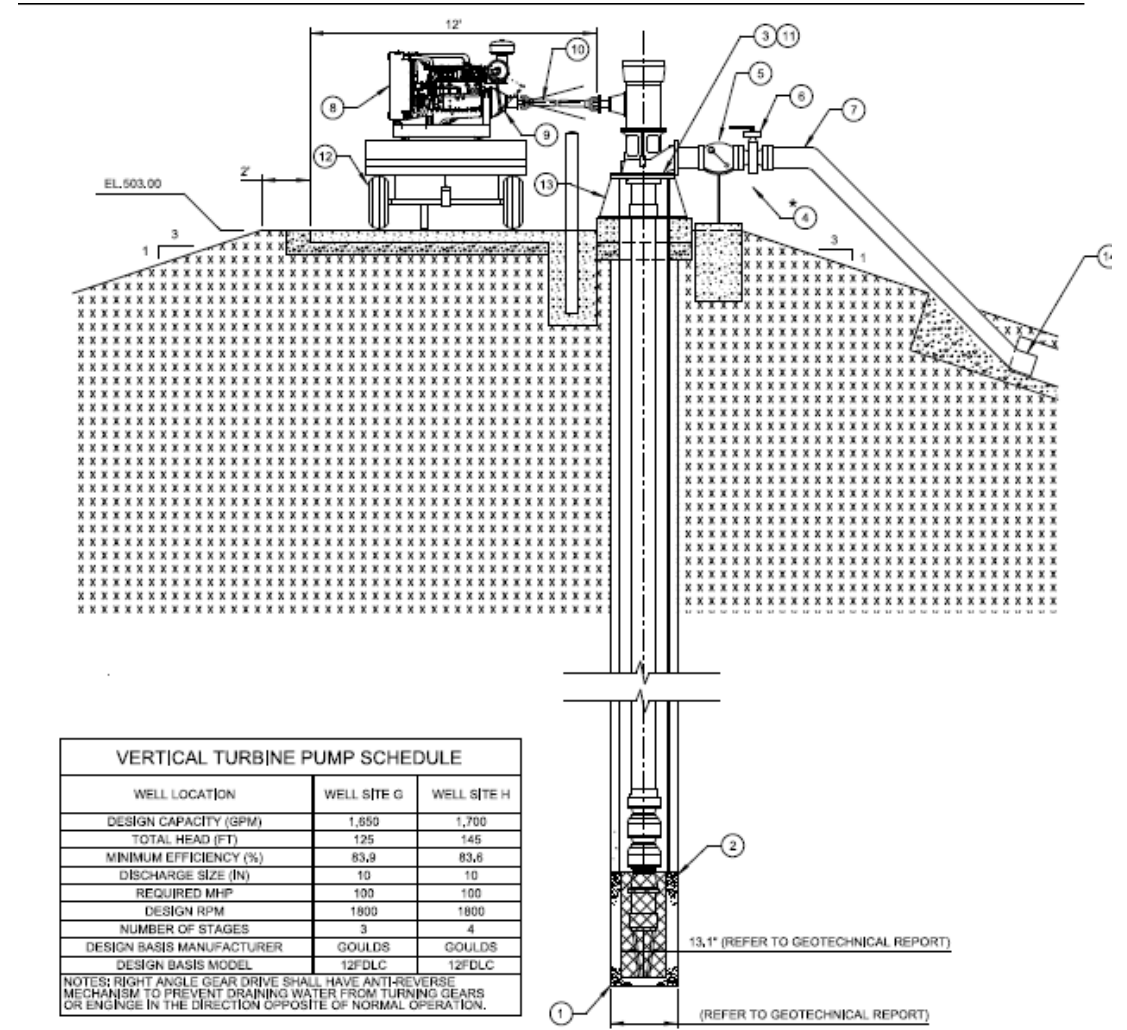
Performing as expected. Due to site access, it is challenging to get fuel truck and personnel to the site during high water conditions.

Well

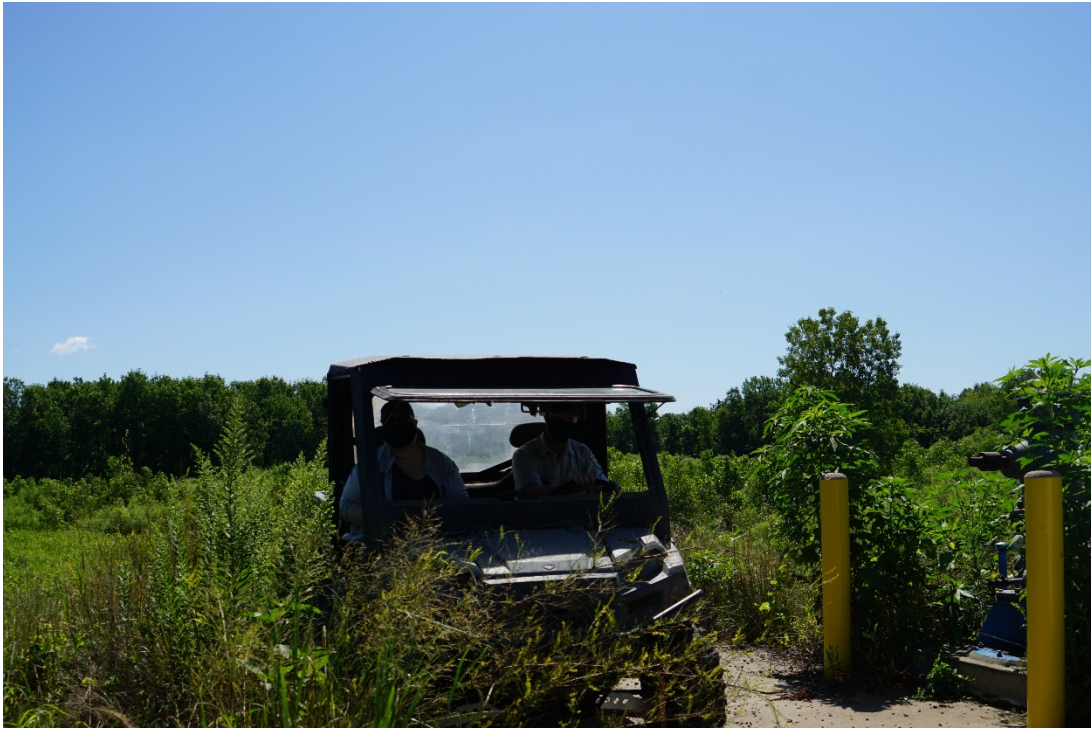
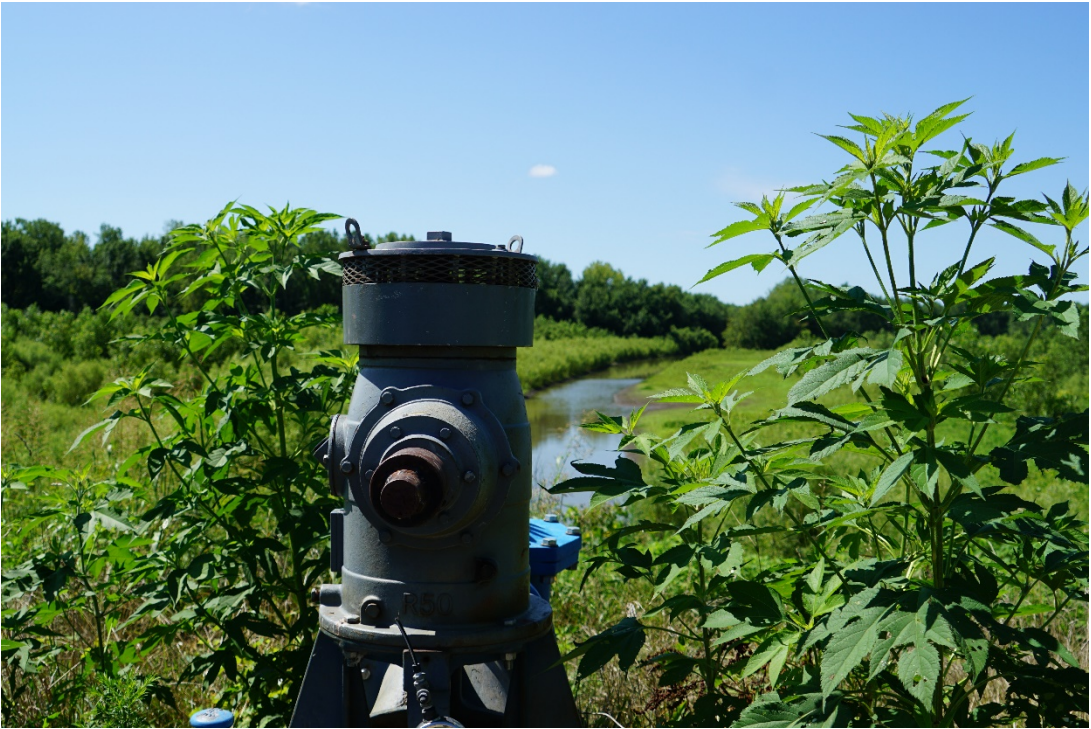
Well

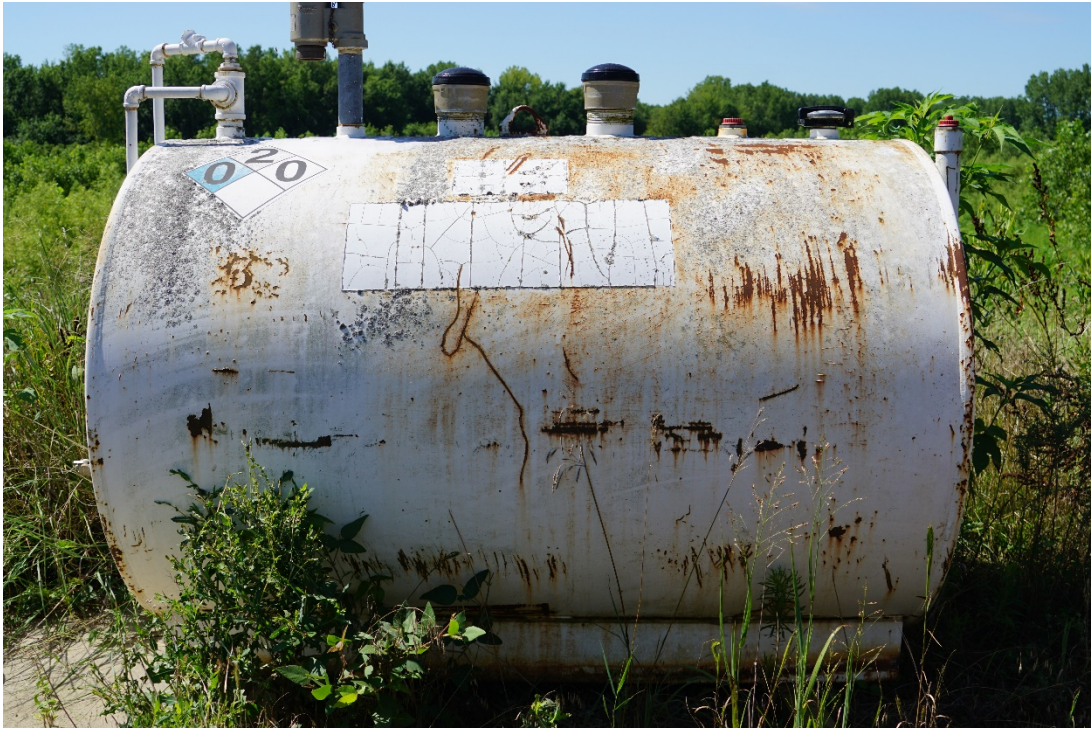
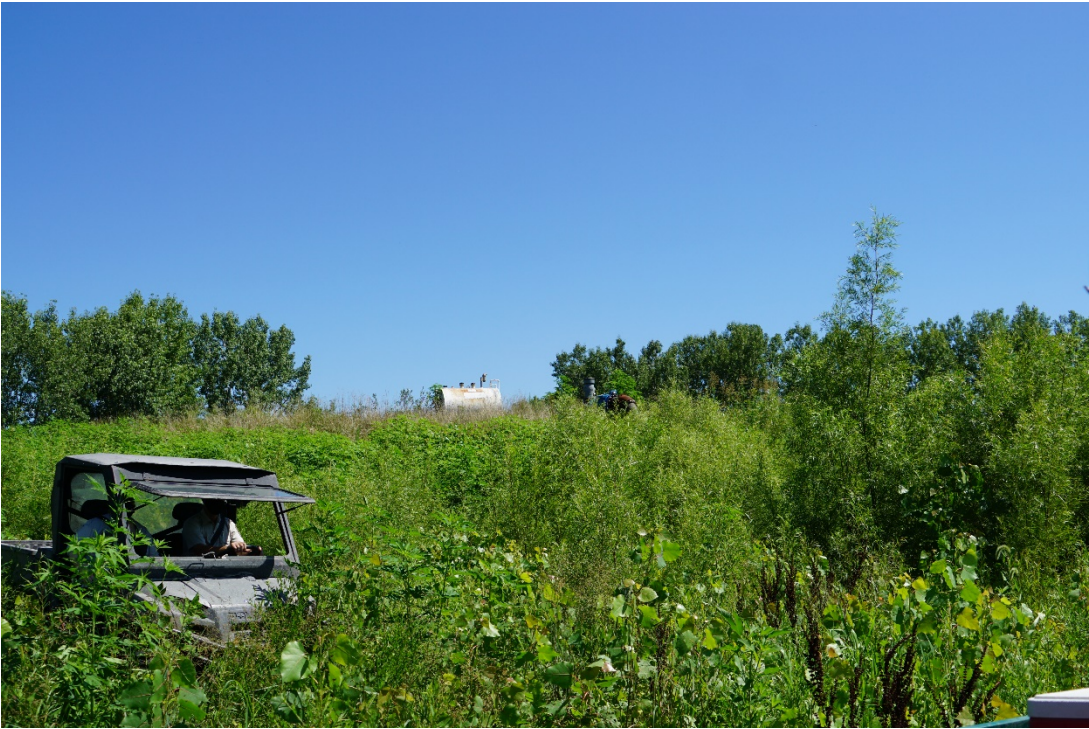
Engines are functioning, but not consistently used because it is very difficult to get a trailer on site.

Well Pump

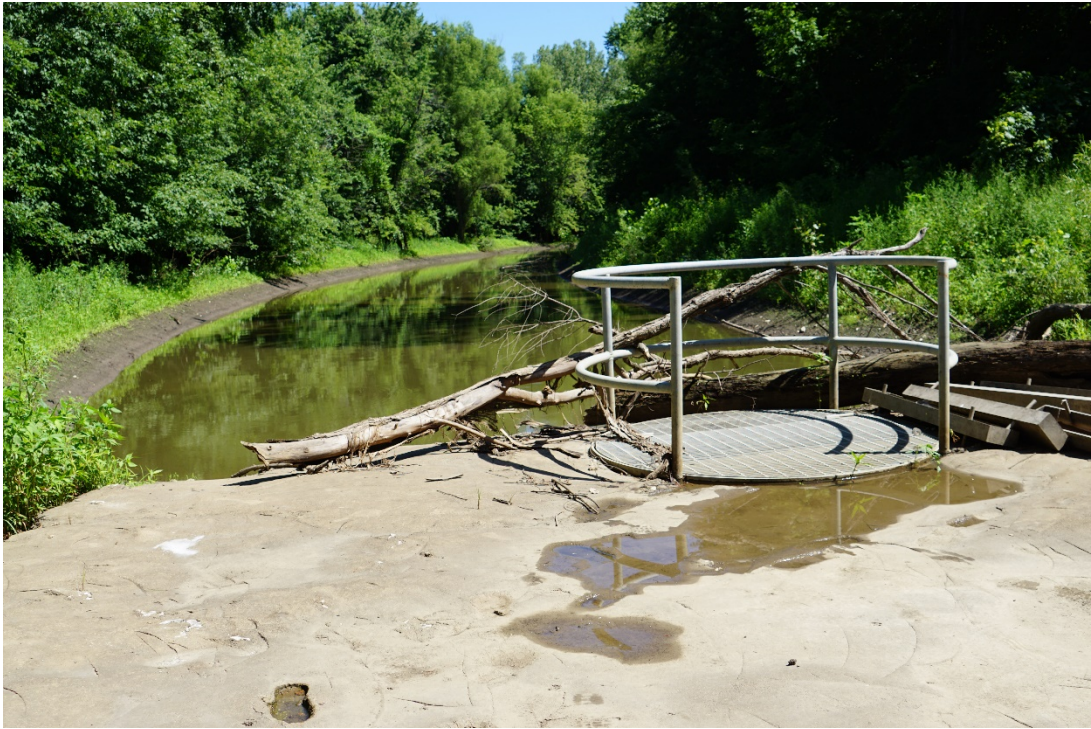
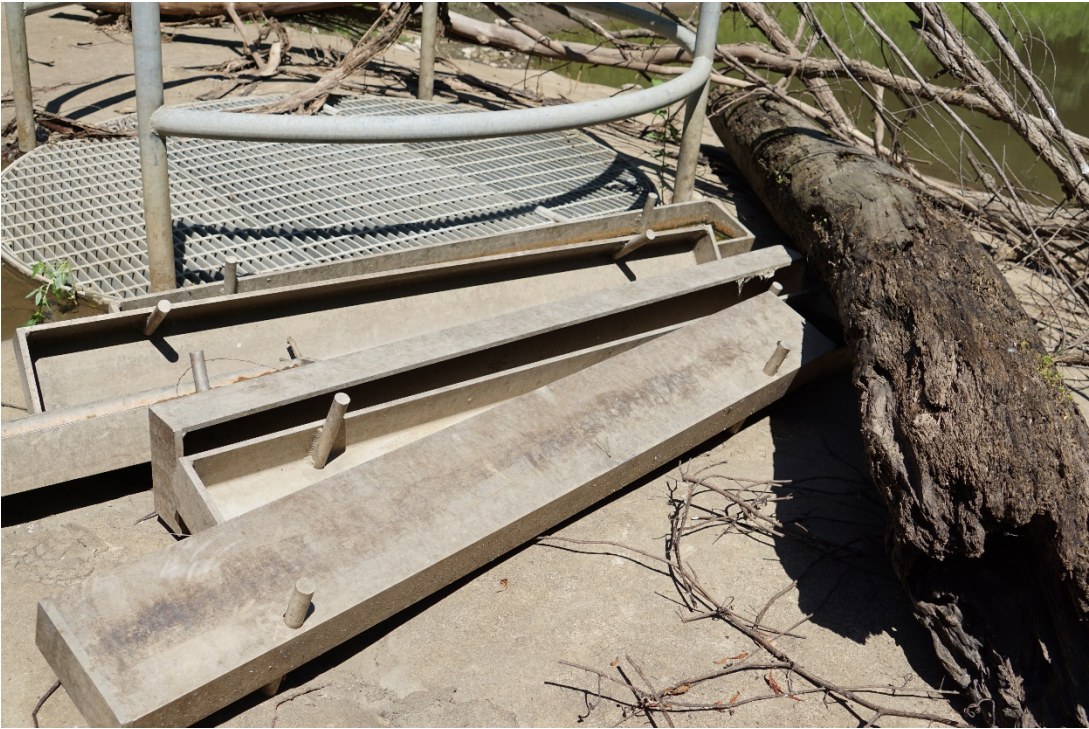
Stoplog Structure A. No concerns. FWS prefers the aluminum stoplogs. Vandalism and theft are not a concern as can be noted with stoplogs remaining unsecured next to the water control structure.

Stoplog Structure A

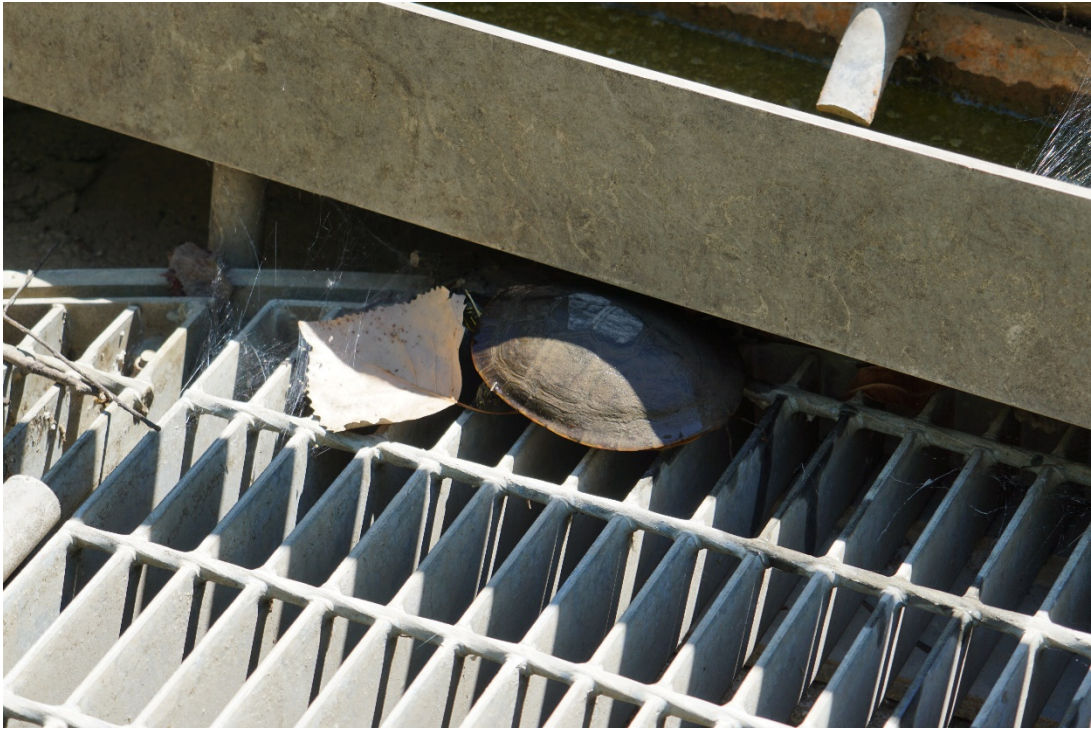
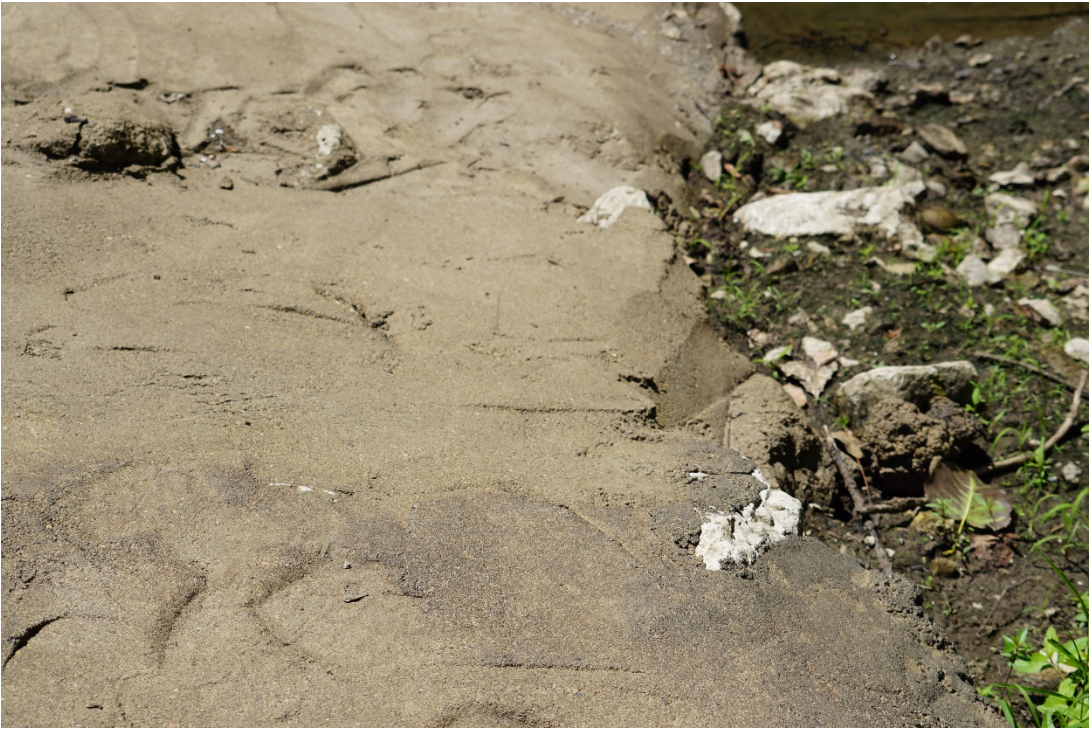
Stoplog Structure A

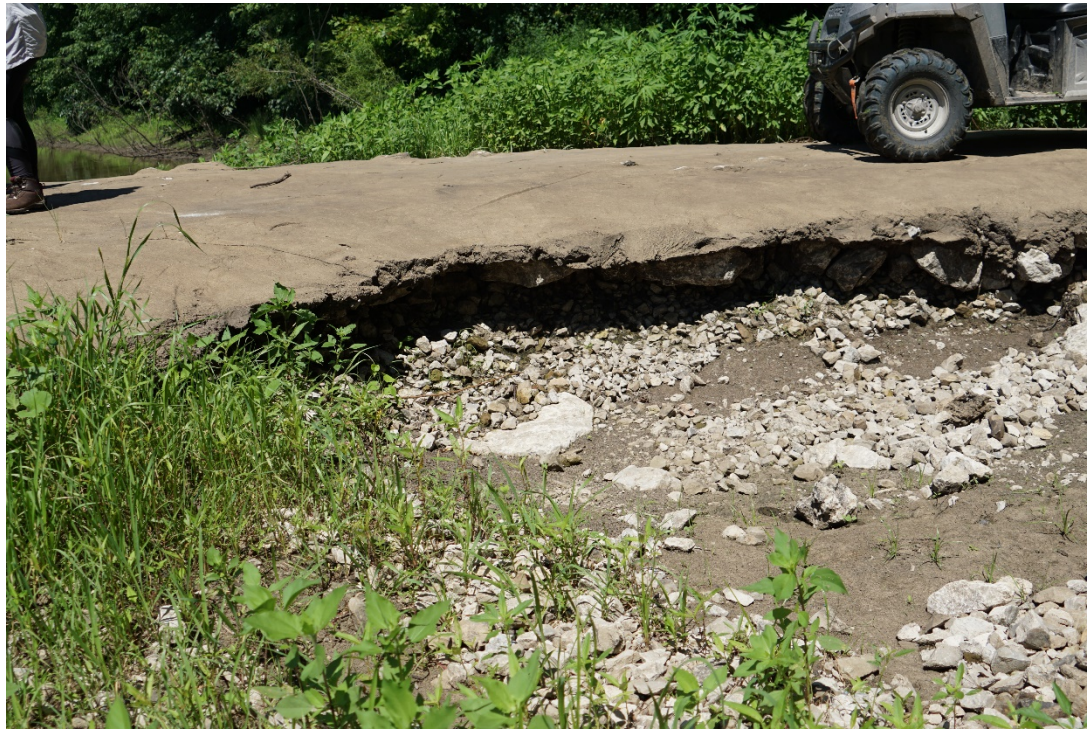
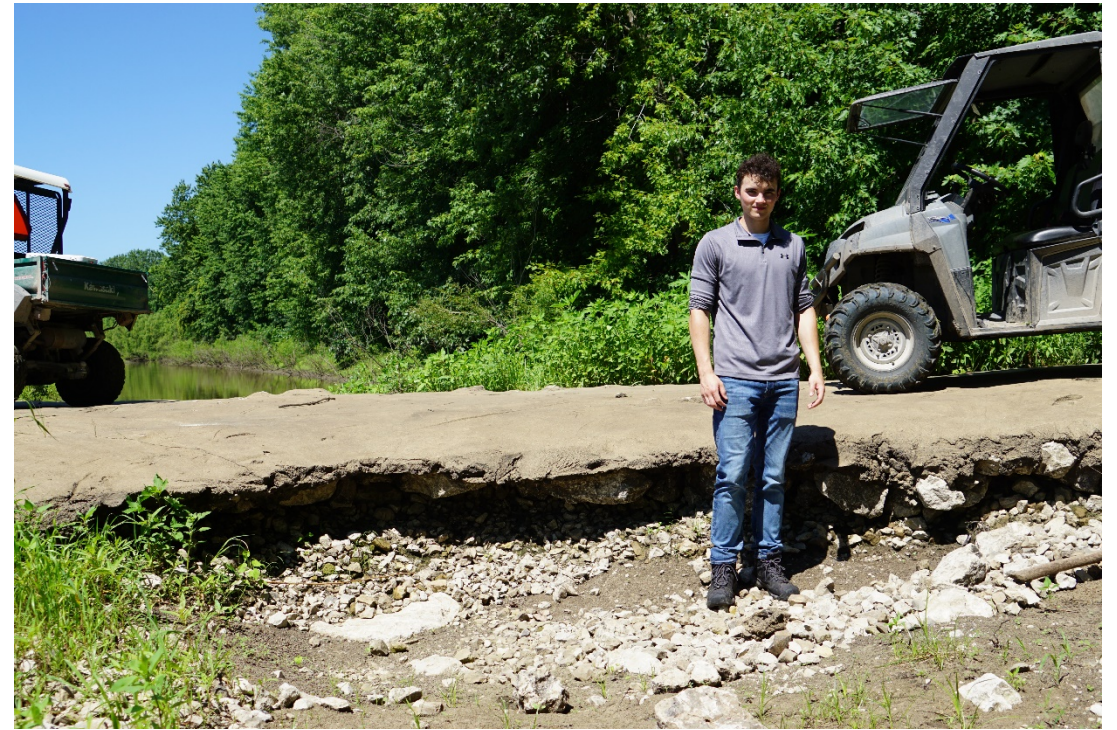
Stoplog Structure B. Significant erosion noted adjacent to the structure. Prolonged erosion could create a connection between the channels and eliminate the ability for water level management in this location. Recommend that riprap be placed along this bank to match the slope on the opposite side of the structure. If trucks carrying riprap cannot access the site, at a minimum, recommend excavating the fill in the channel and placing that fill in the eroded location. Seed the fill. Note that this is a temporary fix, and erosion in the future would be expected with this temporary repair.

Erosion by Road

- Removing sediment building around and in channel culverts.
- Place riprap near eroding berms surrounding stoplog structures B and D.

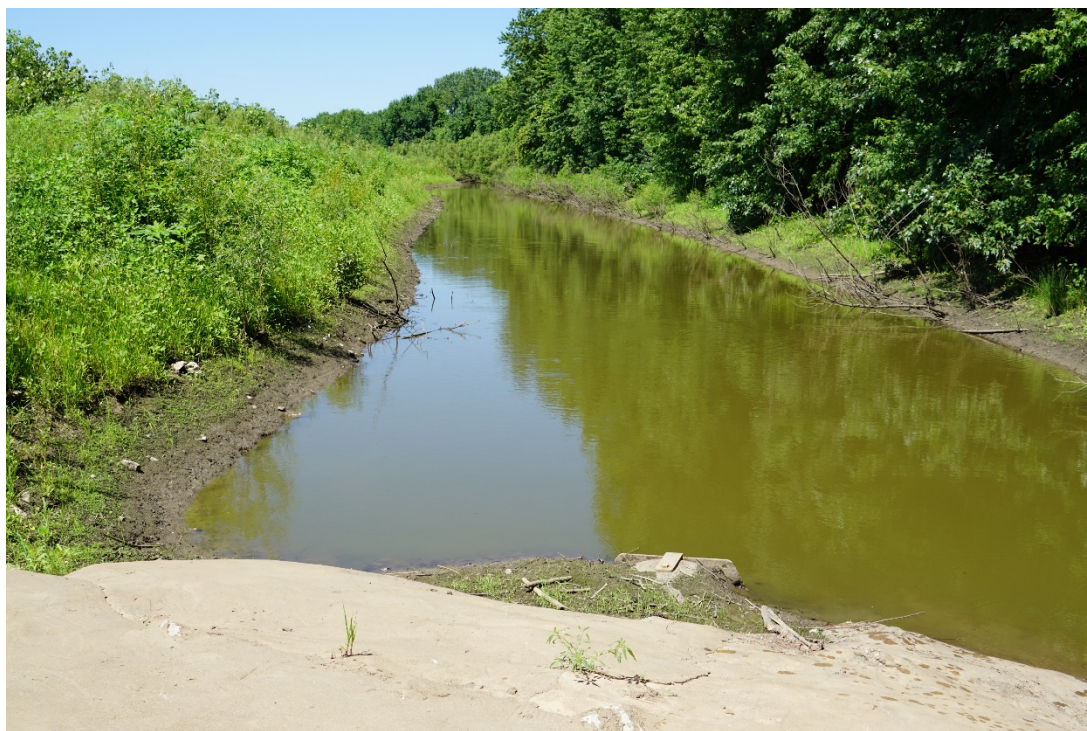
Stoplog Structure B

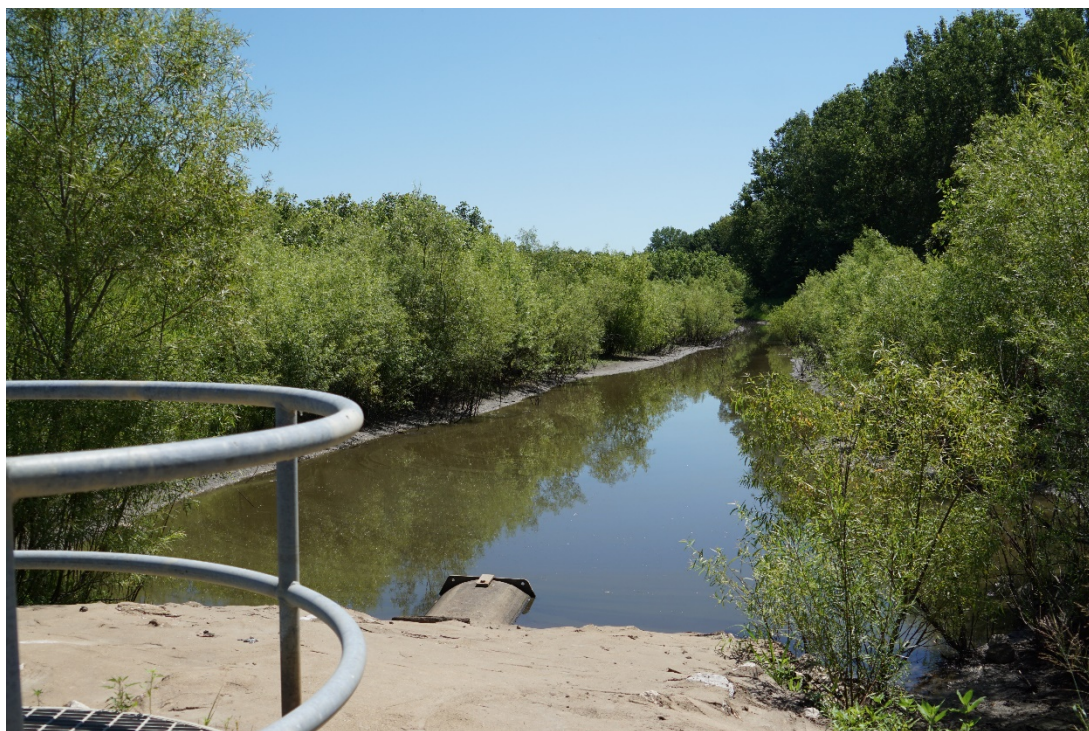
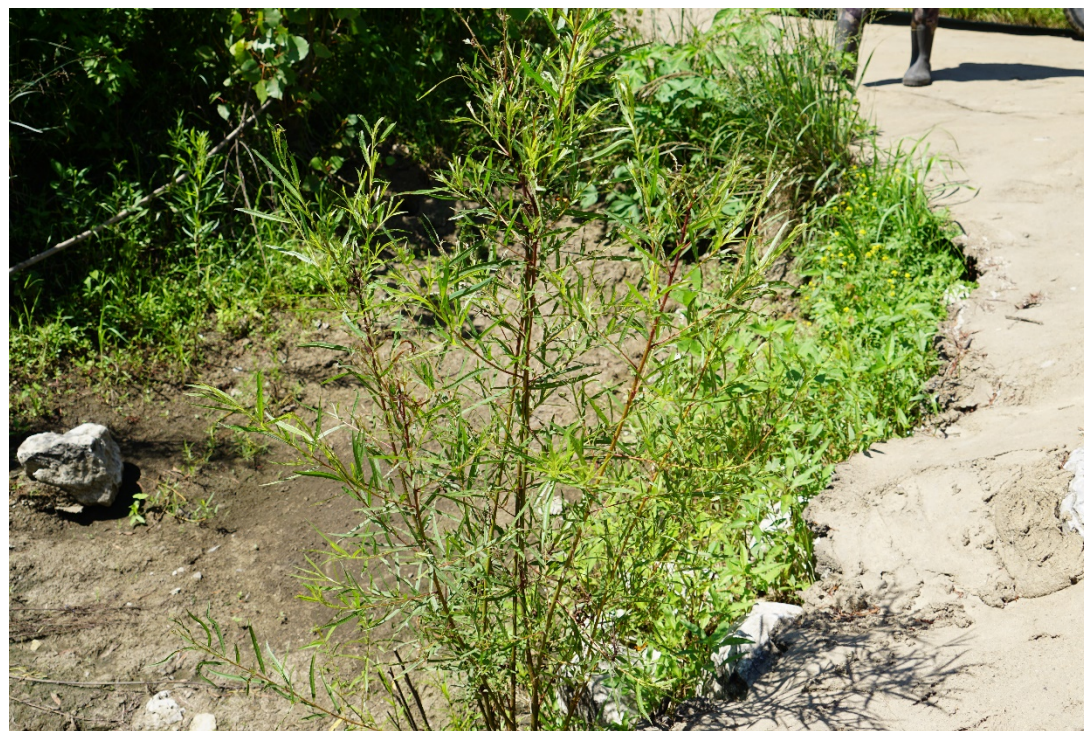
Stoplog Structure D. Minimal erosion noted adjacent to the structure, but the integrity of the structure was not a concern.

Stoplog Structure D

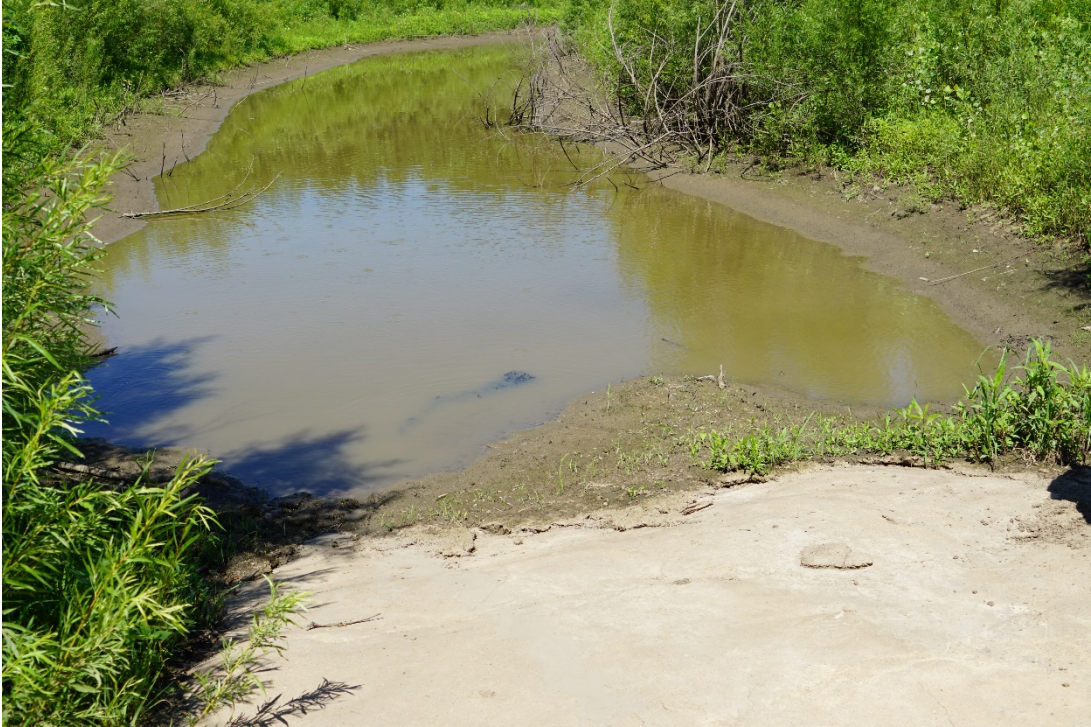
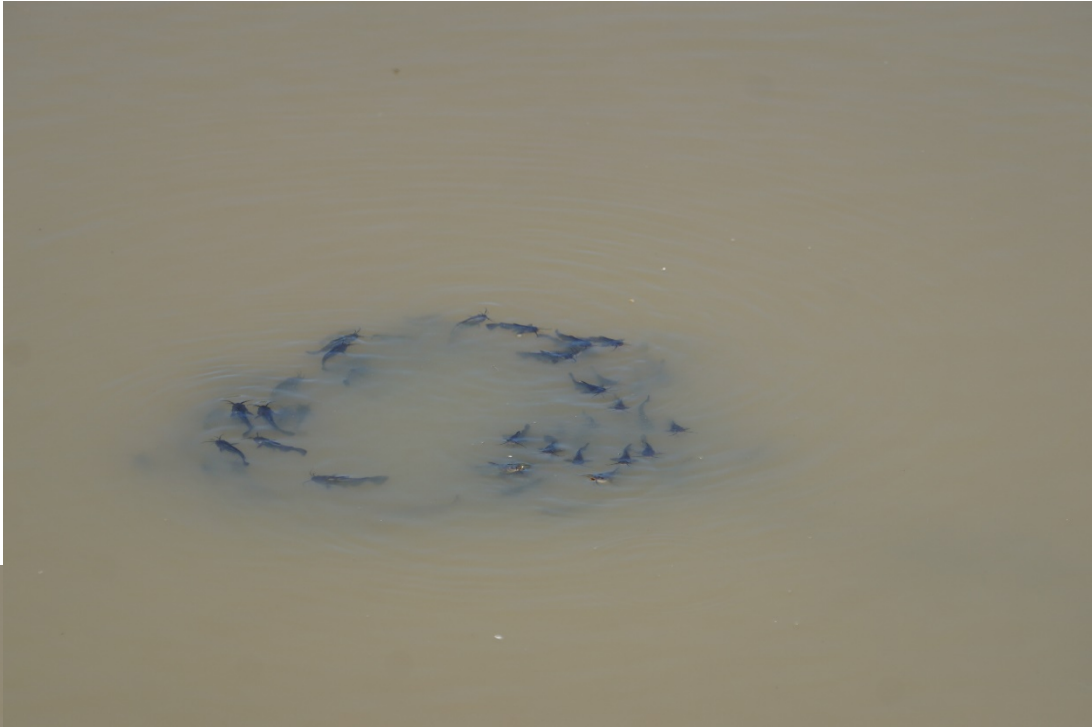
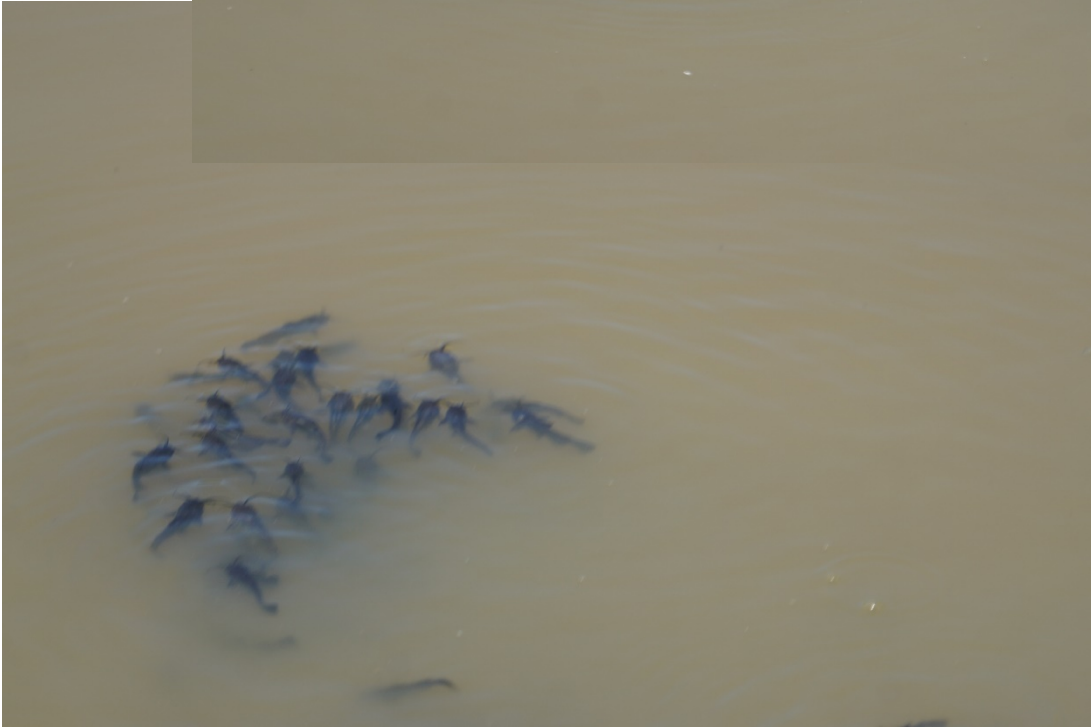
Stoplog Structure D

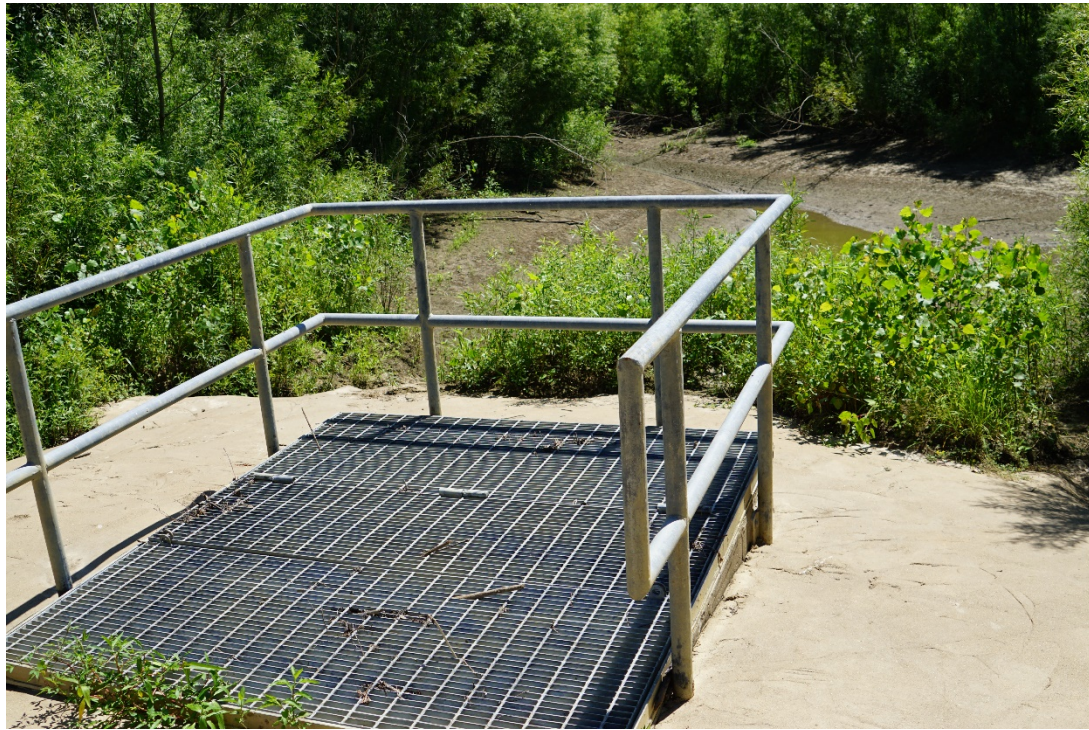
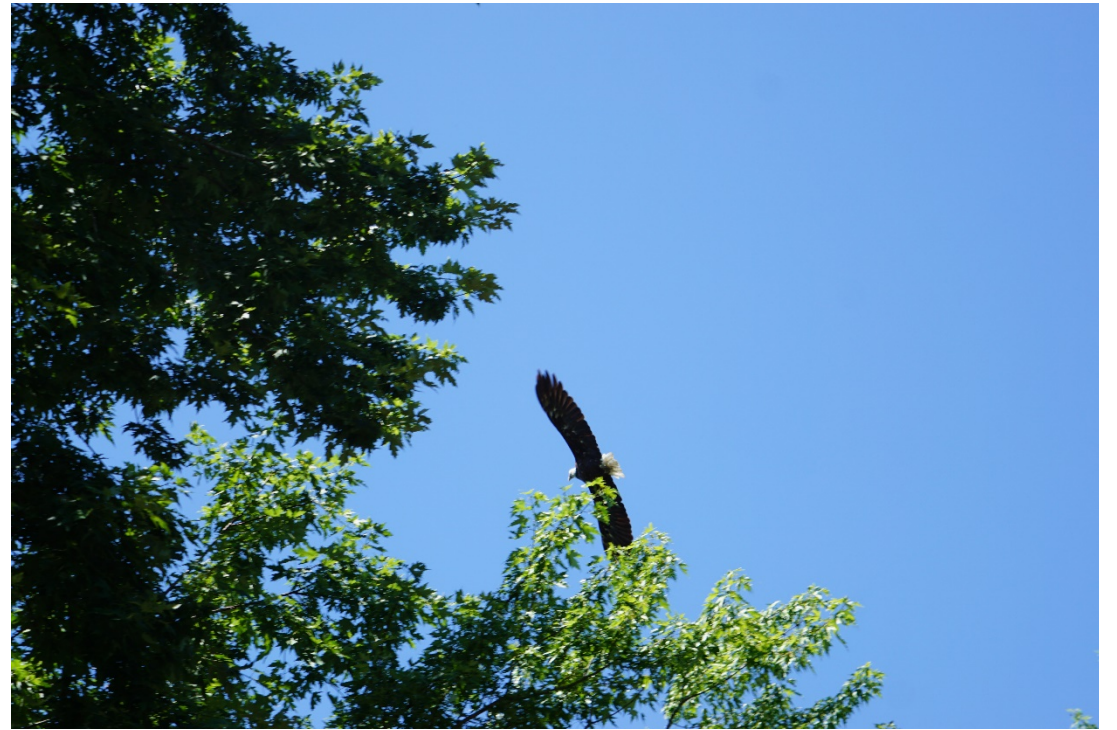
Fox Island Stoplog Structure (C). Fox River Structure: No concerns with the structure, however, the channel opposite the river was significantly sediment in and should be cleared out.

Fox River Structure

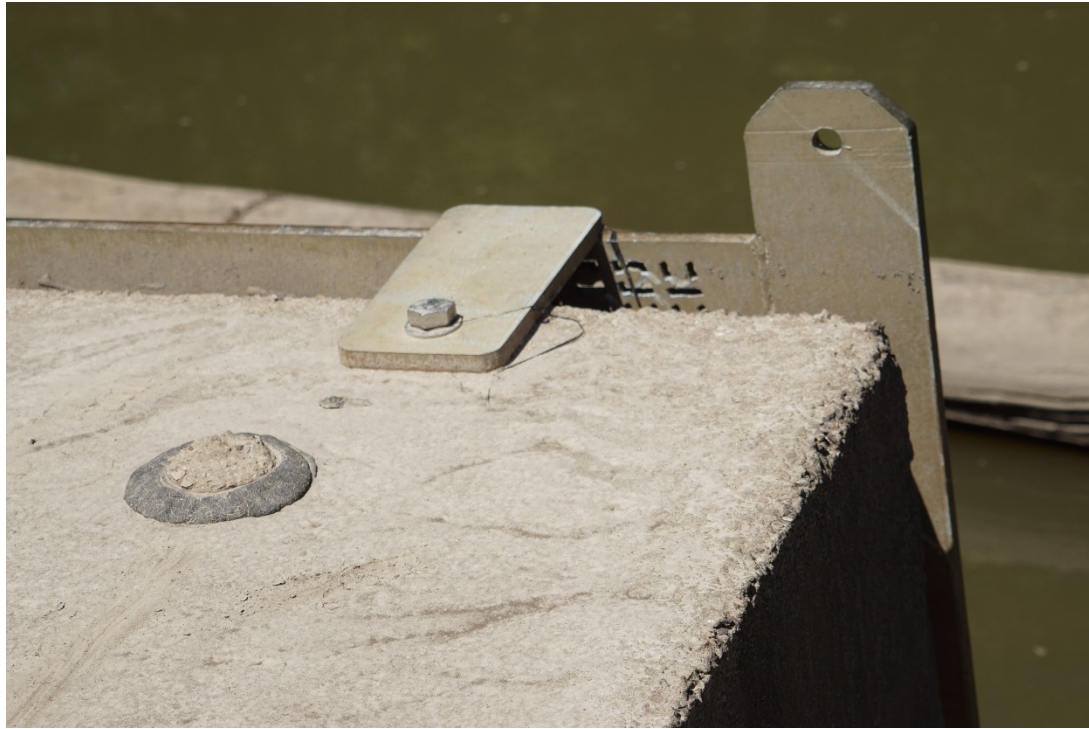
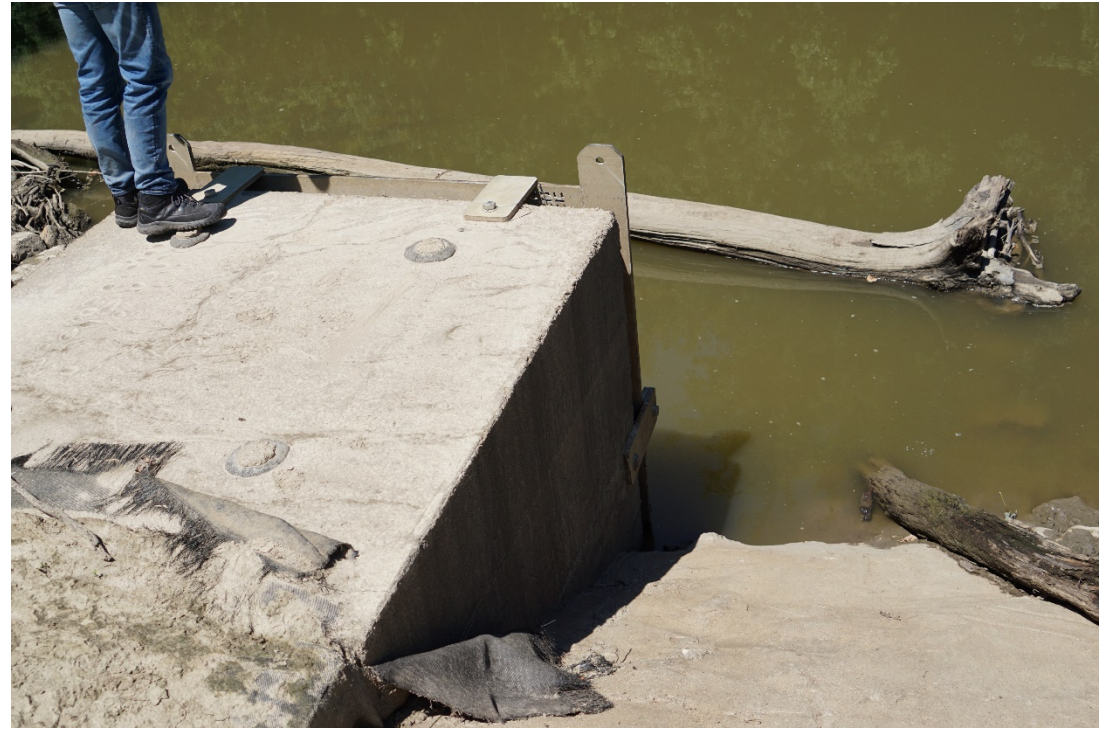
Fox River Stucture

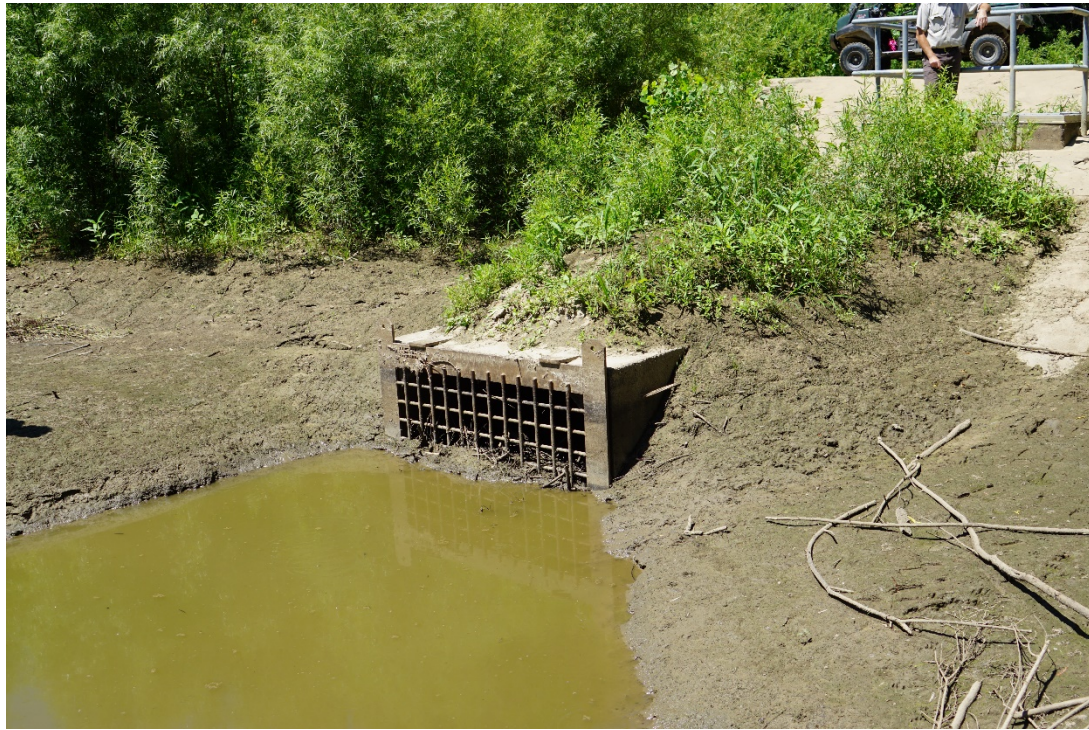
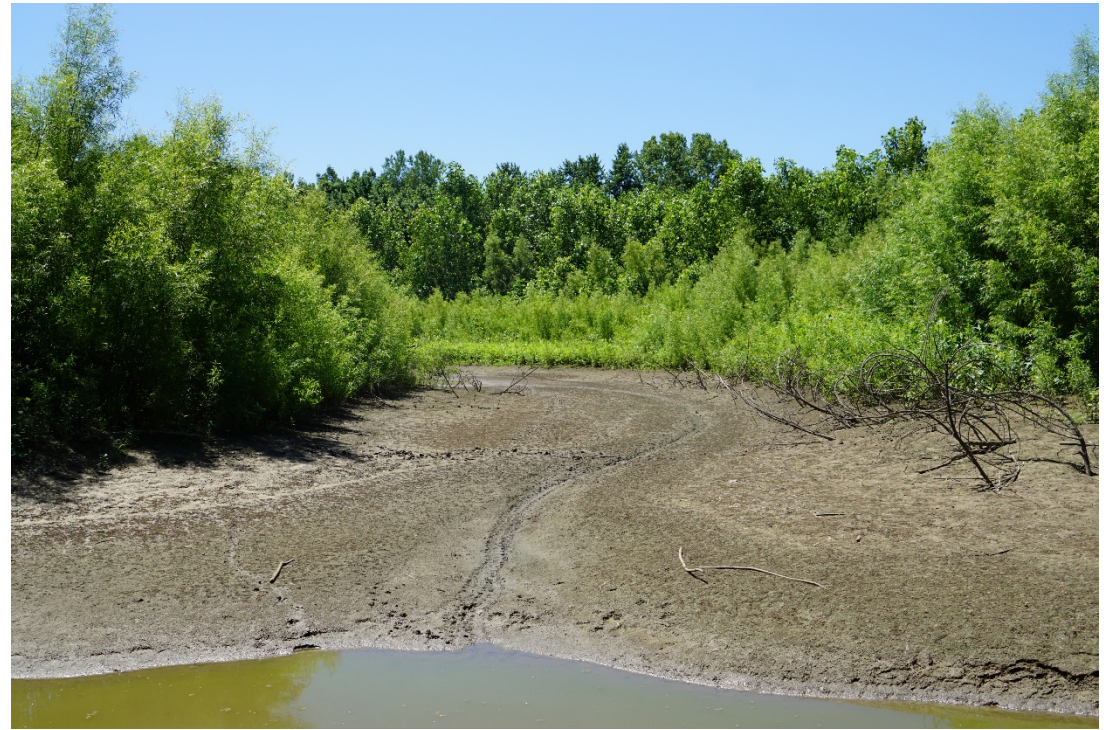
Channel leading into Fox River Structure
