**FOX ISLAND DIVISION
INSPECTION OF COMPLETED WORKS
2020**

Fox Island Division Habitat Rehabilitation and Enhancement Project (HREP)

Pool 20, Upper Mississippi River, Miles 353.6 – 358.5, Clark, Missouri

IX. DATE OF FIELD VISIT: July 23, 2020

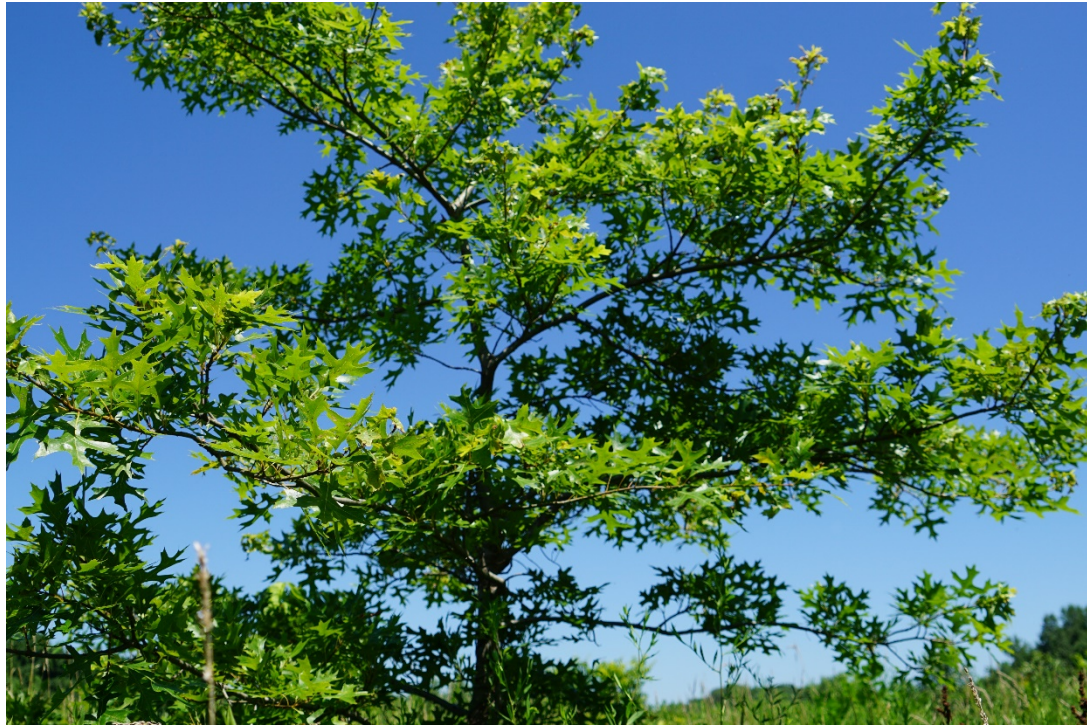
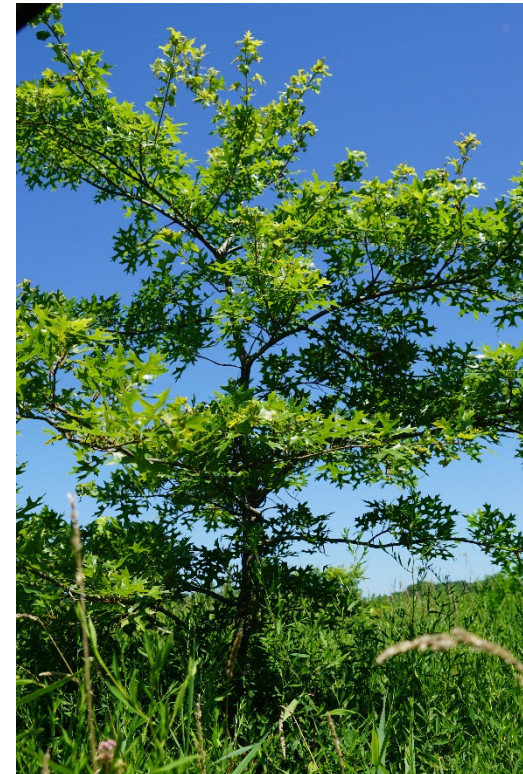
Overcup oak, swamp white oak, pin oak, bur oak, and northern pecan were observed species surviving from the planting efforts. Green ash, eastern cottonwood, black willow, sandbar willow, boxelder, American elm, and silver maple were observed as tree species that have naturally regenerated into the planted areas. Overall, the survival rate appears to now be less than a quarter of the total trees planted; based on observing less surviving trees during this visit in comparison to what was observed during the spring of 2016, which at that time survivorship

was only 33% of total planted trees. Natural regeneration is establishing very well and capturing the planting areas at desirable densities.

Trees!
