SUBJECT: Routine Inspection Stoplogs, Stabilization and Stilling Basins; Fox Island Division HREP, Mississippi River, River Miles 353.6 – 358.5, Clark County, MO.

FOX ISLAND HREP
2016 INSPECTION

ATTACHMENT A

ATTACHMENT B

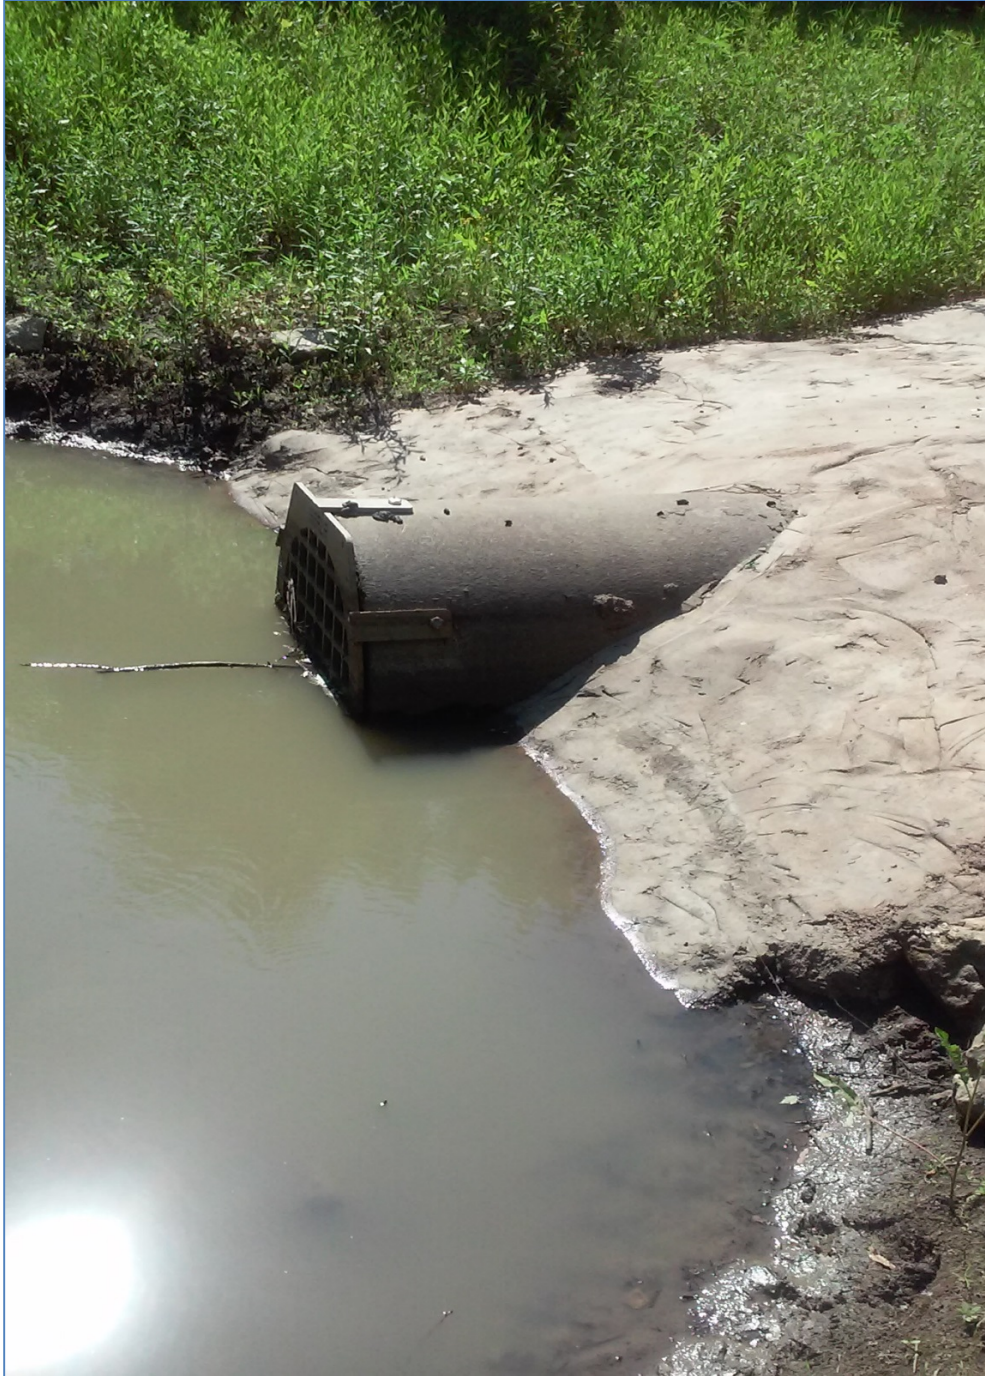
Photo #1 – Stoplog A, upstream gate.

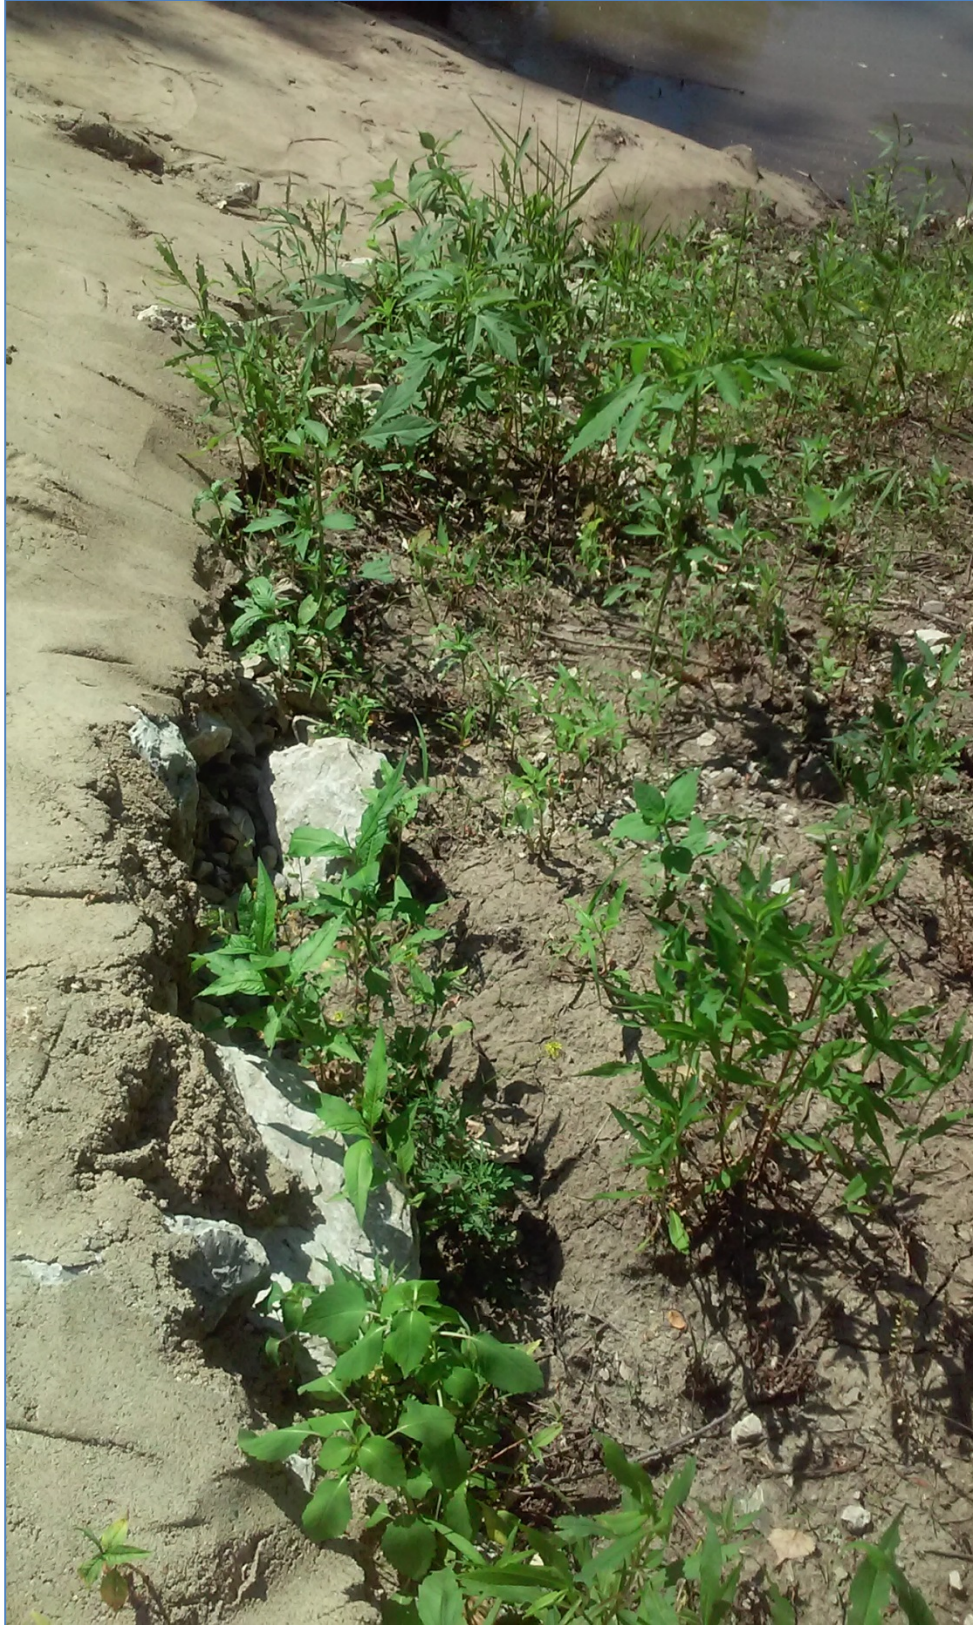
Photo #2 – Stoplog A, edge of riprap/concrete apron.

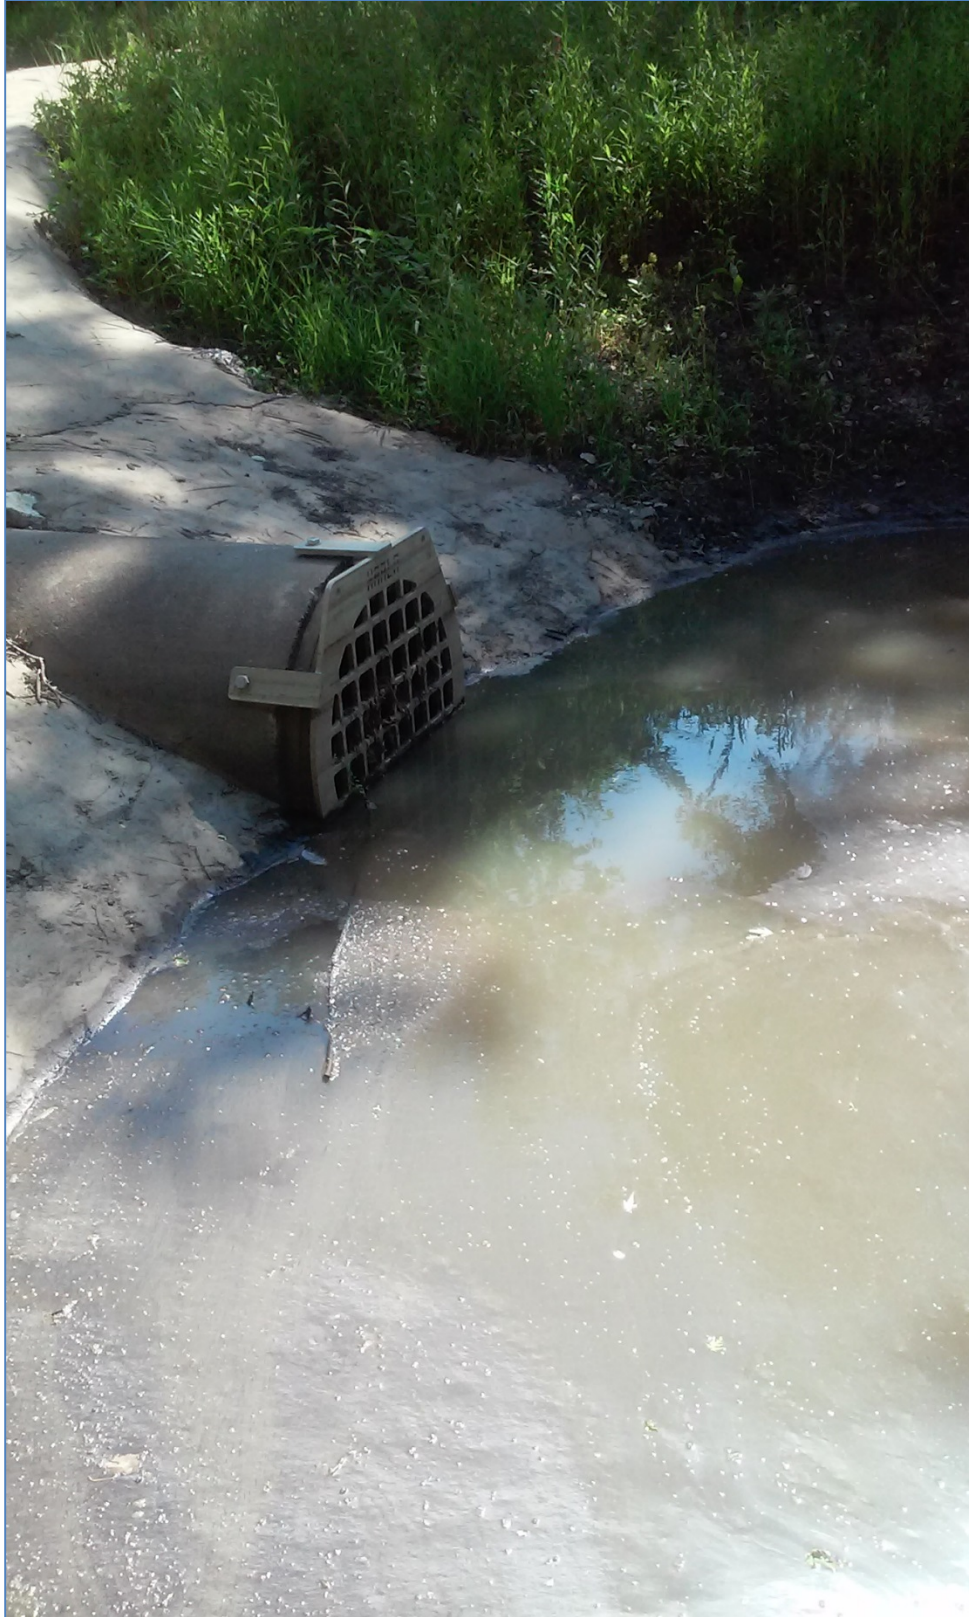
Photo #3 – Stoplog A, downstream gate.

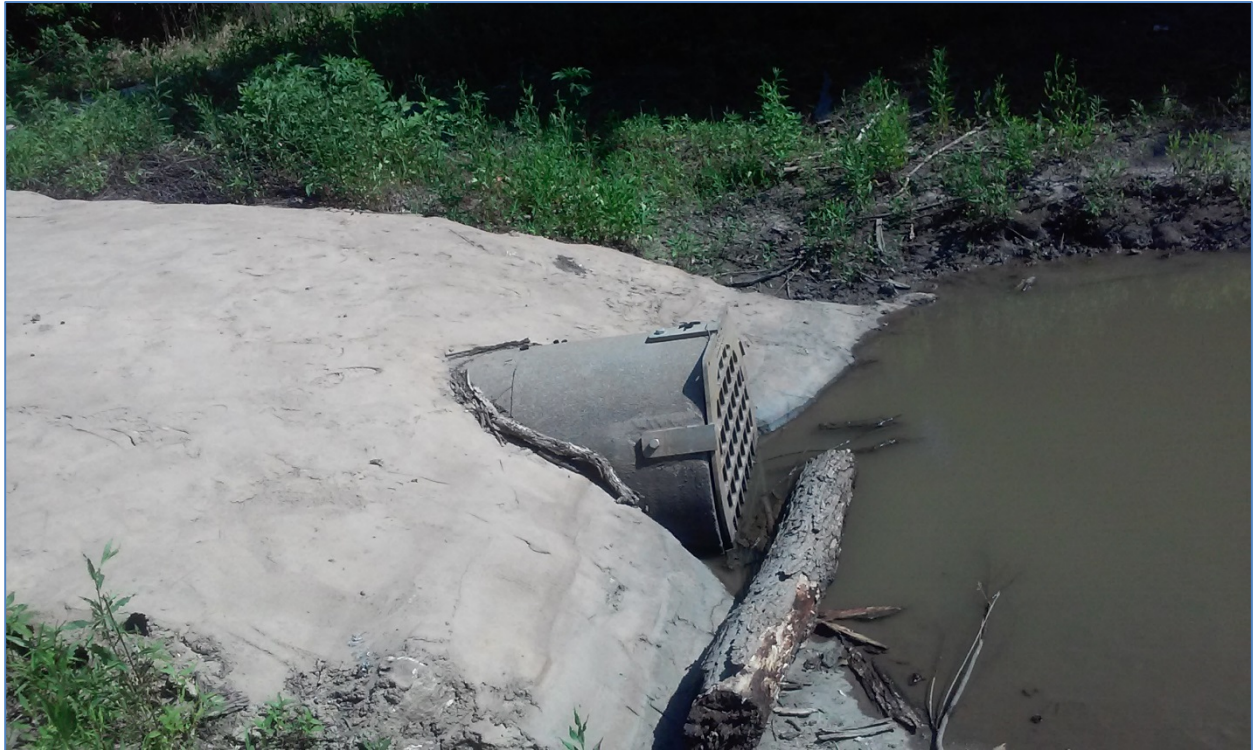
Photo #4 – Stoplog B, upstream gate, debris in front of gate.

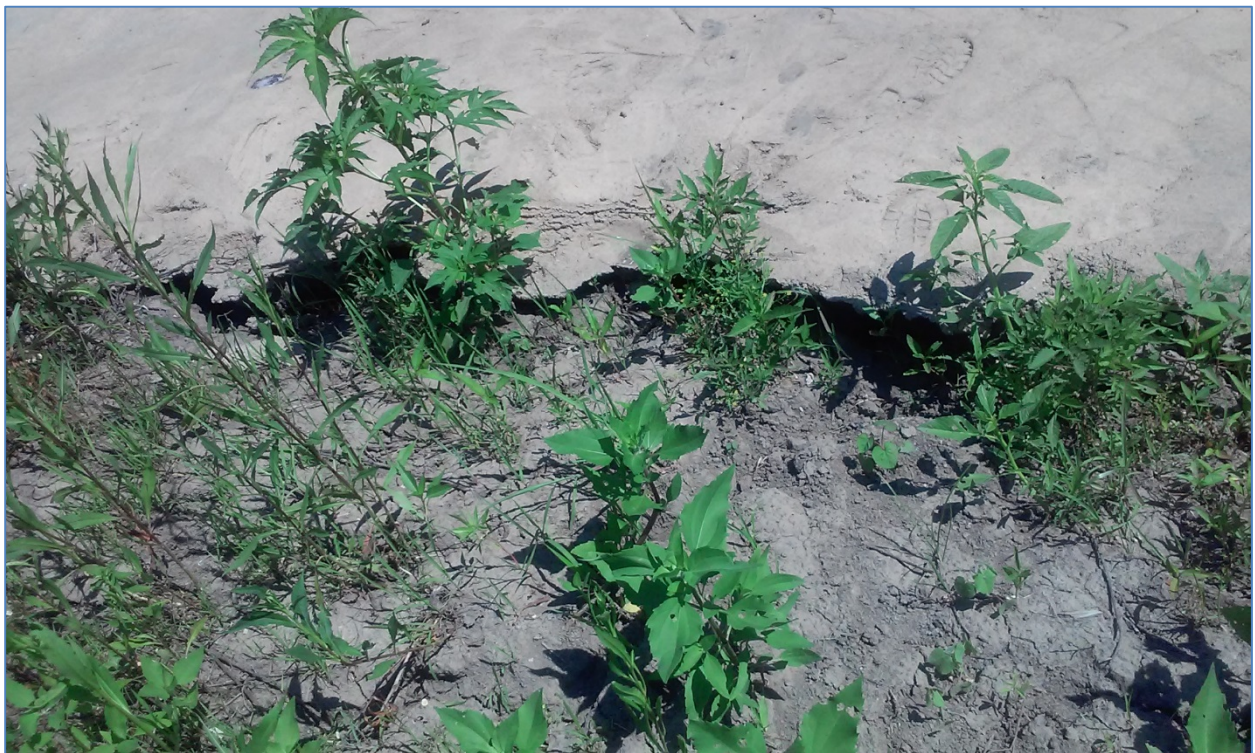
Photo #5 – Stoplog B, erosion at edge of riprap/concrete apron.

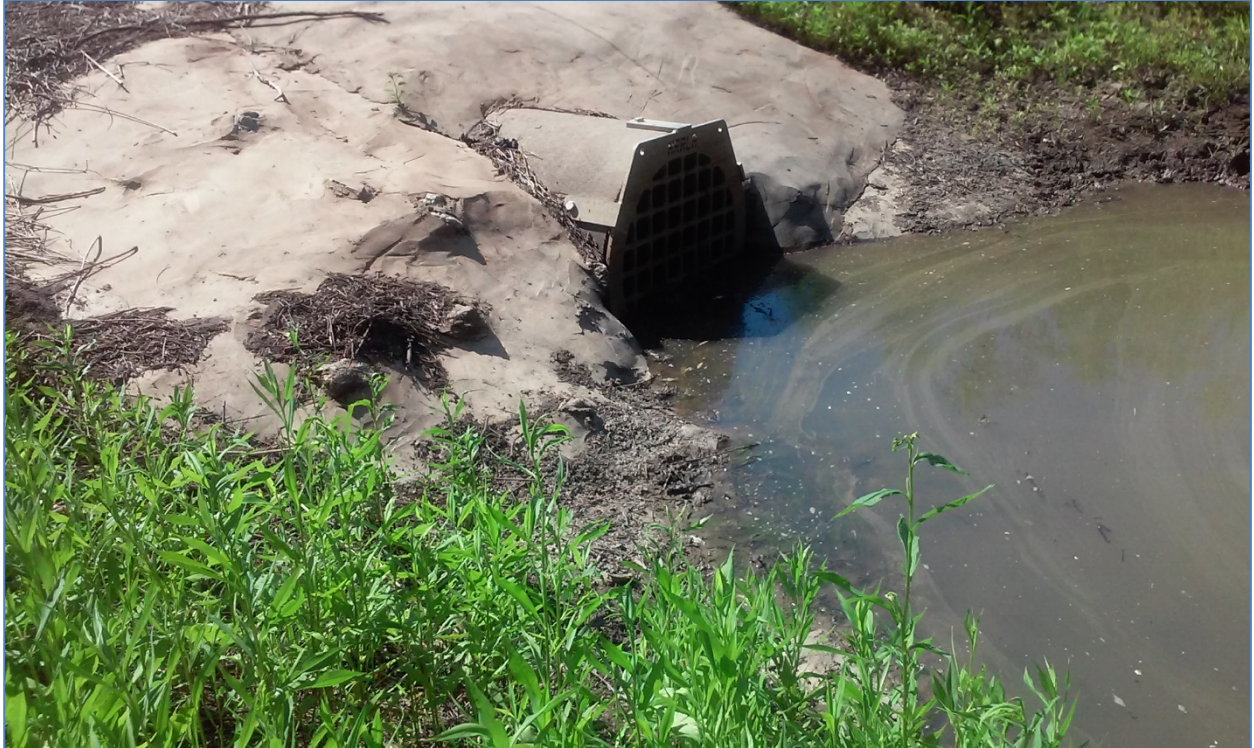
Photo #6 – Stoplog B, downstream gate.

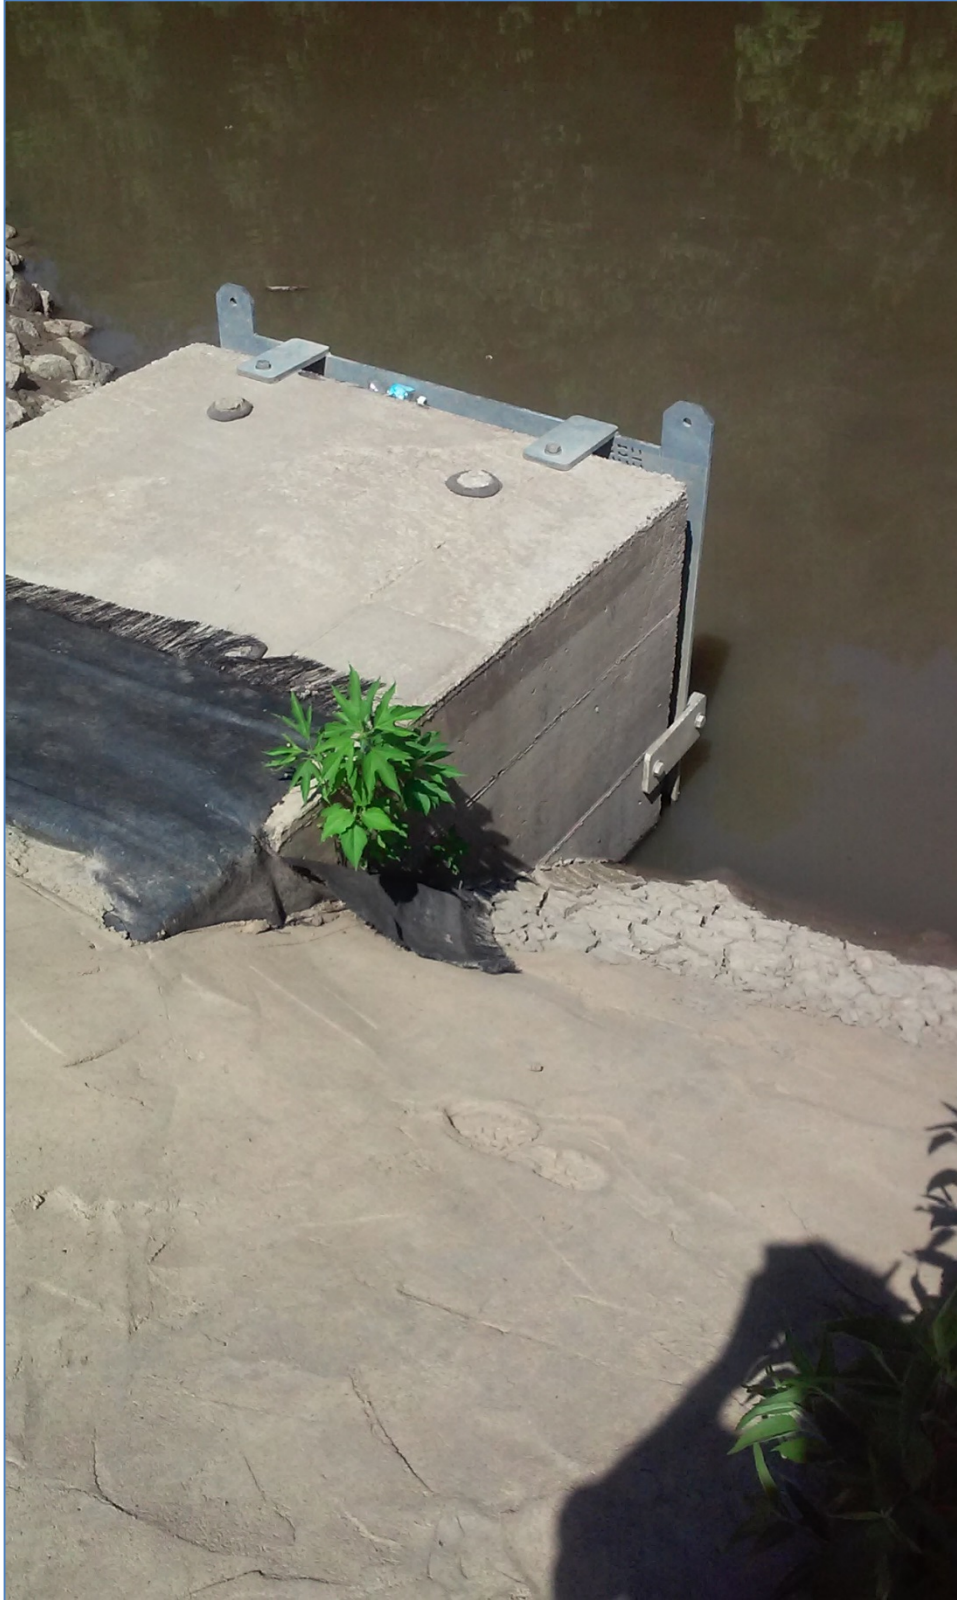
Photo #7 – Stoplog C, downstream gate.

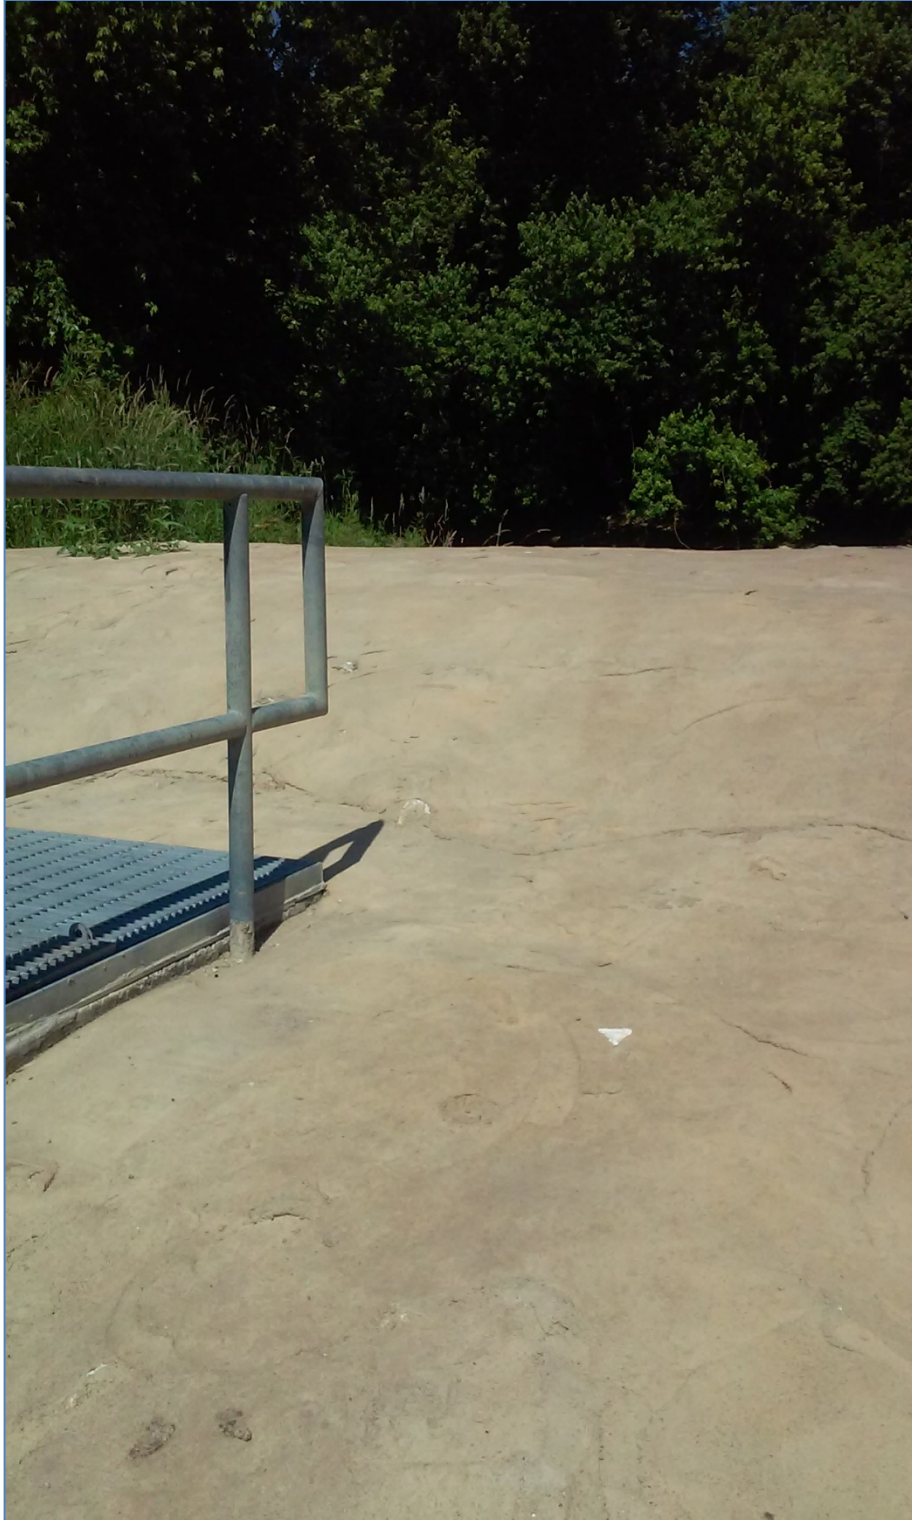
Photo #8 – Stoplog C, riprap/concrete apron and railing.

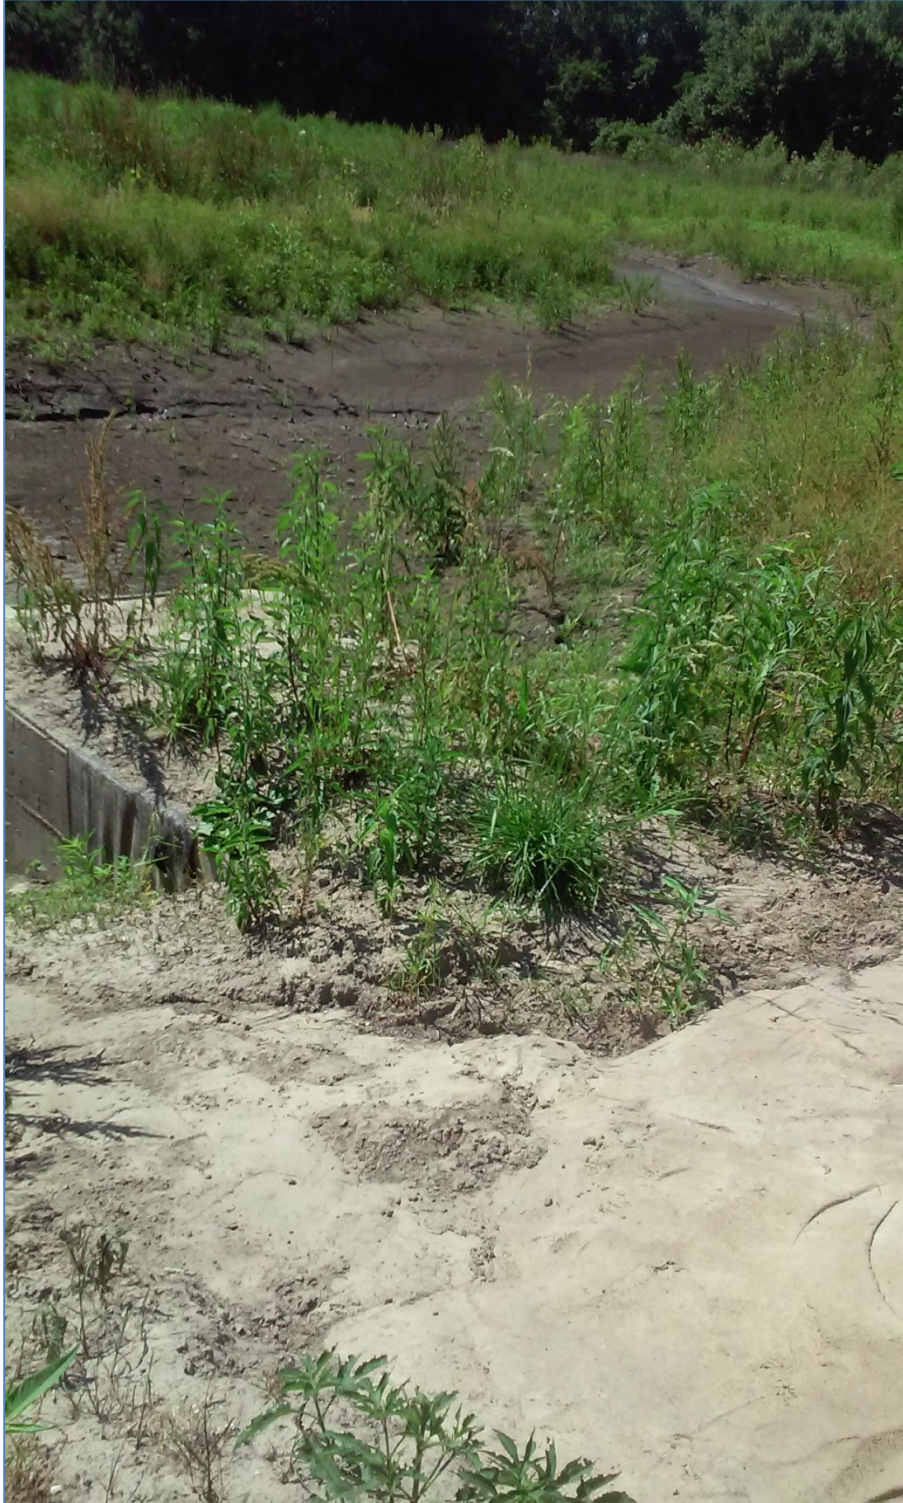
Photo #9 – Stoplog C, upstream gate. Sediment deposition and vegetation growth.

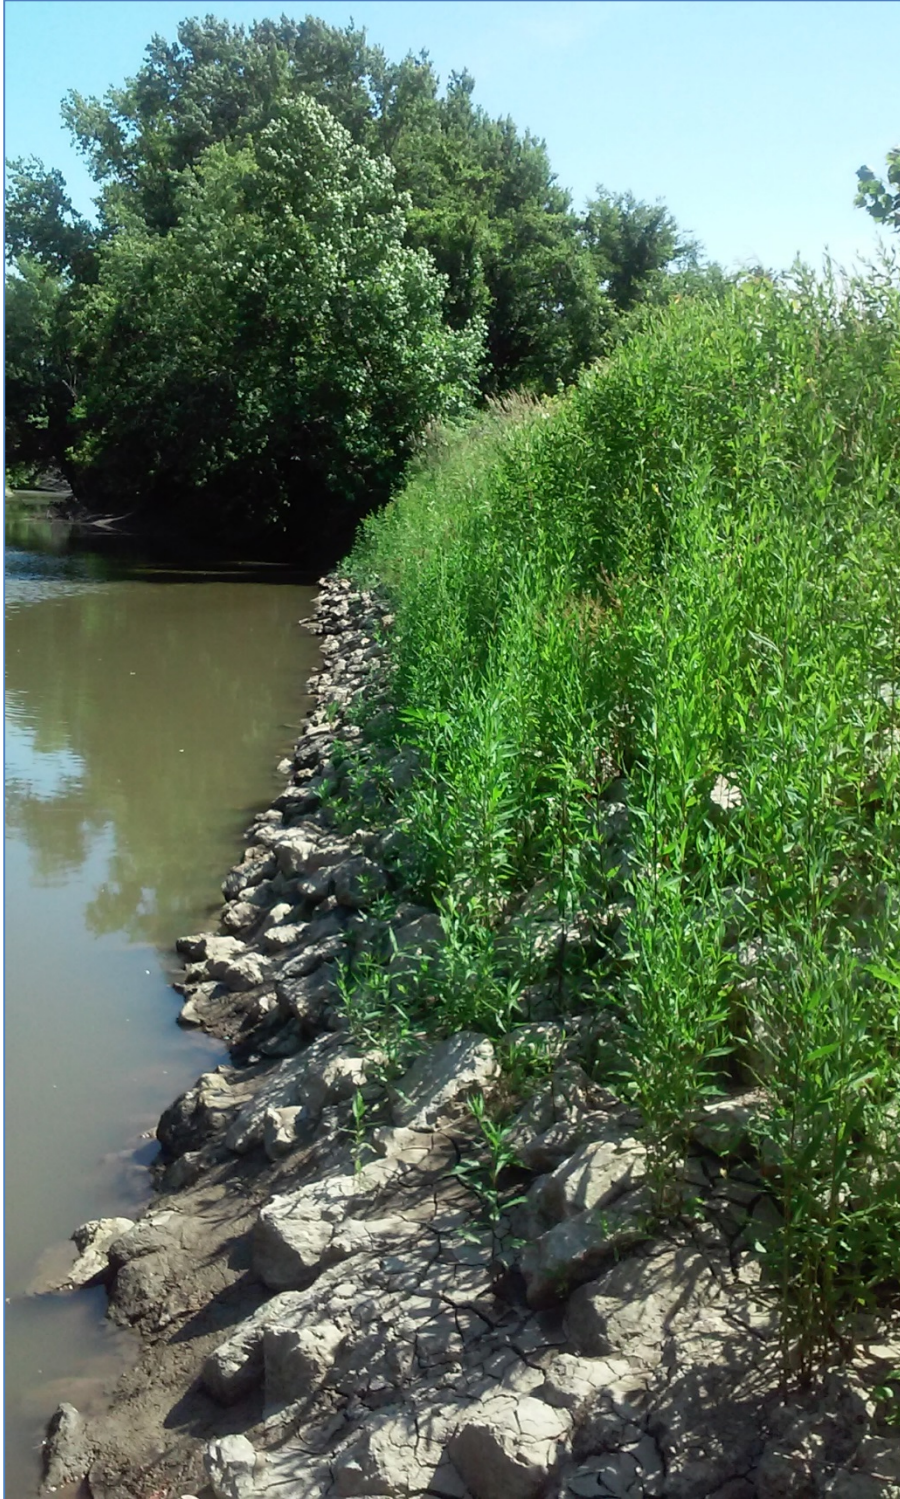
Photo #10 – Riprap upstream of Stoplog C. Moderate vegetation in riprap.

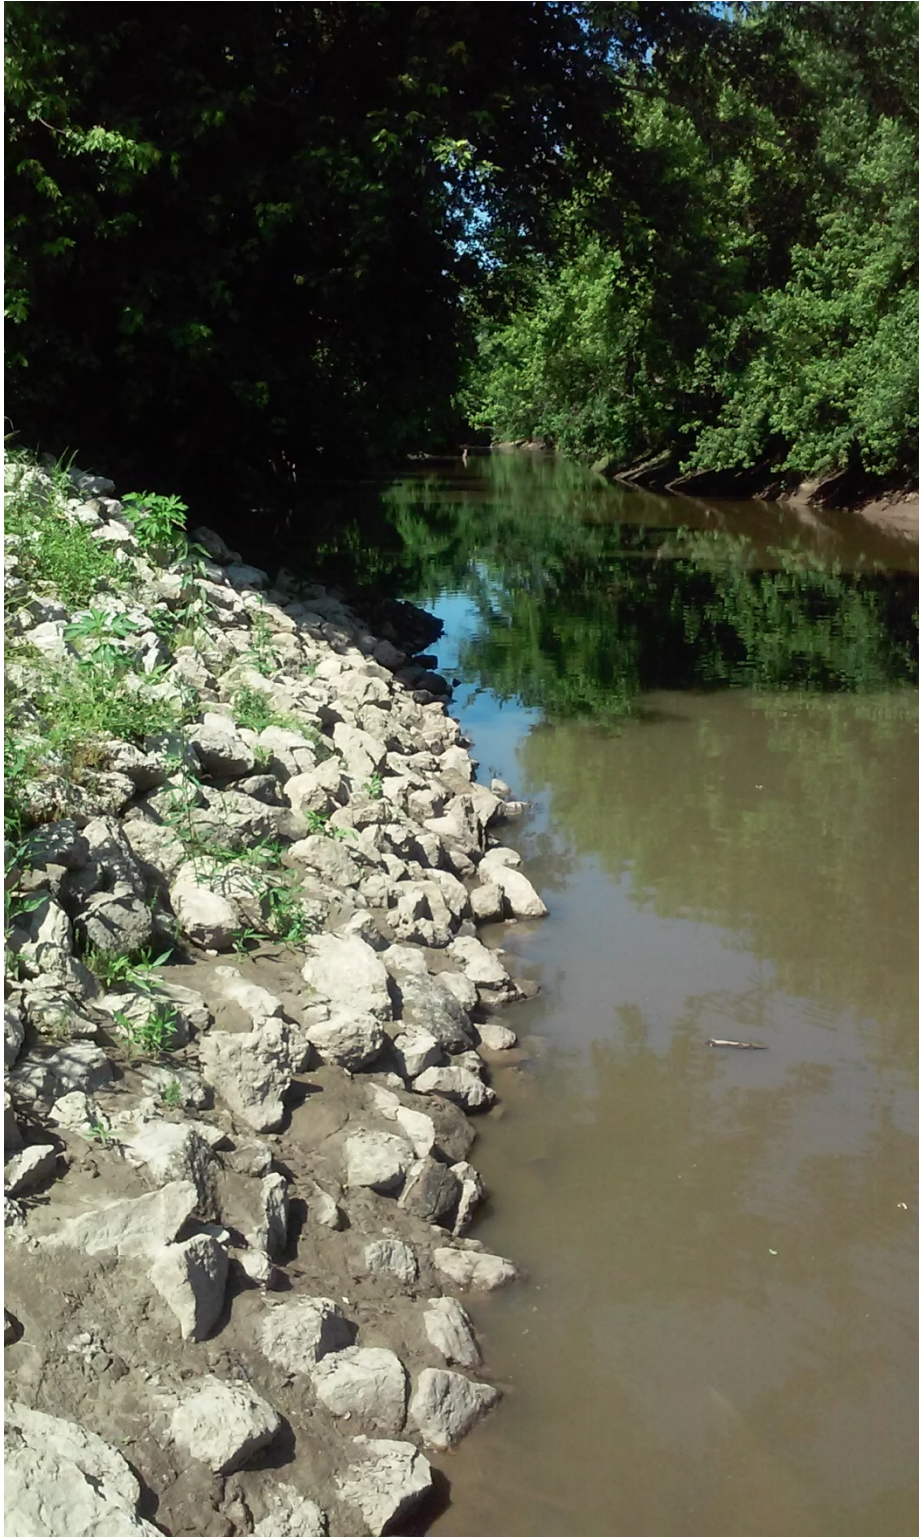
Photo #11 – Riprap downstream of Stoplog C. Some vegetation present.

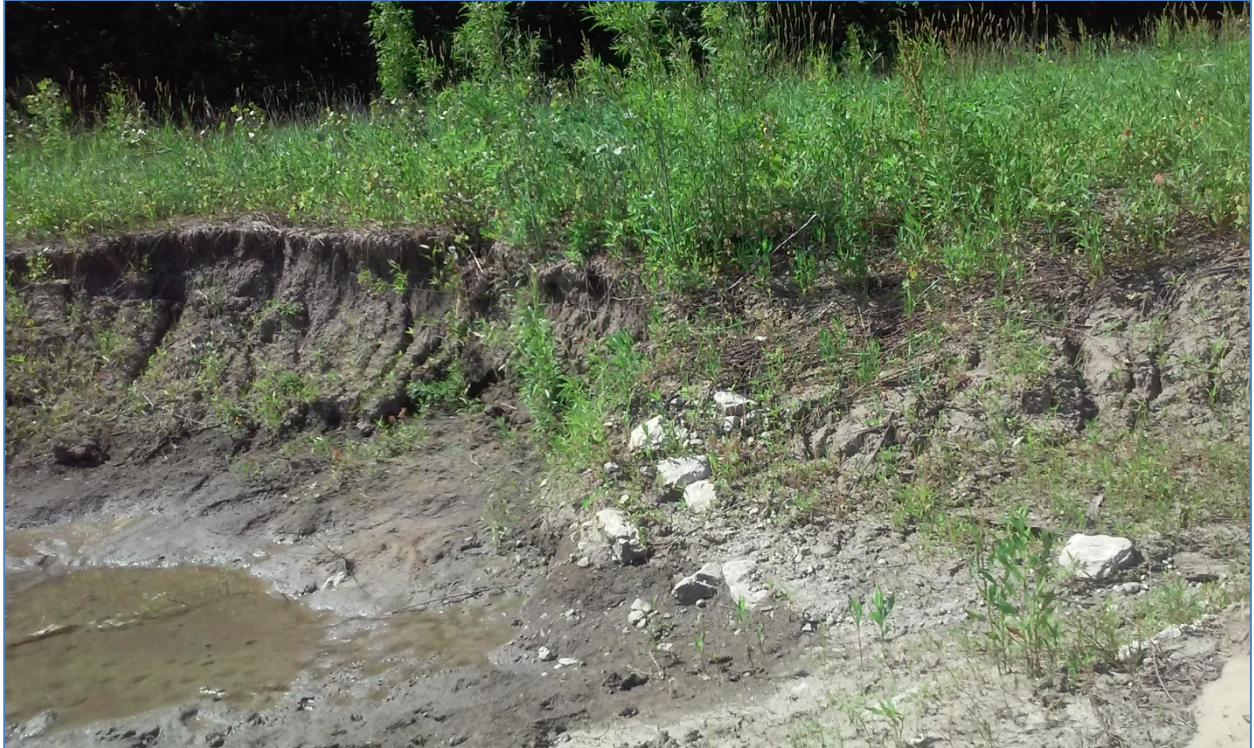
Photo #12-Stoplog D, left descending bank erosion, upstream of stoplog.

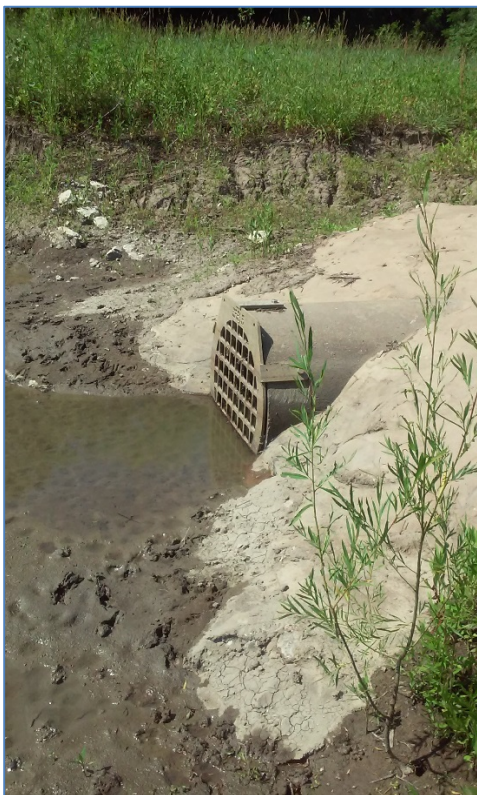
Photo #13-Stoplog D, upstream gate, bank erosion in background.

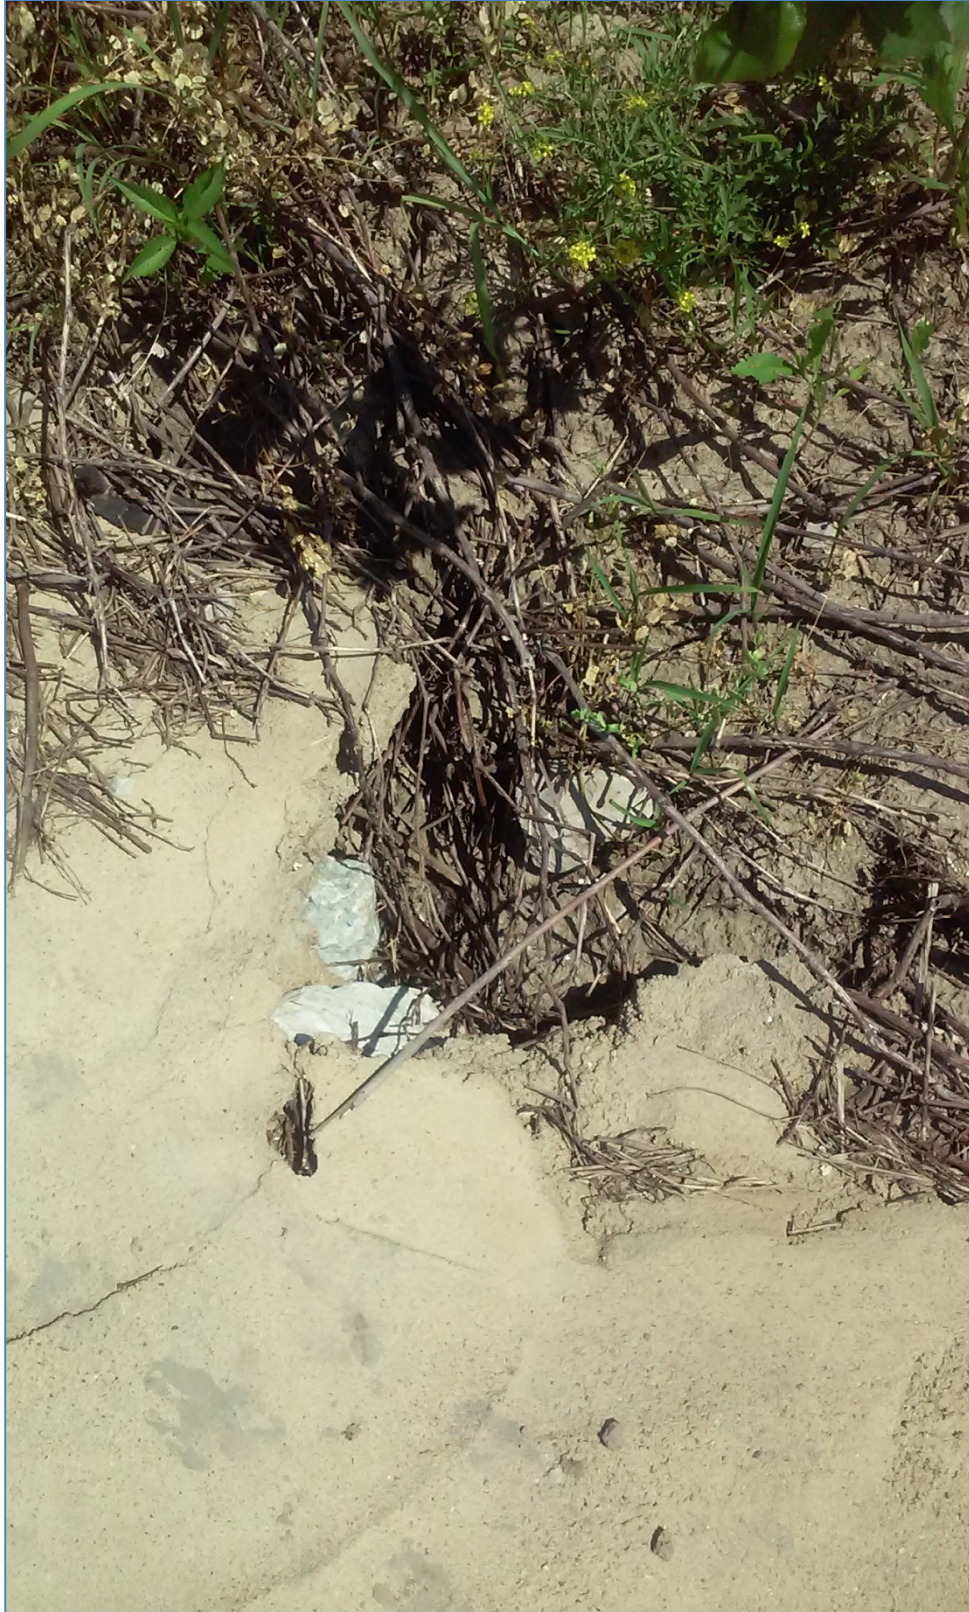
Photo #14-Stoplog D, erosion on edge of riprap/concrete apron.

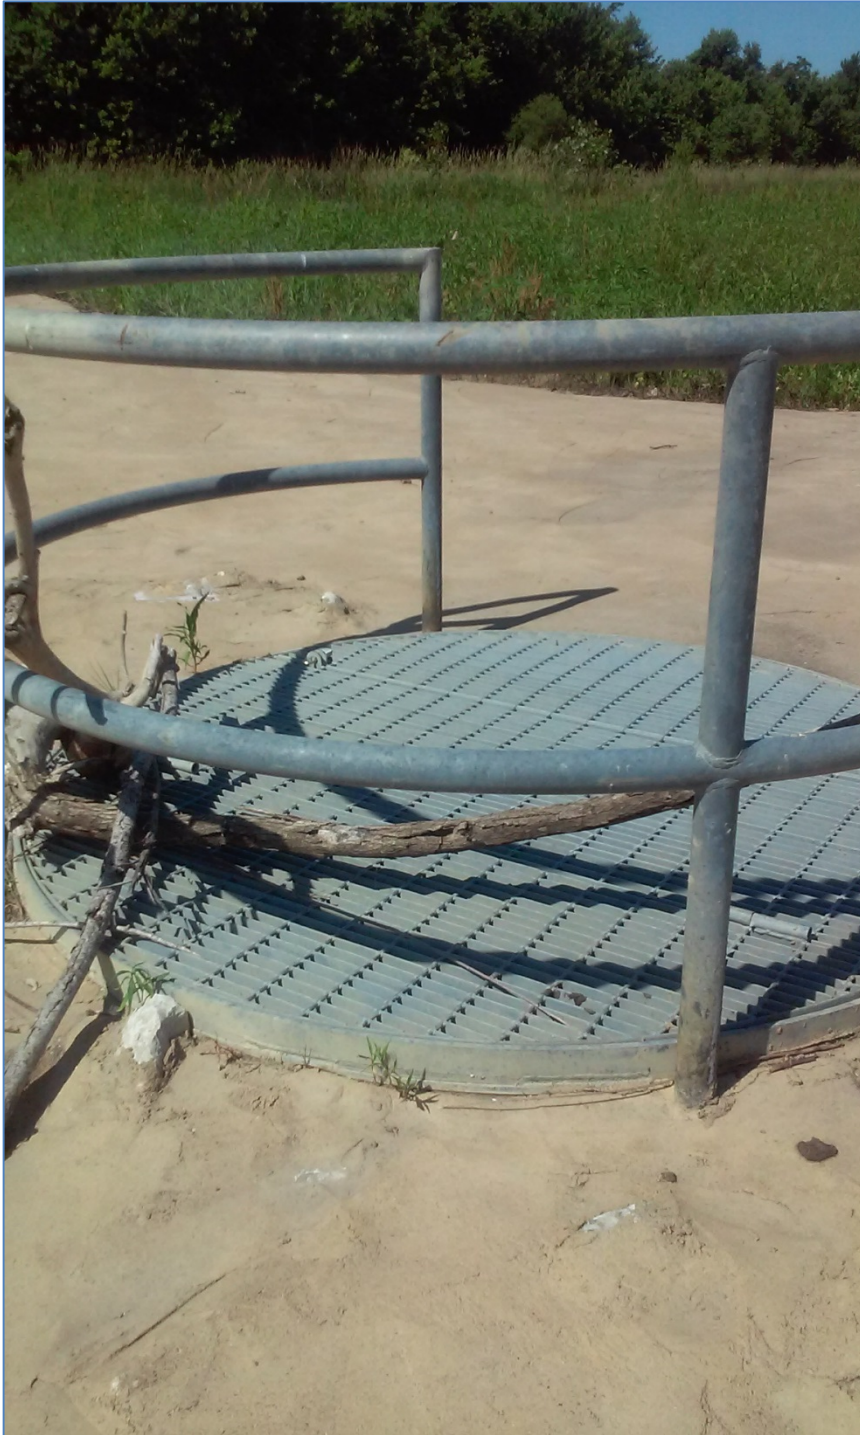
Photo #15 – Stoplog D, debris in railing.

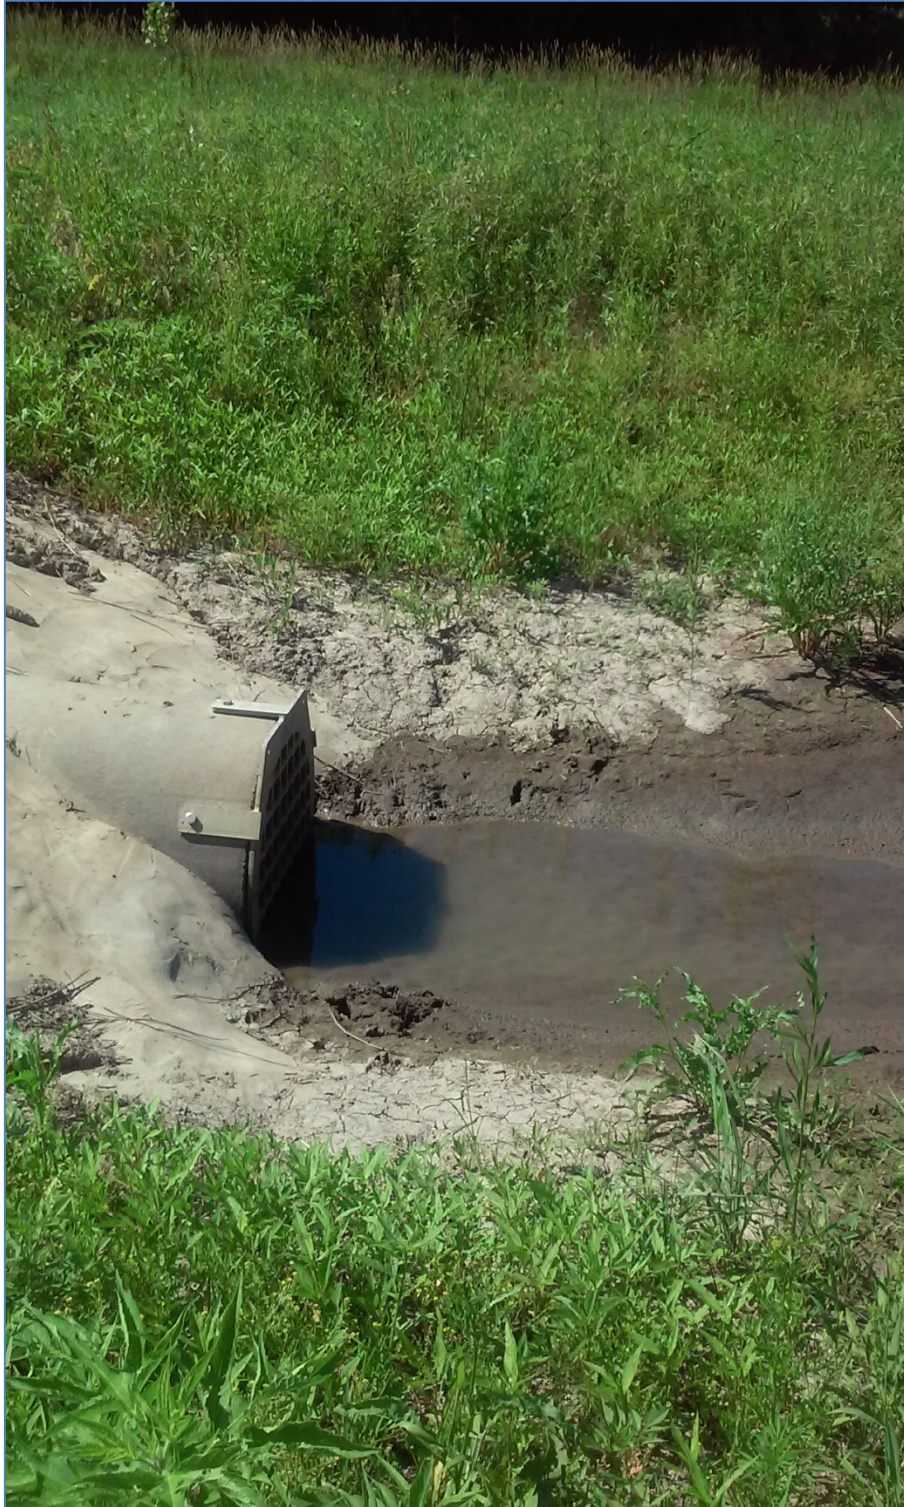
Photo #16 – Stoplog D, downstream gate, some erosion on either side.

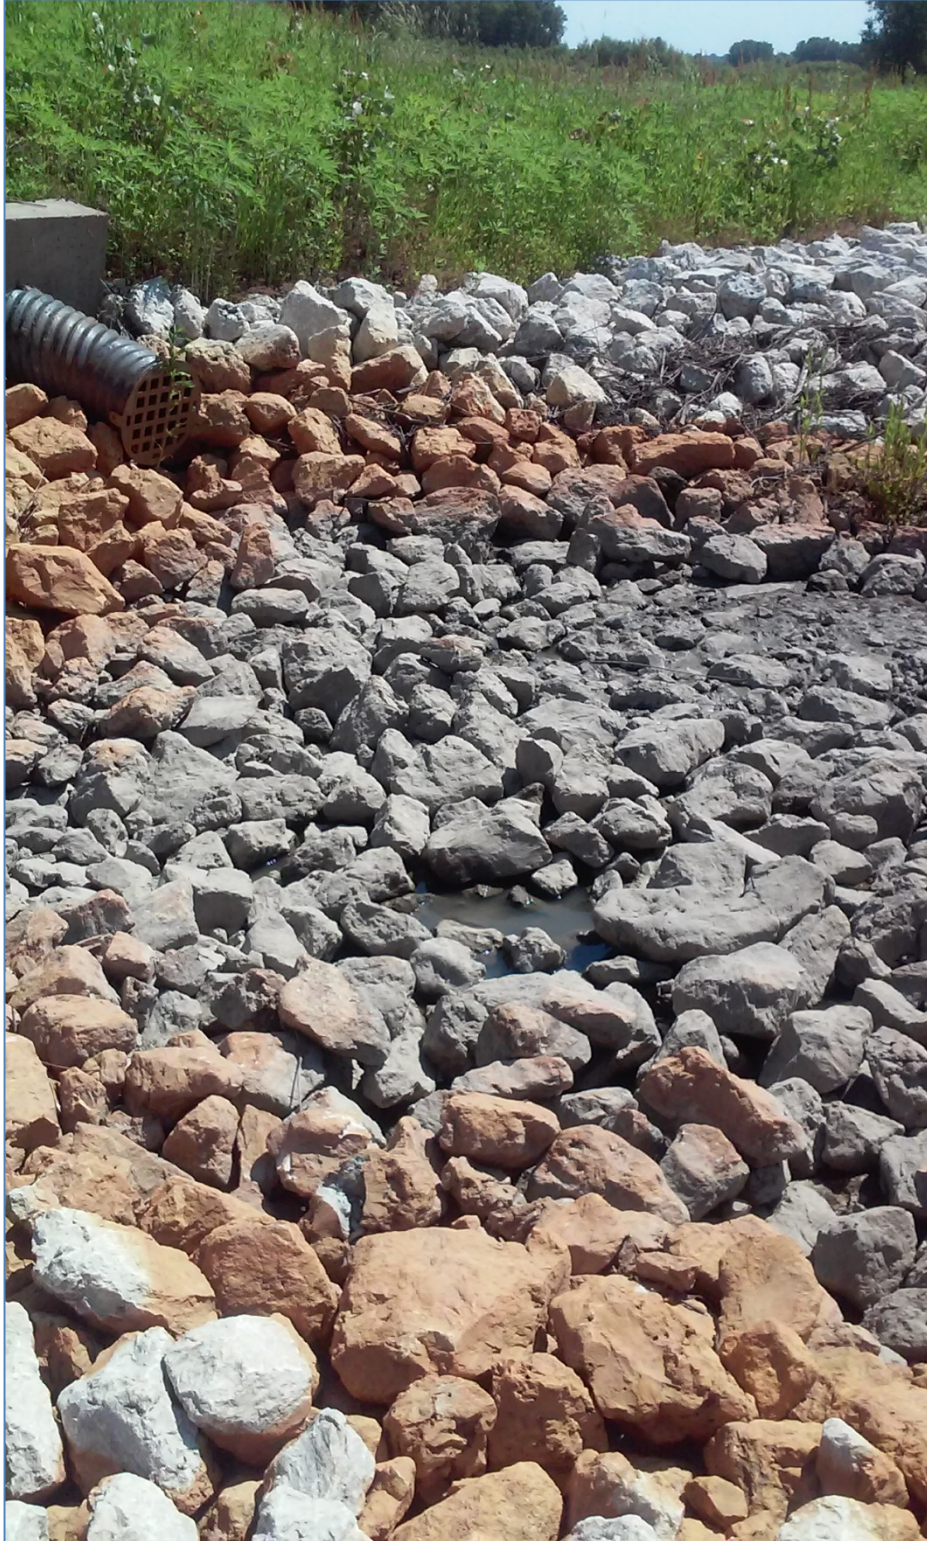
Photo #17 – Well H stilling basin.

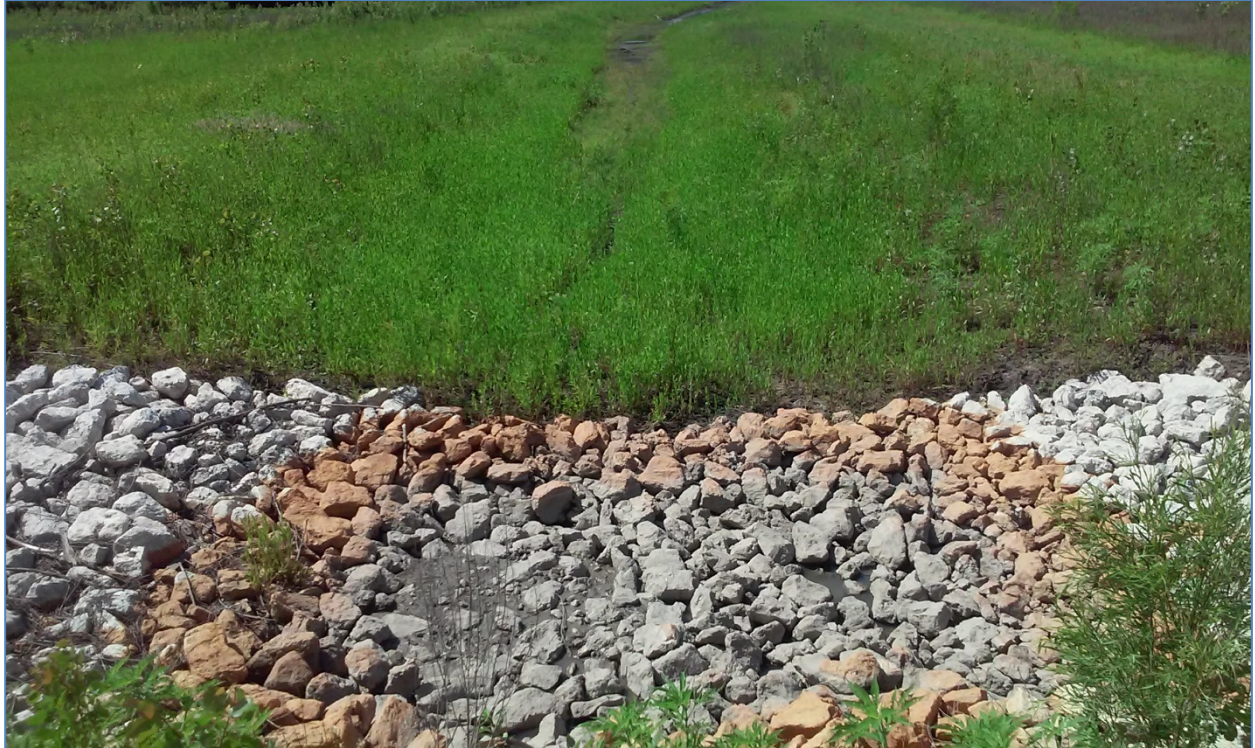
Photo #18 – Well H stilling basin looking downstream.

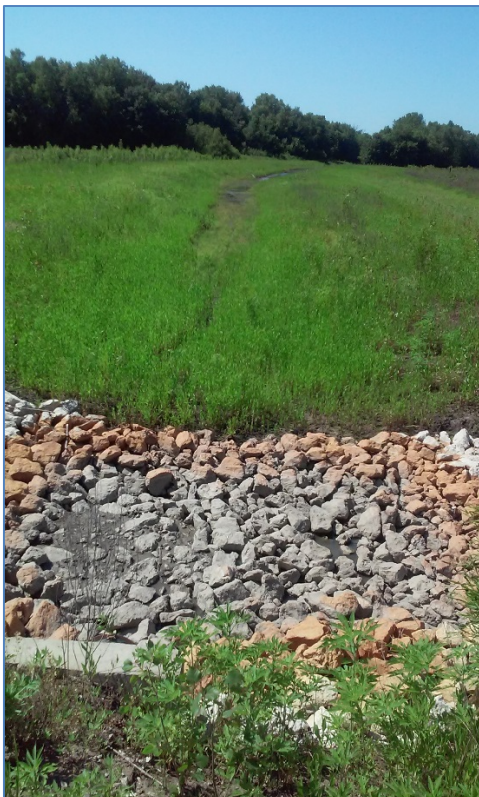
Photo #19 – Well H stilling basin looking downstream.
