SUBJECT: Routine Inspection Stoplogs, Stabilization and Stilling Basins; Fox Island Division HREP, Mississippi River, River Miles 353.6 – 358.5, Clark County, MO.

FOX ISLAND HREP
2016 INSPECTION

ATTACHMENT A

ATTACHMENT B

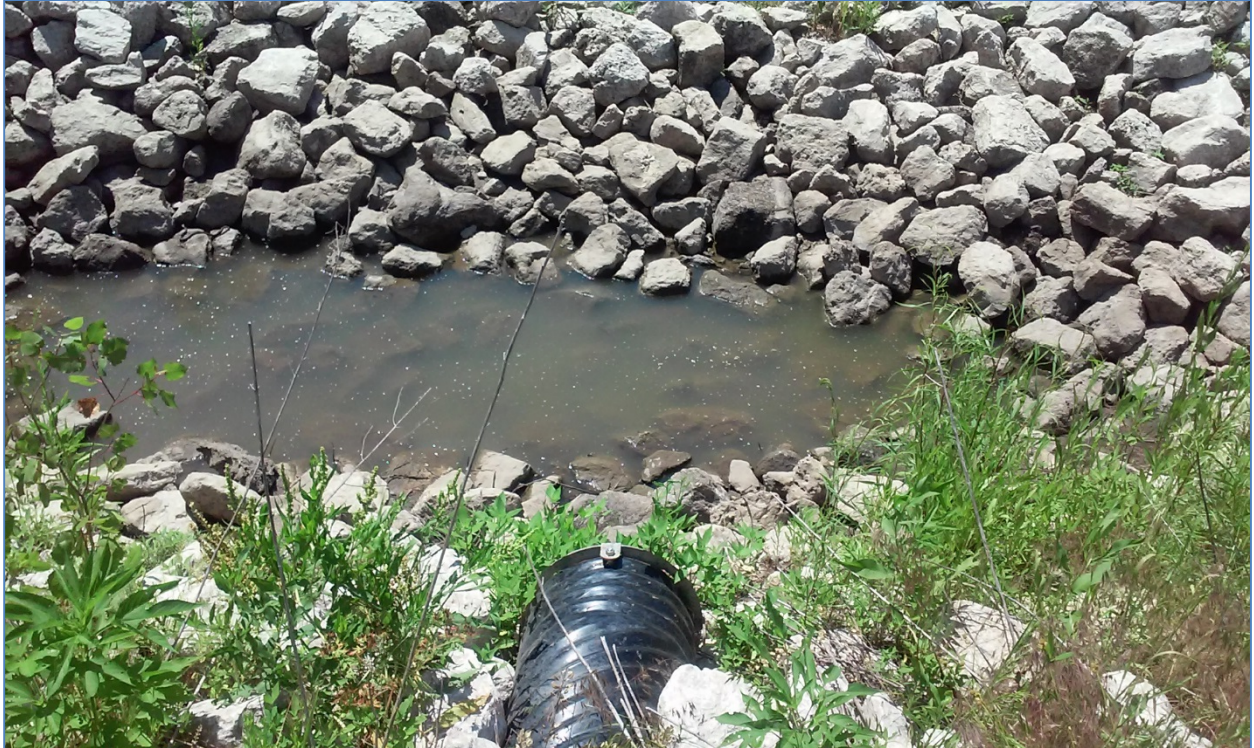
Stilling Basin at Well G	No apparent movement, spalling, or deterioration.	None.	None.	Moderate.	Photo #'s 20, 21, 22.

Photo #20 - Well G stilling basin.

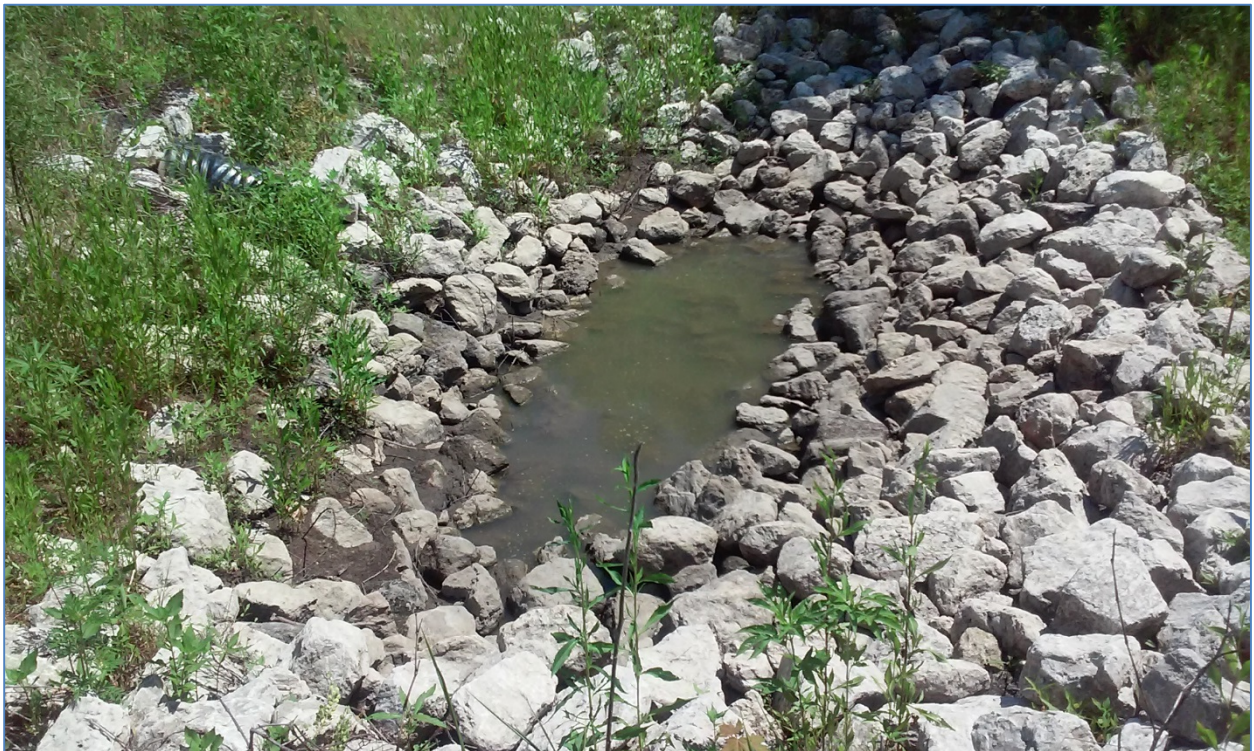
Photo #21 – Well G stilling basin.

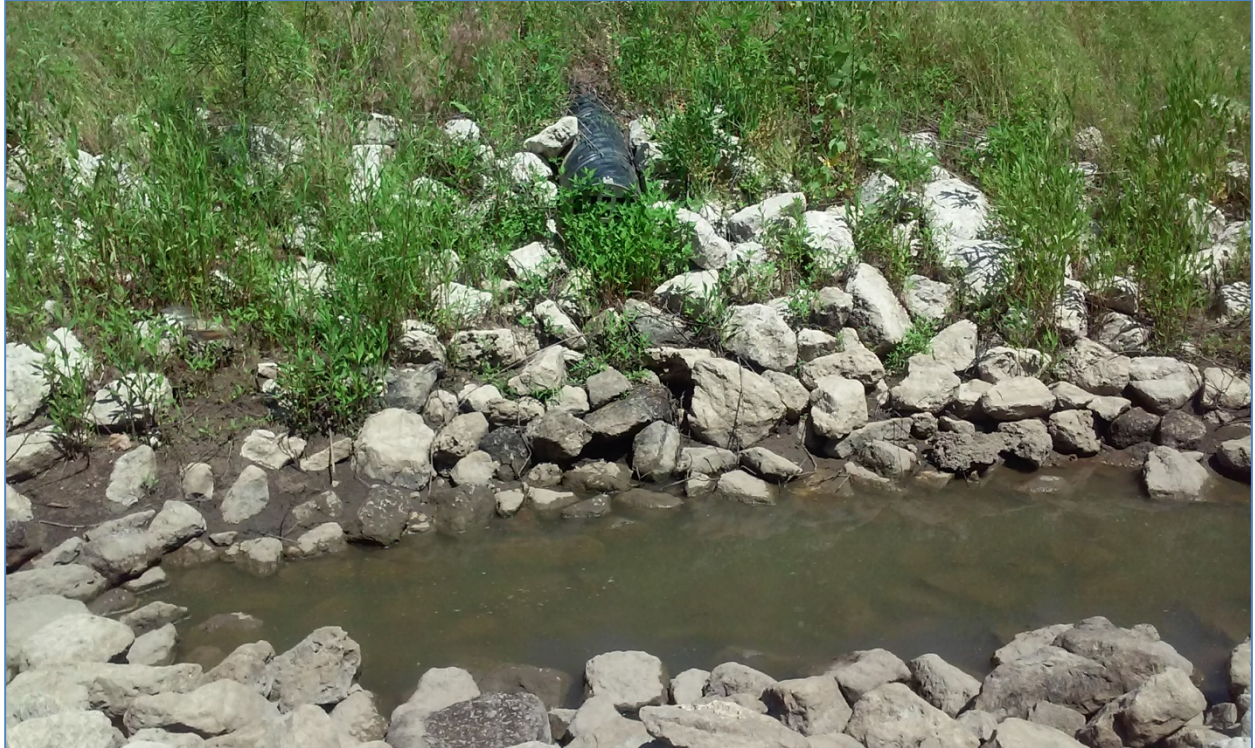
Photo #22 – Well G stilling basin.

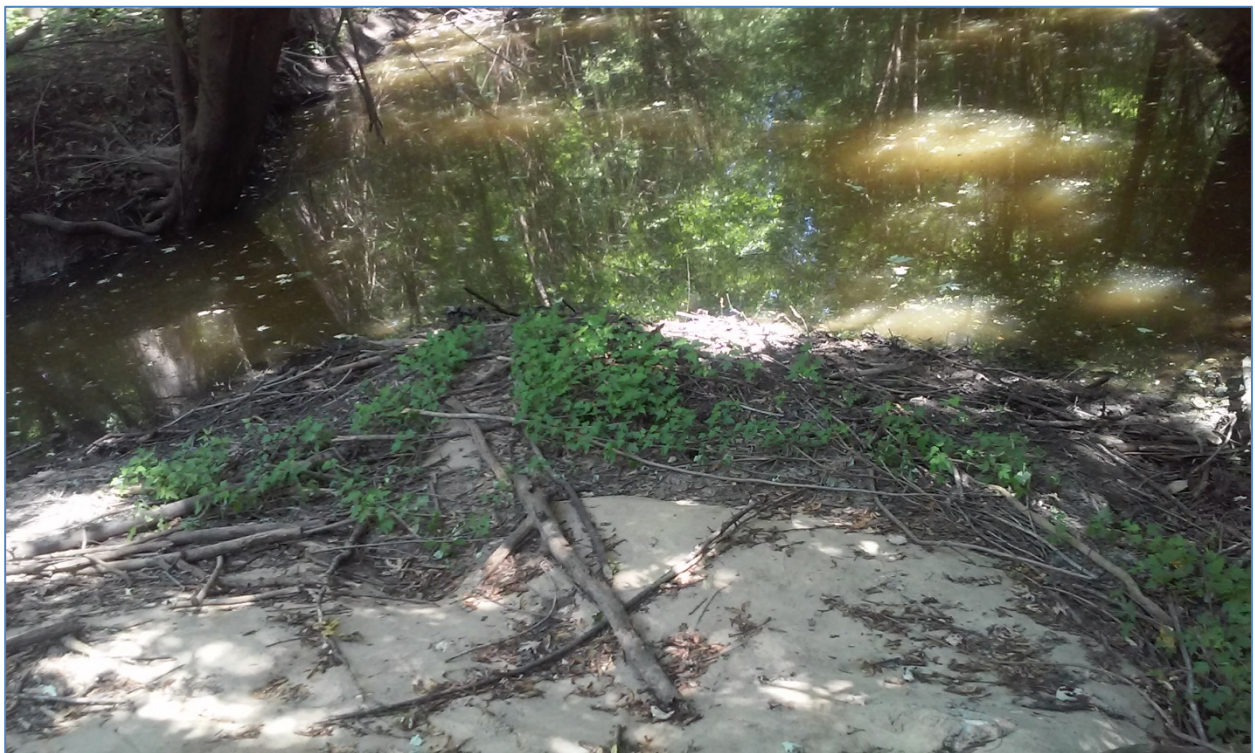
Photo #23 – Stoplog E, upstream gate. Sediment deposition and vegetation on concrete.

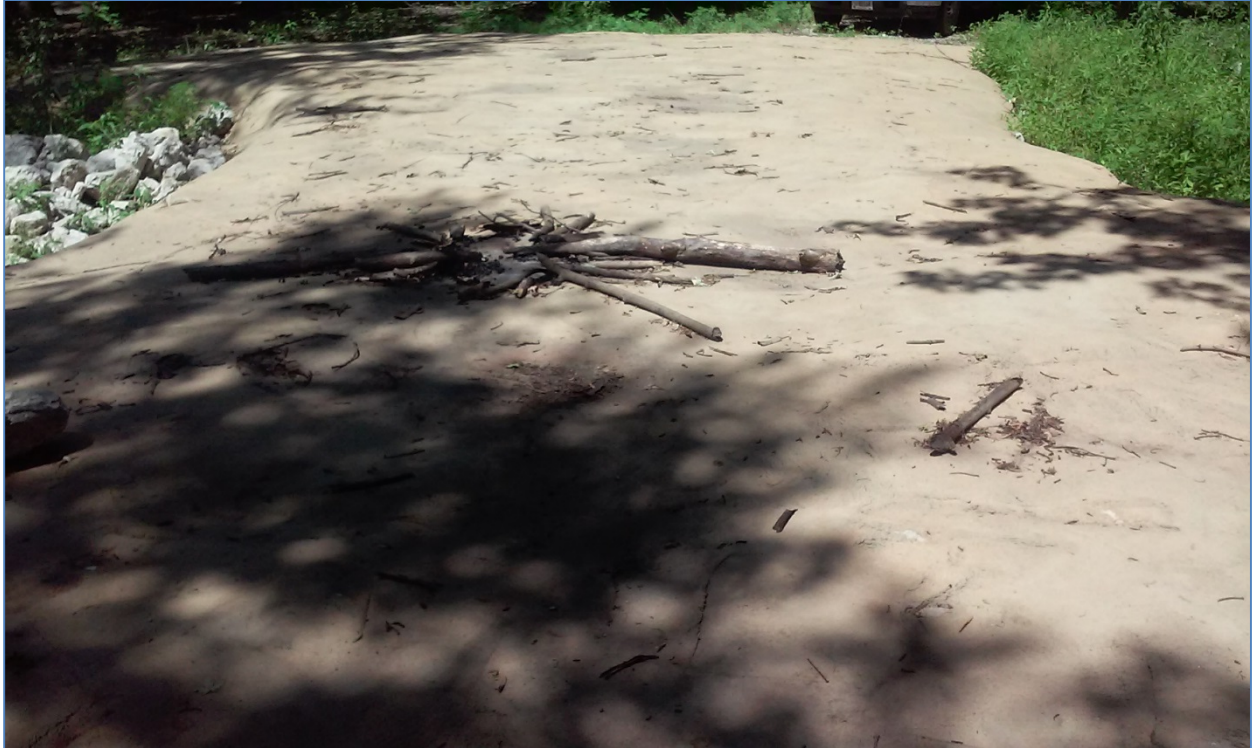
Photo #24 – Stoplog E, riprap/concrete apron. Evidence of campfire.

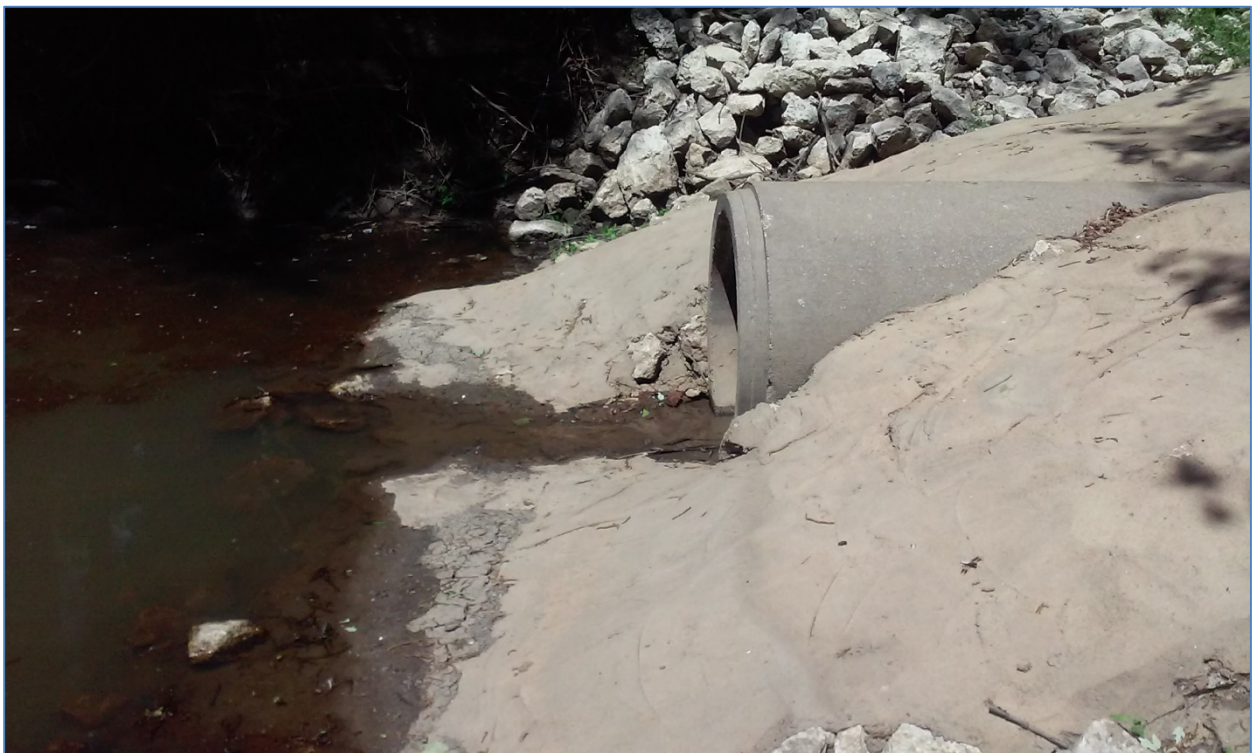
Photo #25 – Stoplog E, downstream outlet.

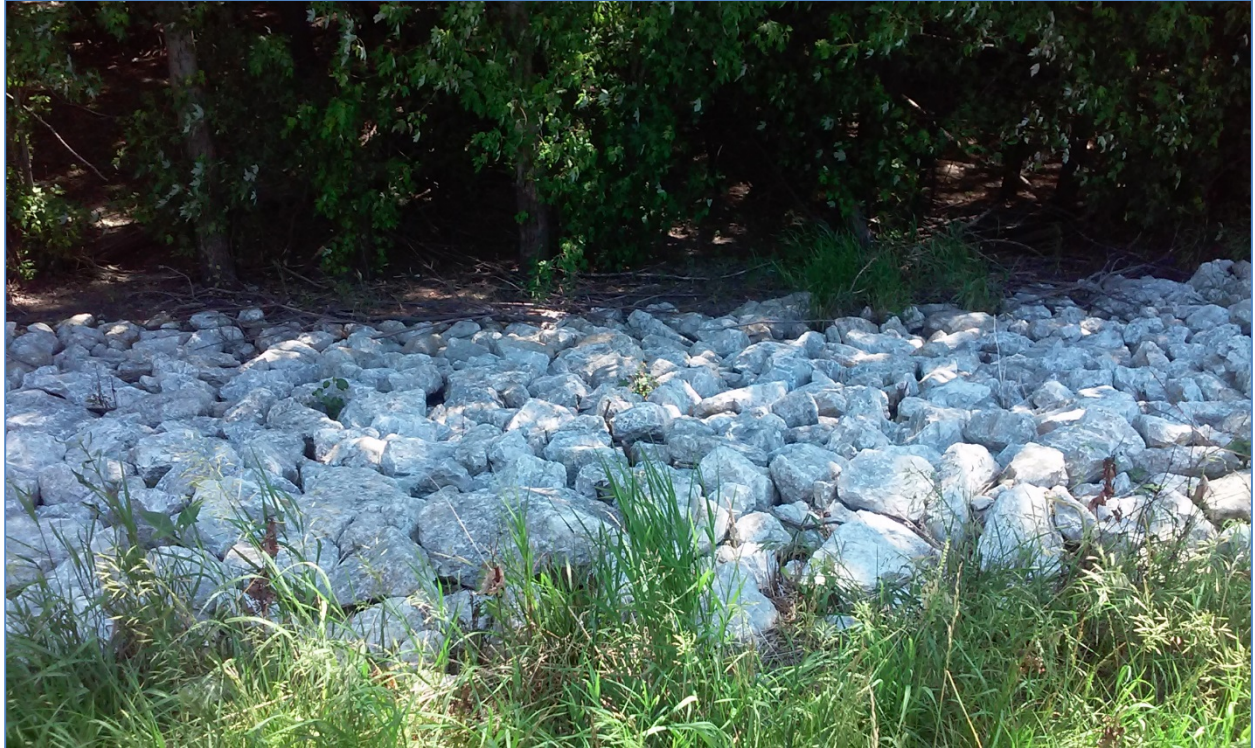
Photo #26 – Mississippi Fox levee improvement area. Minor vegetation.

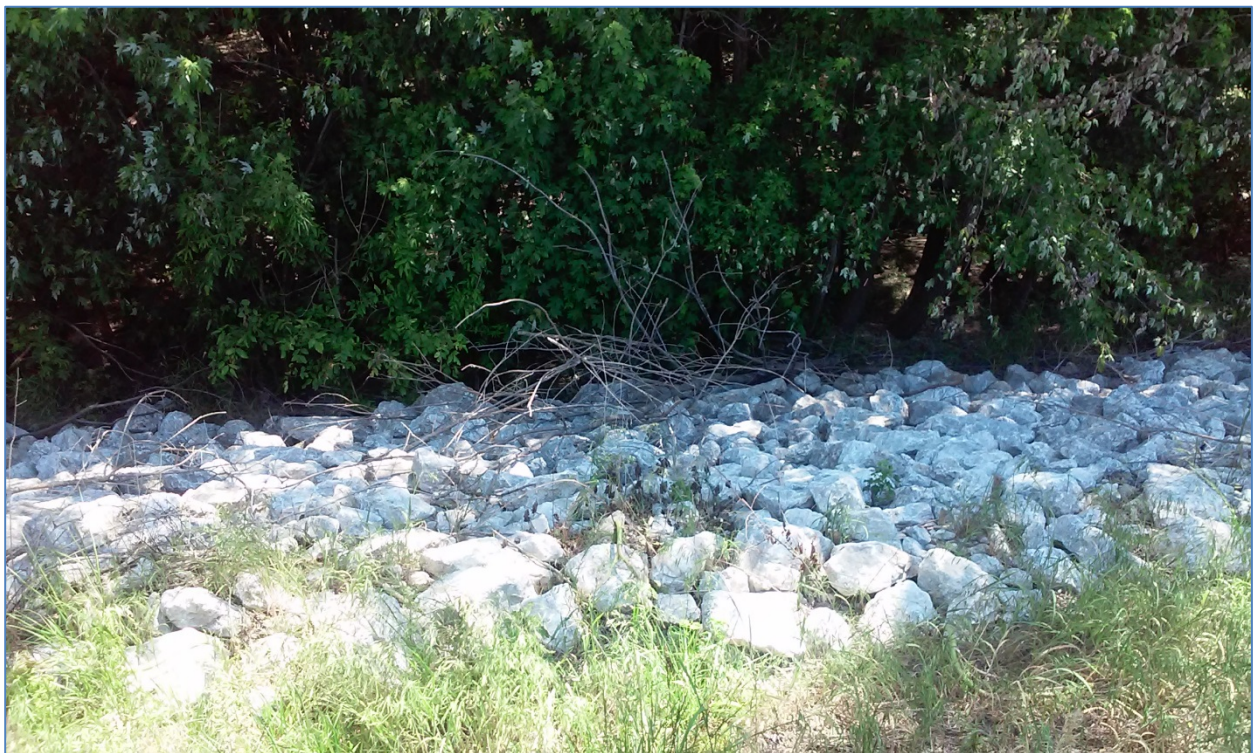
Photo #27 - Mississippi Fox levee improvement area. Minor debris.

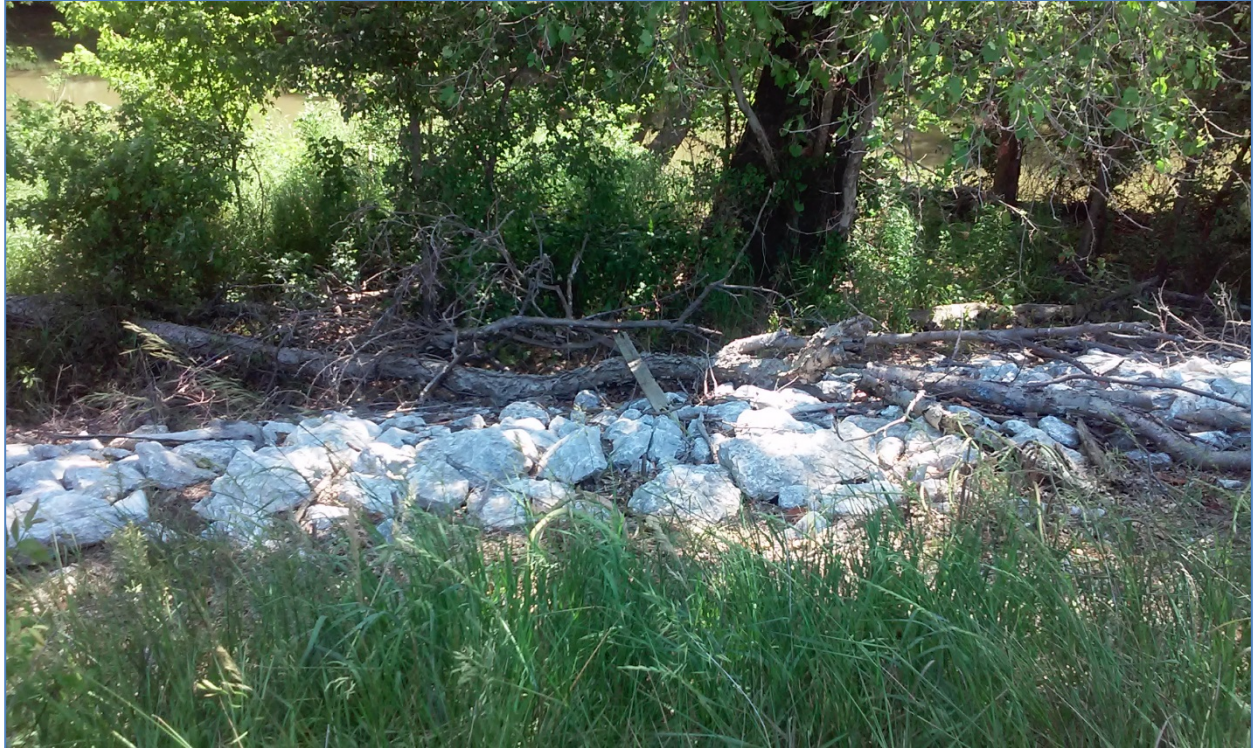
Photo #28- Mississippi Fox levee improvement area. Tree fall.
