MEMORANDUM FOR RECORD:

SUBJECT: Gardner Division (Long Island Division) HREP, 2004 Performance Evaluation Report

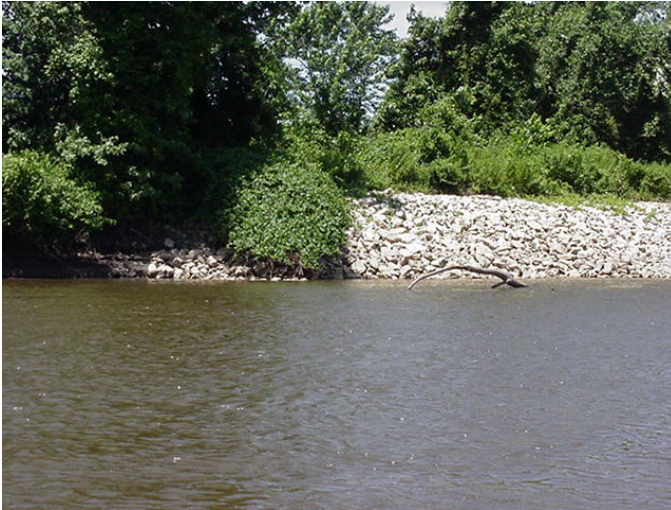
**Photo A-1:** Island A (head on view)

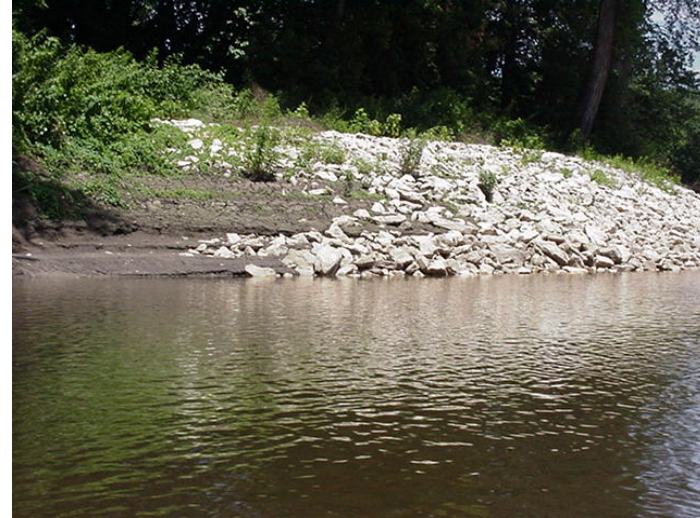
**Photo A-2:** Island A (west side of island)

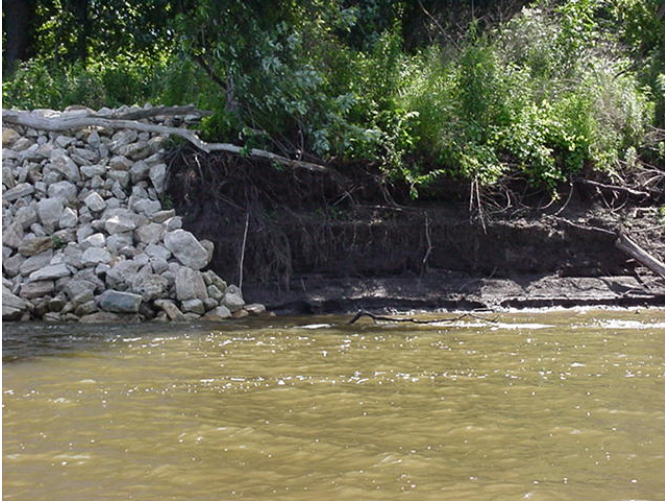
2. The rock protection on the head of Islands A, B, C, D, and E were inspected from a boat. The photographs of the site visit are attached in Attachment A. Over all the rock protection has reduced erosion on the head of the islands to help restore habitat. On Island D, east side, a scour hole can be seen. It was discussed that the scour hole should be watched.

**Photo A-9:** Island D (east side)

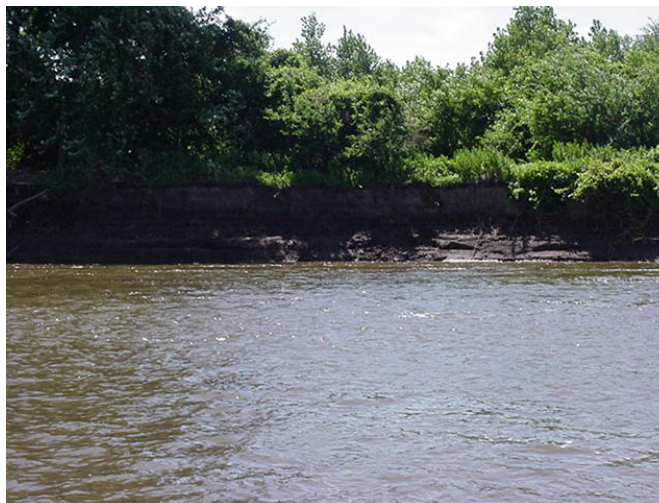
3. The head of Long Island and the head of Lagrange Island have major erosion problems. See photo A-14 thru A-16. At this time, different bankline protections are being evaluated for the head of Long Island and the head of Lagrange.

**Photo A-14:** Head of Long Island

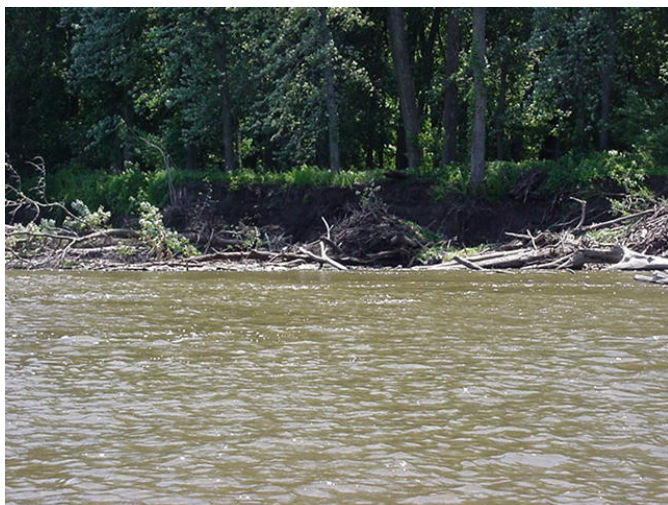
**Photo A-15:** Head of Long Island

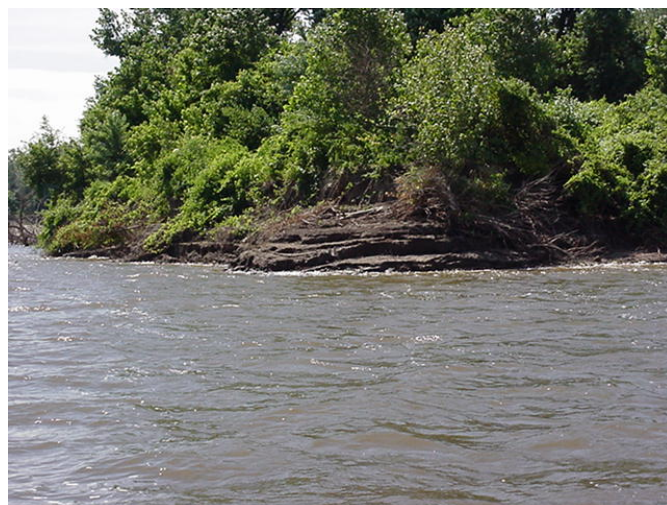
**Photo A-16:** Head of LaGrange Island

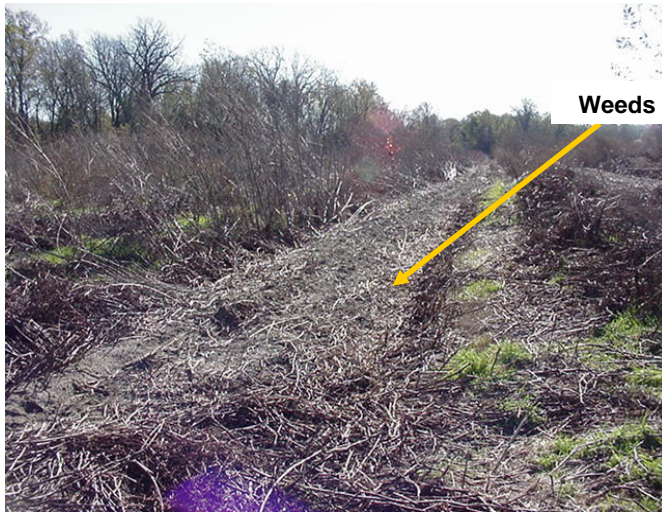
**Photo B-1:** Tree planting from year 2

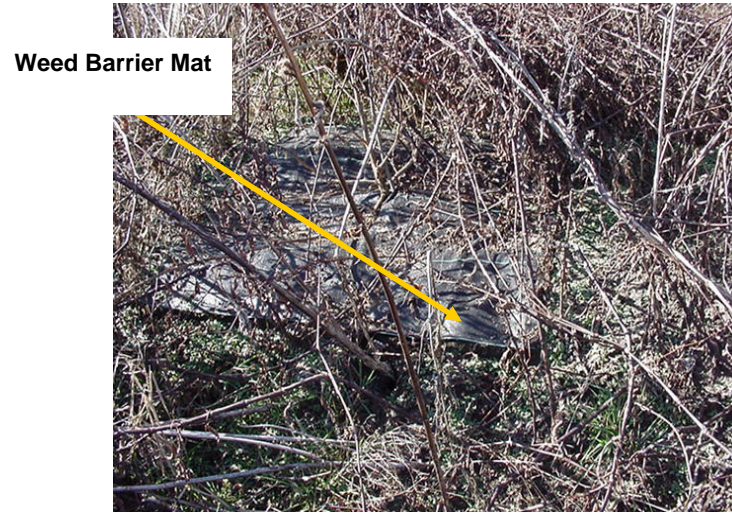
**Photo B-2:** Tree planting from year 2

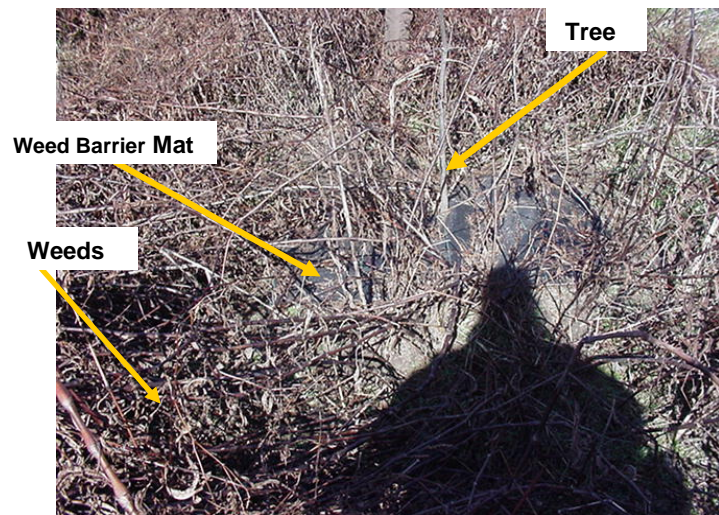
**Photo B-3:** Tree planting from year 2

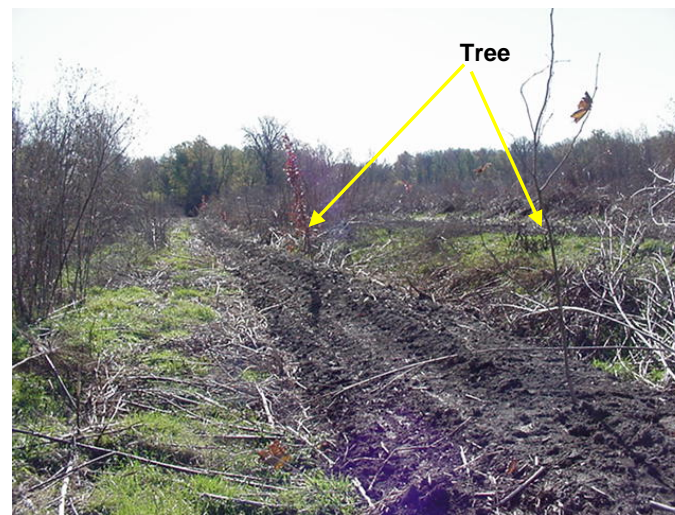
**Photo B-4:** Tree planting from year 3

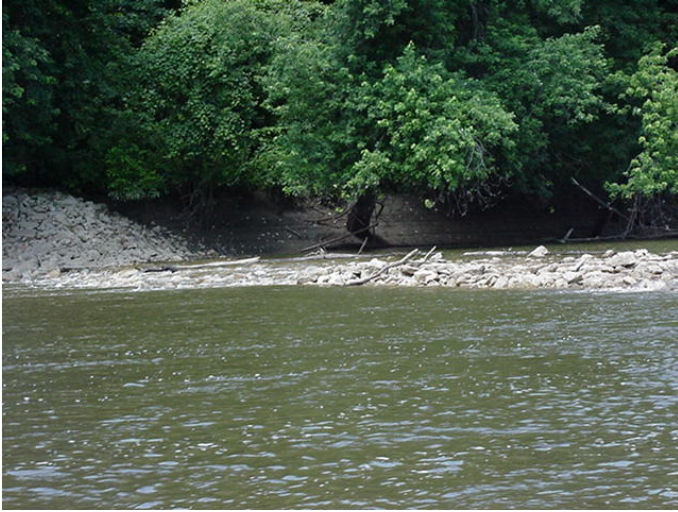
**Photo C-1:** Closing Structure (West Side)

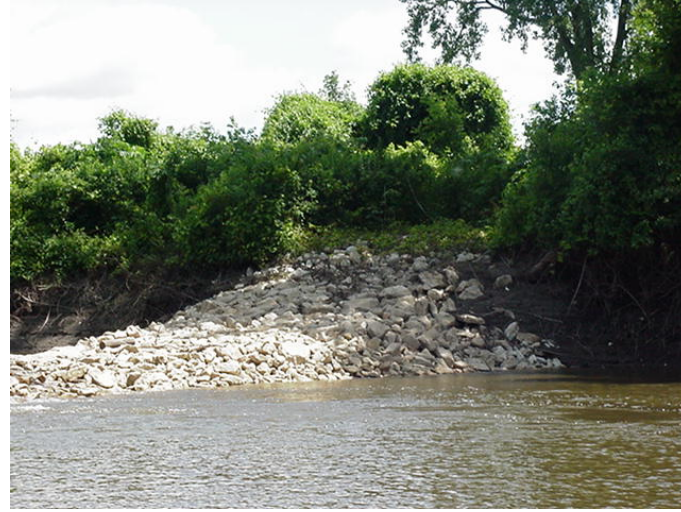
**Photo C-2:** Closing Structure (East Side)

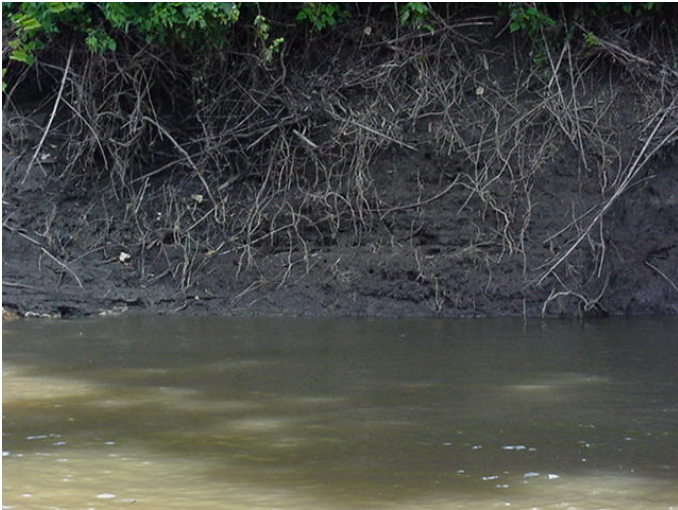
16. Also the closing structure in O'Dell Chute was inspected. The closing structure looked in good condition. However erosion is taking place on the bankline. It was discussed that this area needs to be monitored. Therefore this next PER should discuss if the erosion has worsen. Also, if the USFWS is in the area they will stop by and inspect the closing structure if the water levels allow. After their inspection of the closing structure they will contact the project engineer if the erosion worsens. All photographs from the 7 July 2004 site visit can be viewed in Attachment C.

**Photo C-3:** Closing Structure – East Side Bankline

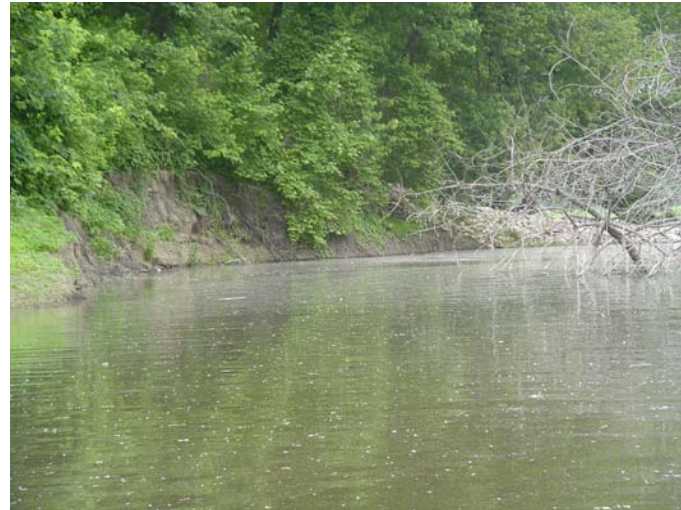
12. The site visit 11/12/03 photographs of the mast tree planting can be seen in Attachment B.
13. Late May of 2004 an inspection of O'Dell Chute closure structure was preformed by the U.S. Fish and Wildlife Service, Dave Ellis and Karen Westphall. Overall all the closing structure was in good condition, however

some erosion is taking place on the bankline near the closing structure. Photographs can be view in Attachment C.

**Photo C-4:** Erosion (Late May-By Karen Westphall)

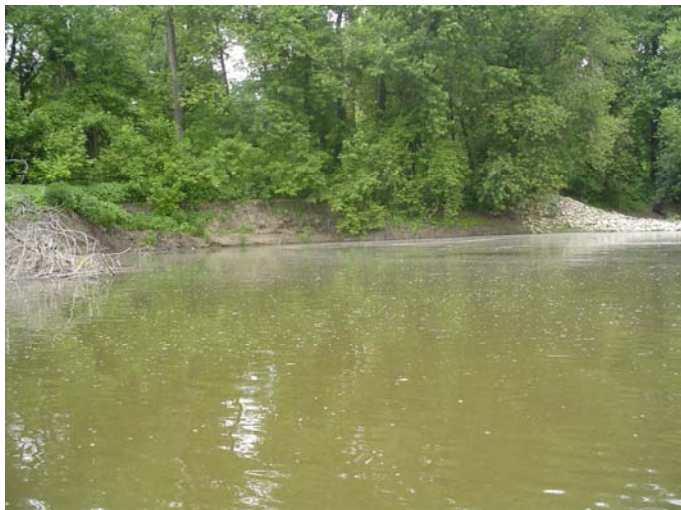
**Photo C-5:** Erosion (Late May- Karen Westphall)

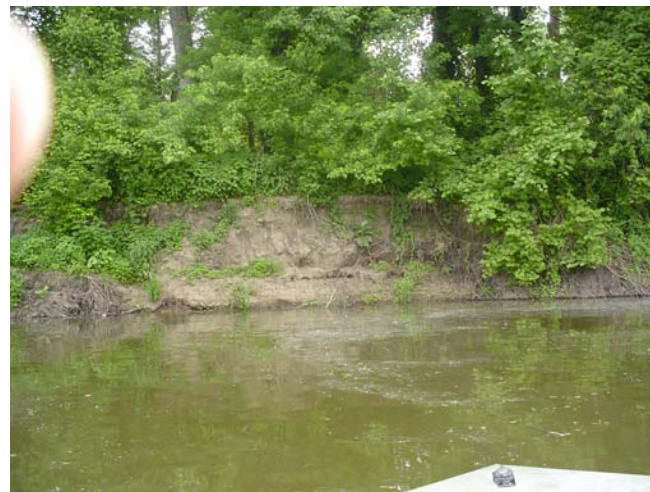
**Photo C-6:** Erosion (Late May- Karen Westphall)
