UMRR HREP
INSPECTION OF COMPLETED WORKS

Long Island Division-Gardner Division (HREP)

Upper Mississippi River Restoration (UMRR)

X. DATE OF FIELD VISIT: 8/18/2016

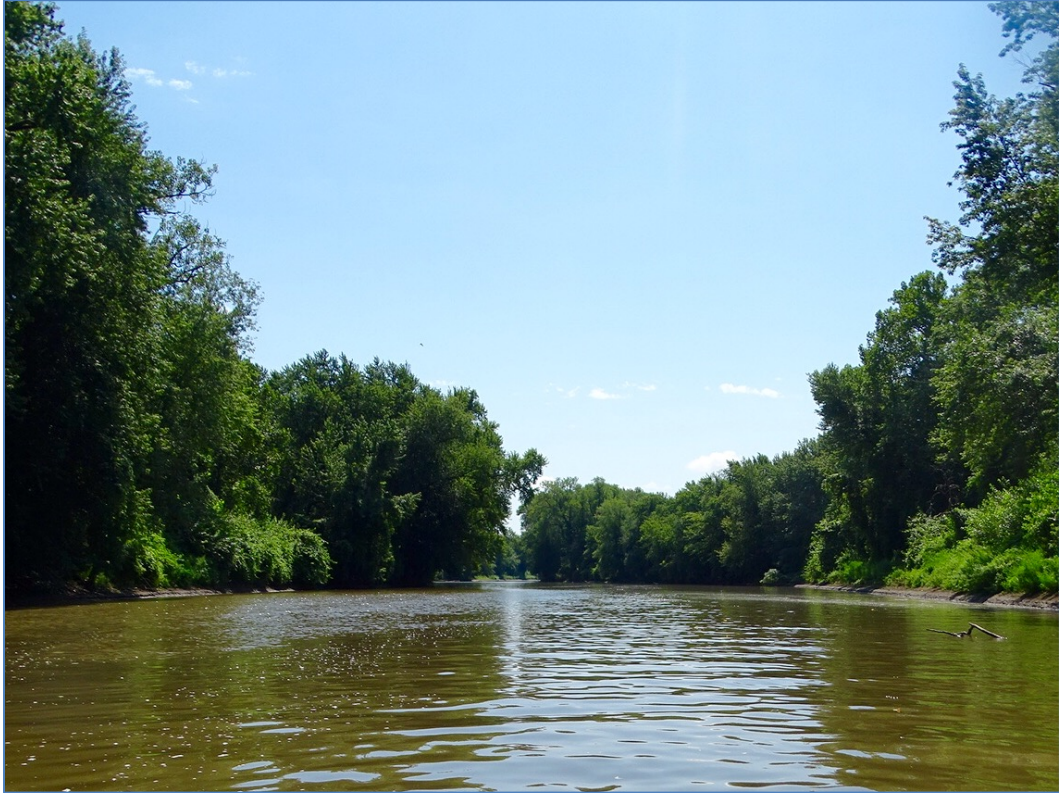
O'Dell Chute was entered at the southern end. Depths of 10 feet or deeper were observed in the entire dredge cut. However, due to elevated pool levels, the actual remaining depth of dredge cuts (below flat pool) were in the 4 to 5 feet range. O'Dell Chute was originally dredged to 7.5 feet below flat pool. Numerous Asian Carp were observed jumping in this chute, following the lead boat. One bald eagle was observed. There have been no concerns with depth in this chute. Several logs were attached to the bank line creating optimum fish habitat. See Photos 1, 2, 3 and 4 in Attachment B.

Photo 1: O'Dell Chute

Bathymetric survey on the O'Dell Chute dredge cut is needed to accurately determine the magnitude and rate of sedimentation.

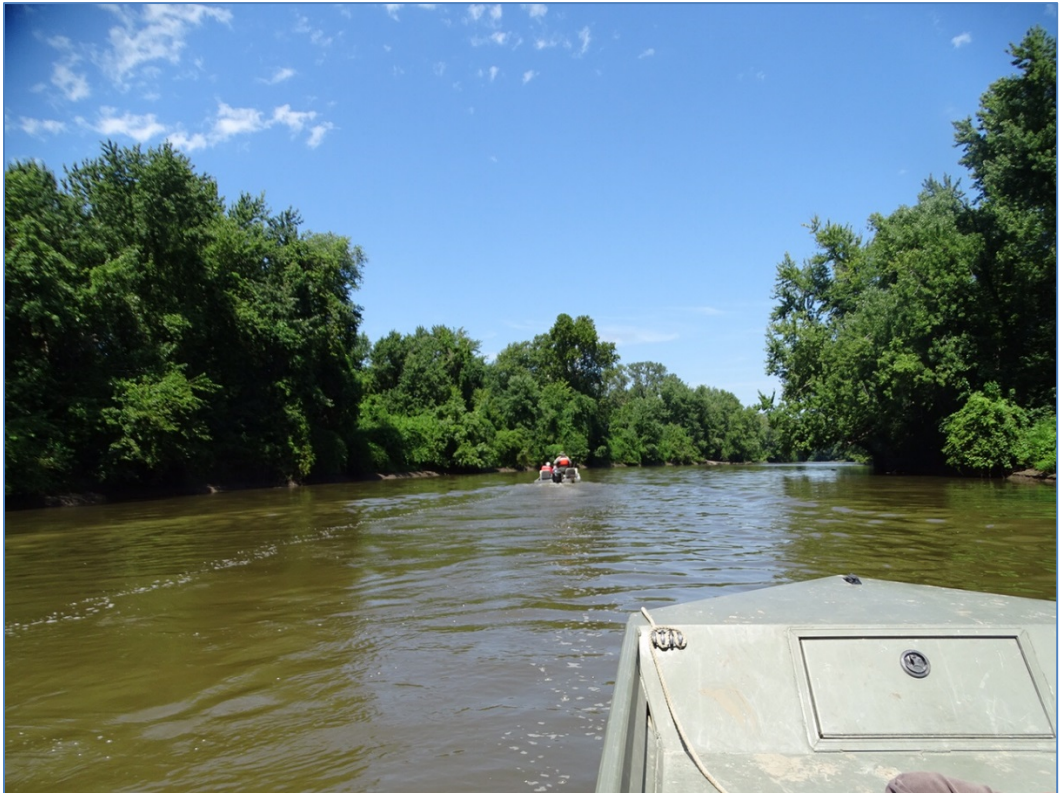
Photo 2: O'Dell Chute

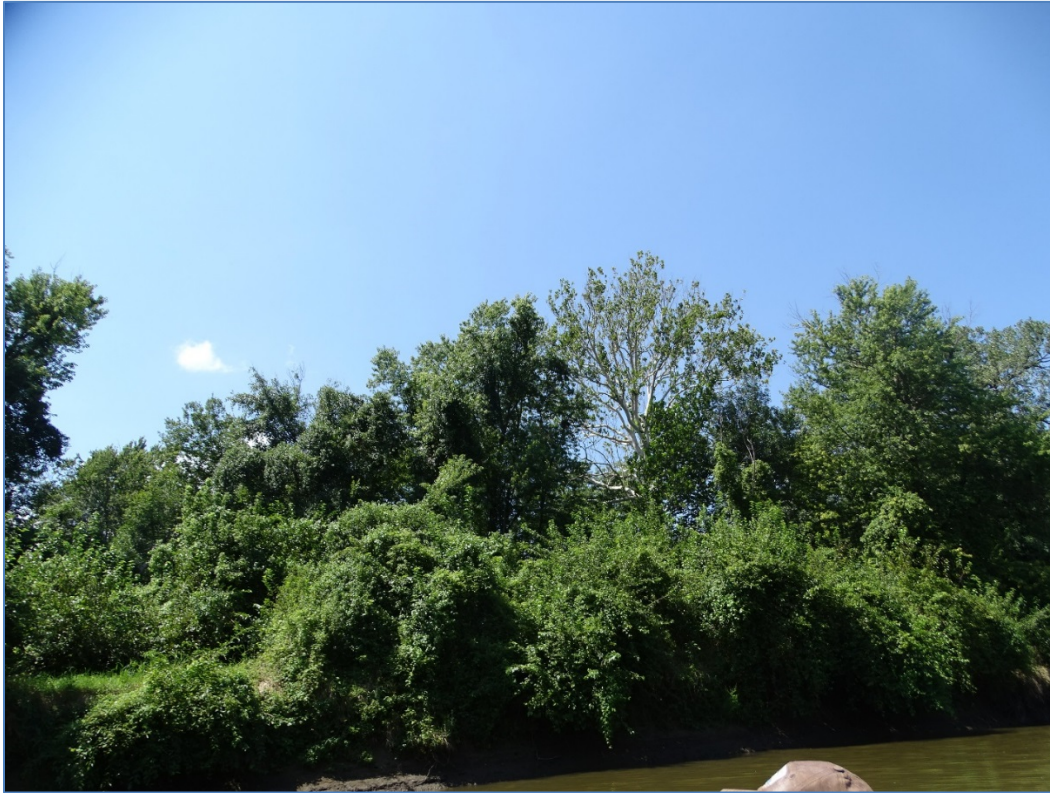
Photo 3: O'Dell Chute left descending bank.

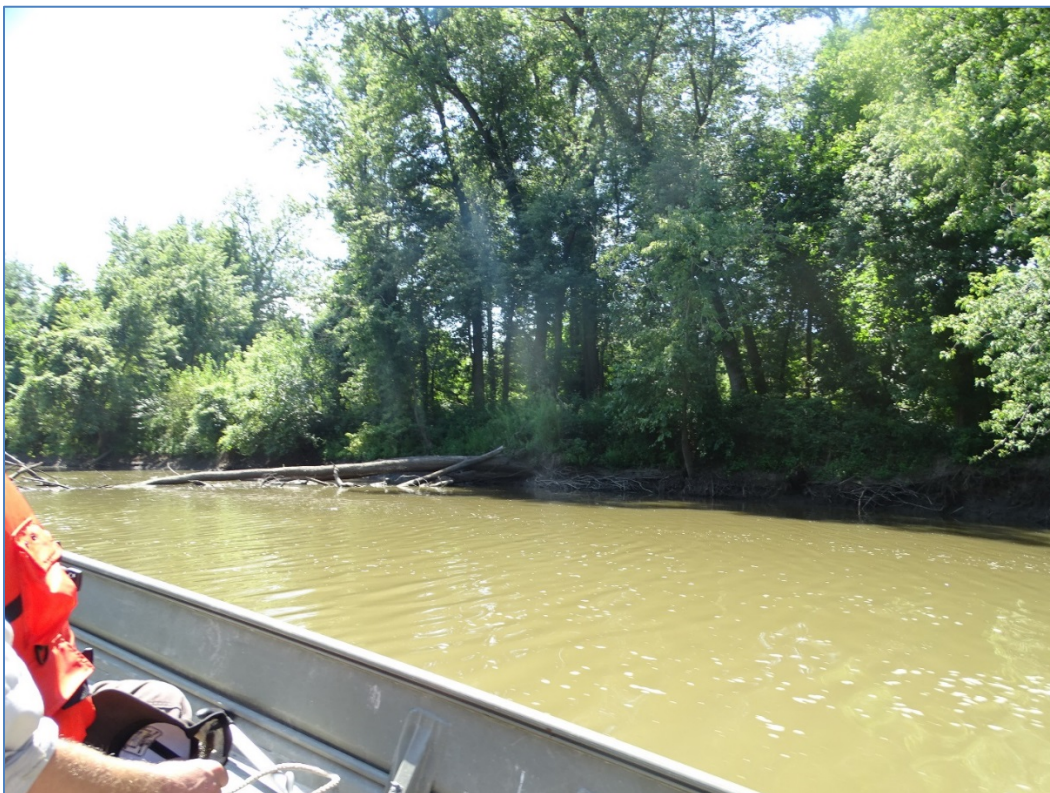
Photo 4: O'Dell Chute right descending bank. Logs creating fish habitat.

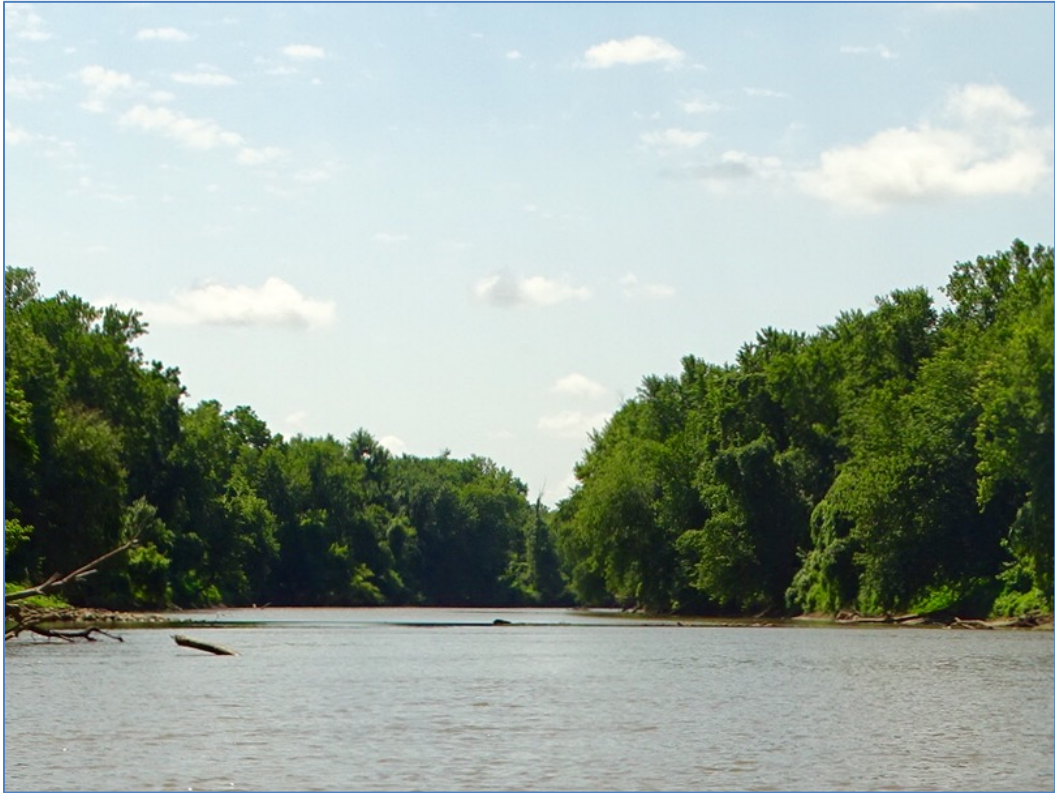
The closure at the upstream end of the O'Dell Chute was observed to be underwater, however, based on breaks on the surface of the water it was clearly recognizable. The entrance to the closure structure was very shallow (2 feet), indicating that the access dredge cut has filled in (as was expected). The closure structure was constructed to stop bed load and suspended sediment from entering O'Dell Chute. The river was pushing the boats away from the closure structure out to the main channel, so it appears that flows are being diverted. Additionally, depths downstream of the structure continue to be deep. (Photos 5, 6 in Attachment B).

Photo 5: Emergent Closure Structure.

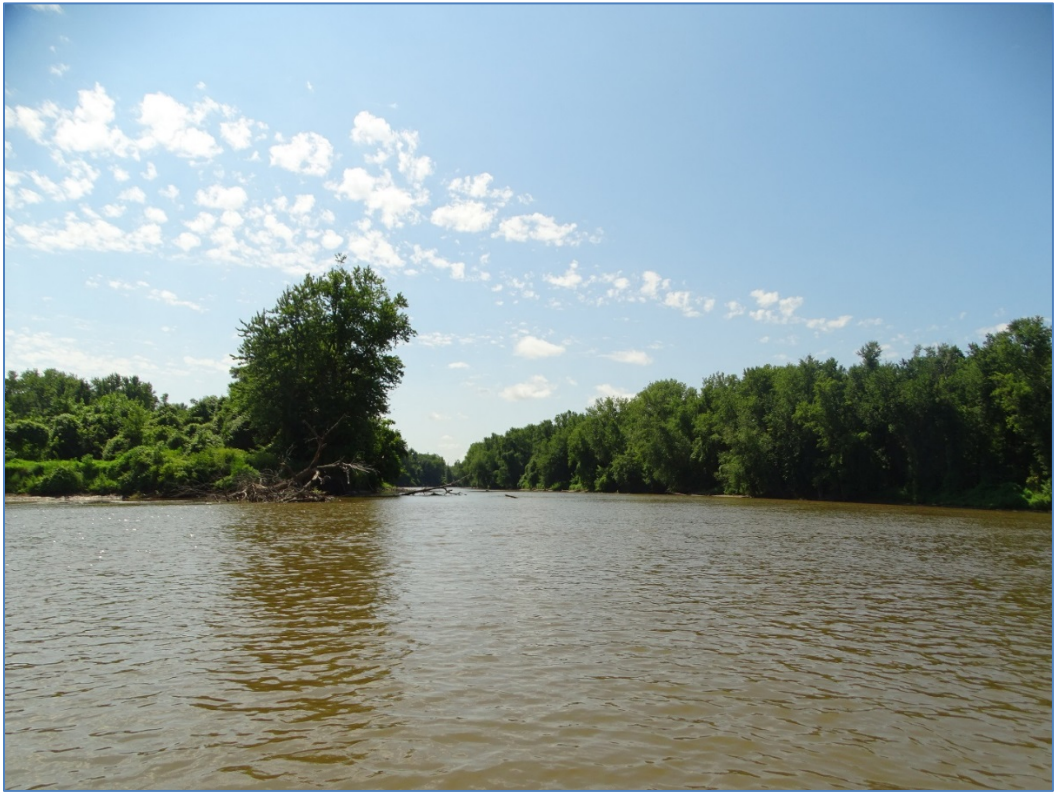
Photo 6: Access channel to Emergent Closure Structure.

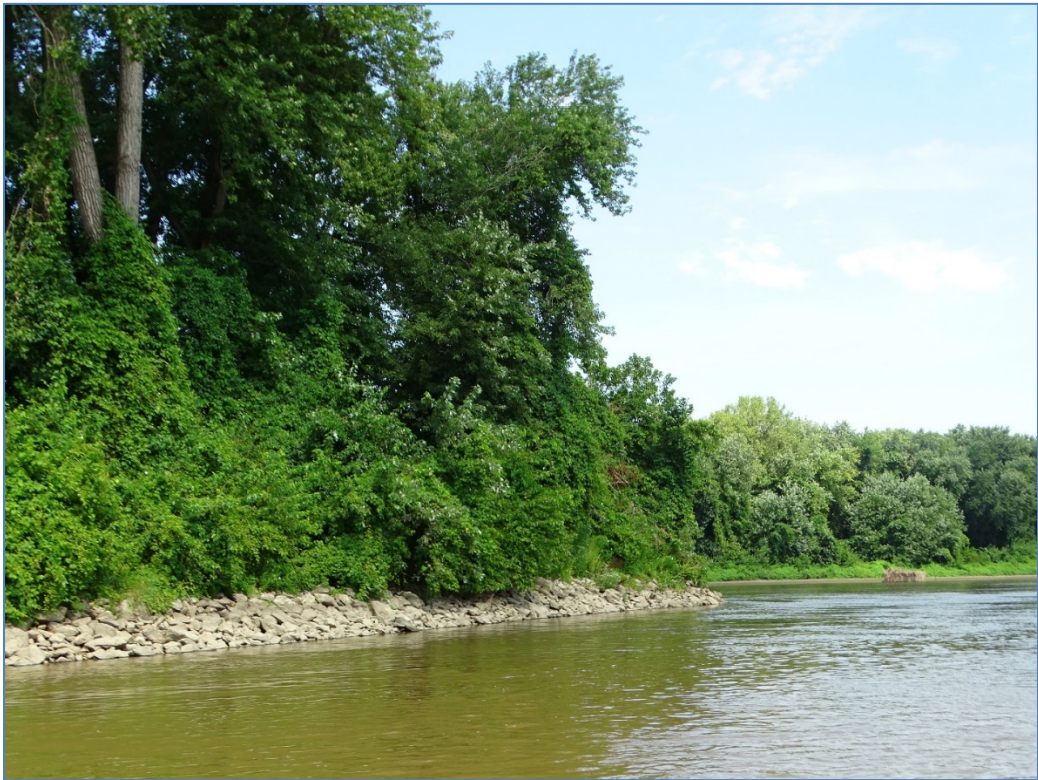
The island further upstream of Canton Chute (Island A) was surrounded by shallower water. A sand stockpile was noted slightly downstream of the west end tie in of the riprap. (Photos 7, 8, and 9 in Attachment B).

Photo 7: Island A east bank.

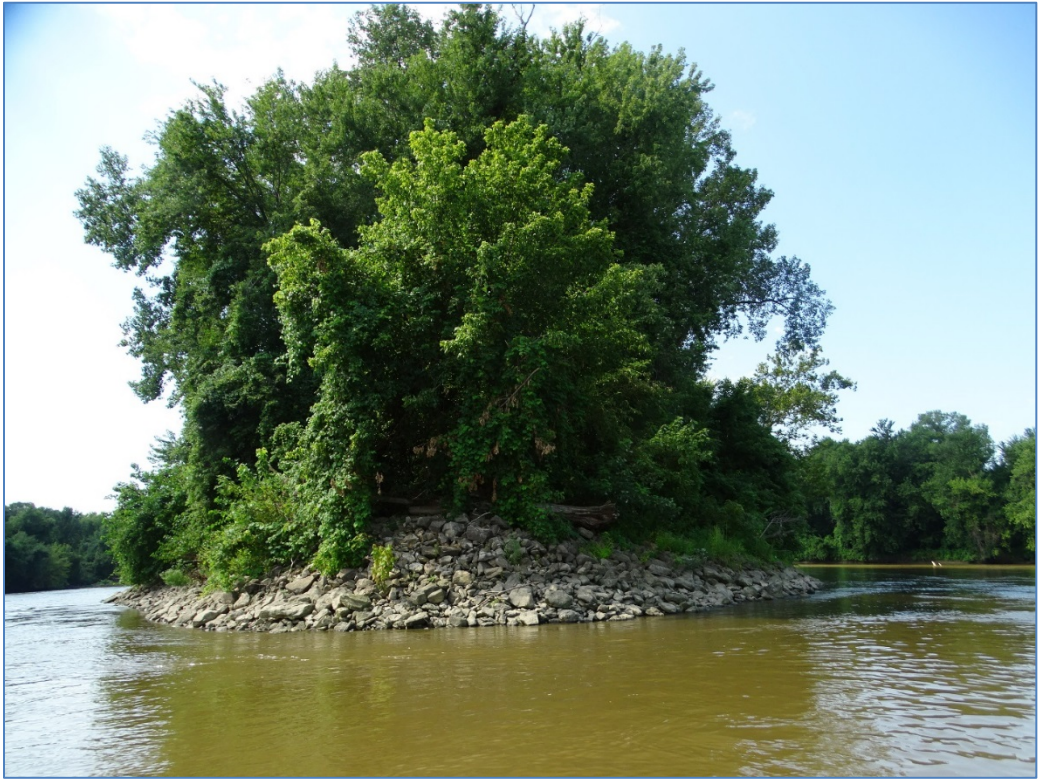
Photo 8: Island A upstream end.

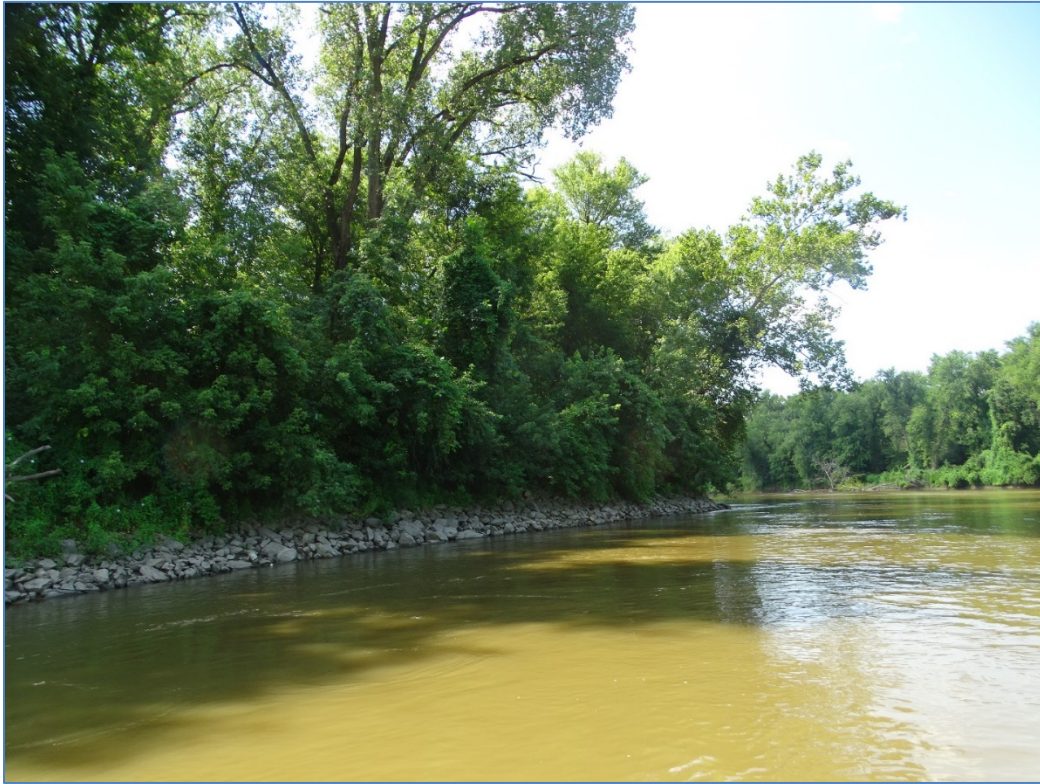
Photo 9: Island A west bank.

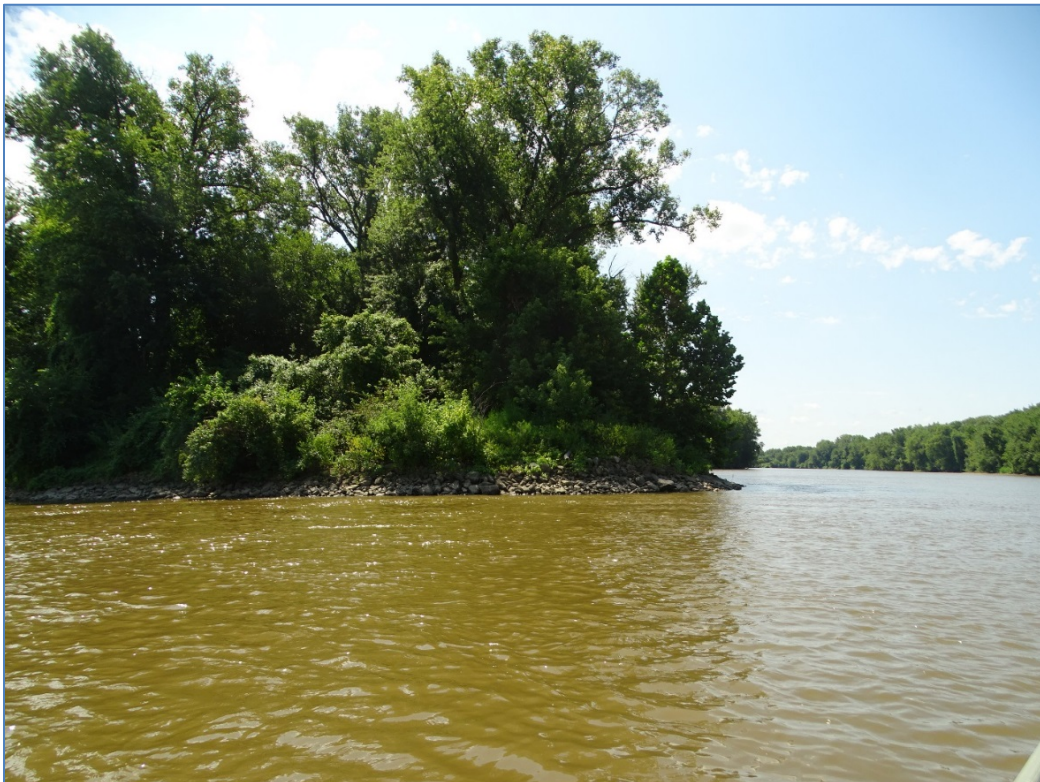
The protection at the head of Shandrew Island remains. Some erosion downstream of the protection areas was noted, but not as significant as the other islands in the Chute. (Photos 10, 11 in Attachment B).

Photo 10: Upstream protection on Shandrew Island.

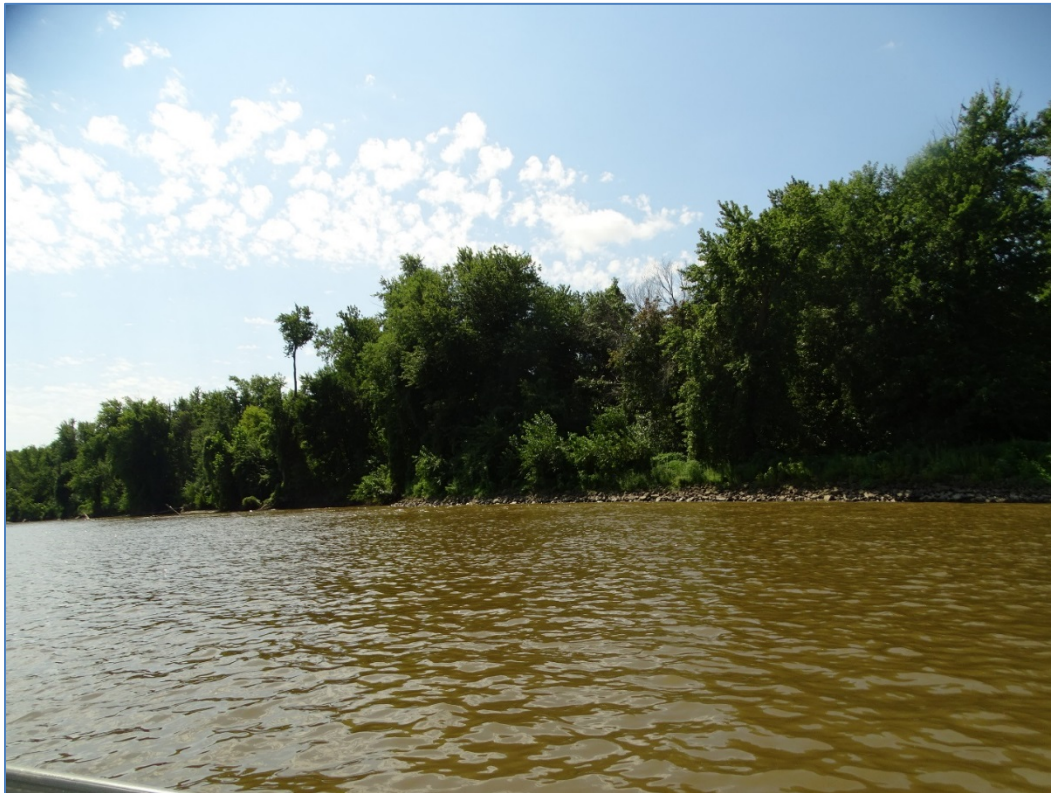
Photo 11: Shandrew Island upstream end.

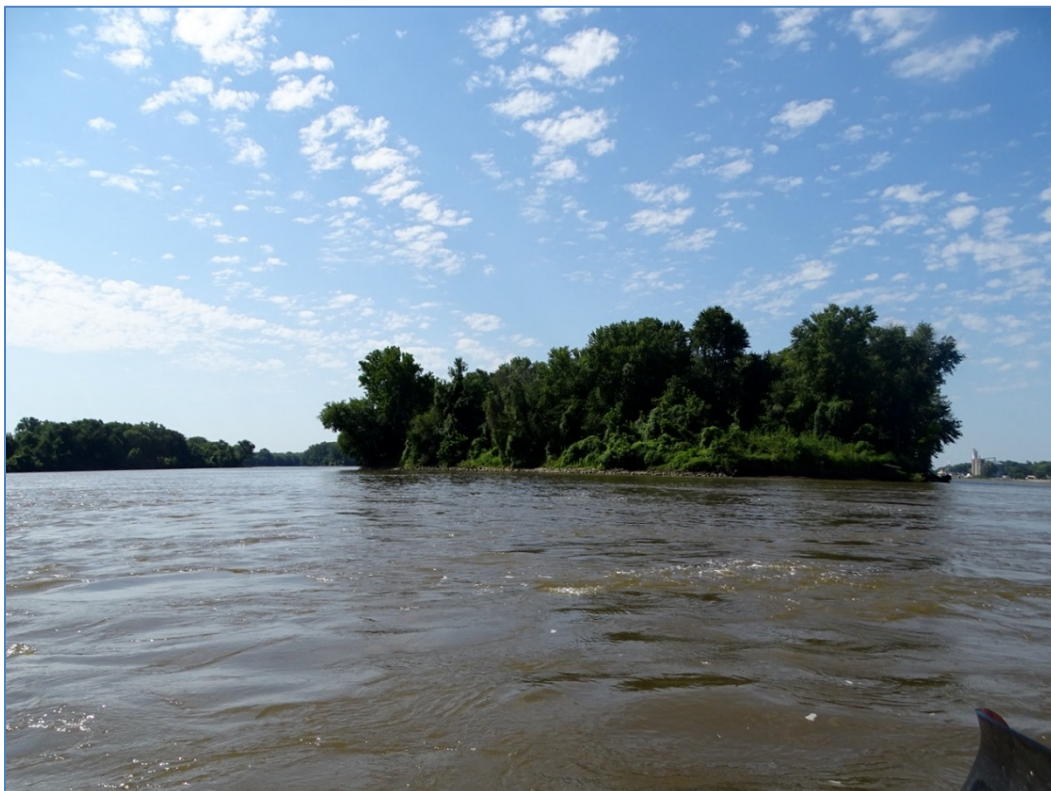
The chevron at the head end of LaGrange Island structure was submerged at the time of the field visit, but disturbances at the surface allowed the boat around the outside circumference of the structure. Depth finders indicated that for the most part the structure is still at the appropriate location. Riprap on the Island bank remains in place, and active erosion does not appear to be rapidly continuing on the island. The depth finder in the interior of the chevron indicated about 6.5 feet at the time of the site visit. The depth finder read about 14 feet on the upstream end of the chevron (Photo 12, Attachment B). An air photo timeline of the erosion at the upstream end of LaGrange Island is included in Attachment C.

Photo 12: LaGrange Island, upstream chevron (submerged).

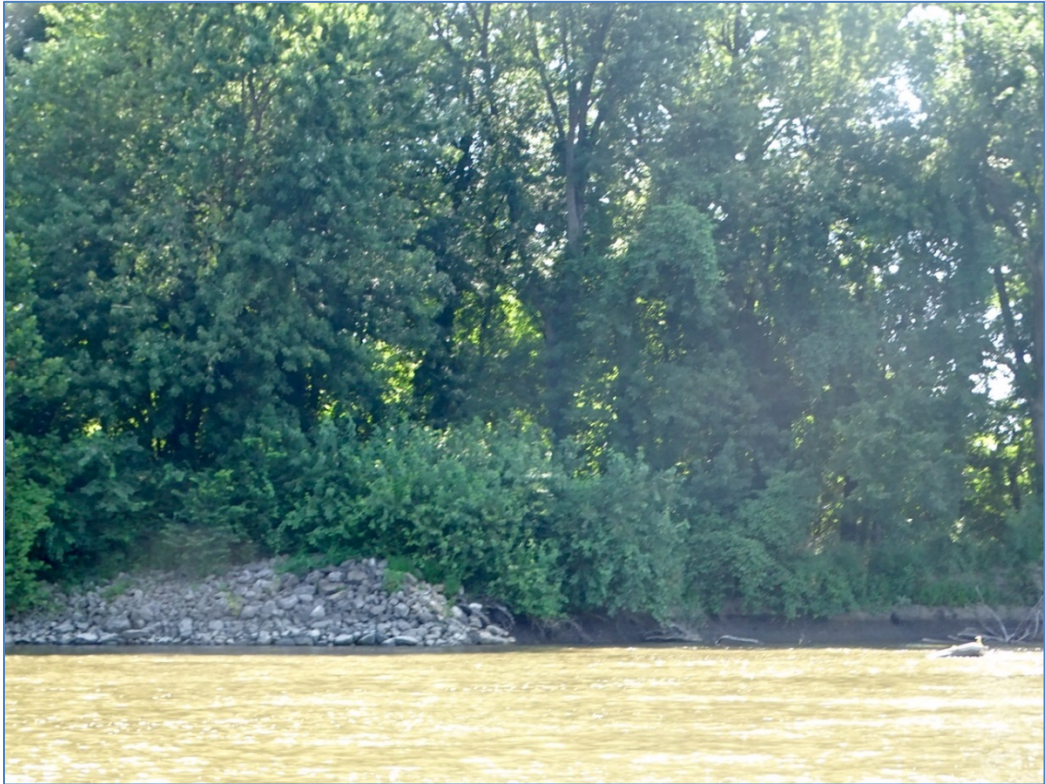
The riprap on Islands D and E remains, however on the west bank immediately downstream of each island, erosion was apparent. It seems that once the riprap ends, the perimeter of the island steps back several feet, creating a narrower island downstream of the riprap. This was observed on all other islands as well, particularly on the west banks. (Photos 13, 14, and 15 in Attachment B).

Photo 13: Island D, end of riprap, westbank.

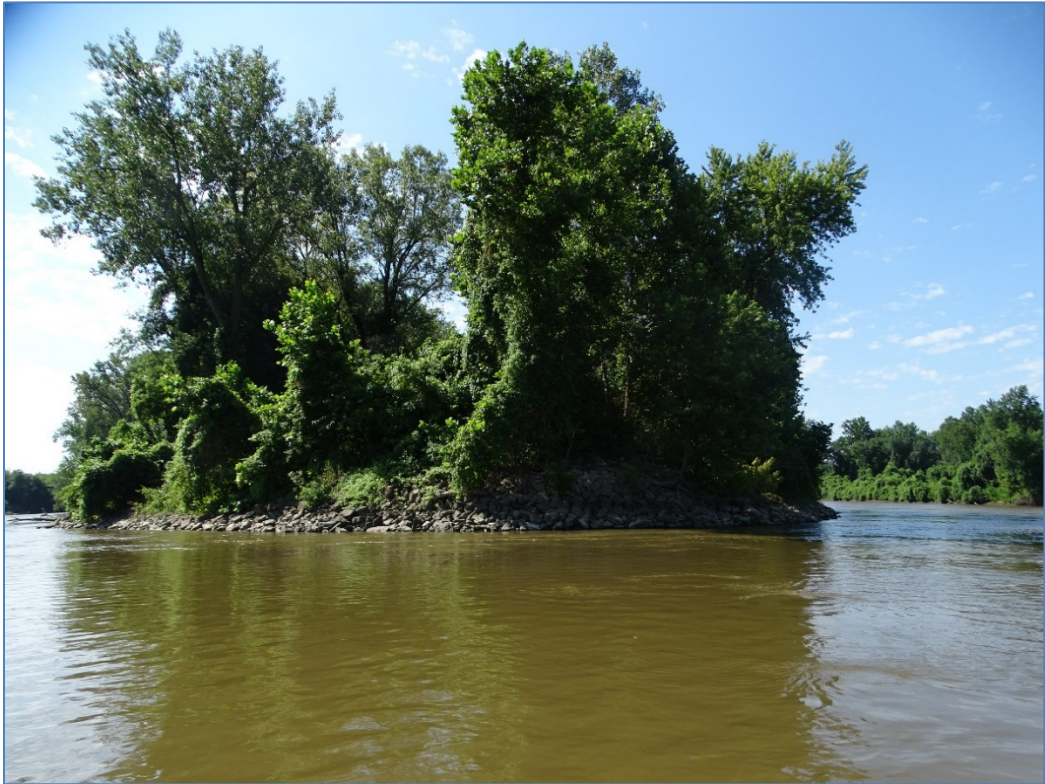
Photo 14: Island E, upstream end.

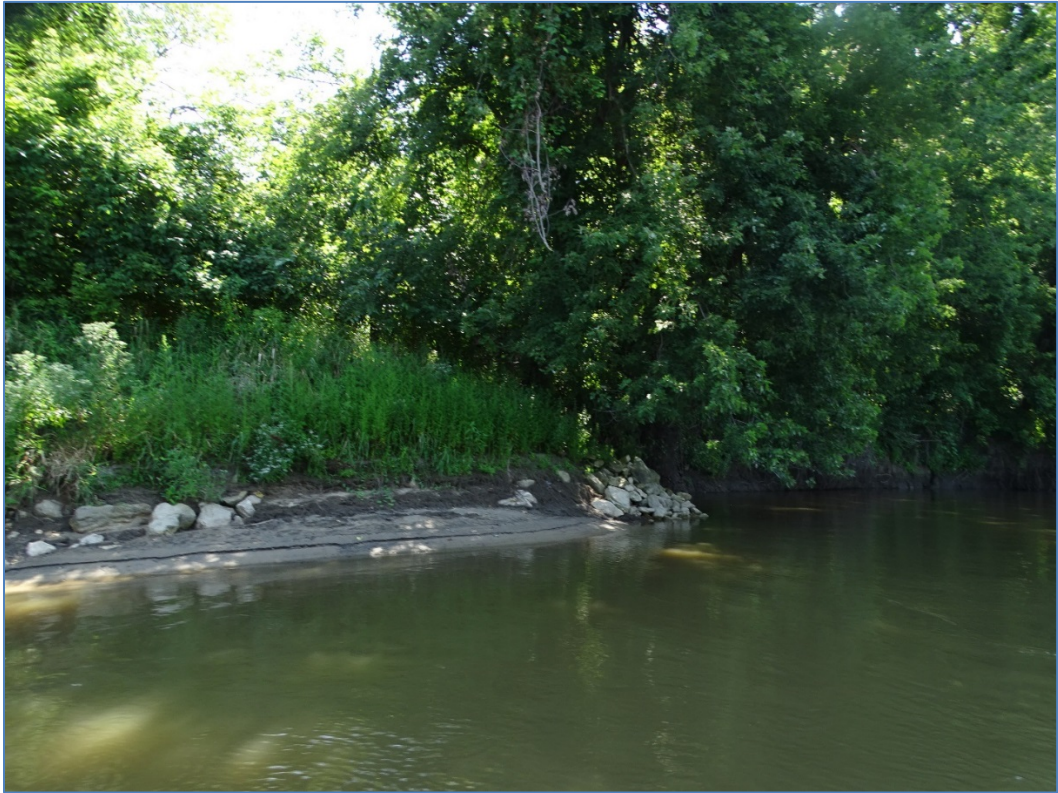
Photo 15: Island E, end of riprap, west bank.

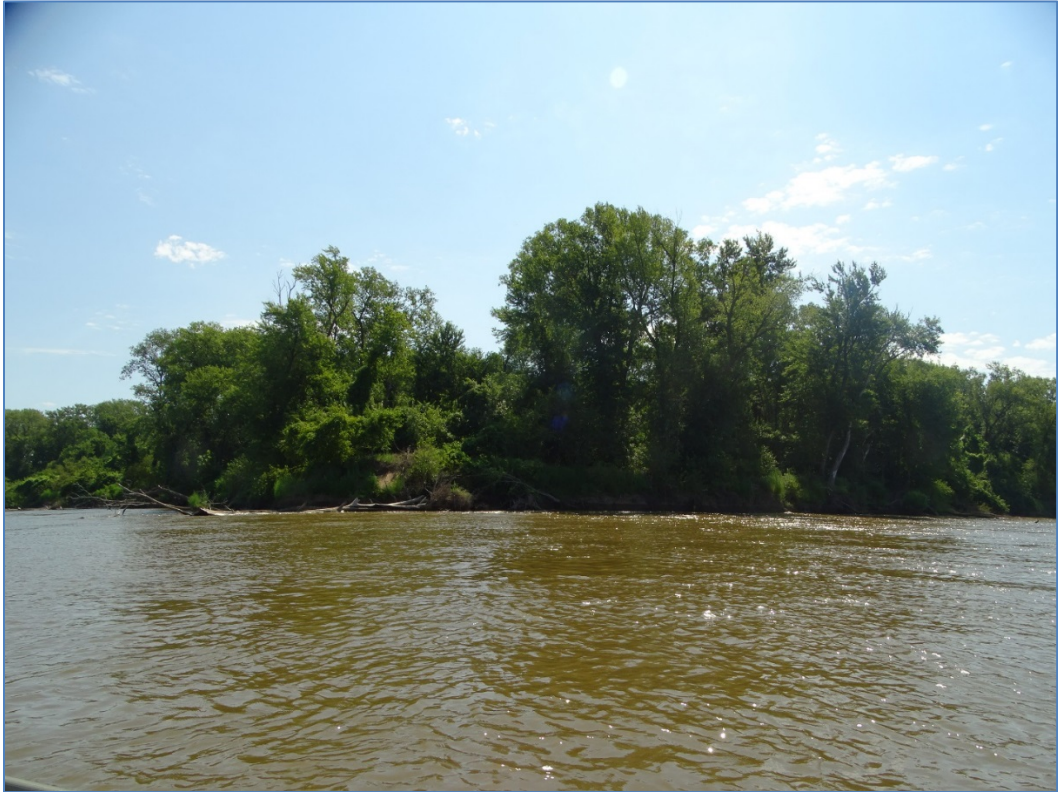
Erosion was observed at the upstream end of Long Island. Water depths adjacent to shore at the upstream end continue to be very deep (up to 25 feet). The head end has degraded to more of a point than in years past. (Photos 16, 17 in Attachment B).

Photo 16: Long Island upstream end.

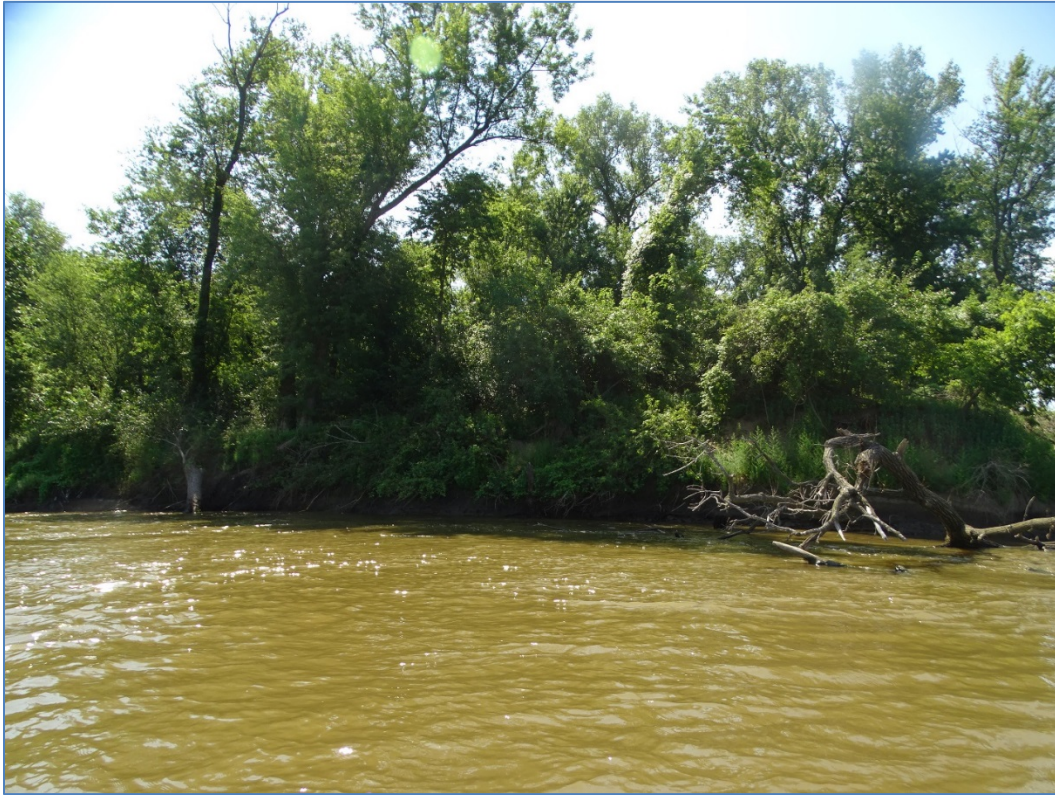
Photo 17: Long Island east bank, upper end.

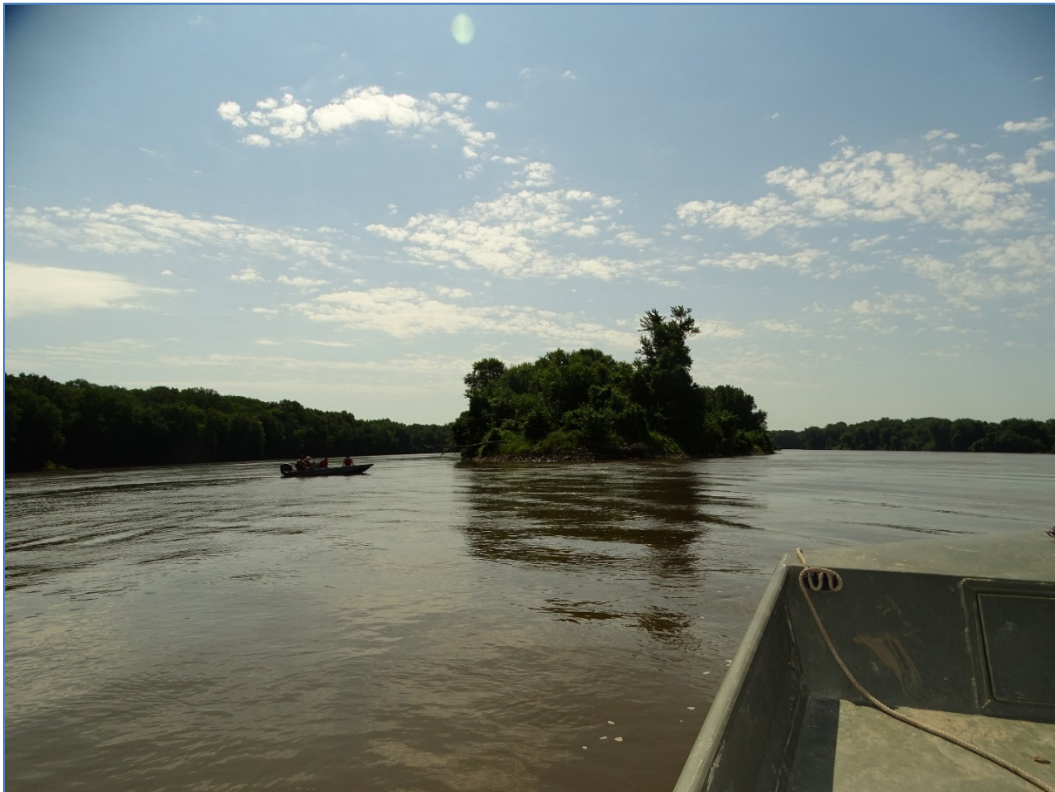
Island's B and C have similar riprap protection and downstream erosion to islands D and E. The vegetation on island B is significantly overtaken by grape vine, Japanese hops, reed canary grass, and morning glory, which is likely to damage the floodplain forest. (Photos 18, 19, and 20 in Attachment B).

Photo 18: Island B, upstream end.

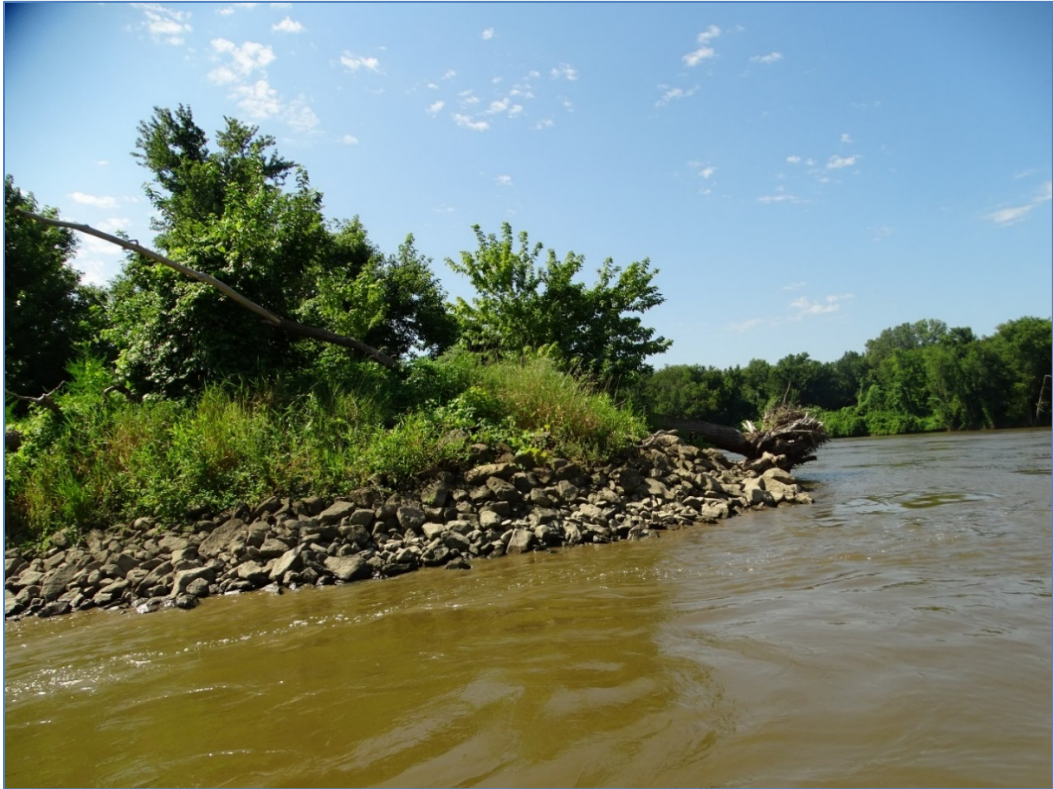
Photo 19: Island B, upstream end, riprap.

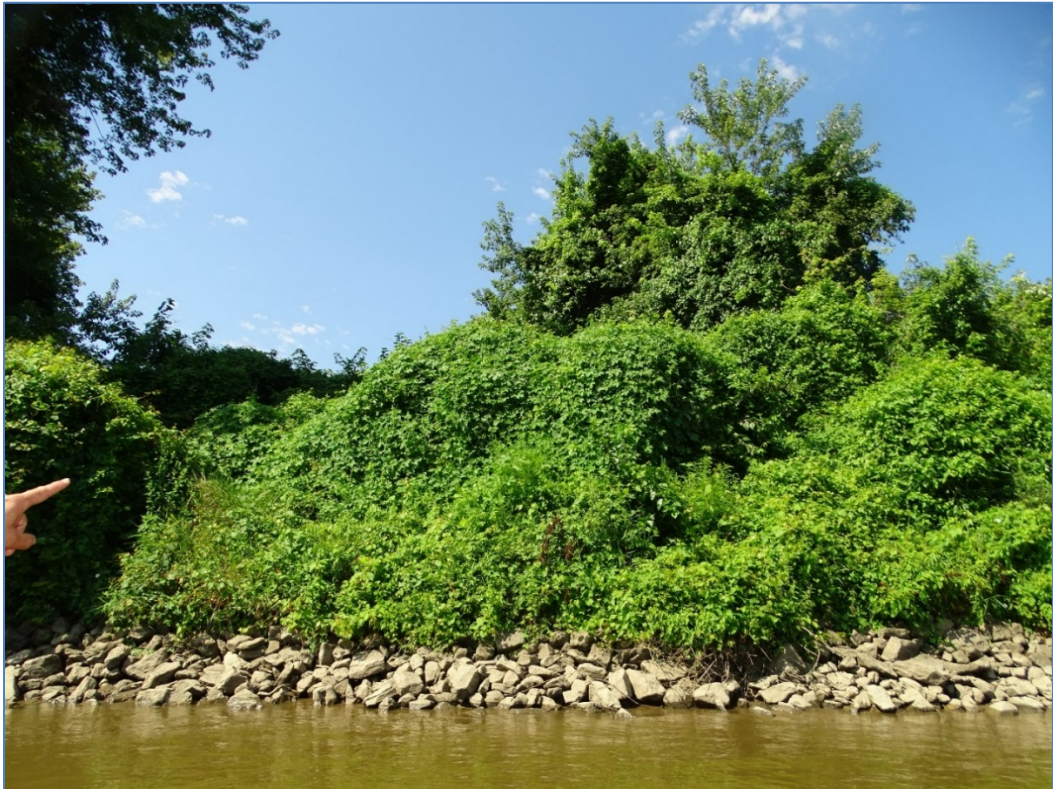
Photo 20: Island B, Japanese hops over wild grape.

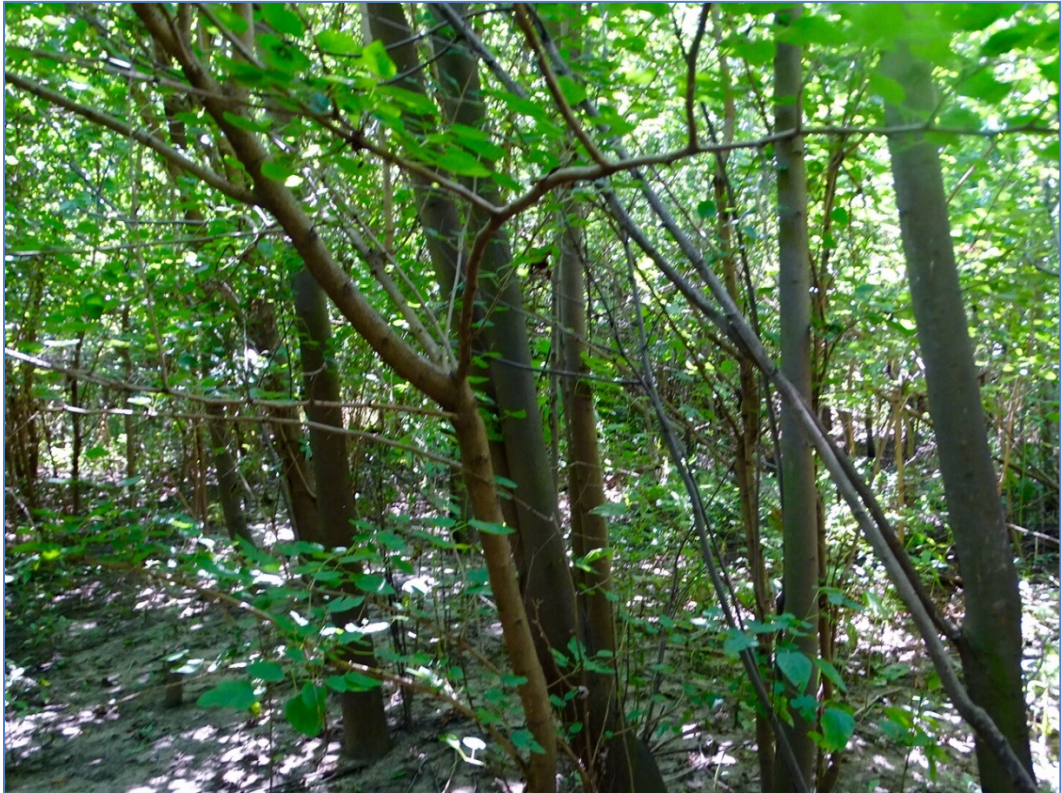
The reforestation site was visited. Following tree mat removals, an experience referred to as a special bonding time, the trees have started to thrive. Three years of aerial spraying helped control the vine species (see timeline below), and willow and silver maple are growing in between the planted trees, providing shade cover so that the weeds do not over take the trees, and forcing the planted trees to grow straight and up. A thinning may occur in the near future at this site to remove some trees adjacent to the hard mast trees. Several pecan and oak trees were located and they look very healthy. Several stump sprouts were also observed. Closer to the bank line, there was indication of beaver activity, but generally on black willow and silver maple. The berms have filled in the interior with sediment, but based on different soil colors, the berm locations can still be identified. (Photos 21, 22 in Attachment B)

Photo 21: Reforestation area.

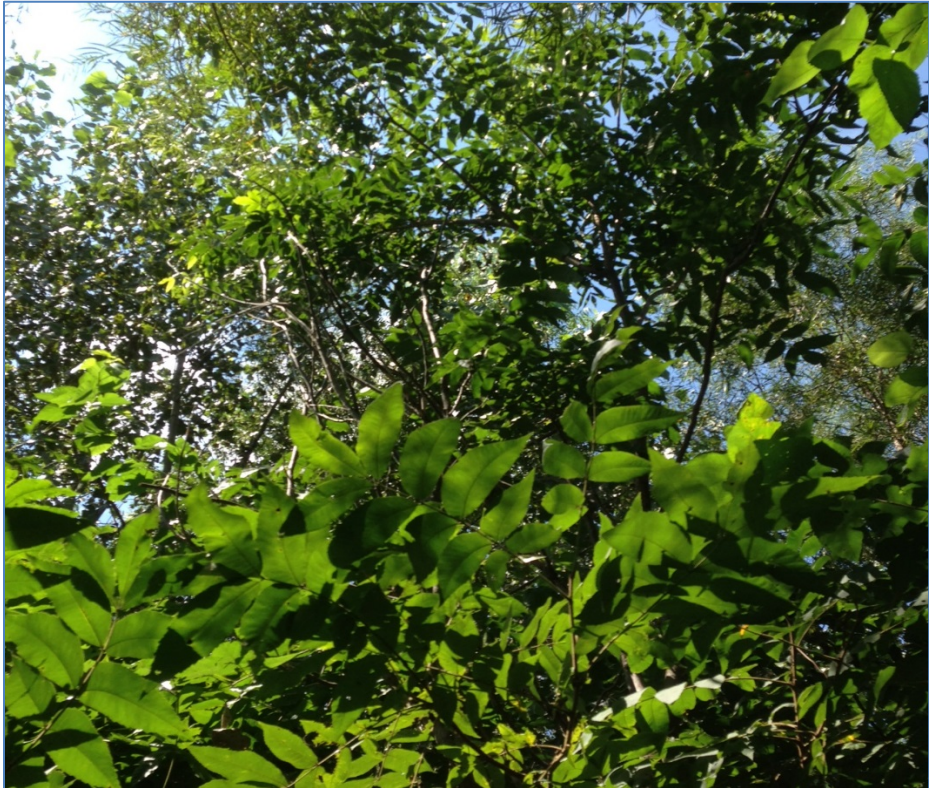
Photo 22: Pecan Tree (largest observed).

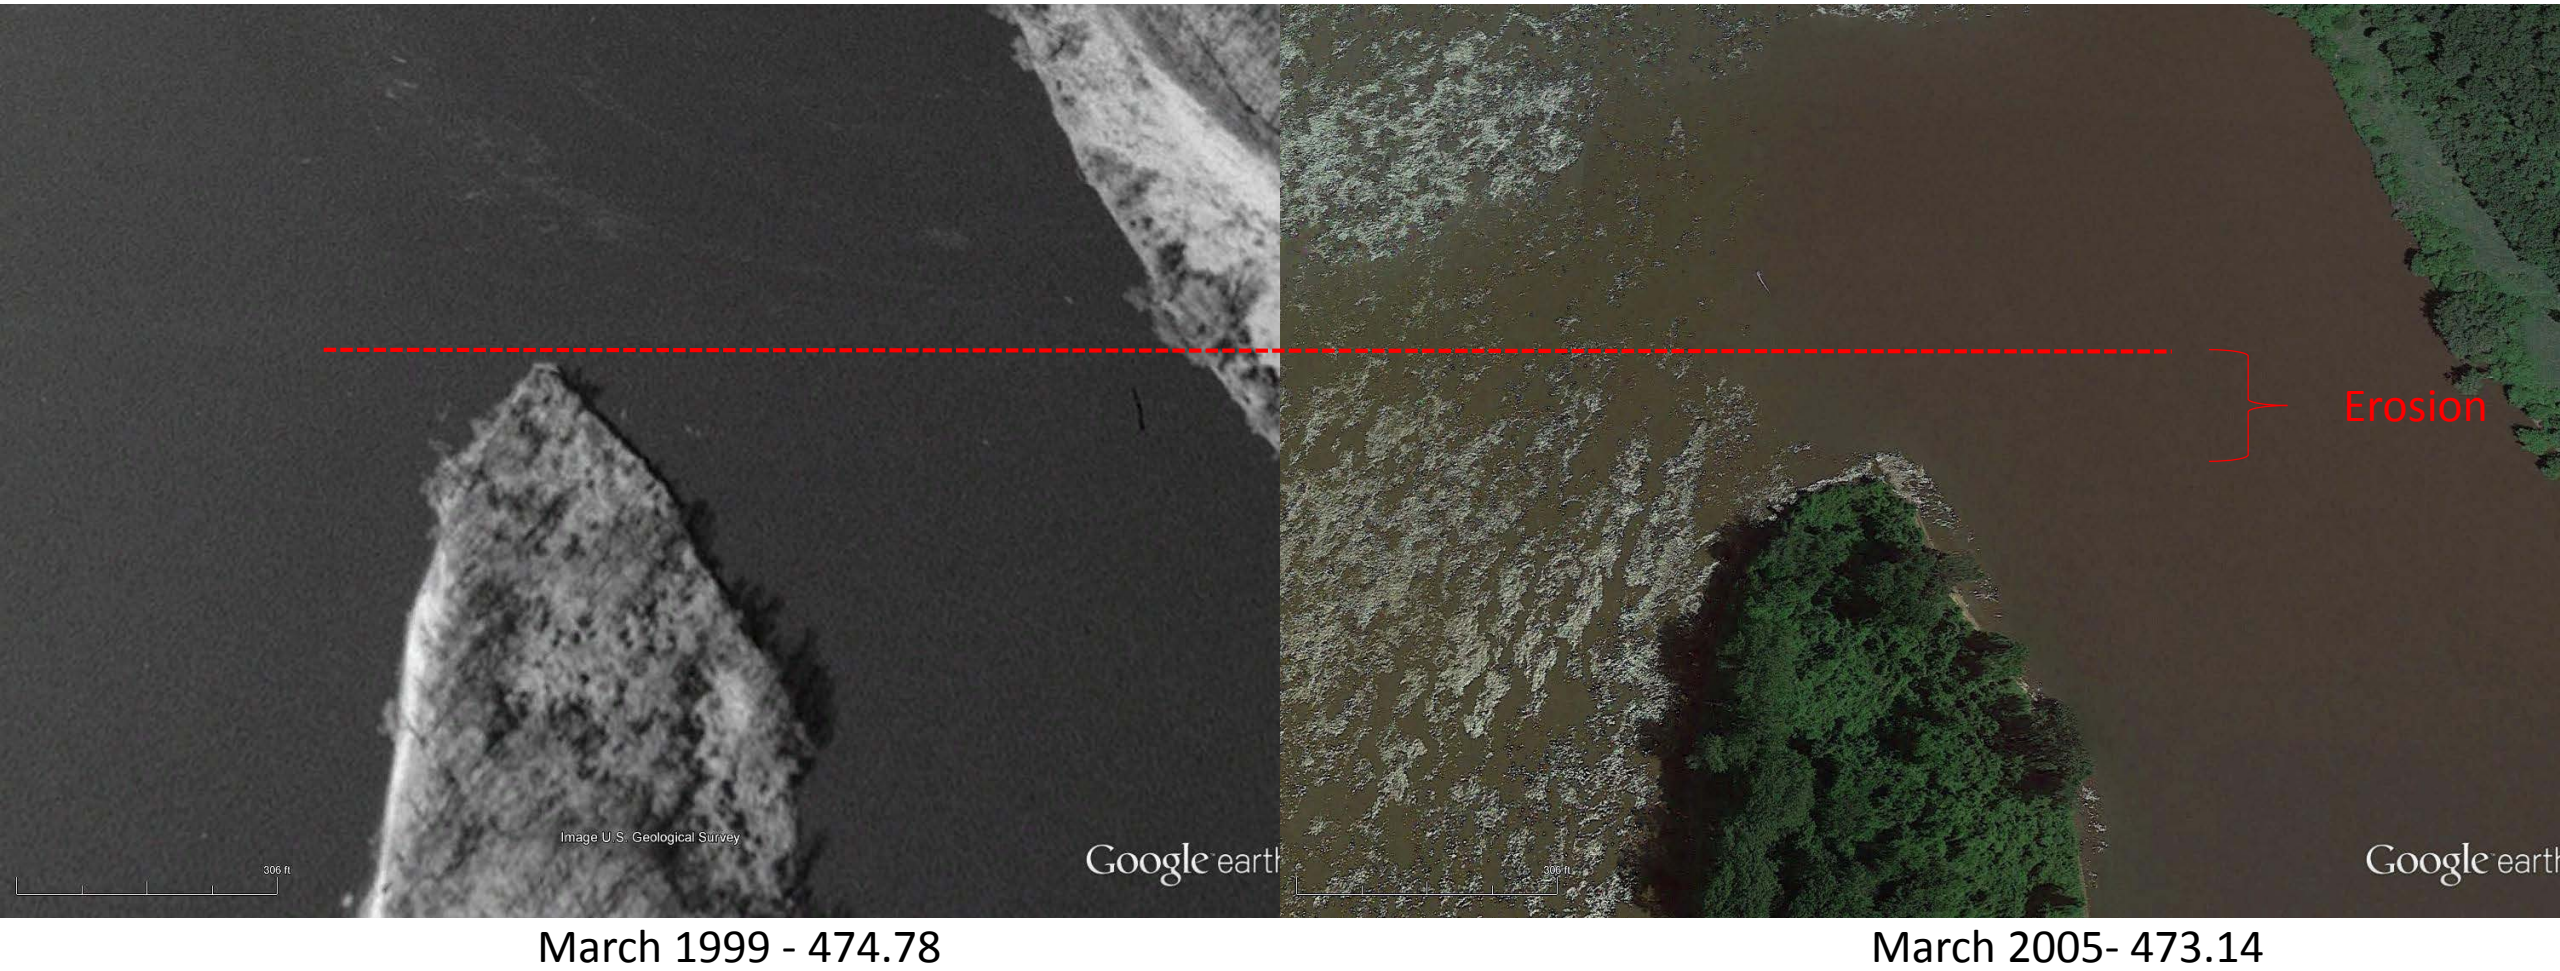
Island Erosion Prior to Chevron
