UMRR HREP
INSPECTION OF COMPLETED WORKS

Long Island Division-Gardner Division (HREP)

Upper Mississippi River Restoration (UMRR)

X. DATE OF FIELD VISIT: 8/18/2016

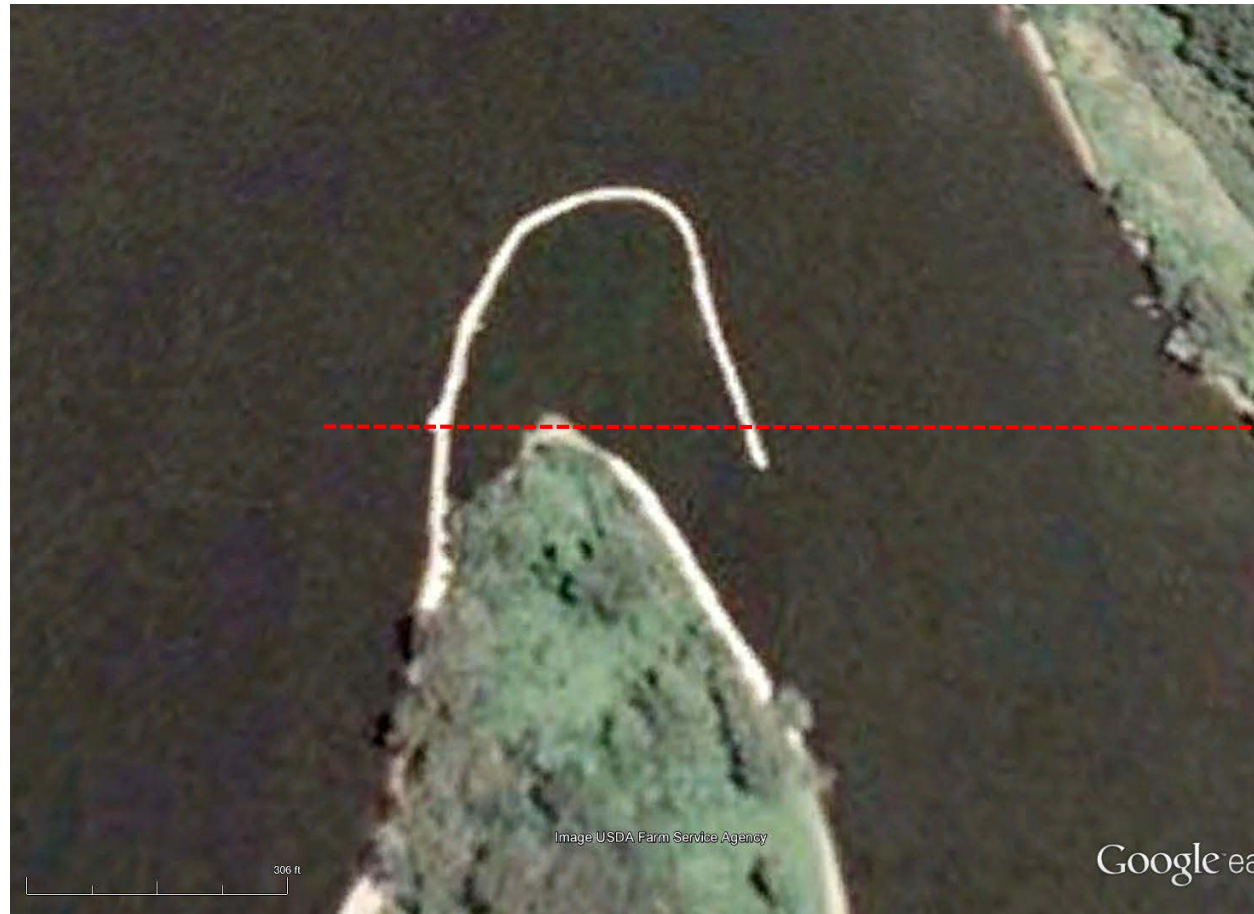
The chevron at the head end of LaGrange Island structure was submerged at the time of the field visit, but disturbances at the surface allowed the boat around the outside circumference of the structure. Depth finders indicated that for the most part the structure is still at the appropriate location. Riprap on the Island bank remains in place, and active erosion does not appear to be rapidly continuing on the island. The depth finder in the interior of the chevron indicated about 6.5 feet at the time of the site visit. The depth finder read about 14 feet on the upstream end of the chevron (Photo 12, Attachment B). An air photo timeline of the erosion at the upstream end of LaGrange Island is included in Attachment C.

Island Erosion Post Chevron Construction
