**UPPER MISSISSIPPI RIVER SYSTEM
ENVIRONMENTAL MANAGEMENT PROGRAM
POST-CONSTRUCTION PERFORMANCE
EVALUATION REPORT SUPPLEMENT (PERS2)**

**MONKEY CHUTE HABITAT REHABILITATION
AND ENHANCEMENT PROJECT**

**JUNE 2001
12-YRS POST CONSTRUCTION**

**POOL 21
MISSISSIPPI RIVER MILE 325
MARION COUNTY, MISSOURI**

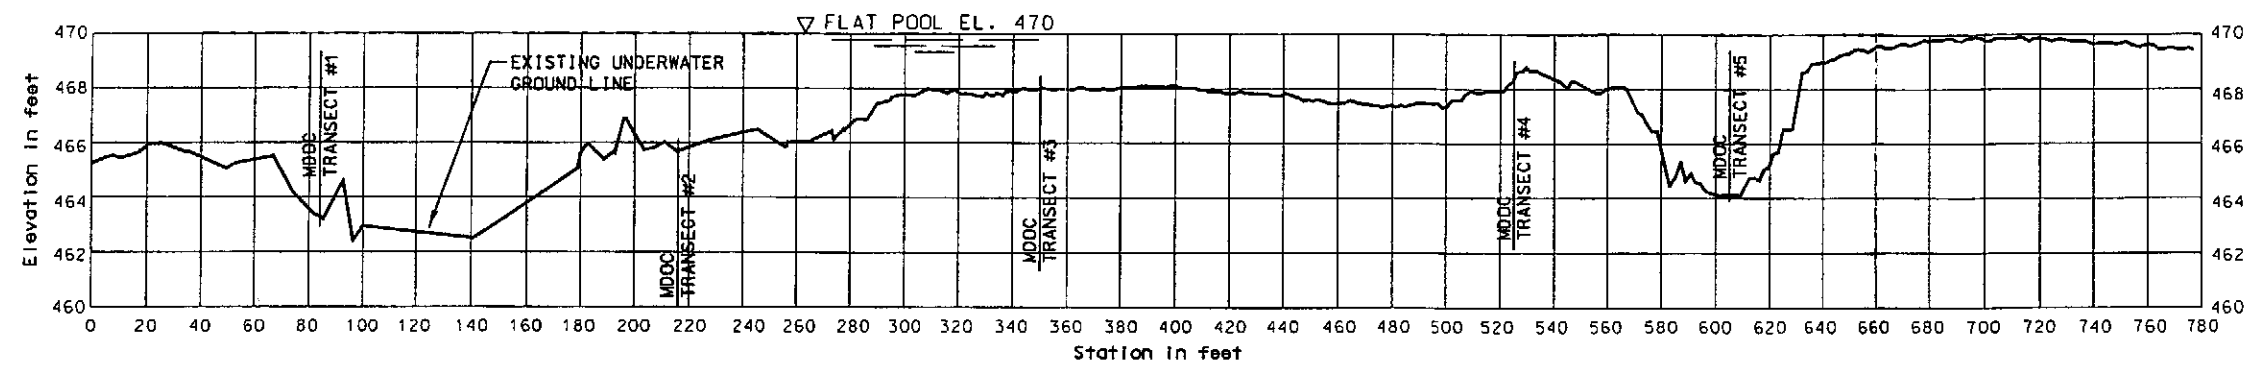
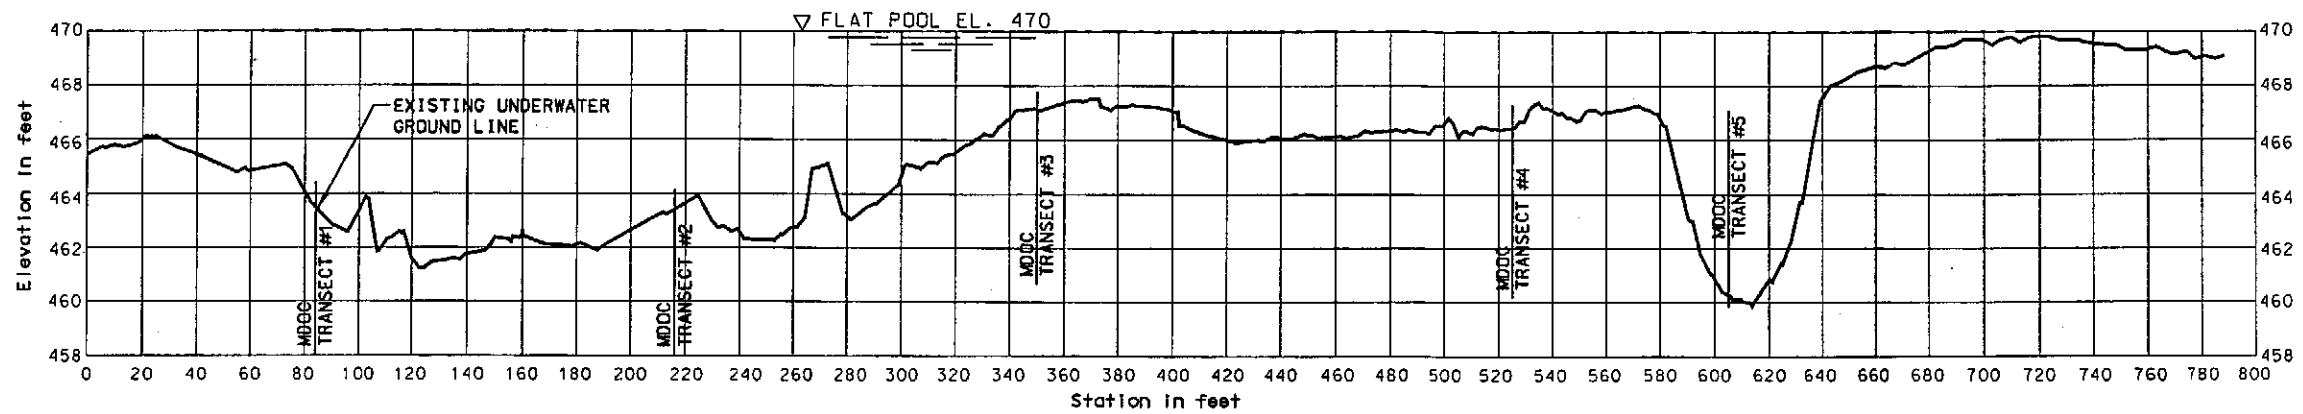
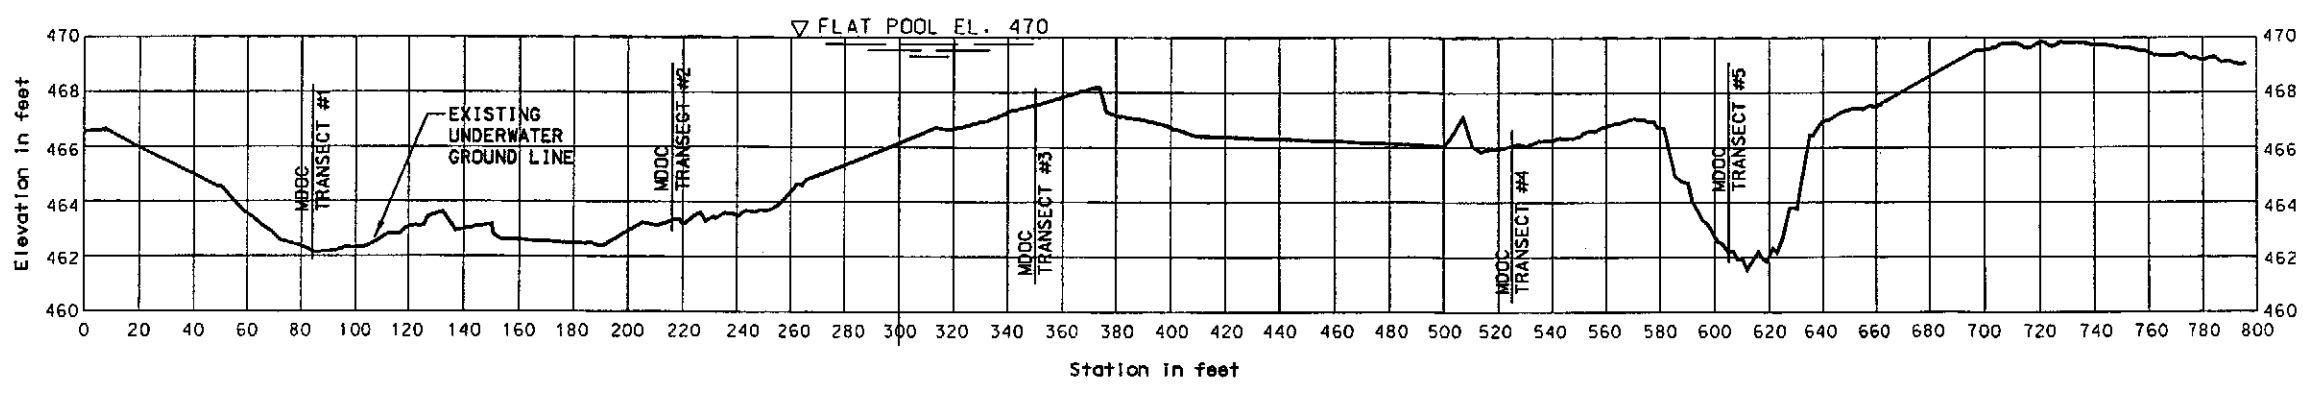
**MONKEY CHUTE
PROFILES A, B AND C**

1. THE STARTING LOCATION FOR PROFILES A, B AND C (0+00) EQUALS -2+00 AS SHOWN ON PLATE #1.
2. THE 1998 CORPS PROFILES A, B AND C SHOW HOW SILT ACCUMULATION IS REACHING THE FLAT POOL ELEVATION OF 470.0 AROUND STATIONS 680 TO 780, ABOVE.

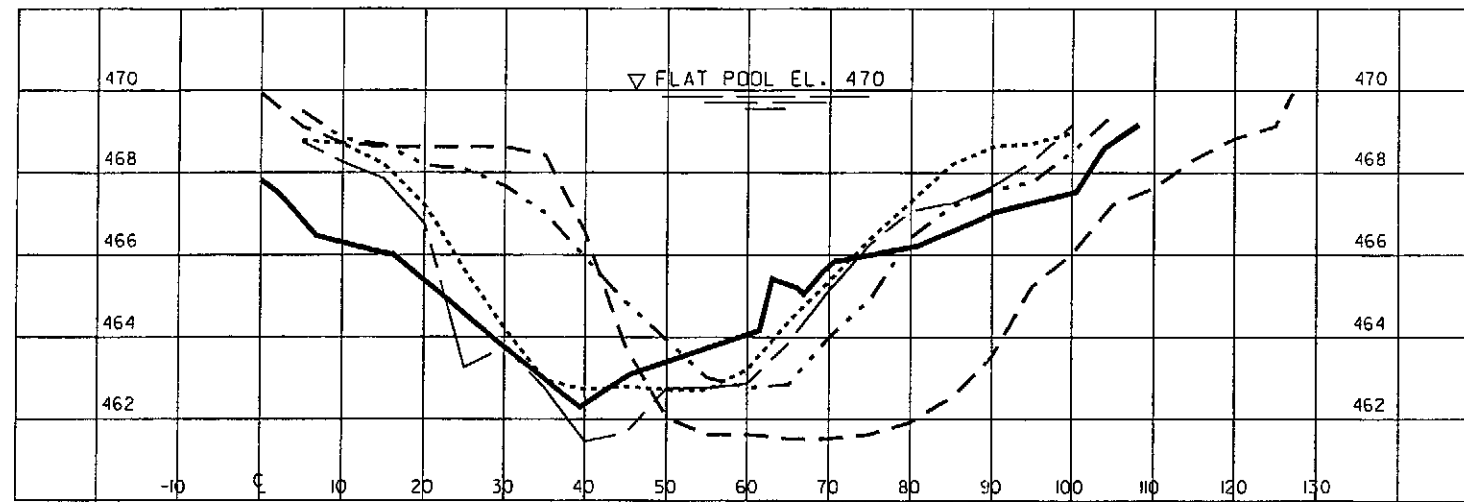
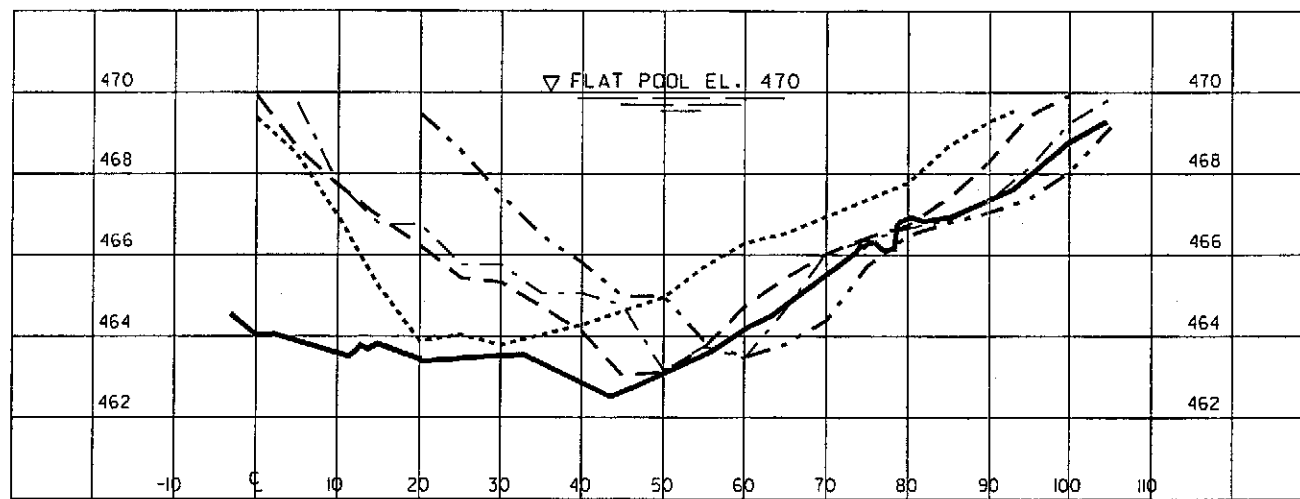
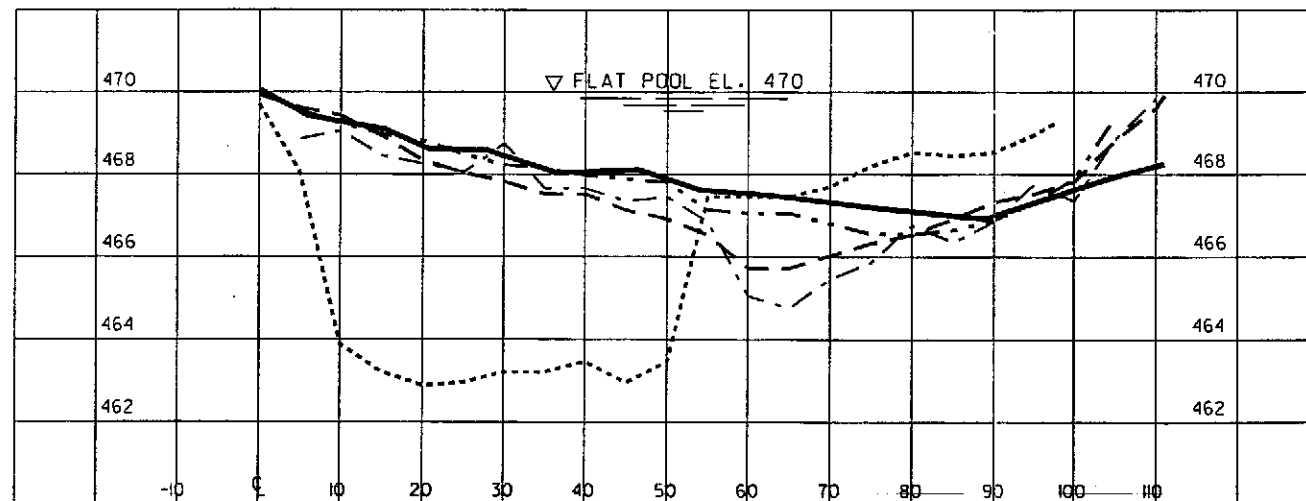
UPPER MISSISSIPPI RIVER
ENVIRONMENTAL MANAGEMENT PROGRAM
POOL AT CHUTE, MISSOURI
**MONKEY CHUTE
TRANSECTS 1, 2 AND 3**

You mentioned movement at transect 1, the mouth of Monkey Chute. Trees that were marked as boundary posts soon after the channel was dredged apparently fell into the river. We have noticed that there continues to be some movement at both upstream and downstream edges of the mouth. Current flowing into and out of the chute may saturate the banks and cause failures at the mouth.

1. THE MDOC TRANSECTS #1 THRU #5 SHOW HOW SILT ACCUMULATION HAS SHIFTED ALONG THE MOUTH AND DREDGED AREA OF THE CHUTE FROM 1989 TO 1998.
