**UPPER MISSISSIPPI RIVER SYSTEM
ENVIRONMENTAL MANAGEMENT PROGRAM
POST-CONSTRUCTION PERFORMANCE EVALUATION
REPORT SUPPLEMENT (PERS1)**

**MONKEY CHUTE HABITAT REHABILITATION
AND ENHANCEMENT PROJECT**

**POOL 21, RIVER MILE 325
MARION COUNTY, MISSOURI**

APRIL 1998

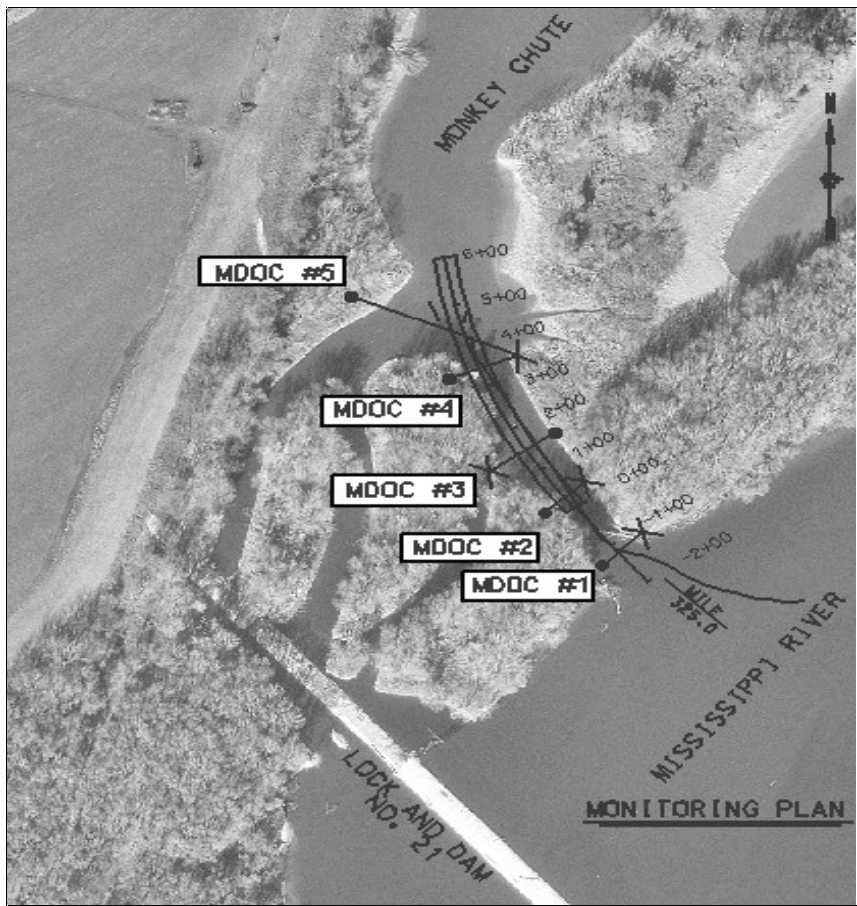
FIGURE 4-1. Monkey Chute Monitoring Plan.

d. Missouri Department of Conservation. The MDOC has collected sediment transect data on an annual basis and, beginning in 1997, on a semi-annual basis since project completion. The transect locations are shown in Figure 4-1 and on plate 1. The MDOC sediment transect data are shown on plates 2 and 3. The MDOC has also conducted fish sampling for largemouth bass (with the Illinois Department of Natural Resources) and paddlefish.

(1) Monitoring Results. Channel depths are more or less the same as previous surveys, ranging from 4 feet to 11 feet below flat pool (elevation 470 feet NGVD 1912). The MDOC commented that trees marked as boundary posts apparently fell in the river soon after the project was completed (see Appendix B). The MDOC notes that there continues to be movement at both the upstream and downstream sides of the mouth. This is evident in the lateral movement of the channel at MDOC transect 1.

The MDOC 1995 monitoring efforts noted a deep hole (maximum depth of 12 feet) between MDOC transects 4 and 5. The MDOC had purchased a new 3-D depth finder in 1995 and wanted to see if fish were using the project area. The depth finder identified the hole, which MDOC subsequently verified with manual measurements. Because the hole does not fall along one of the transects, its presence was not detected prior to this time. The 1995 MDOC transect 5 appears to encompass a portion of this hole. The MDOC 1997 monitoring efforts indicate that the hole has increased both in size and in depth from 1995 to 1997.

The continued movement at MDOC transect 1 indicates that the channel side slopes have not stabilized in this vicinity. Debris and eddy currents during high flows and the proximity of the spillway at Lock and Dam 21 may also be contributing factors. The shallower area between transects 3 and 4 may be due to the remnant wing dam.

The MDOC discussed possible reasons for the existence and expansion of the deep hole in a December memo (see Appendix B). One possibility for the existence of the hole was that it was created during project construction or was a borrow source for construction of the Fabius Drainage District levee. Another possible reason for the hole and its apparent movement may be that the hole filled with loose sediment after dredging, which was subsequently flushed during recent high water events (1993, 1995, and 1997). Water flowing across the dredged material placement site during high flow may be creating turbulent water as it meets with water from the main portion of the project area. Finally, the dredged channel may have been close enough to an existing deep hole that the side slopes on the deep hole failed, resulting in its subsequent enlargement.

The MDOC should continue biennial monitoring of the transects. Continued monitoring will help determine the dynamics of the deep hole at MDOC transect 5. The Corps will profile the channel and deep hole area following the 1998 high water period. If monitoring efforts note continued movement of the deep hole, the Corps will initiate a hydraulic model study.
