UPPER MISSISSIPPI RIVER SYSTEM
ENVIRONMENTAL MANAGEMENT PROGRAM
POST CONSTRUCTION PERFORMANCE
EVALUATION REPORT (PER 1F)

**MONKEY CHUTE
RESTORATION
PROJECT**

**POOL 21
UPPER MISSISSIPPI RIVER
MILE 325
MARION COUNTY, MISSOURI**

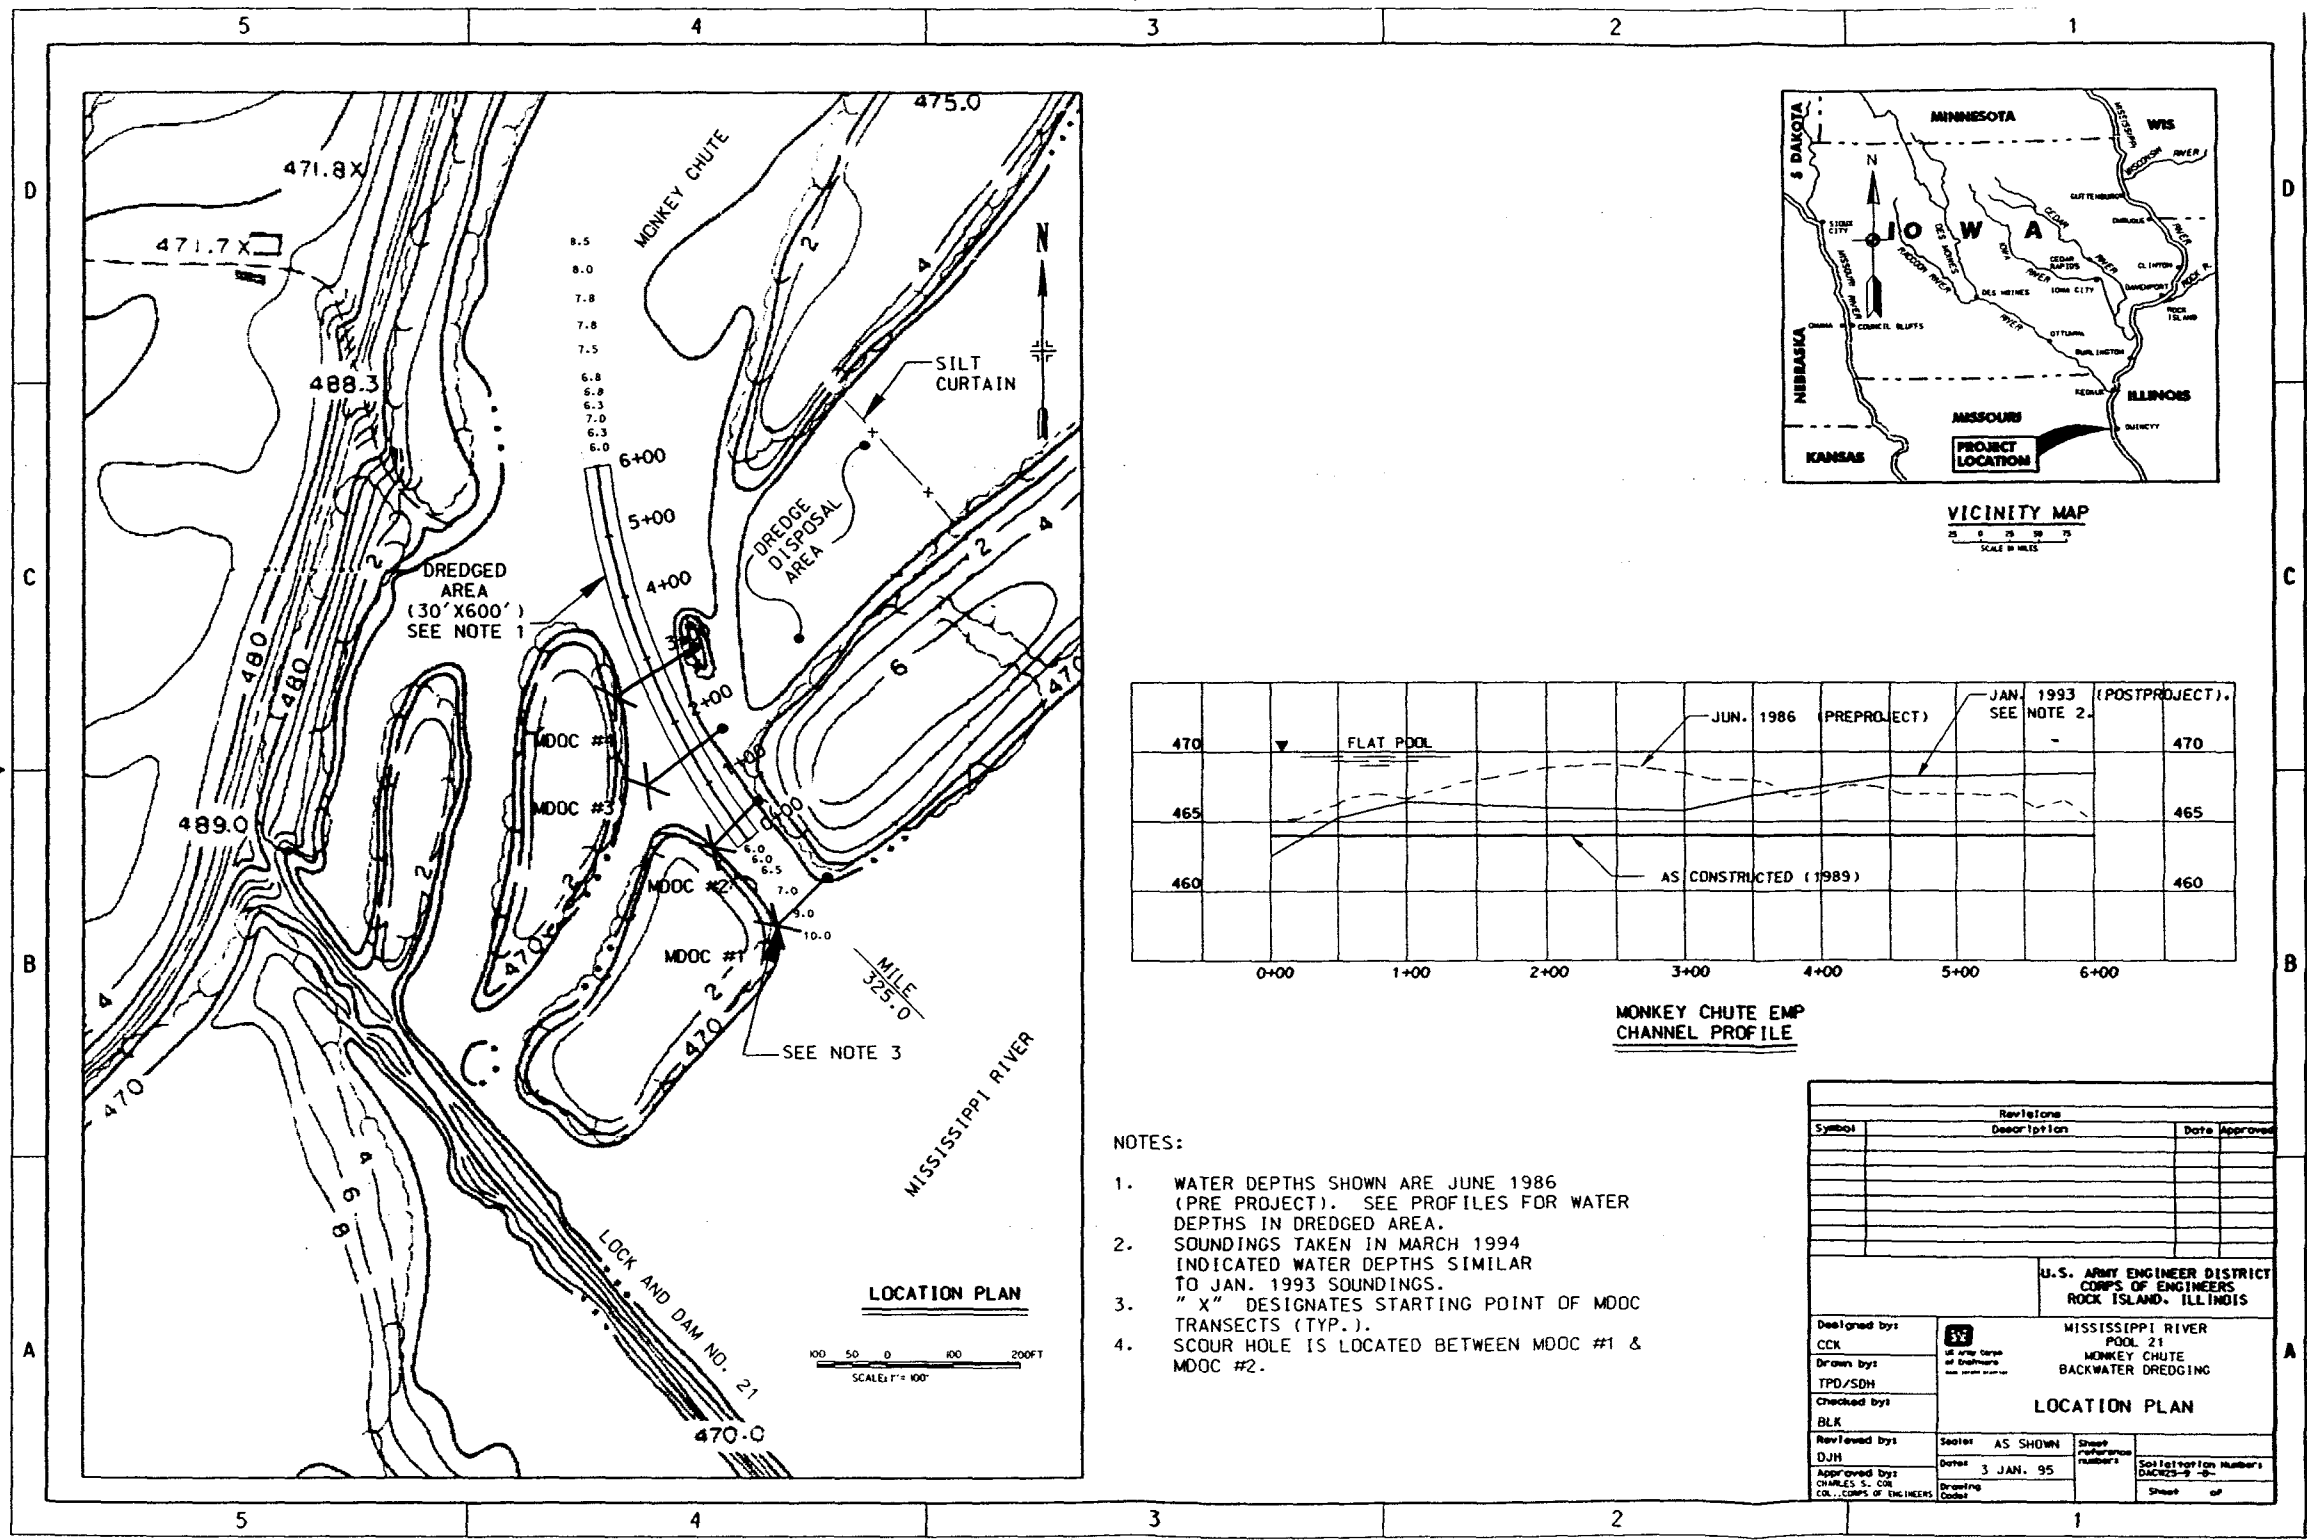
b. Corps of Engineers. As part of the Flood of 1993 Damage Assessment, the Corps reviewed pre-flood surveys of the Monkey Chute dredged channel. The sounding profiles are shown on Plate 1. Post-flood soundings were performed in March 1994. The March 1994 soundings indicated water depths similar to the January 1993 soundings. No post-construction water quality data has been collected for this project. Pre- and post-construction aerial photography is shown on Plate 4.

(1) Monitoring Results. Corps pre-flood surveys (January 1993) of the Monkey Chute dredged channel indicated that the channel had already experienced heavy siltation at the upstream end. The January 1993 soundings revealed that the upstream 240 feet of channel (40 percent of the channel length) had a water depth of only 1.5 to 3 feet at flat pool conditions, compared to the post-construction water depth of 6 feet. Post-flood soundings are similar to the pre-flood soundings, i.e., approximately 40 percent of the channel length had a water depth of only 1.5 to 3 feet. Both surveys indicate the presence of a scour hole between the chute opening and the dredged channel. The water depth at the scour hole was 7.5 feet pre-flood and 9.5 feet post-flood at flat pool conditions. The water

1. WATER DEPTHS SHOWN ARE JUNE 1986 (PRE PROJECT). SEE PROFILES FOR WATER DEPTHS IN DREDGED AREA.
2. SOUNDINGS TAKEN IN MARCH 1994 INDICATED WATER DEPTHS SIMILAR TO JAN. 1993 SOUNDINGS.
3. "X" DESIGNATES STARTING POINT OF MDOC TRANSECTS (TYP.).
4. SCOUR HOLE IS LOCATED BETWEEN MDOC #1 & MDOC #2.

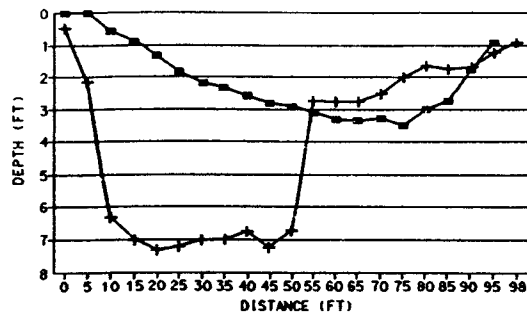
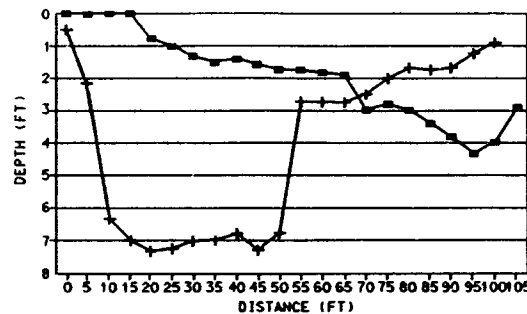
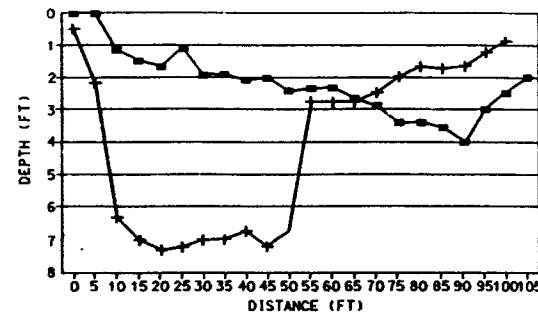
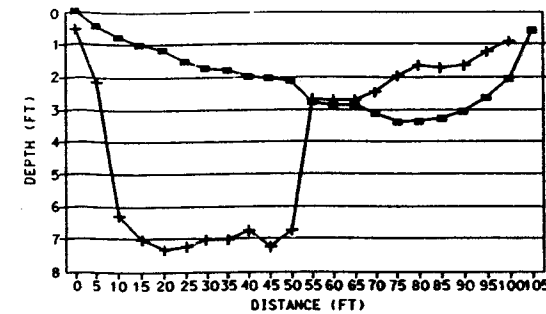
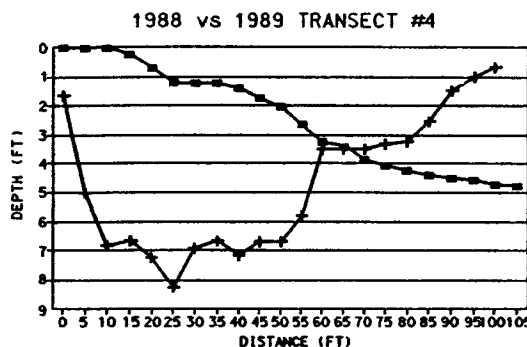
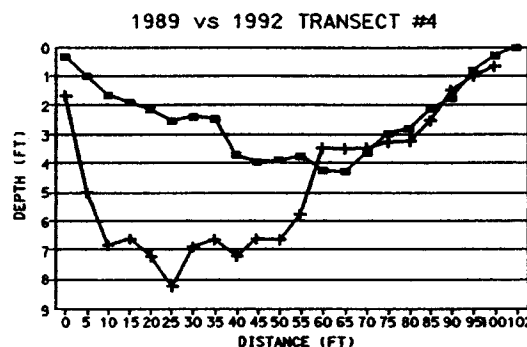
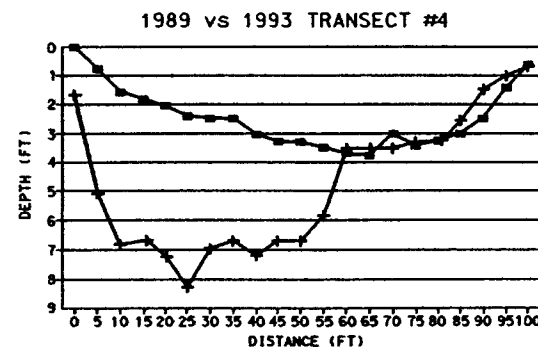
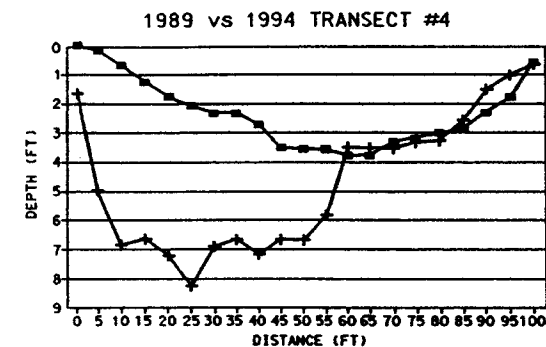
d. Missouri Department of Conservation. The MDOC has collected sediment transect data on an annual basis since project completion. The location of these transects is shown on Plate 1. The MDOC sediment transect data are shown on Plates 2 and 3.

MDOC sediment transects reveal water depths in 1992 at the upstream end of the channel similar to pre-project water depths. MDOC transects also indicate lateral movement of the channel bottom to the right as the channel progresses upstream. MDOC conversations with fishermen indicate that a healthy, year-round sport fishery still exists within the Monkey Chute backwater area.

Transects 1 and 2 show little deposition, maintaining post project depths at approximately 7 feet. As the pre project depth at transect 2 was only 2 feet, it's encouraging to see the deep water here being maintained. Transects 3 and 4 show considerable reduction in depth as early as 1992, four years after the project was finished. In 1989, immediately following project construction, maximum depths at transects 3 and 4 were approximately 7 feet and 8 feet respectively. At these sites four years later, maximum depths recorded at 4 feet are approaching pre project conditions.

I haven't elaborated in length over the data, as I believe they clearly show heavy accretion at transects 3 and 4 and no accretion at transects 1 and 2.

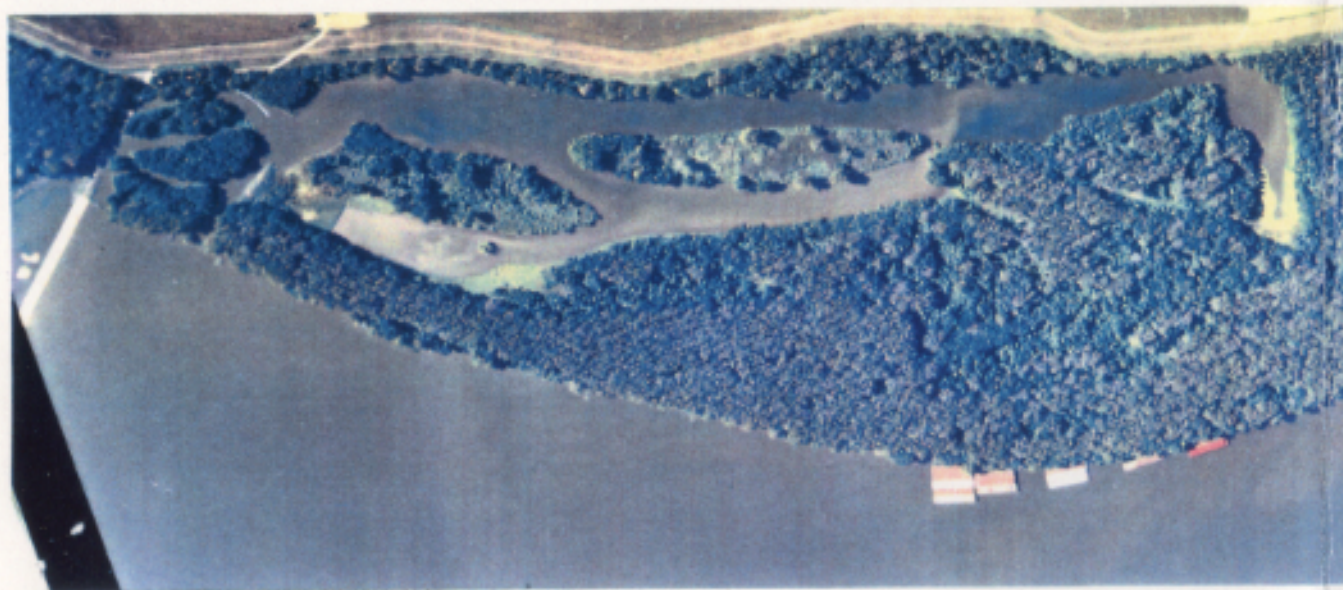
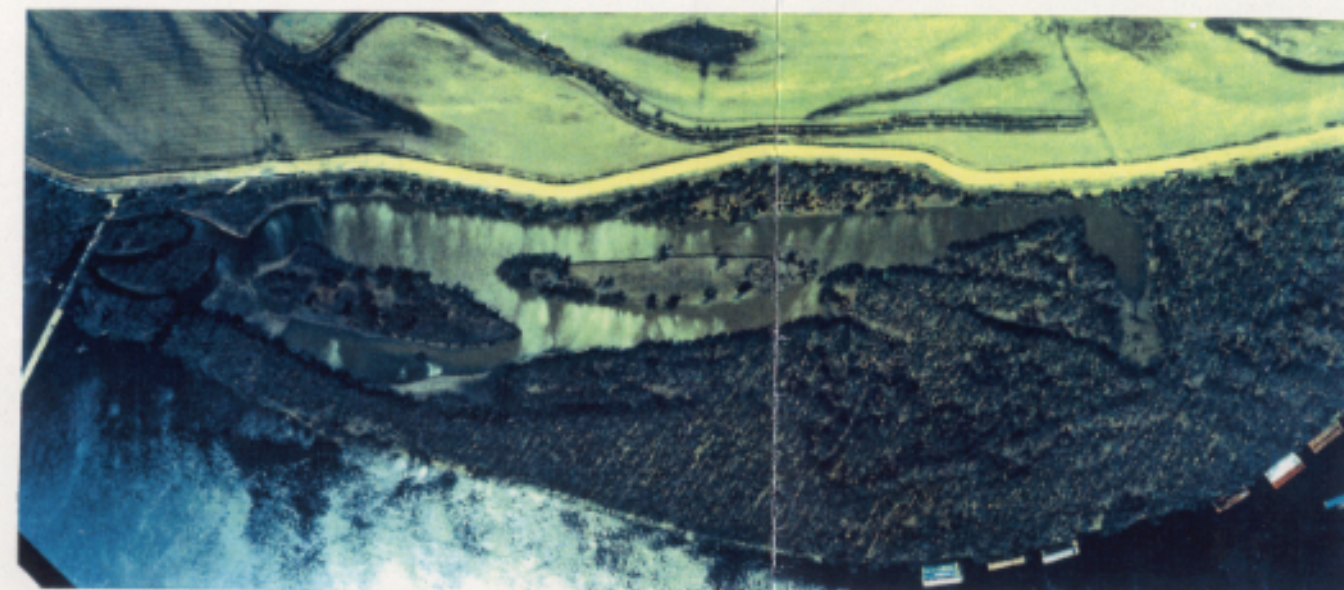
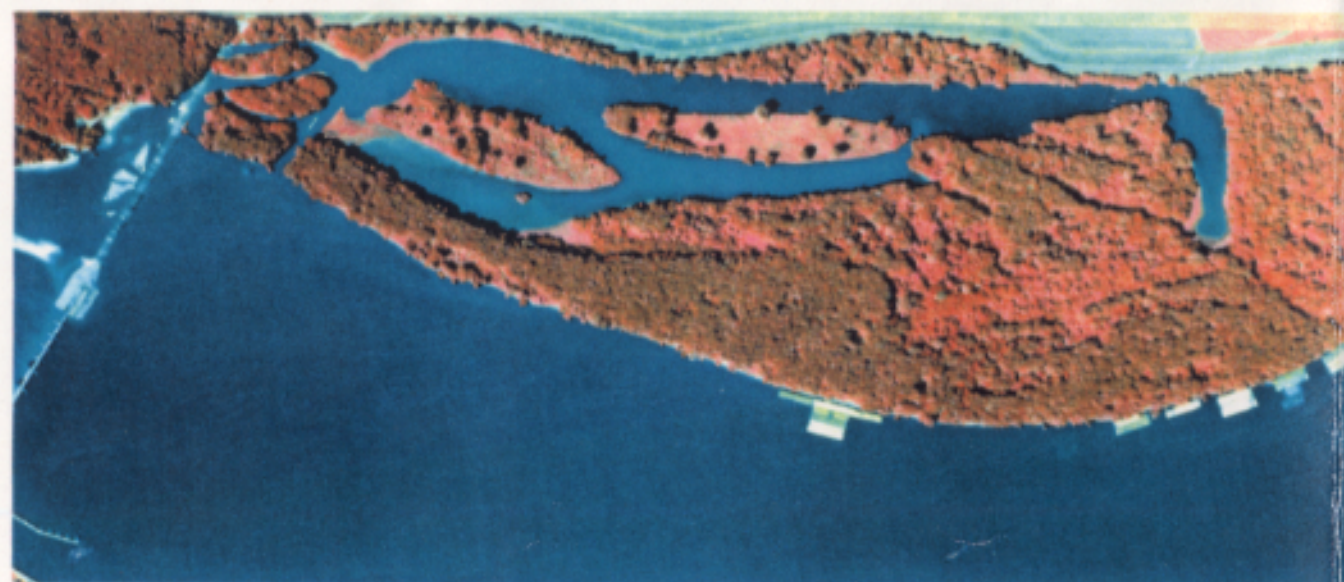
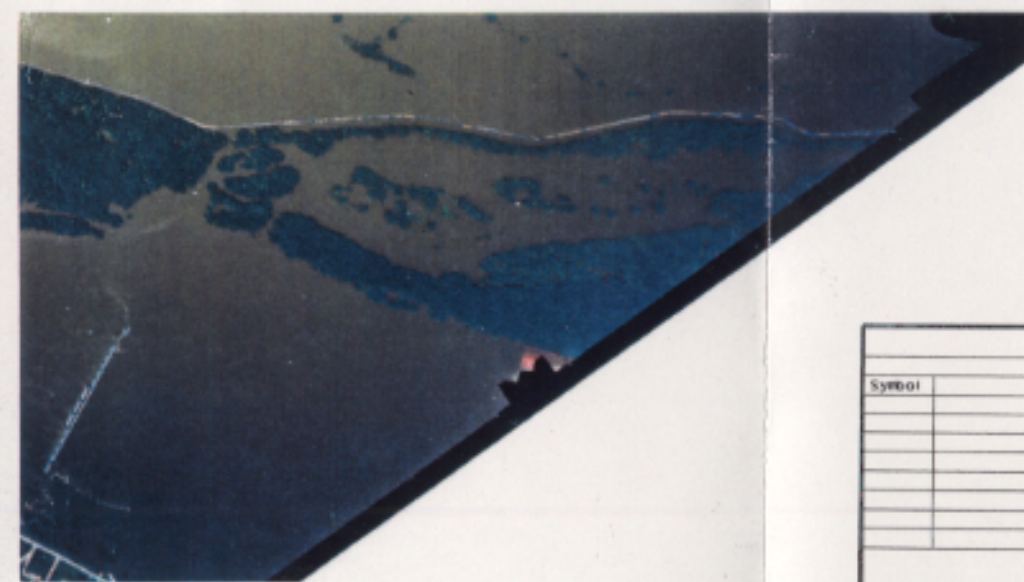
(1) Monitoring Results. Aerial photography from 1984, 1989, 1993, and 1994 reveal conversion of the uppermost reach of the Monkey Chute backwater area from open water to marsh to lowland brush habitat. The continued existence of a healthy, year-round sport fishery could be due, in part, to the presence of three deep holes (19-20 feet deep) in the backwater area. MDOC staff inquiries as to the history of the deep holes indicate the Monkey Chute backwater area was used as a borrow source for construction of the Fabius Drainage District levee.

(2) Dredged Material Placement Site.. All vegetation in this area is voluntary and consists primarily of invasive species. Plate 4 photography shows vegetation established on the dredged material in 1989, inundation of the dredged material site by the flood in 1993, and subsequent loss of vegetation in this area in 1994. Future projects should consider planting a mast component on dredged material. Corps foresters recommend placing a minimum of 4 feet of dredged material above existing ground elevation. While the finished grade of the dredged material placement site is not known, the 4-foot minimum placement height should ensure survival of mast tree plantings during most high water events.
