**UMRR HREP
INSPECTION OF COMPLETED WORKS
2016**

Potter's Marsh Habitat Rehabilitation and Enhancement Project (HREP)

Pool 13, Mississippi River Miles (RM) 522.5 to 526.0, Carroll and Whiteside Counties, IL

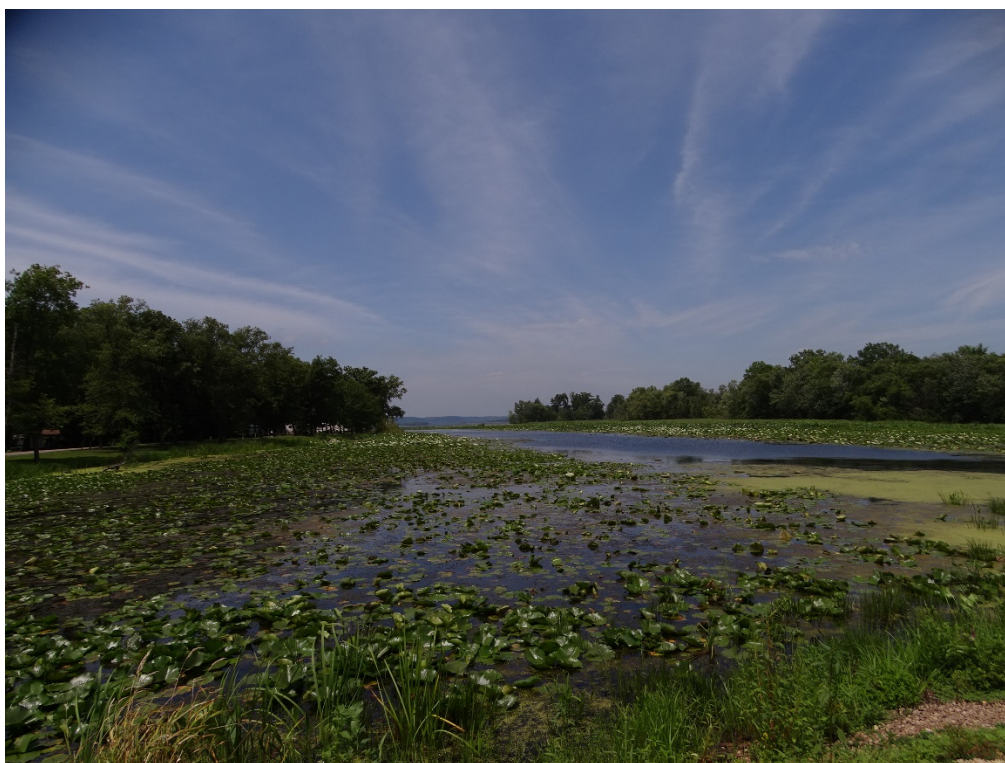
Sediment Trap: According to the USFWS, the excavation into the project (near the bridge/causeway) has significantly settled in. There are no recent hydrosurveys of the area.

Photo 1: View from Thomson Causeway Recreation Area access road – Sediment Trap and Hydraulic Dredging

Continued HREP monitoring at this site. Conduct hydrosurveys of dredge cuts.

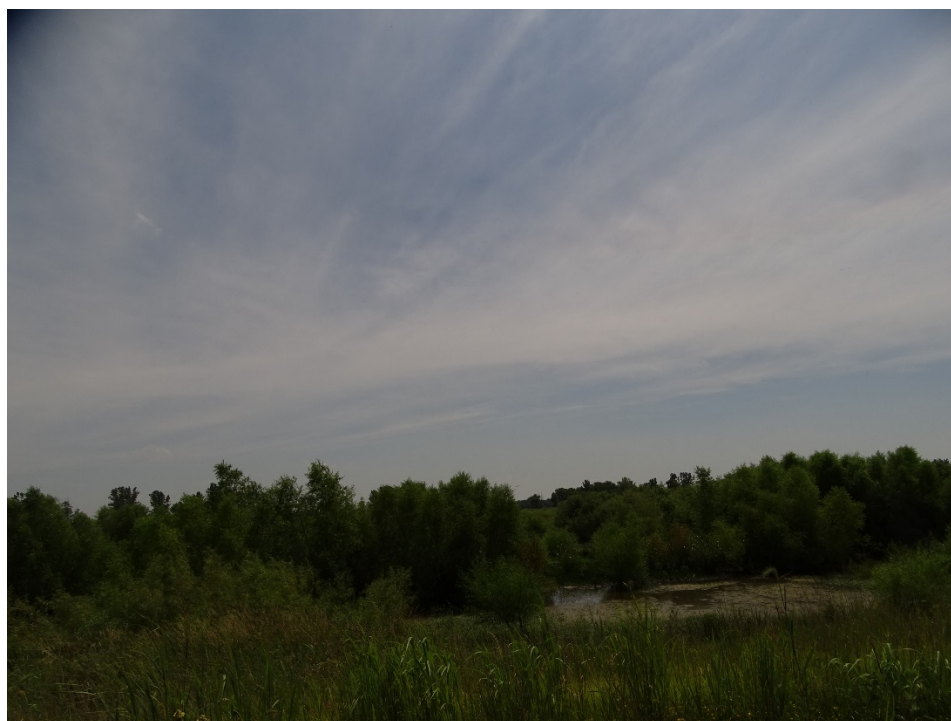
Marsh: The confined placement site is in good condition. The containment dike remains in good condition, and is well maintained with little woody debris or erosion noted. The slopes are satisfactory with good vegetation cover, and the top of the dike is graded properly and mowed. The interior holds water and has diverse vegetation.

Photo 2: Containment Interior, looking south from the containment dike road

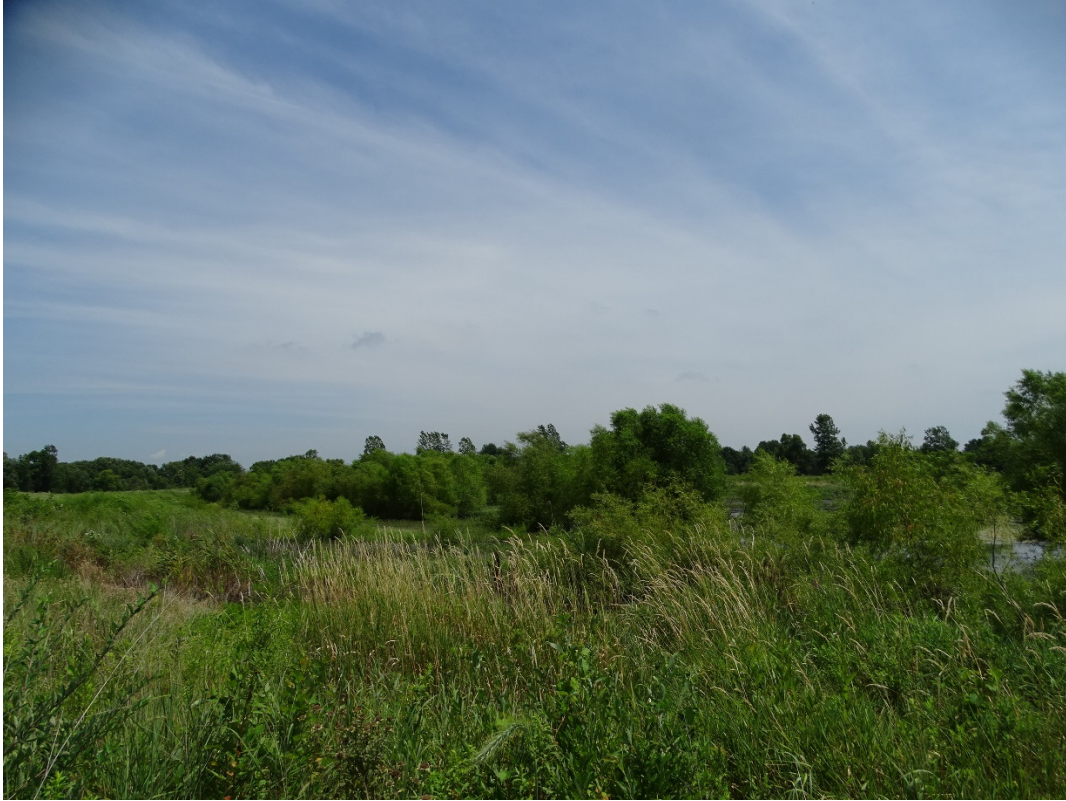
Photo 3: Containment Interior, looking southeast from the containment dike road

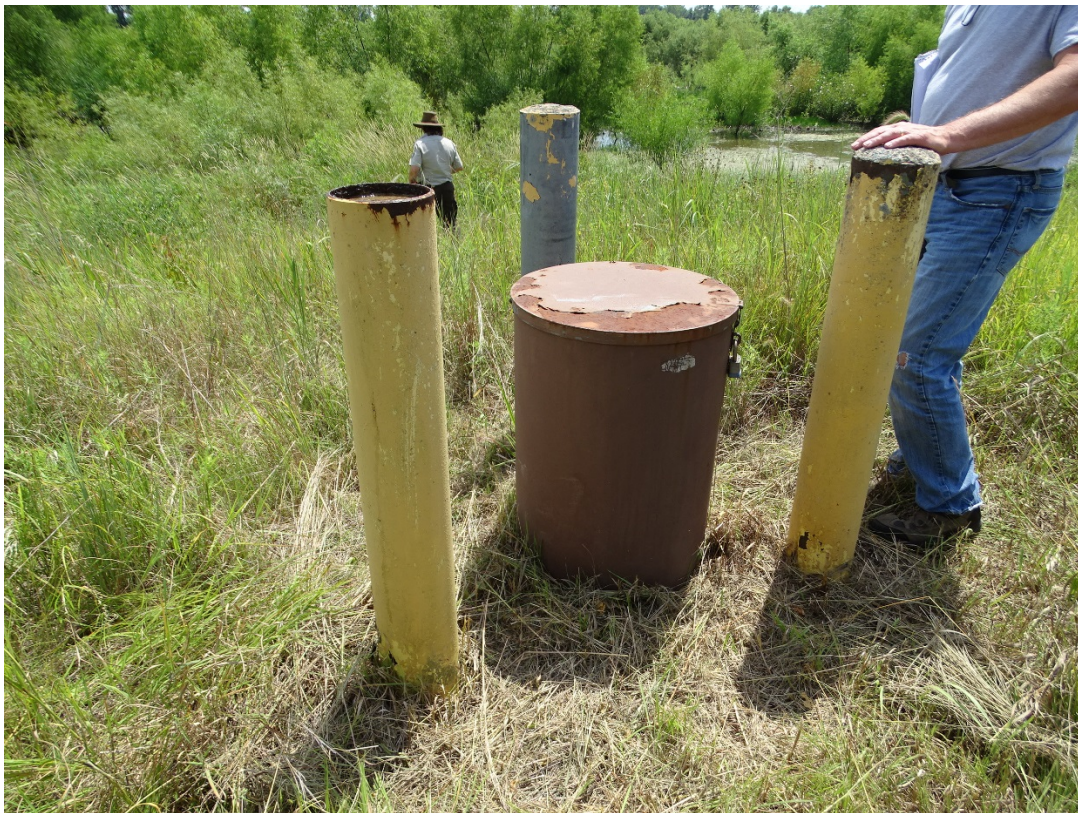
Marsh well pump: The water well and pump are maintained well and continues to operate adequately.

Photo 4: Well

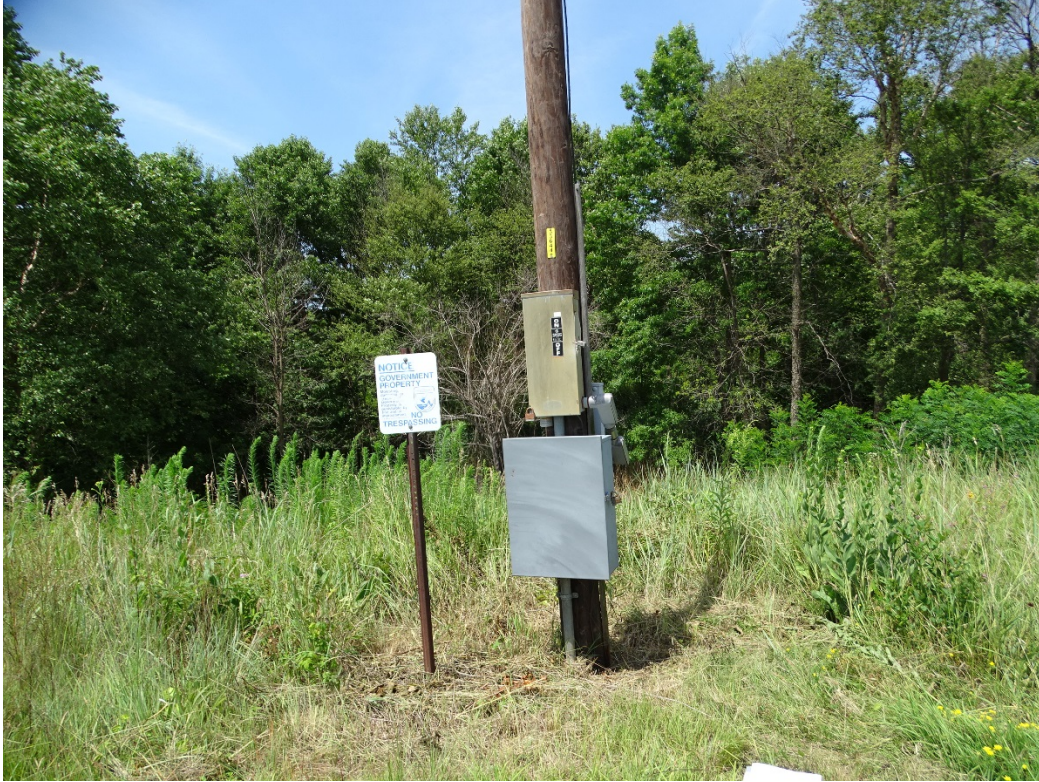
Photo 5: Electrical equipment for the well

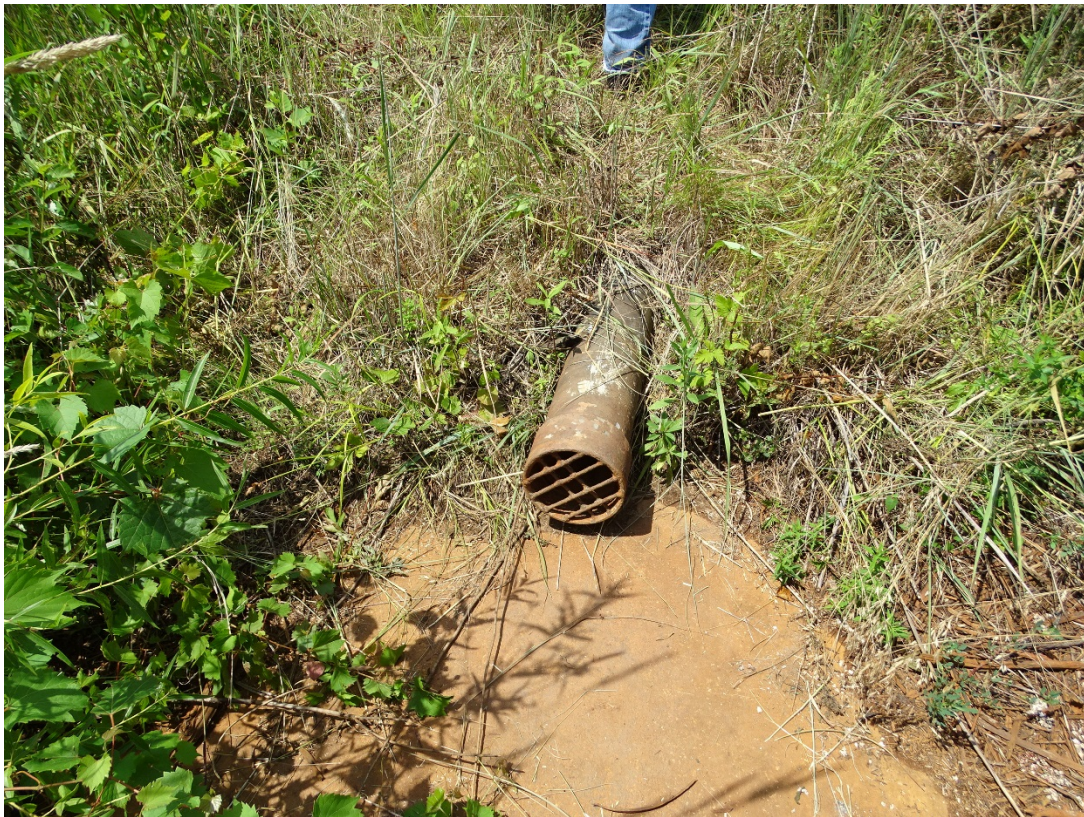
Photo 6: Well outlet pipe

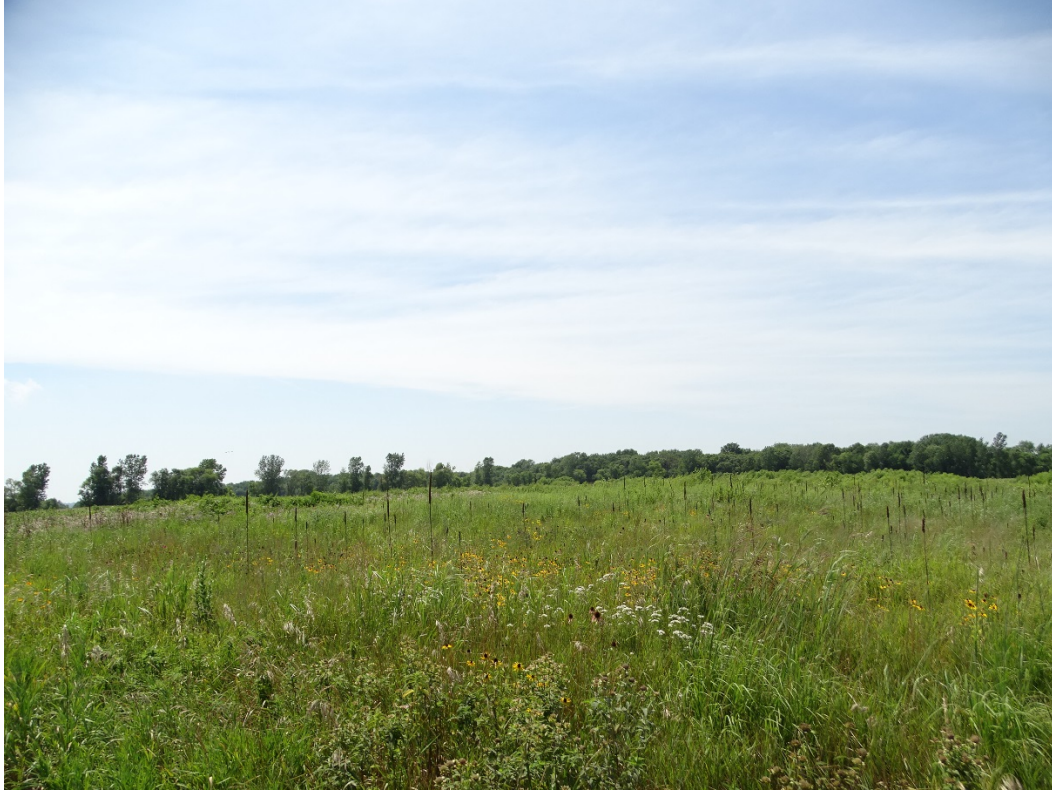
Photo 7: Vegetation in the containment interior

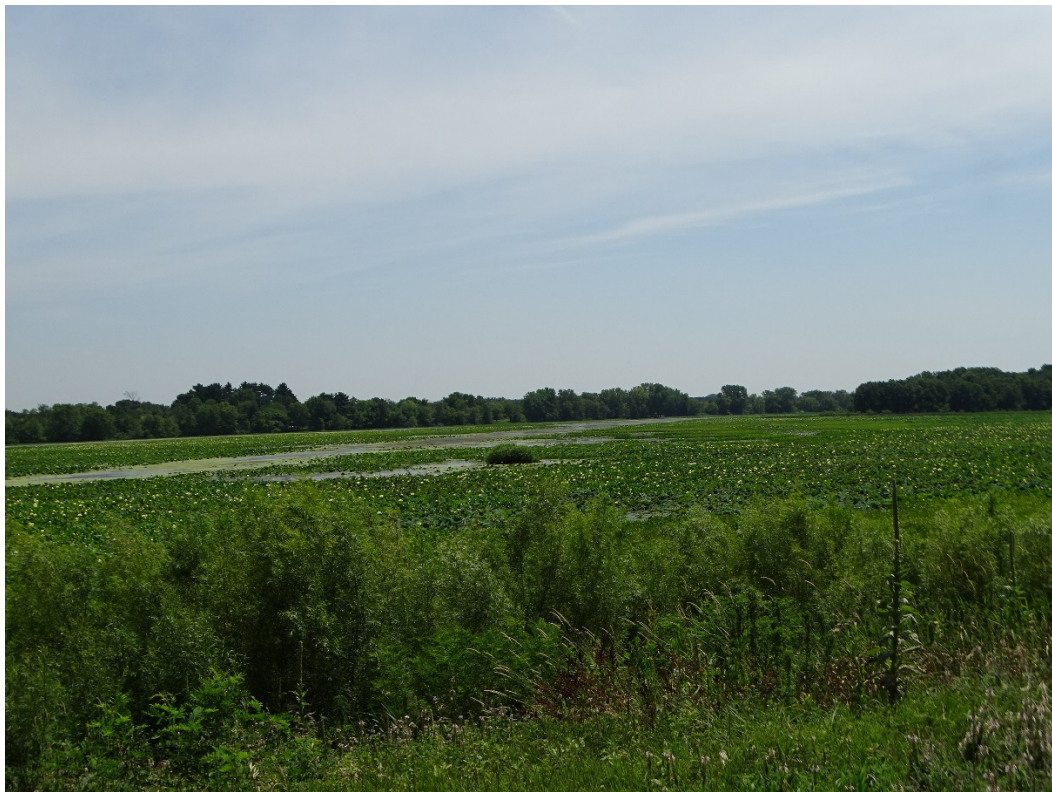
Photo 8: Habitat channels

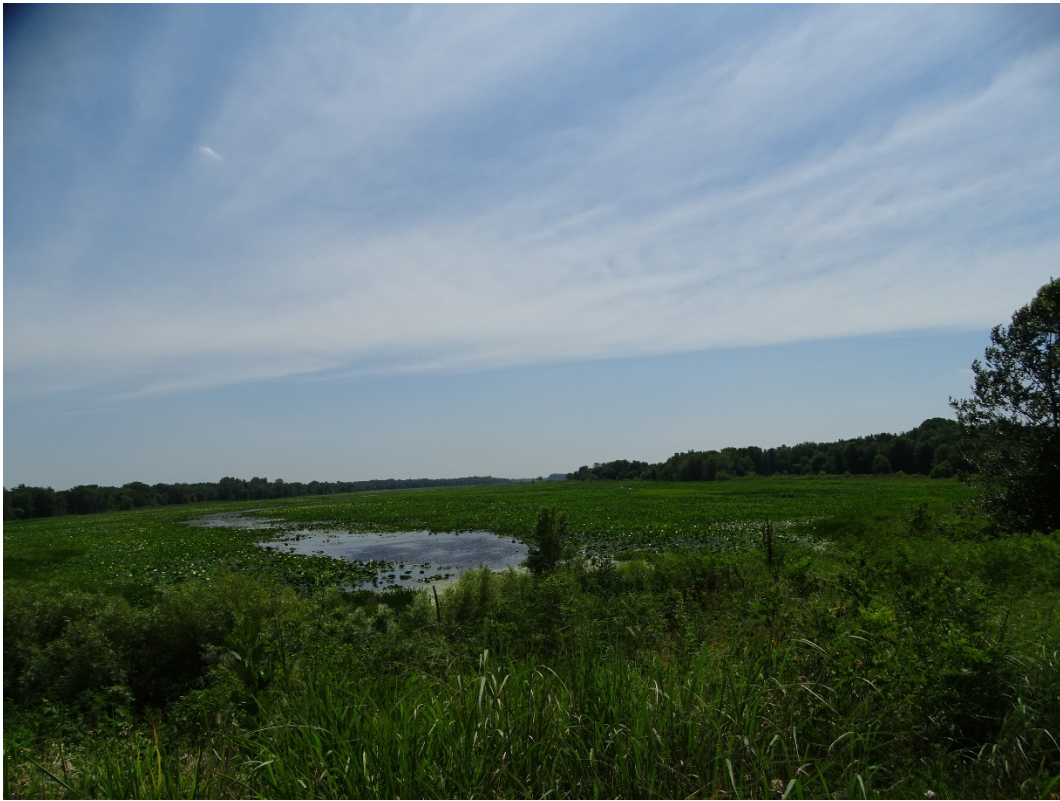
Photo 9: Mallard Bay, looking southwest from the containment dike road

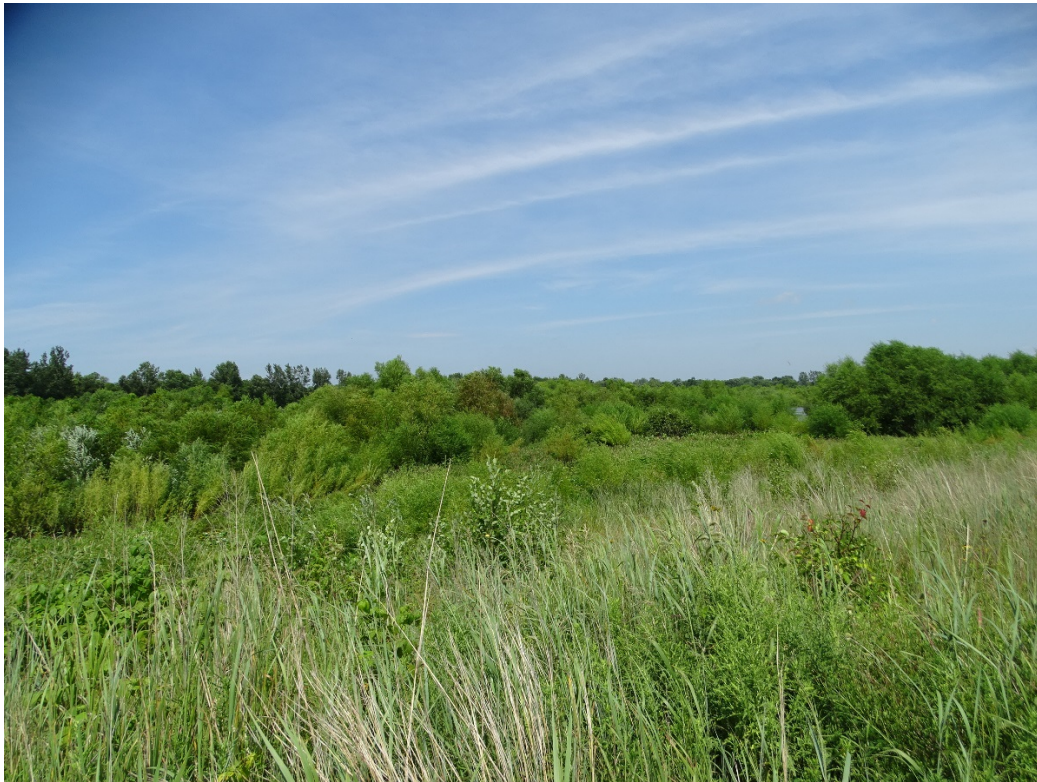
Photo 10: Containment Interior vegetation, looking northeast from the road

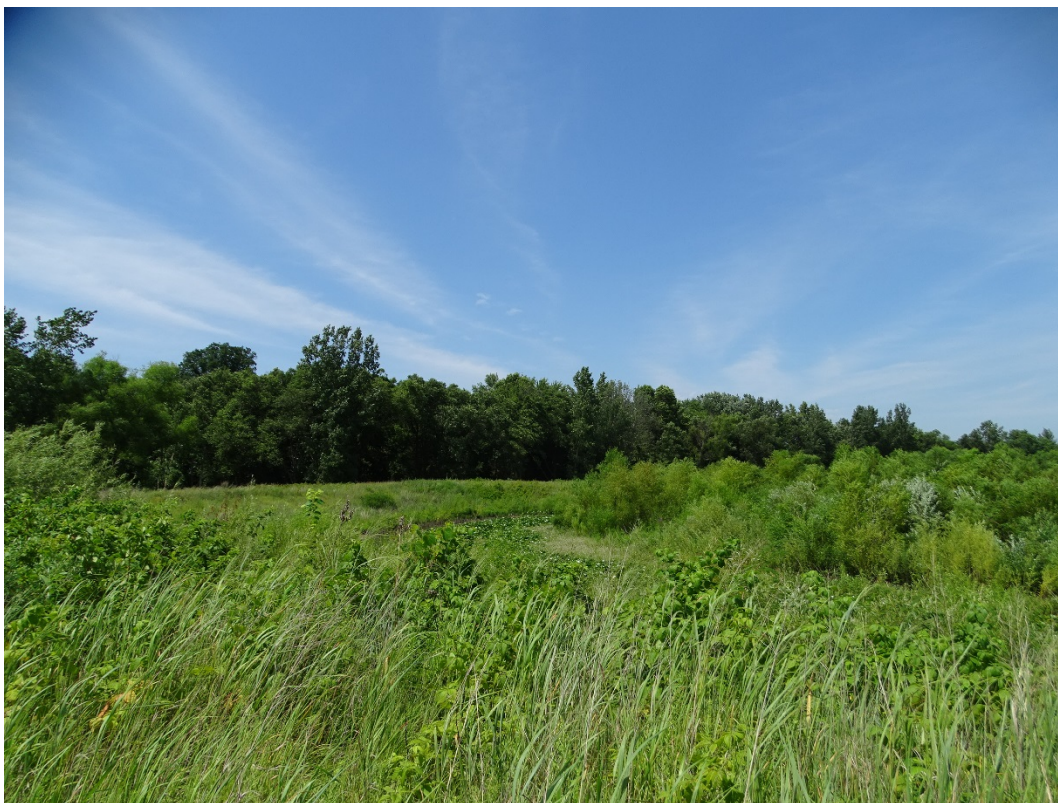
Photo 11: Containment Dike and Interior, looking north from the containment dike road

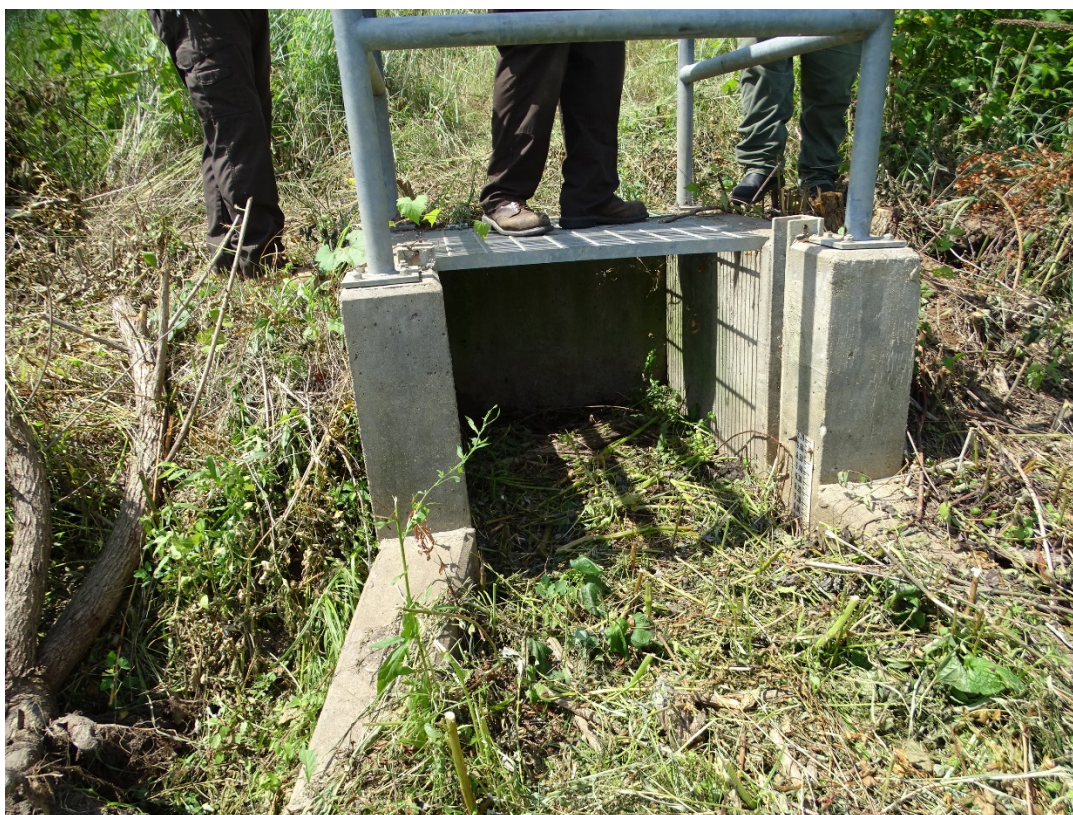
Photo 12: Stoplog structure

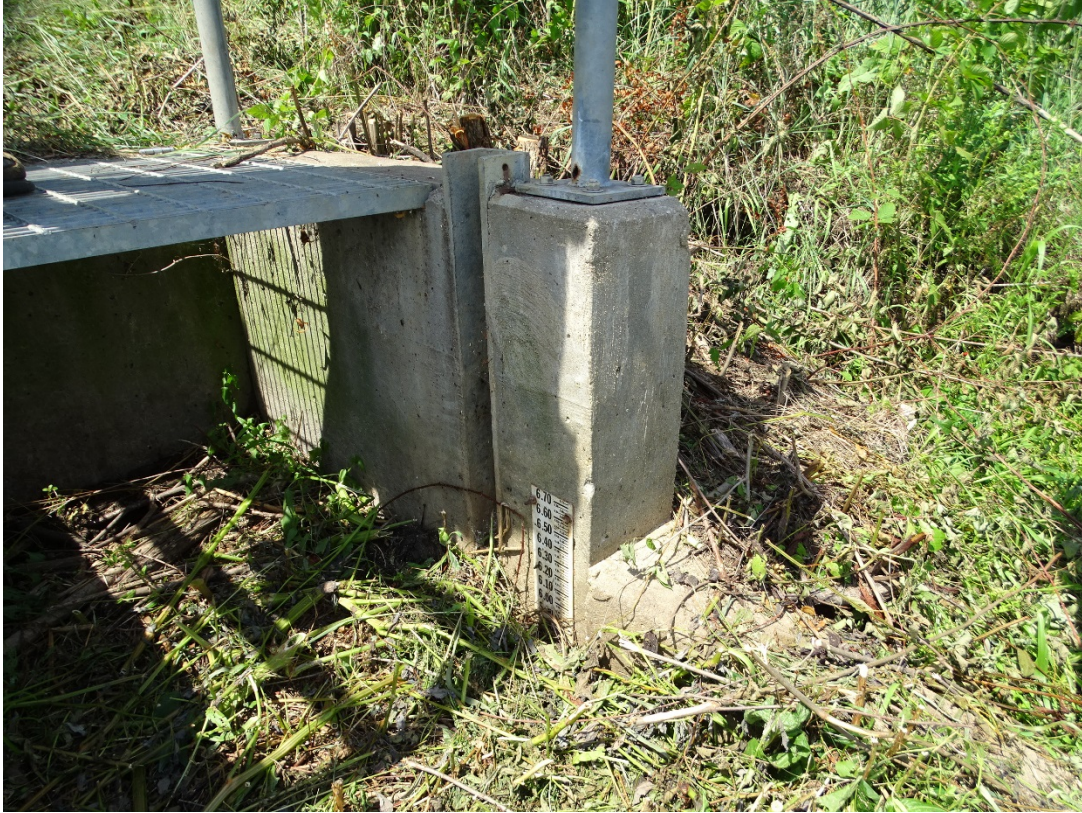
Photo 13: Stoplog structure and gage

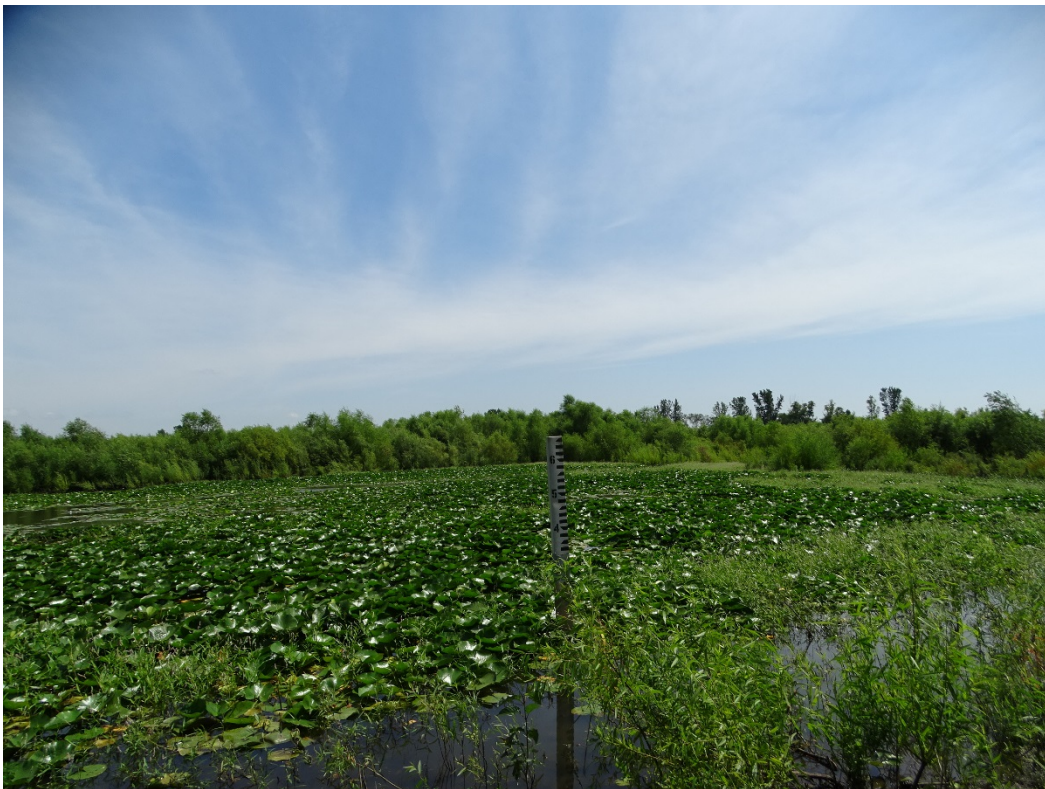
Photo 14: Containment dike interior and gage

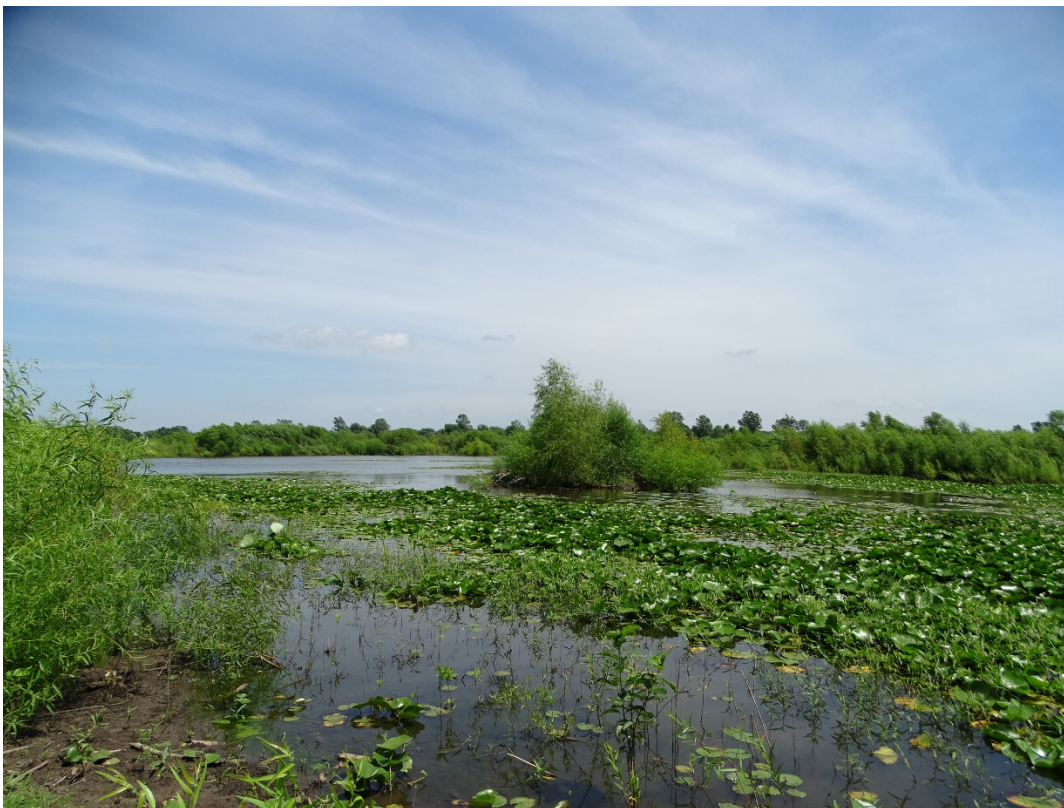
Photo 15: Beaver lodge in the containment interior, looking east

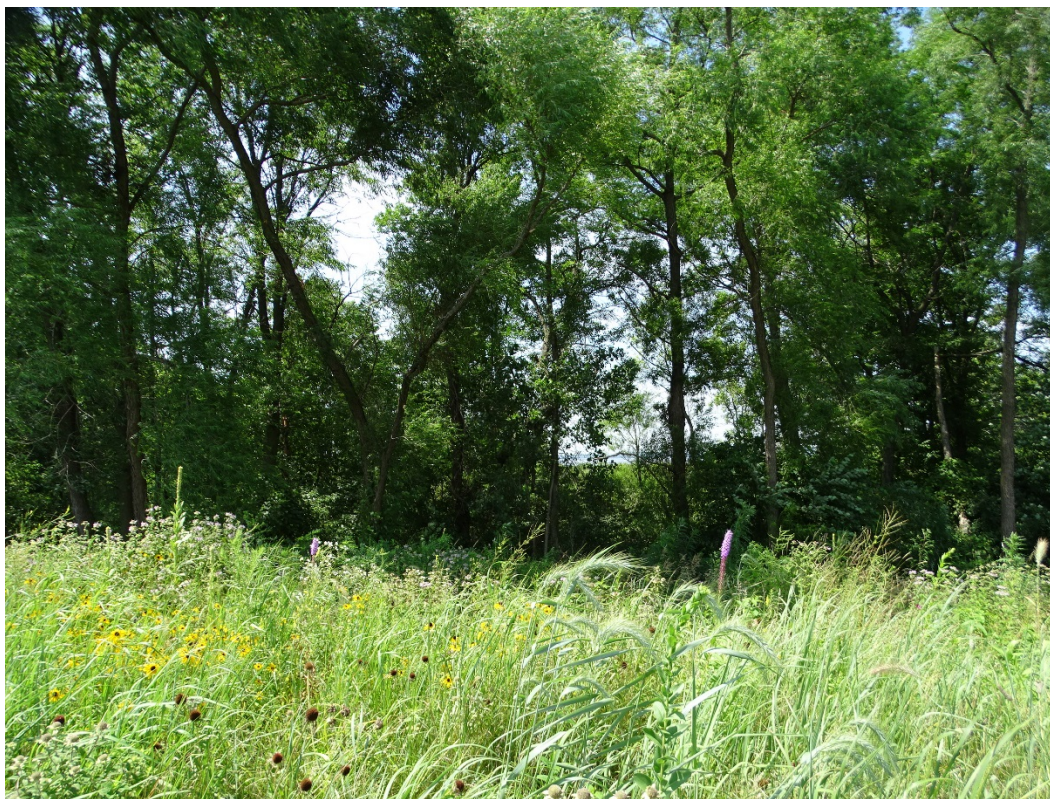
Photo 16: Vegetation, looking north from the containment dike road

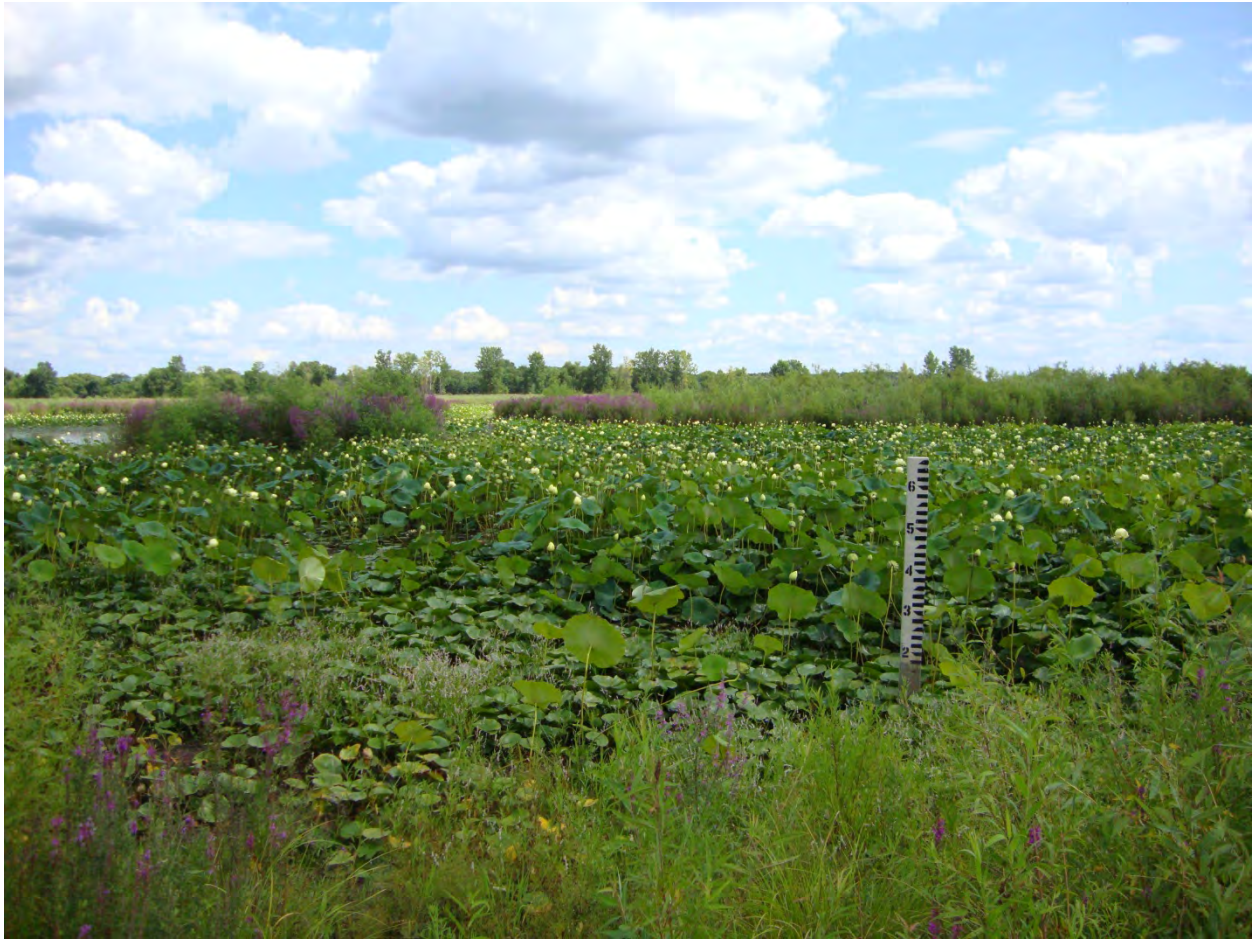
Old beaver lodge (covered in purple loosestrife) and staff gauge, looking from structure, August 2013.

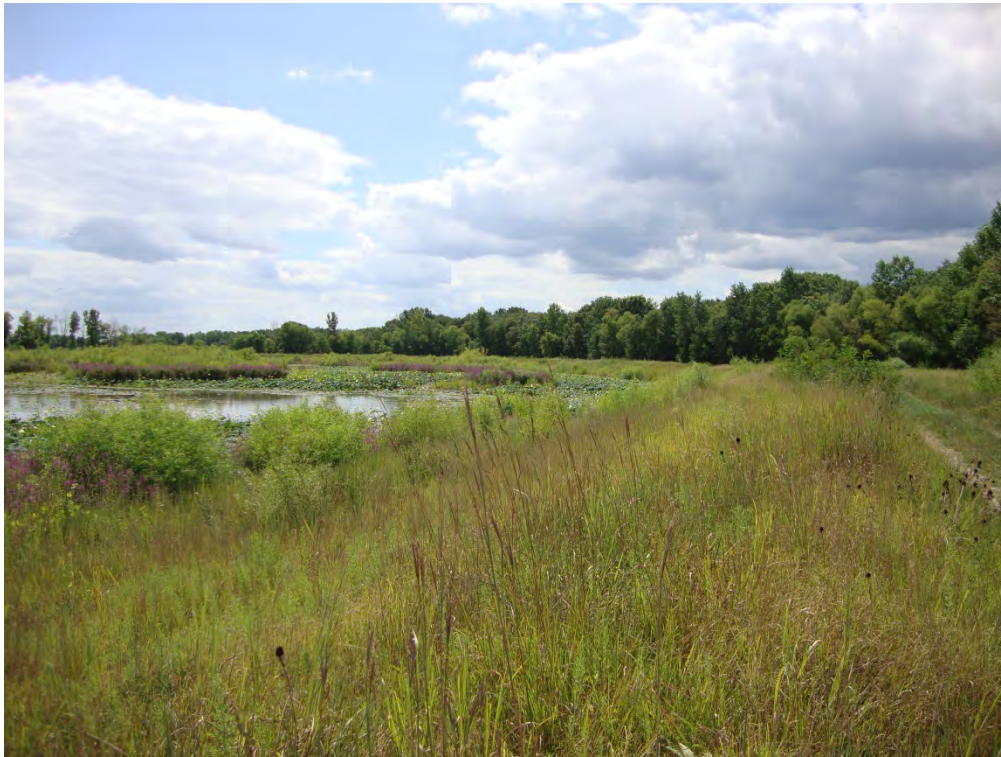
Photo 1: Containment dike and interior, looking southwest from access road.

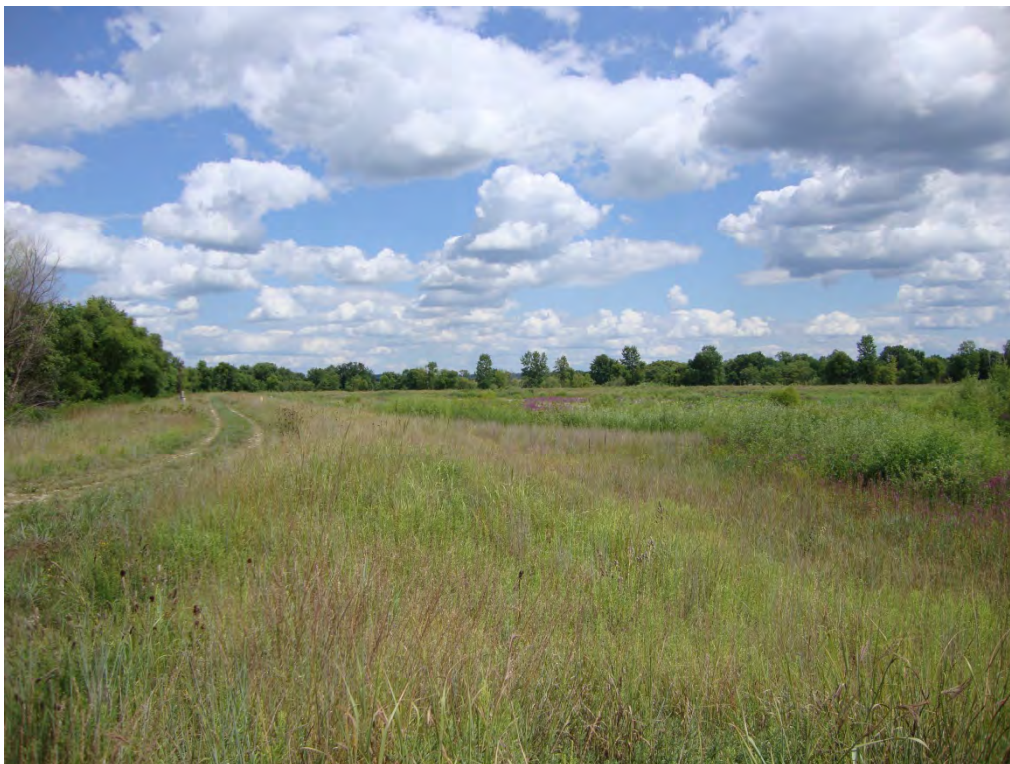
Photo 2: Containment dike and interior, looking northeast from access road.

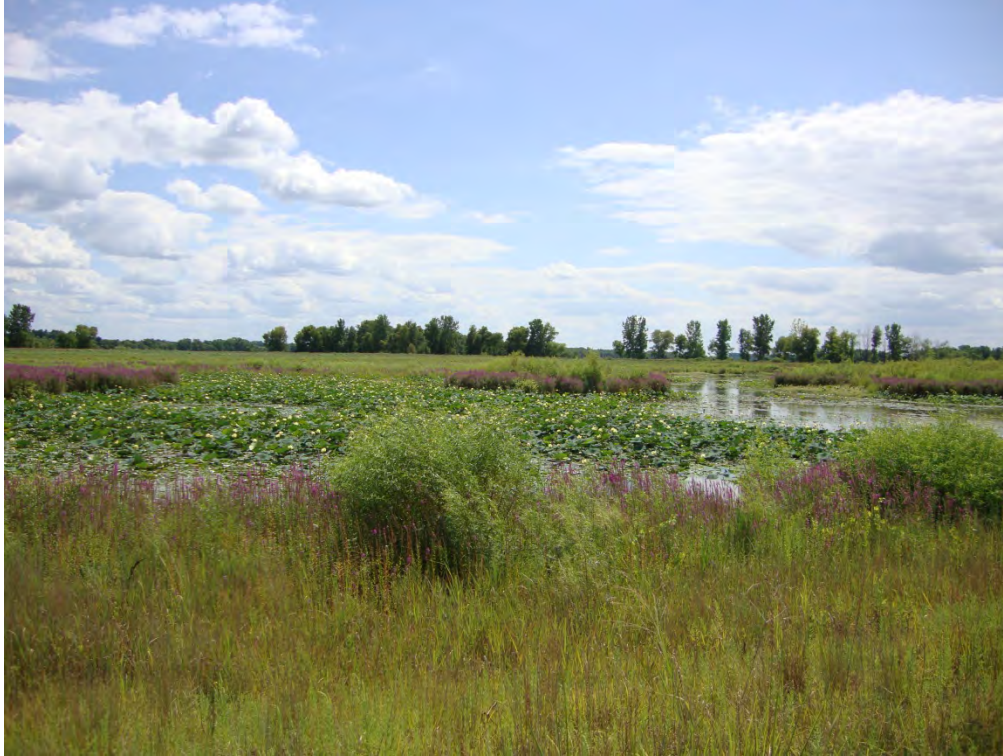
Photo 3: Interior, looking south from access road area.

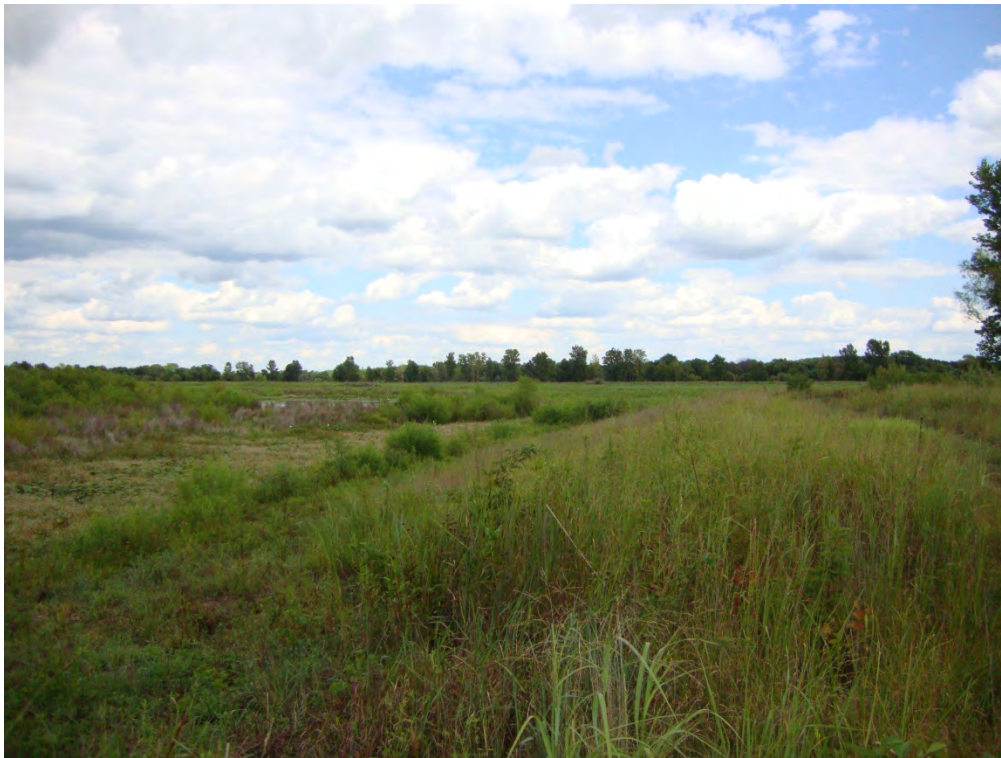
Photo 4: Containment dike and interior, southwest corner looking east.

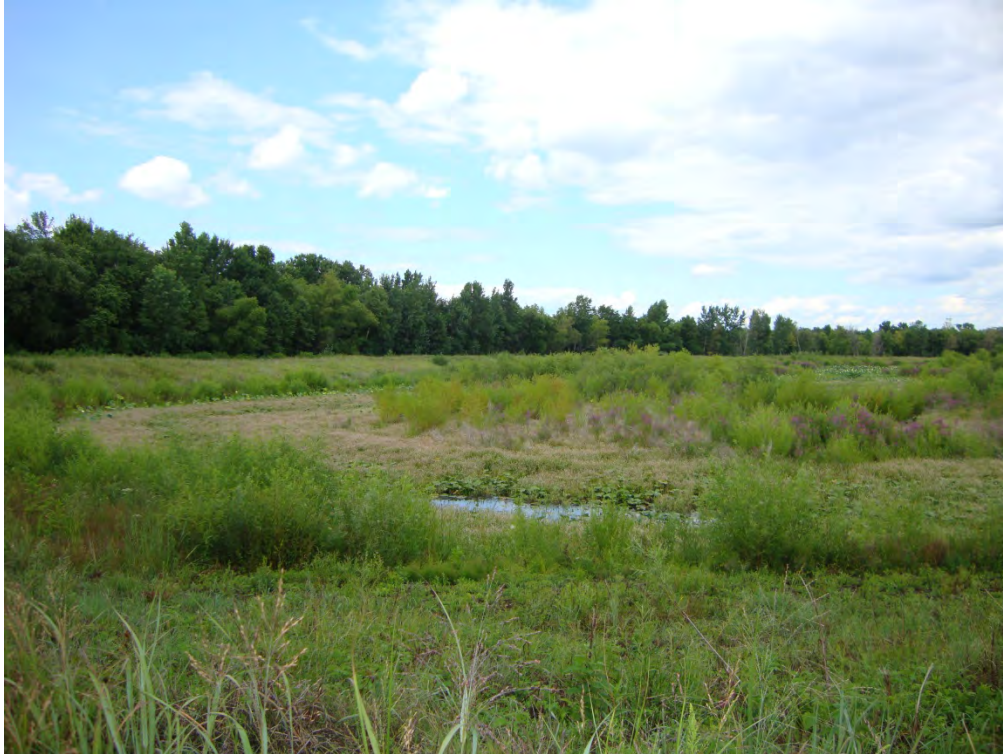
Photo 5: Containment dike and interior, southwest corner looking northeast.

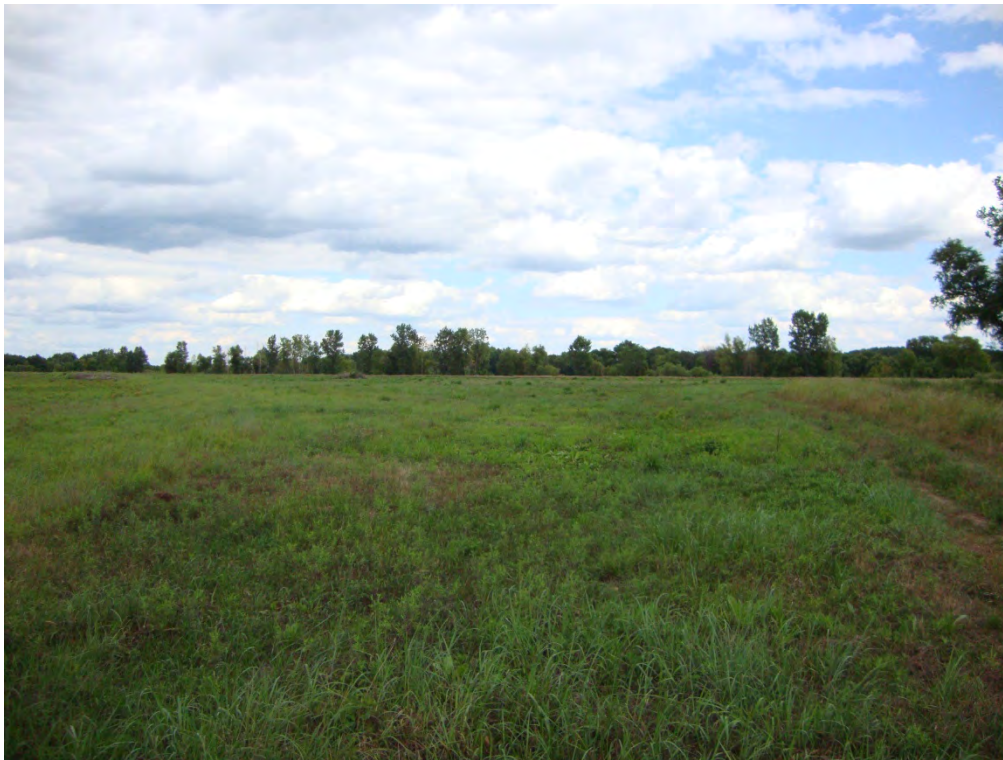
Photo 6: Containment dike and interior, southwest side looking east.

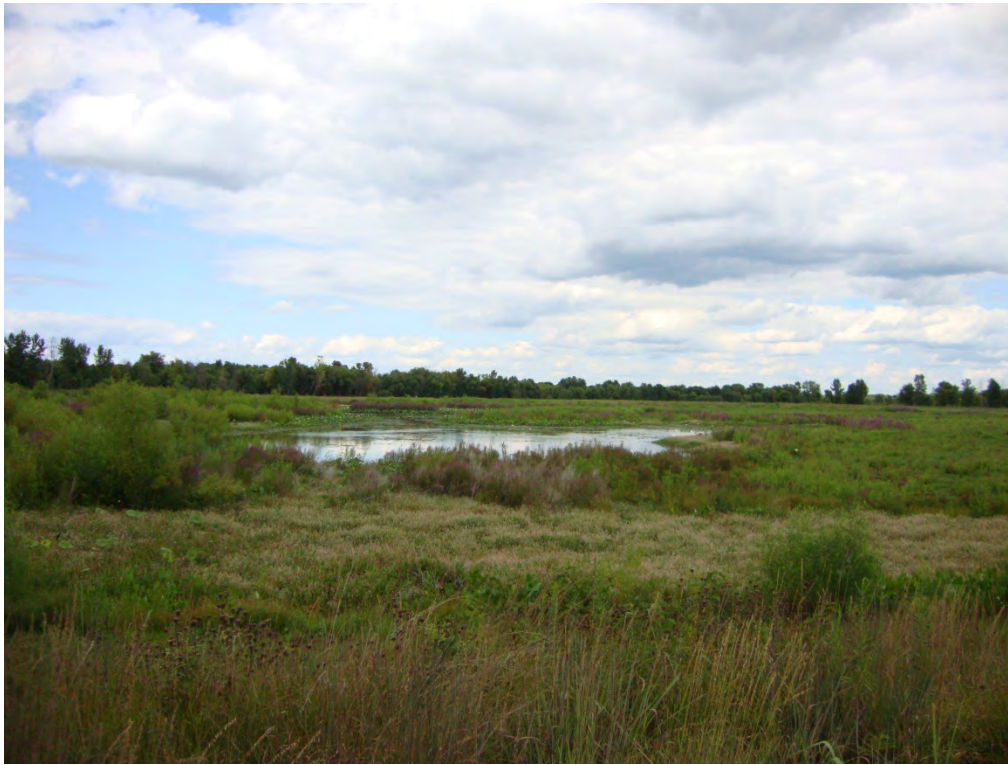
Photo 7: Interior, southwest corner looking northeast.

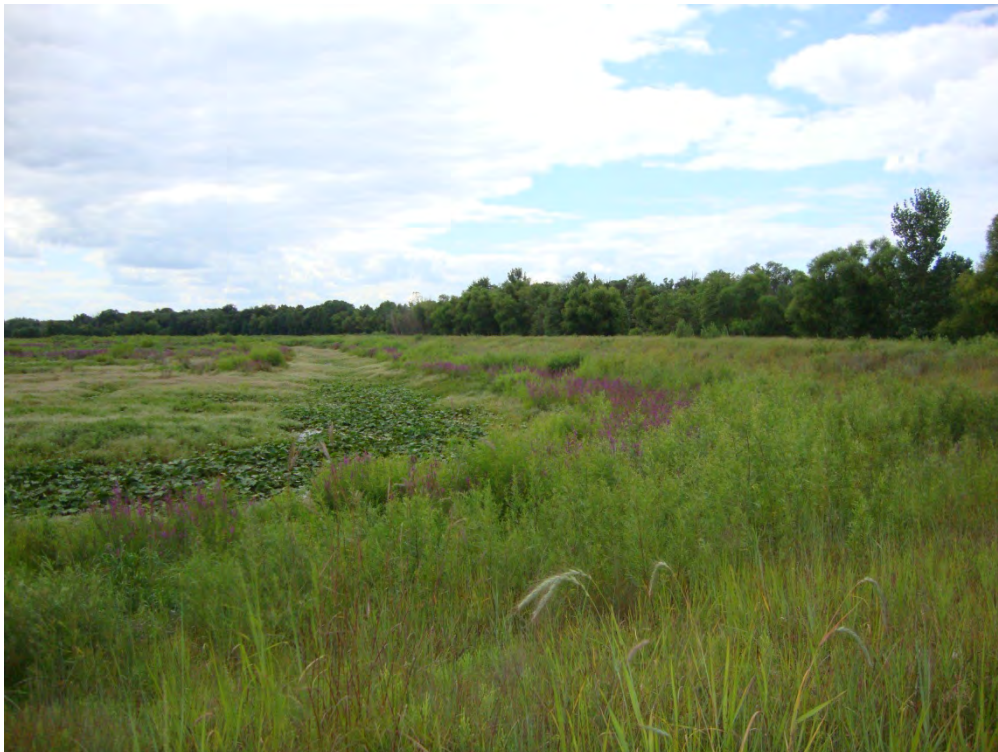
Photo 8: Containment dike and interior, northeast corner looking west (toward well).

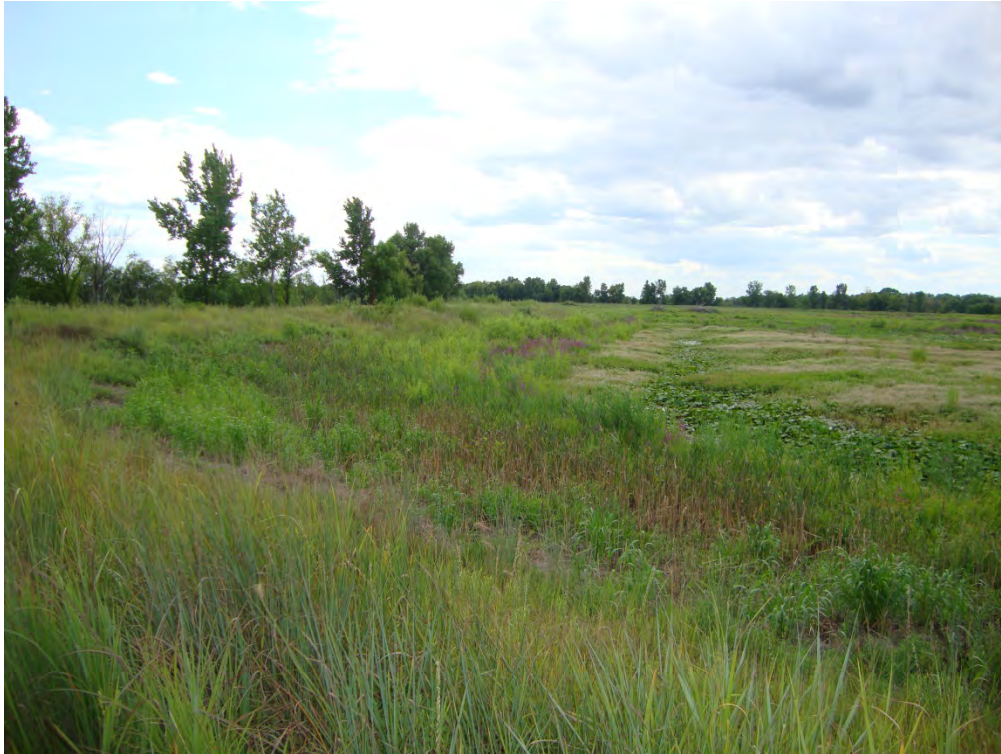
Photo 9: Containment dike and interior, northeast corner looking southwest.

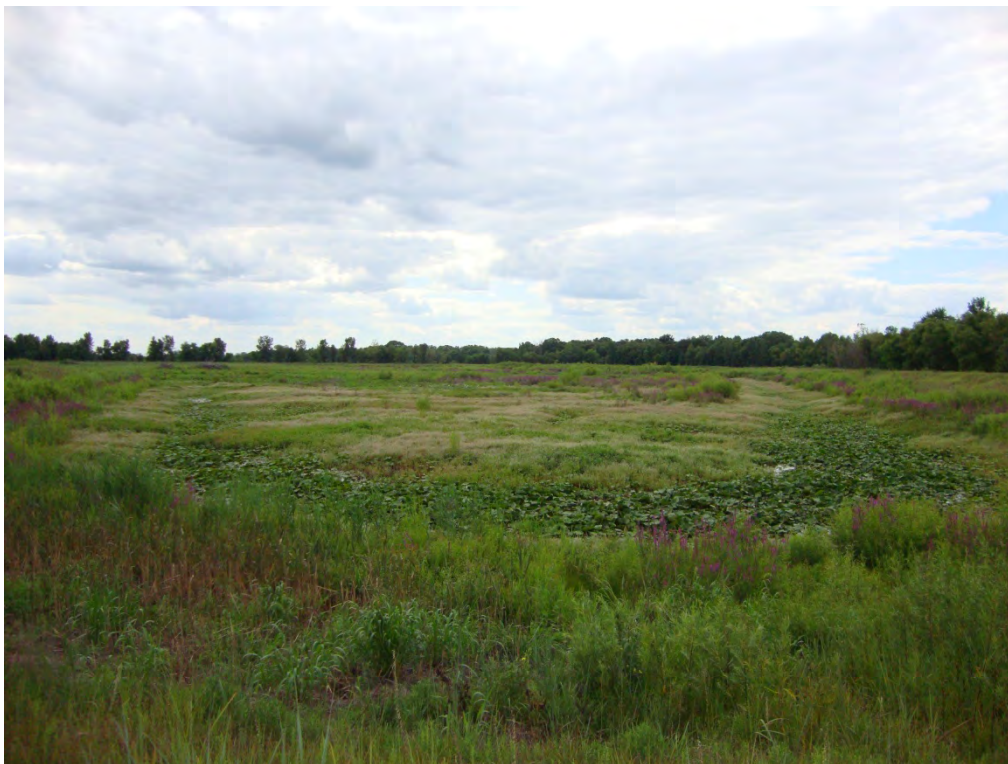
Photo 10: Interior, northeast corner looking southwest.
