**UMRR HREP
INSPECTION OF COMPLETED WORKS
2016**

Potter's Marsh Habitat Rehabilitation and Enhancement Project (HREP)

Pool 13, Mississippi River Miles (RM) 522.5 to 526.0, Carroll and Whiteside Counties, IL

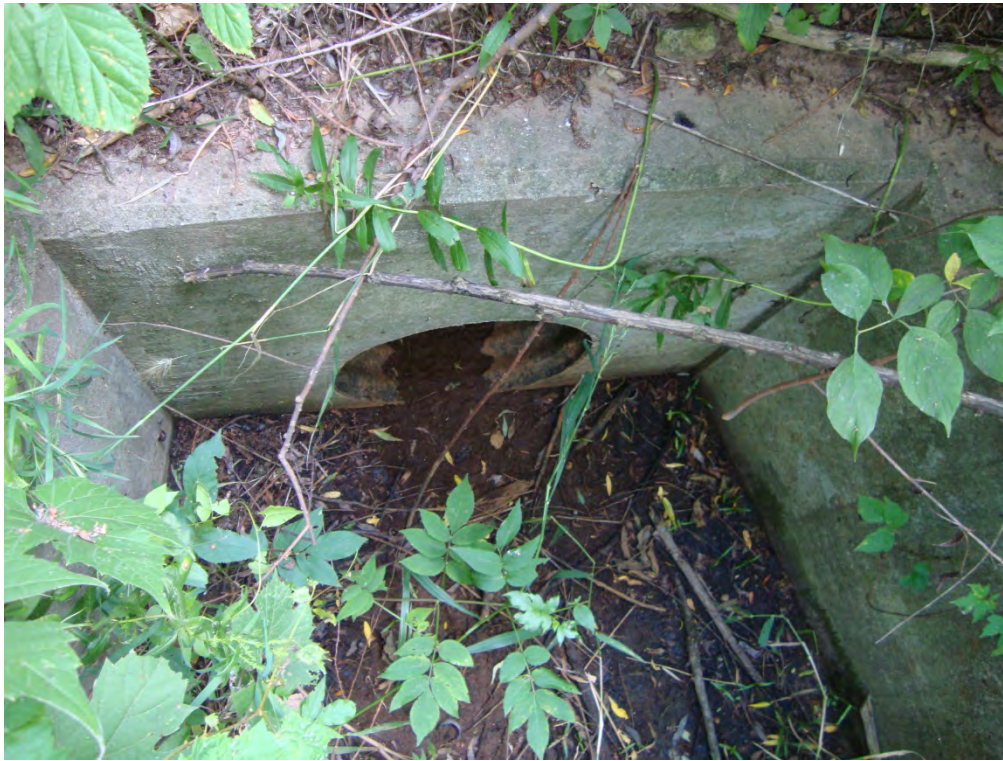
Photo 11: Stoplog structure outlet headwall.

1. Repair beaver damage to dike around stoplog structure. A layer of riprap next to the structure would help prevent future damage. Continued damage could lead to piping through the dike.
2. Repair interior slope damage approximately at STA 45+00. This is a safety hazard for mowing and other maintenance work.
3. Continue to remove woody vegetation growing next to stoplog structure.

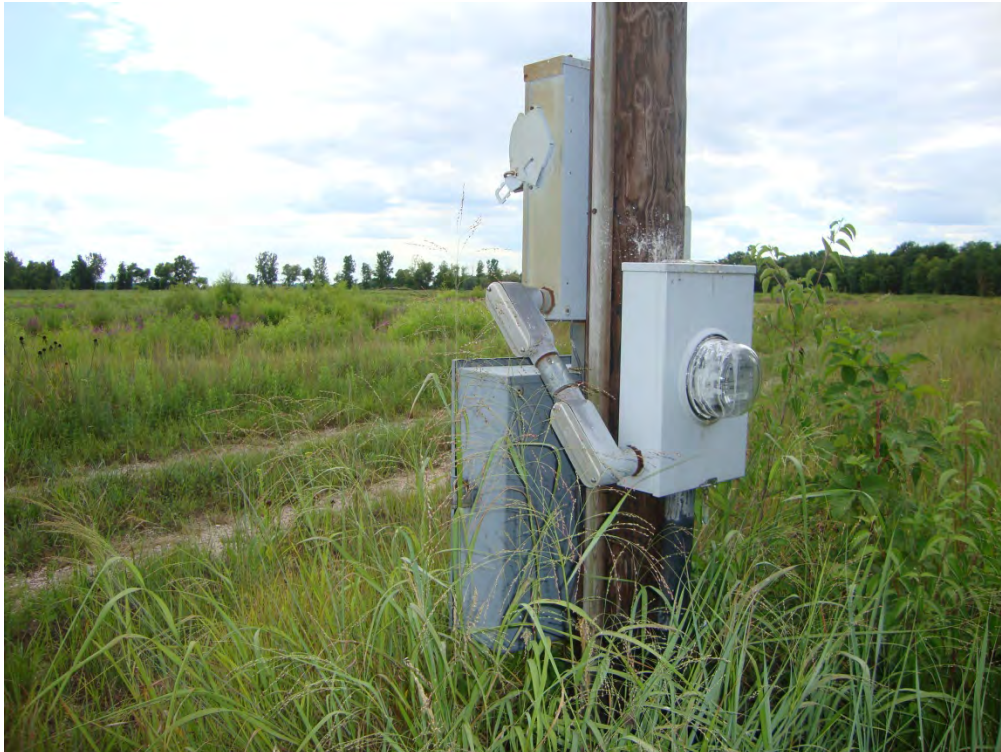
Photo 12: Well electrical.

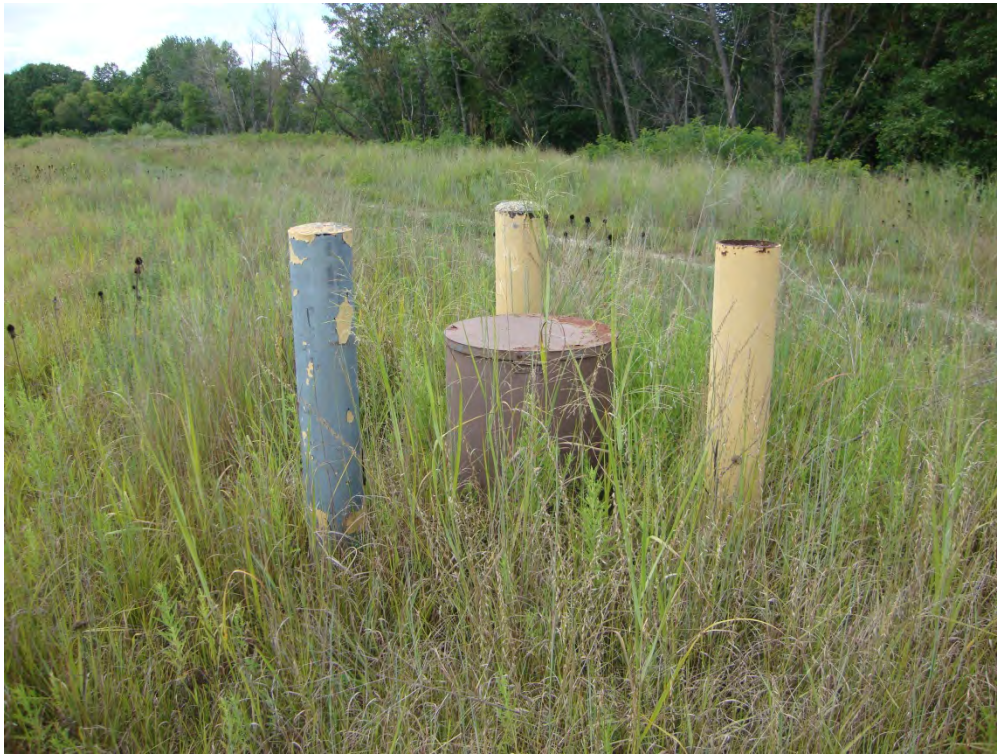
Photo 13: Well.

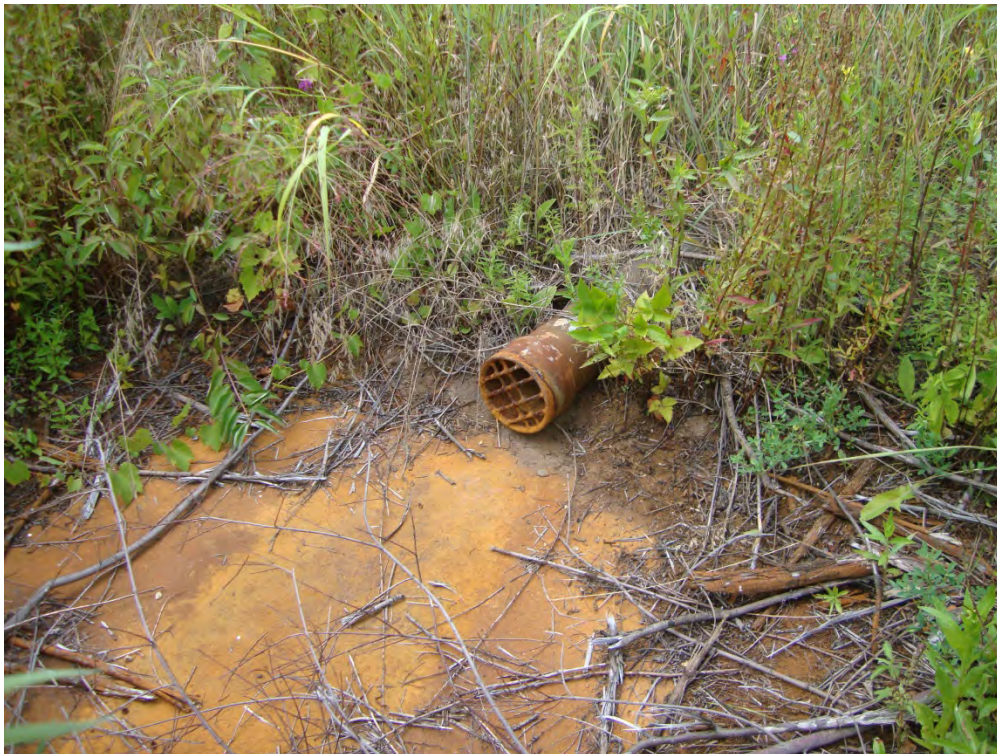
Photo 14: Well outlet pipe.

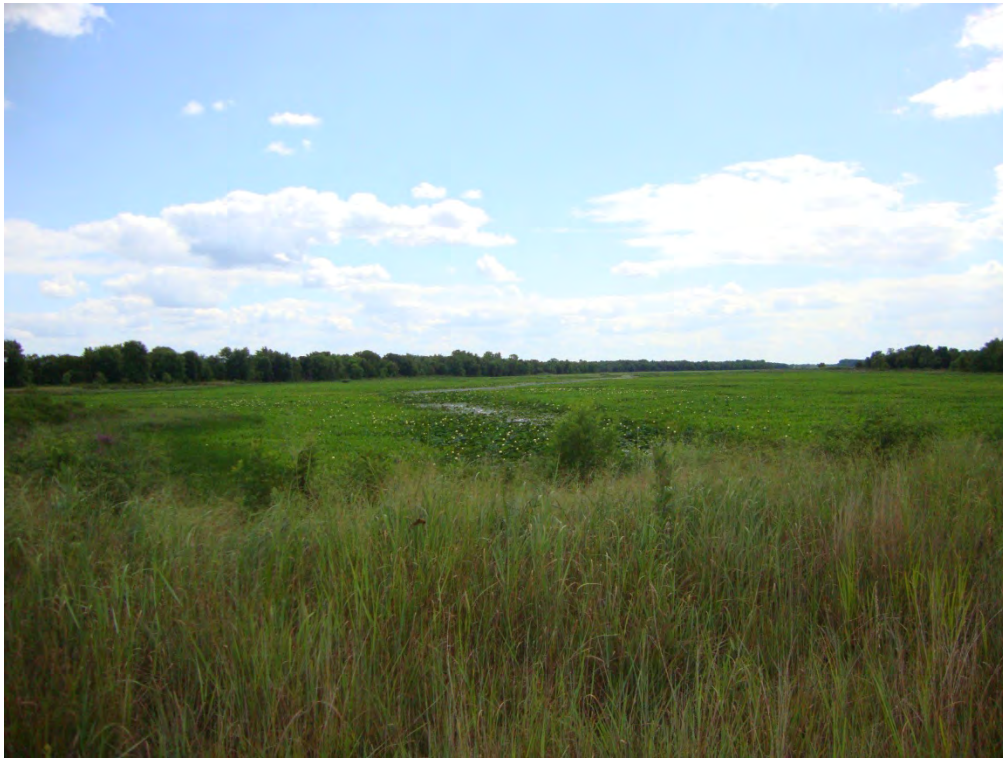
Dredge Cuts	Did not inspect. Photo 15.	Have Corp perform bathymetric surveys, perhaps for future Project Evaluation Report. Previously, the Corps provided their 2007 survey cross-sections which indicated cuts are continuing to fill in, especially cuts C and K.

Photo 15: Dredge cut, looking west toward river from southwest corner of containment dike.

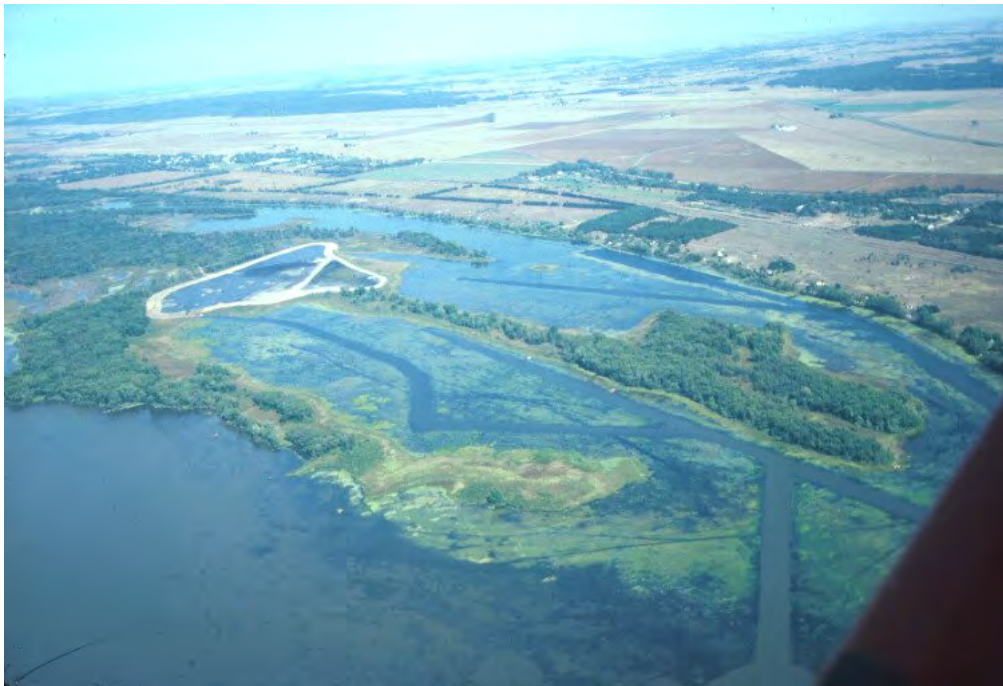
Photo 16: Potters Marsh project area, looking northwest from river. (2004 photo?)
