**UPPER MISSISSIPPI RIVER SYSTEM
ENVIRONMENTAL MANAGEMENT PROGRAM
POST-CONSTRUCTION
INITIAL PERFORMANCE EVALUATION REPORT**

**SPRING LAKE HABITAT REHABILITATION AND
ENHANCEMENT PROJECT**

JANUARY 2004

**POOL 13
MISSISSIPPI RIVER MILES 532 - 536
CARROLL COUNTY, ILLINOIS**

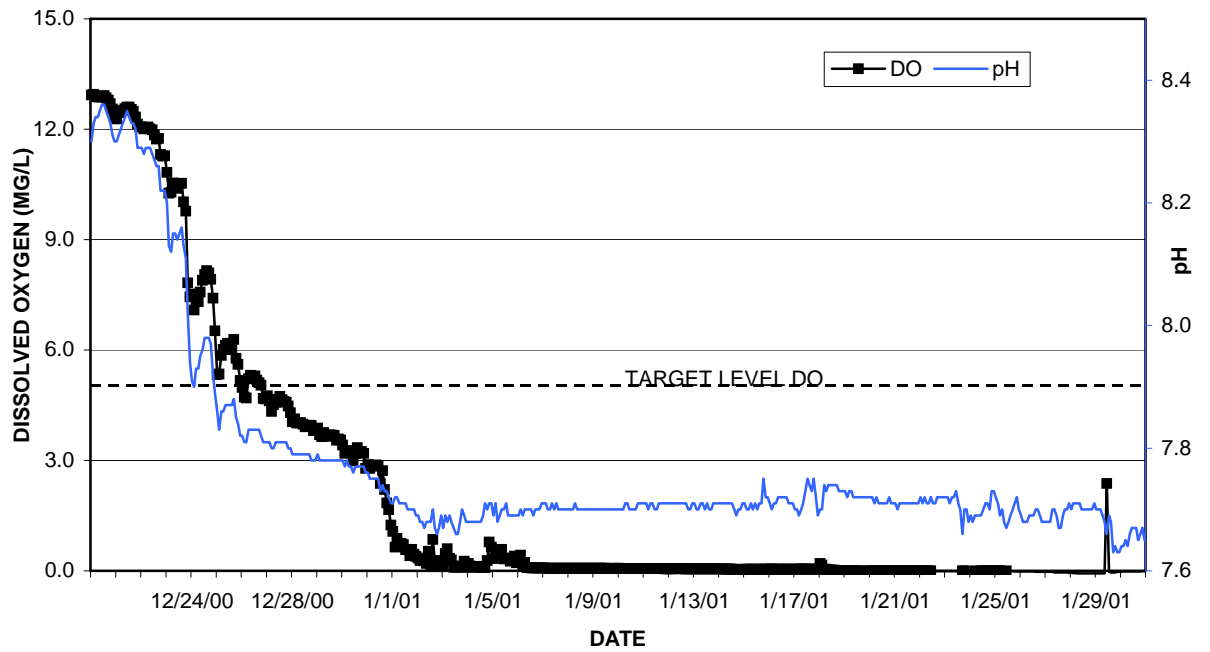
Figure C-1 W-M532.6Q Continuous Monitor (Dec. 20 2000 to Jan. 31 2001)

located in a channel, nearly two miles downstream from the gated inlet structure. DO concentrations here ranged from 2.20 mg/l – 22.98 mg/l. Ten DO measurements were less than or equal to 5 mg/l; however, none of these occurred during the winter months. Six of the low DO readings occurred from July 11-September 17, 2002. These readings could possibly be due to oxygen demand created by an algal bloom which was evident in the main basin of the lake for nearly the entire summer. The monitoring results from grab samples collected at site W-M534.8R are found in Table D-2. This site is located in the main basin of the lake, about one-half mile east of the gated inlet structure. DO concentrations here ranged from 3.45 mg/l – 23.33 mg/l. Five DO measurements were less than or equal to 5 mg/l, with one occurring during the winter months (3.88 mg/l on January 20, 1999). Table D-3 shows the monitoring results from grab samples collected at site W-M534.6V. This site, located in a shallow area dominated by American lotus, is nearly 1.5 miles east of the gated inlet structure. DO concentrations here ranged from 1.94 mg/l – 24.89 mg/l. Twelve DO measurements were less than or equal to 5 mg/l, with all occurring during the summer months. The monitoring results from grab samples collected by ILDNR personnel at site W-M532.3T are found in Table D-4. This site is located in an open area of the lake, about three miles southeast of the gated inlet structure. DO concentrations here ranged from 2.5 mg/l – 25.0 mg/l. The DO concentration was less than or equal to 5 mg/l only once (January 11, 2001) at this location.

In-situ continuous monitors were deployed at site W-M532.6Q on seven occasions during the winter months. The monitor deployed on January 3, 2002 did not contain any useable data; however, DO readings taken in the field at the time of deployment and retrieval indicated supersaturated conditions. As discussed previously, a fish kill was reported in January 2001. This event coincided with an extended period of low DO concentrations measured from late December 2000 through mid-February 2001 (see Figures D-1 and D-2). The DO concentration was below 5 mg/l for 44 consecutive days. In fact, near anoxic conditions were observed for much of the period. With the exception of a brief excursion below 5 mg/l during the January 20 through February 17, 1999 deployment (see Figure D-3), the DO concentrations of the remaining winter deployments were similar to those shown in Figure D-4, where concentrations always exceeded 5 mg/l and were occasionally supersaturated.

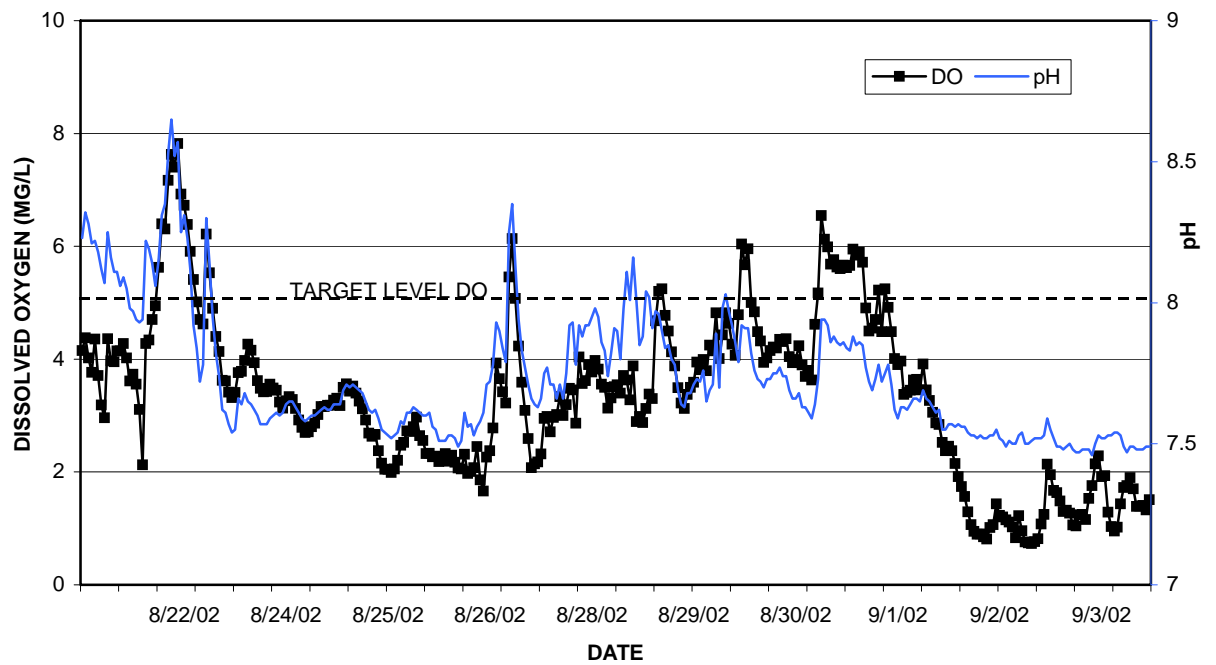
Figure C-7 W-M532.6Q Continuous Monitor (Aug. 20 to Sept. 5 2002)

In-situ continuous monitors were deployed at site W-M532.6Q on 29 occasions during the summer months. Data from monitors deployed on July 1, 1999 and June 11, 2002 were not useable. Representative graphs of the range of DO concentrations observed during the remaining summer deployments are found in Figures D-5 through D-8. Every summer deployment had at least one concentration fall below the 5 mg/l target level. The results from most summer deployments were similar to the August 3-17, 1999 deployment (see Figure D-5). The typical diel pattern of rising daytime DO concentrations followed by falling nighttime concentrations is evident in this figure. For most summer deployments, the diel DO pattern oscillated around the 4 to 6 mg/l range, with high DO concentrations commonly in the 6 to 8 mg/l range and low values typically in the 2 to 4 mg/l range. The most favorable DO conditions observed during a summer deployment occurred from June 8-20, 2000 (see Figure D-6). During this deployment, only two DO concentrations were below 5 mg/l and supersaturated concentrations were common during the daytime. The most adverse summer DO conditions were observed over a period of two deployments: August 21 through September 4, and September 4-17, 2002. As shown in Figures D-7 and D-8, there was one stretch where the DO was continuously below 5 mg/l for nearly 11 days.

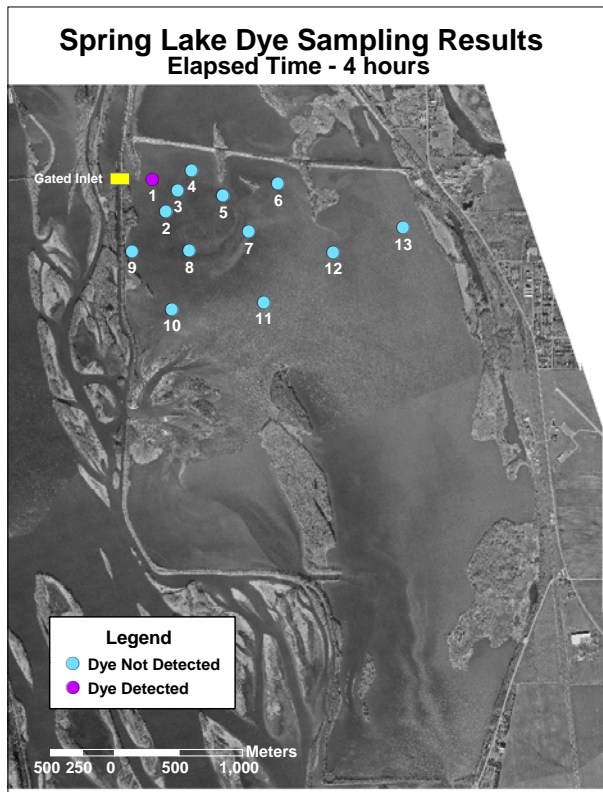
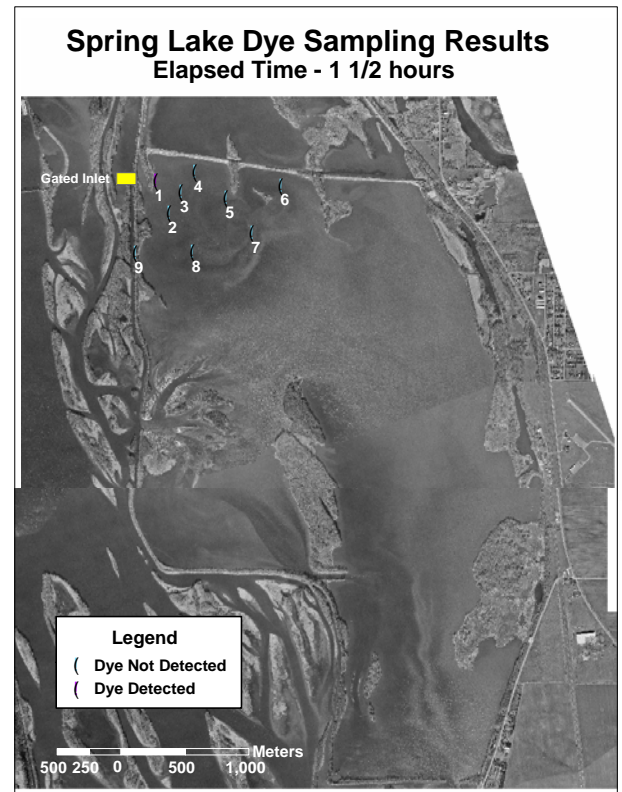
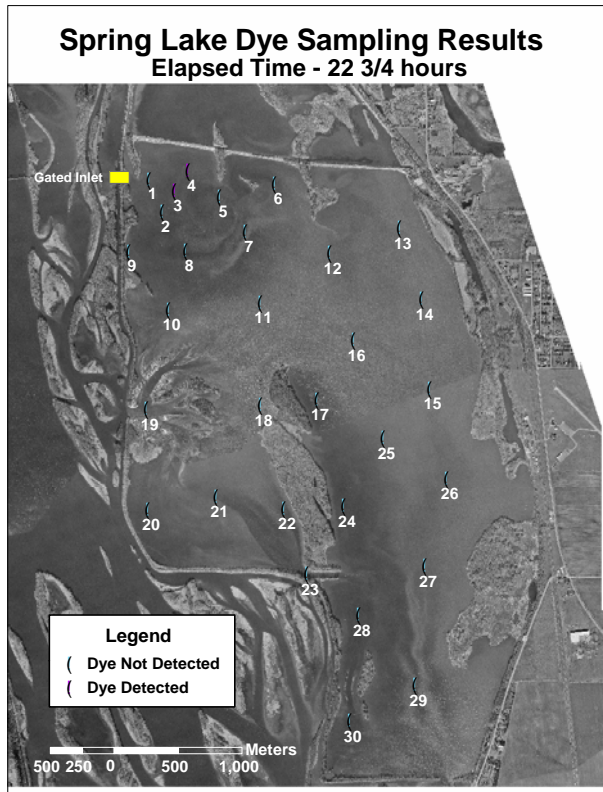
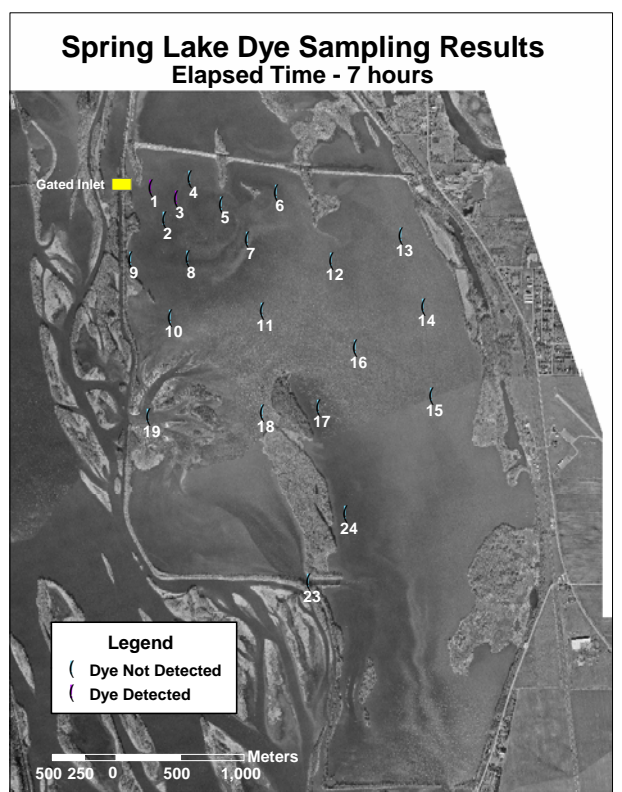
Figure C-9 Spring Lake Dye Dispersion, February 5-6, 2002.

The middle portion of lower Spring Lake is bisected by Silo Island. The primary route of the dye appears to be to the east side of the island in the deeper portions of the lake. The area west of the upper part of Silo Island is relatively shallow. A significant amount of sediment deposition has occurred here due to previous failures of the perimeter levee. Much of this area is above the normal lake level and is covered with willow trees. This has somewhat isolated the area from the main basin of the lake. On the final sampling event, dye was detected at site 19, which is located in a channel near the perimeter levee where a previous failure occurred. With time, the dye most likely flowed down channels in the vicinity of the former levee breach and eventually reached sites 20, 21 and 22.
