# **Interim Report For The Upper Mississippi River - Illinois Waterway System Navigation Study**

**US Army Corps  
of Engineers**

**November 1997**

## Bank Erosion Field Survey Report of the Upper Mississippi River and Illinois Waterway

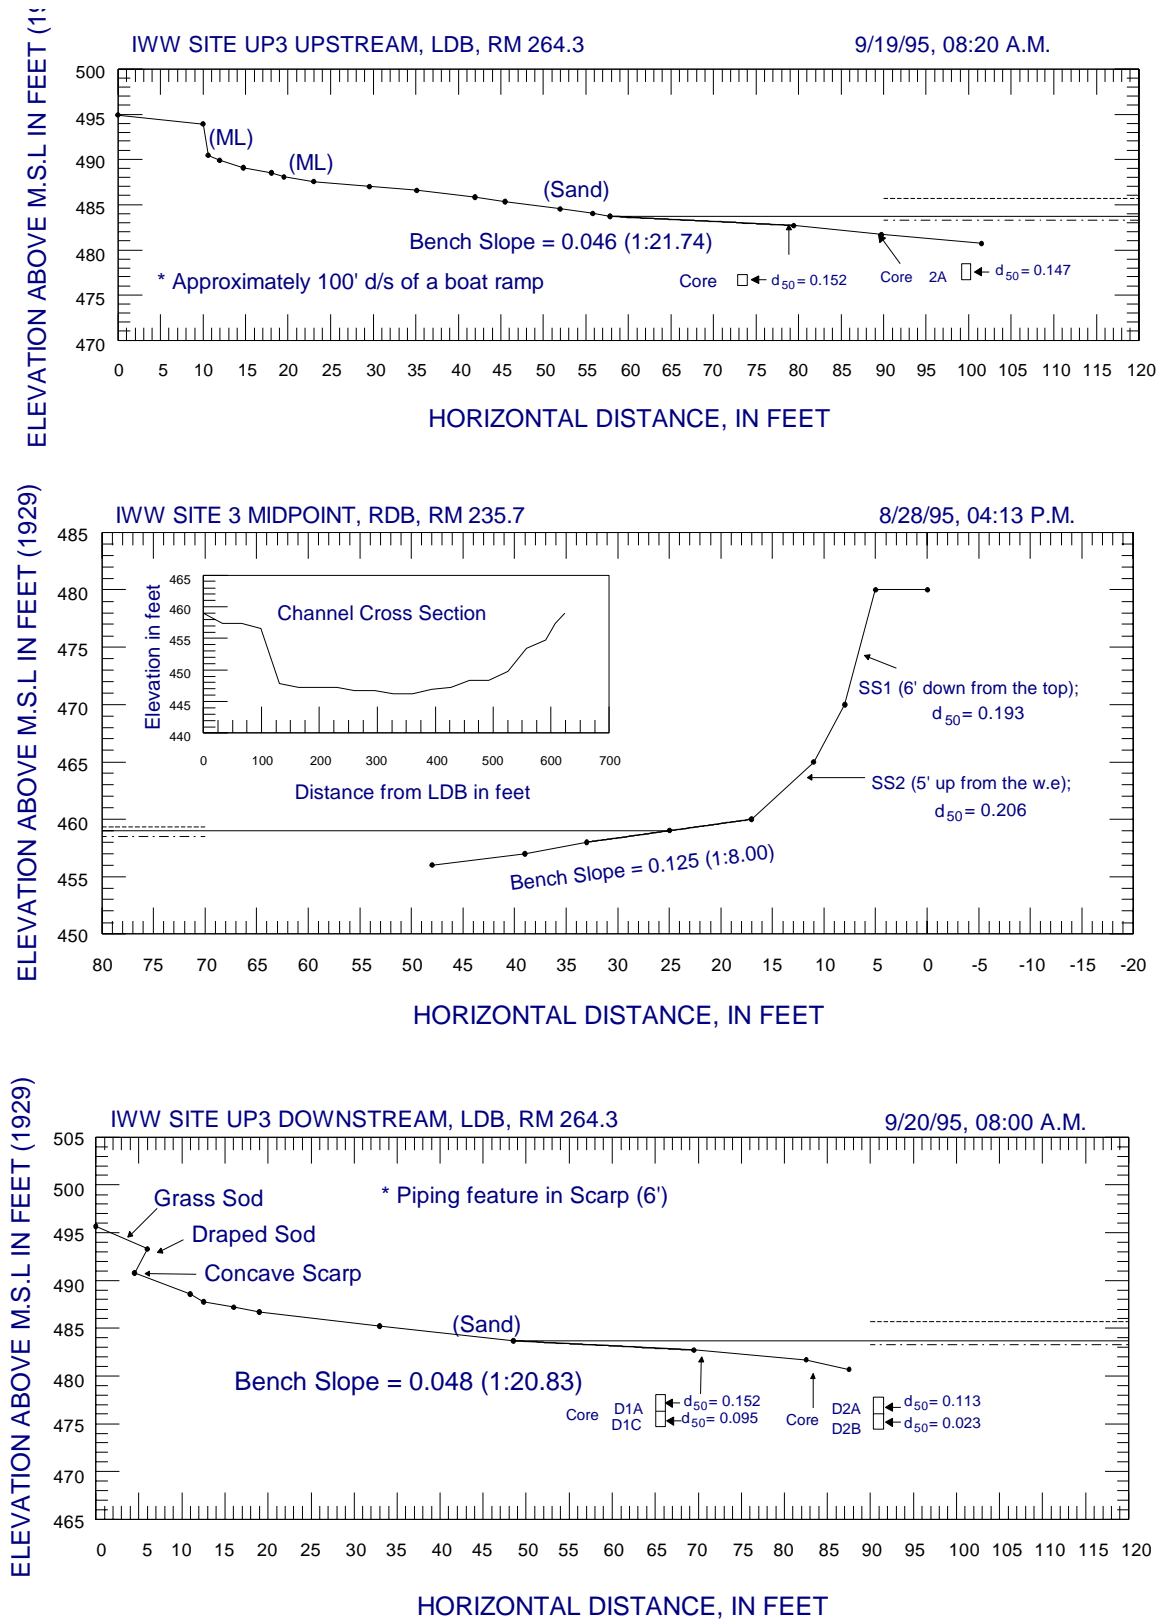
**Figure 6-40. Bank sections at site UP3**

Bench slopes varied only slightly from 1V:21.7H, and the bench was covered with noncohesive sandy materials. This site can be classified as type 3 (see figure 6-20 and table 6-4). Erosional undercutting, rework and transport by waves and currents at high stages or during floods could be major causes of erosion at this site. After the flood receded, the bank soil may slip and fall as blocks, as shown in the downstream section. Land use as a trailer park can be a factor at this site too. Seepage at the recession stage of a flood could also play a significant role in bank failure. Waves and disturbances created by local boating activities can cause entrainment of recently deposited sediments from bench areas.

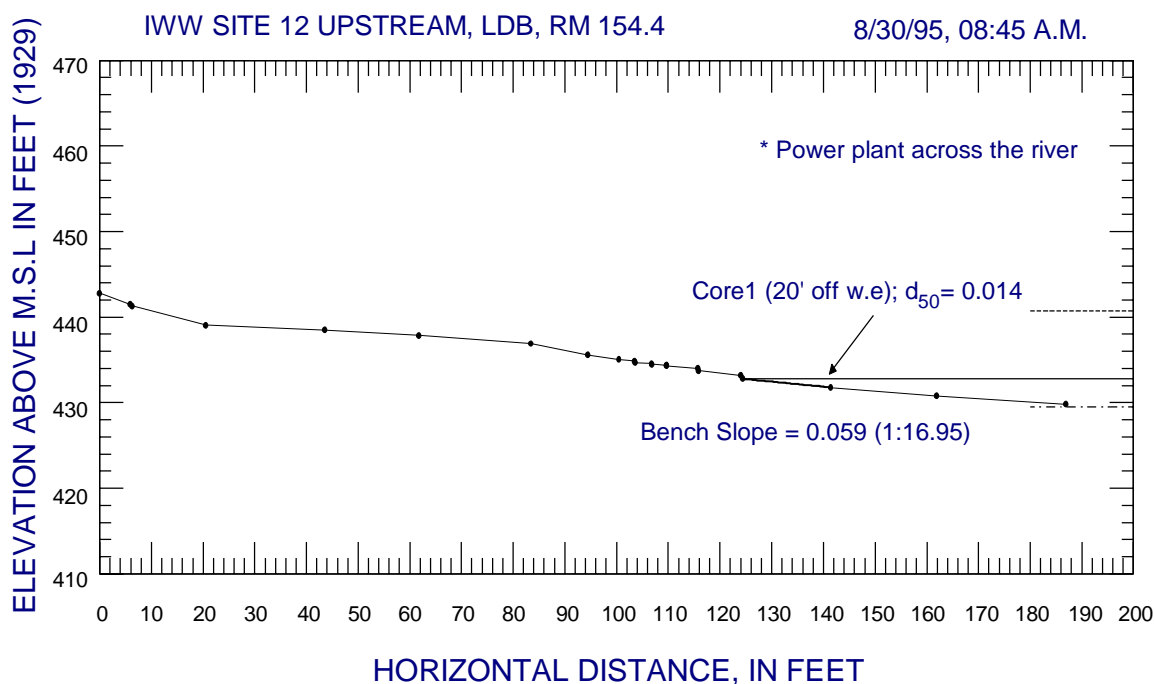
**Figure 6-77. Bank sections at site 12**

An obvious scarp was present at the water's edge. Figure 6-77 shows the three measured bank sections and a reduced cross section. The wide bench has a mild slope. At the top of the bank, tall trees and a scarp were hidden behind a belt of tall weeds and young willows. Vegetation formed a band approximately 90-100 feet wide on the bank. A berm was present inside the vegetation zone and its soils were desiccated. The open bench area was wet and clayey, and had piping features. The OHW is 440.7 feet and NP is 429.5 feet above msl. At OHW, the water would submerge some of the vegetation on the bank. Small scarps in the vegetation zone were below the OHW level and the scarp at the upstream section was at the water's edge. Table 6-22 gives the recurrence frequencies for various stages at this site.

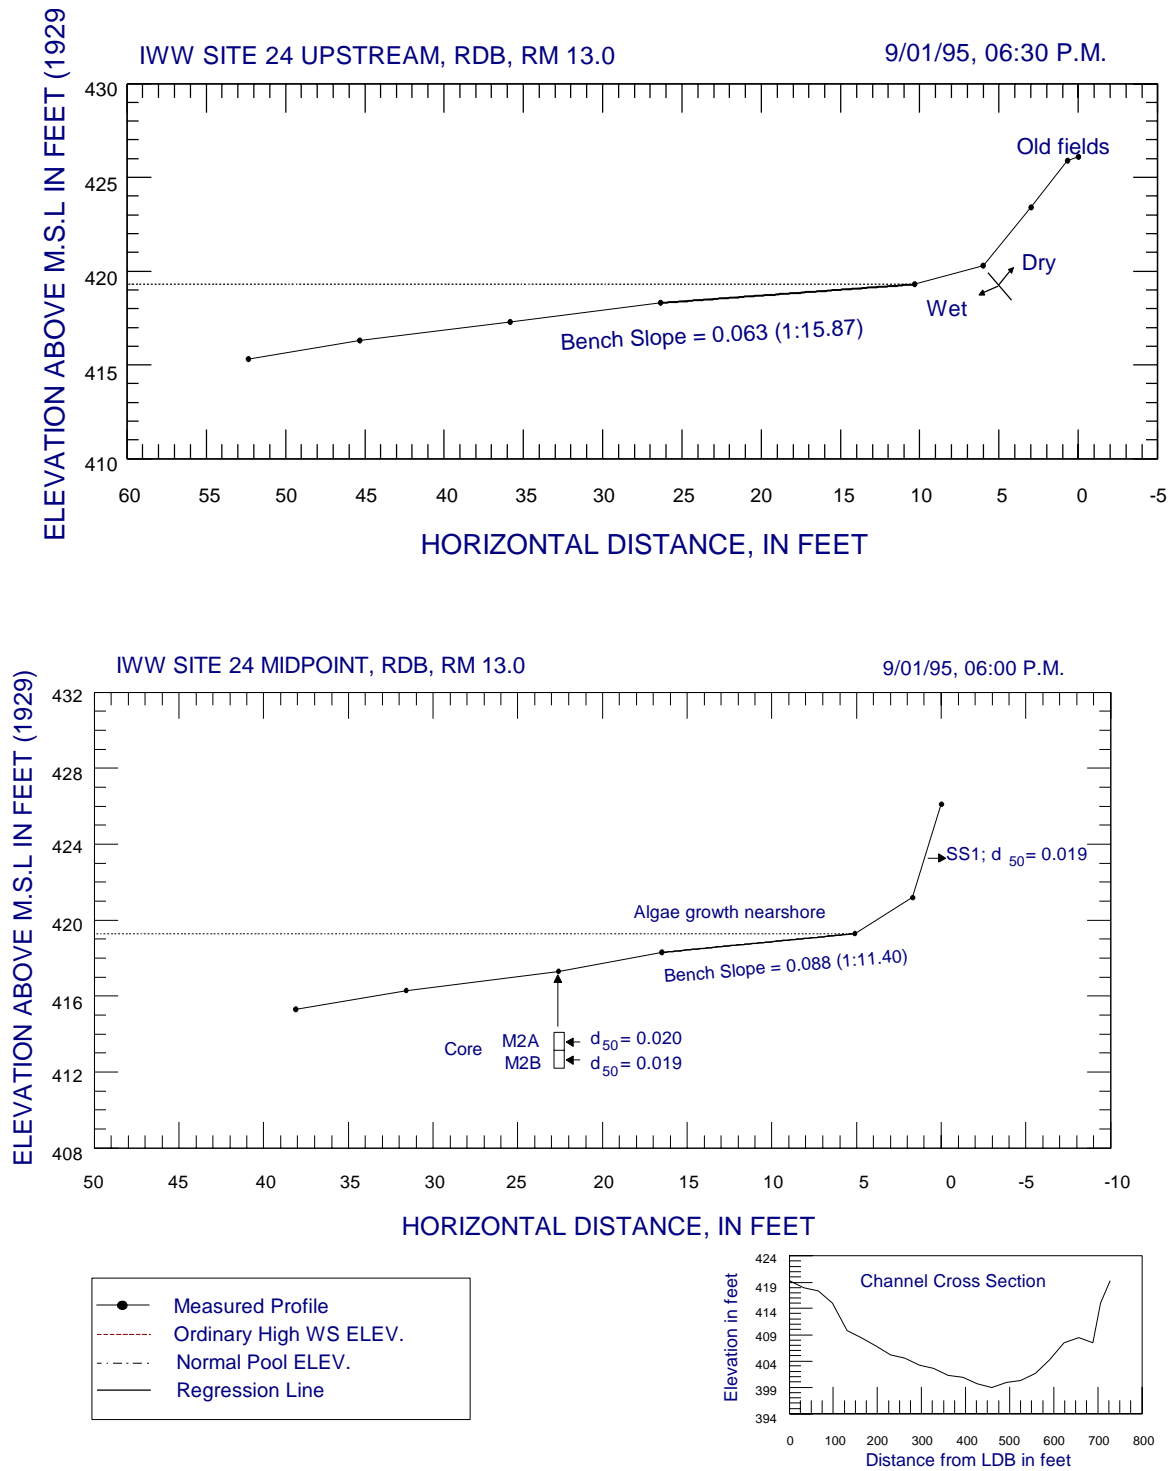
**Figure 6-112. Bank sections at site 24**

The bank characteristics are similar to those at other sites in the Alton Pool. Figure 6-112 shows the three measured bank sections and a reduced cross section. Land cover on the top and upper portion of the bank was dense seasonal vegetation, mostly above the water line. The sloping bank below the vegetation zone was bare; the base of the bare area was moist and algae was growing near the water's edge. The stage at the time of the survey was at about the 90% recurrence frequency stage. The subaqueous bench at the site was broader and flatter than the bench at site 23. The bench was covered with a layer of thick sediment in the nearshore area, but farther riverward the bench surface was hard. The stage analysis (table 6-34) indicated that the bare bank face was located between the 50% and 25% recurrence stages. The 50% recurrence stage, 420.3 feet, was at the base of the scarp.

Bench slopes varied slightly from 1V:25.0H to 1V:15.9H in this reach. The bank soils were cohesive. This site can be classified as a combination of types 2 and 5 (figures 6-19, 6-22, and table 6-4). Erosion processes could be traced as initiated by piping; debris-induced local currents and wave wash extend the erosion; rework and transport by waves and currents at various stages of pool-level fluctuation then remove the failed soils or recently deposited sediment.
