UPPER MISSISSIPPI RIVER SYSTEM ENVIRONMENTAL MANAGEMENT PROGRAM POST-CONSTRUCTION PERFORMANCE EVALUATION REPORT - YEAR 3 (2001) AND FLOOD DAMAGE ASSESSMENT (2001)

## PRINCETON REFUGE HABITAT REHABILITATION AND ENHANCEMENT

NOVEMBER 2001

US Army Corps of Engineers Rock Island District POOL 14 MISSISSIPPI RIVER MILES 504.0-506.4R SCOTT COUNTY, IOWA

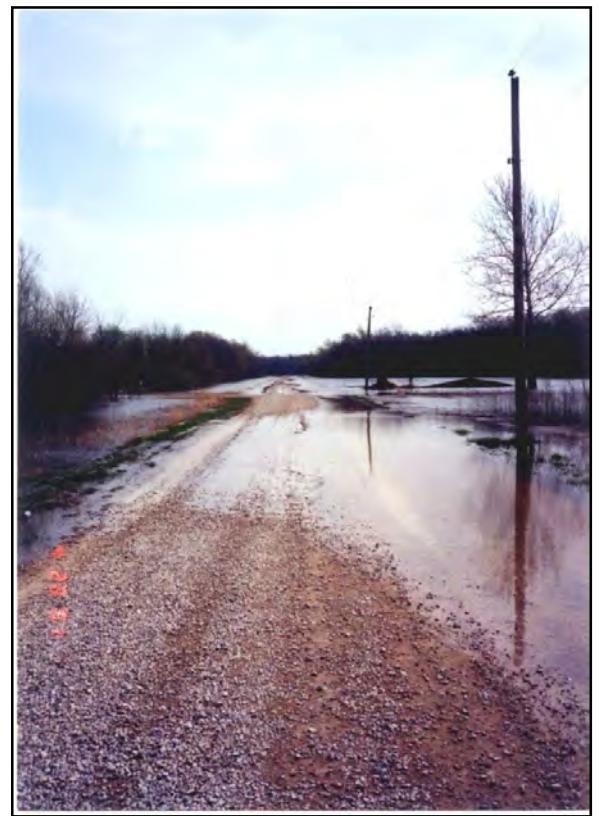
Photo 1 – April 20, 2001 – Overflow Roadway

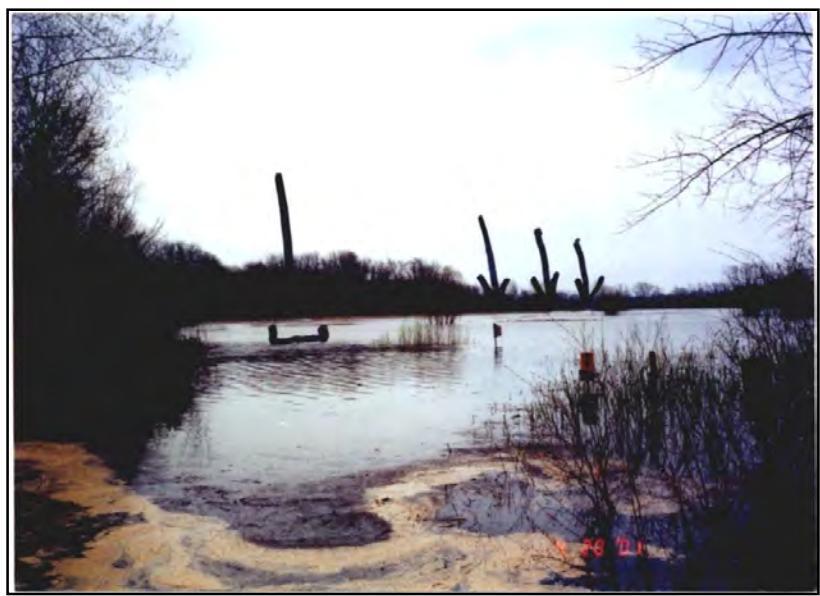
Photo 2 – April 20, 2001 – North Perimeter Levee
