UPPER MISSISSIPPI RIVER SYSTEM ENVIRONMENTAL MANAGEMENT PROGRAM POST-CONSTRUCTION PERFORMANCE EVALUATION REPORT – YEAR 7 (2005)

PRINCETON REFUGE HABITAT REHABILITATION AND ENHANCEMENT PROJECT

US Army Corps of Engineers Rock Island District POOL 14 MISSISSIPPI RIVER MILES 504.0-506.4R SCOTT COUNTY, IOWA

JUNE 2005

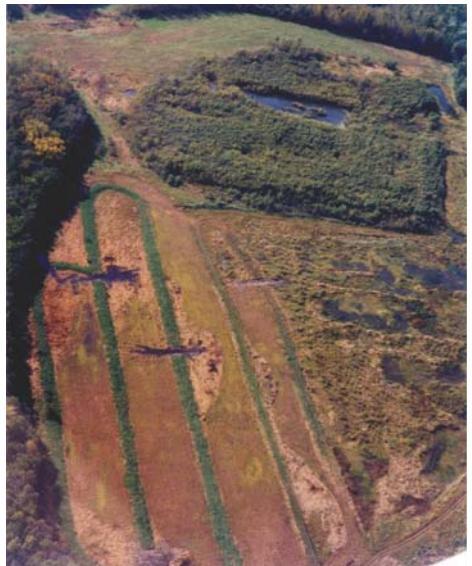
- Photo 1 October 2, 2001 NWMU borrow area south of transmission line
- Photo 2 October 2, 2001 NWMU borrow area in northwest corner
- Photo 3 October 2, 2001 Northeast corner NWMU before Stage III construction
- Photo 4 December 19, 2001 Northeast corner NWMU after Stage III construction

For the low section of perimeter levee just upstream from the gatewell structure near the pump station, it is recommended that this area be raised to the design grade as shown on Plate 9 of the O&M Manual. The sandbags should be removed and the low section should be stripped, filled in, and seeded. The topsoil should be stripped to a depth not less than 6 inches. Borrow material for embankment may come from any of the approved borrow areas as identified on Plate 2 in Appendix K and as seen on Photos 1 and 2 in Appendix G.

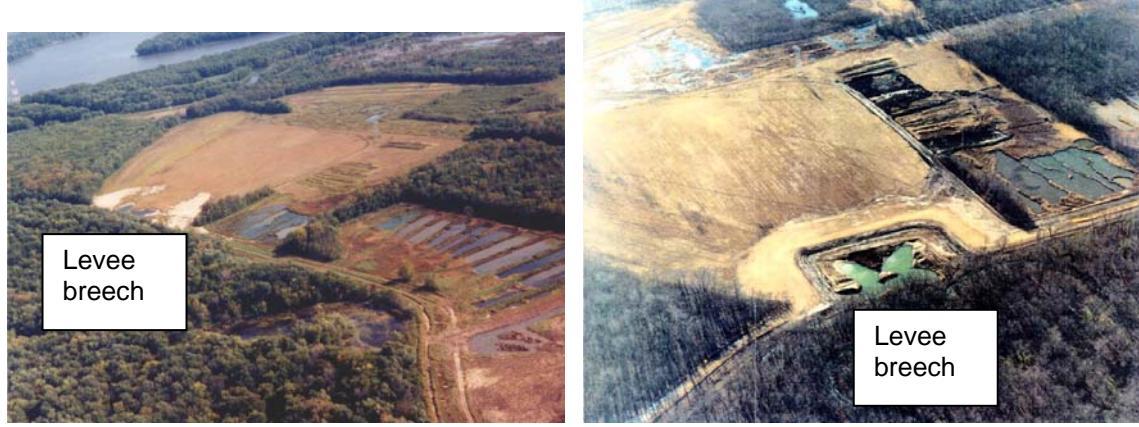
Photo 3

During the Flood of 2001, the perimeter levee from Station 0+00 to Station 40+00 received moderate to severe damage; including several scour areas and a large breach (see Photos 3 and 4 in Appendix G). A Stage III contract was awarded to repair this damage. Stage III drawings are presented in the O&M Manual, Appendix L, Plates 52 through 59. Several factors were identified in the Flood Damage Assessment dated November 2001 as possible causes of the flood damage to the levee. One of the factors was the grade of the overflow roadway. The design for the overflow roadway was to be 2 feet lower than the north perimeter levee to ensure proper function during flood events. The as-built construction drawings show the final grade of the north perimeter levee at elevation 582.3 feet NGVD and the overflow roadway at elevation 580.3 feet NGVD, which provides the required 2foot difference. However, 8 inches (minimum) of granular surfacing was then placed on the overflow roadway. This would place the top of the overflow roadway at approximately elevation 581 feet NGVD. A land survey performed in September 2001 verified that this was indeed the case. The average top elevation of the north perimeter levee was found to be 582.45 feet NGVD, while the overflow roadway showed an average top elevation of 581.05 feet NGVD. The result was a 1.4-foot difference between the two ends rather than the required 2-foot difference.

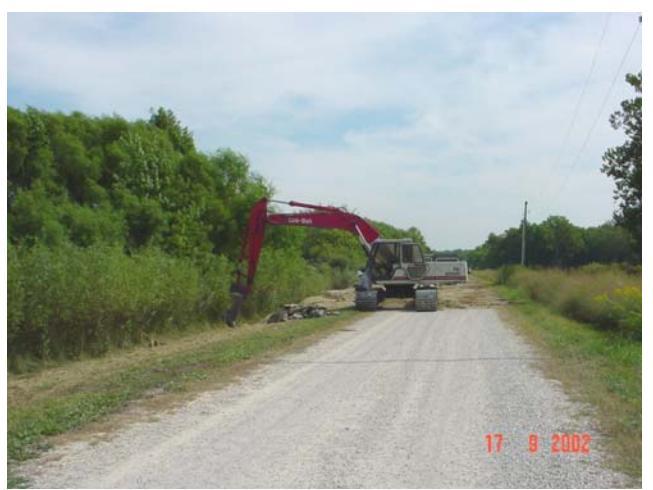
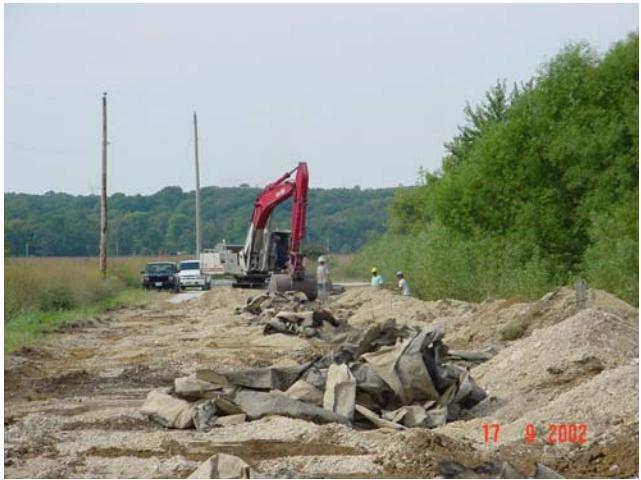
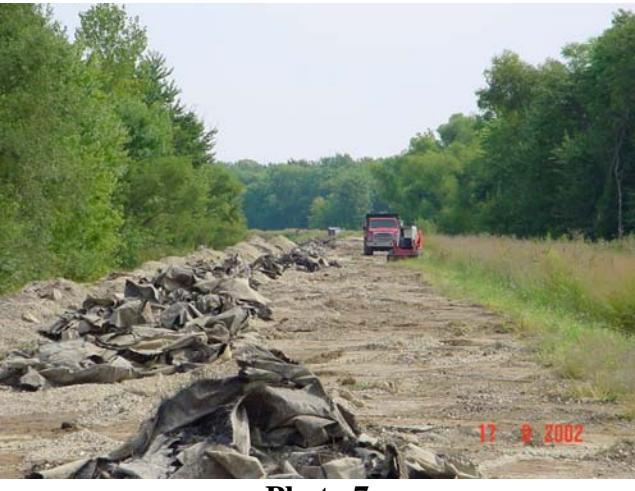
Photos 5, 6, & 7 – Stage IV initiation, geotextile fabric removal and roadway excavation

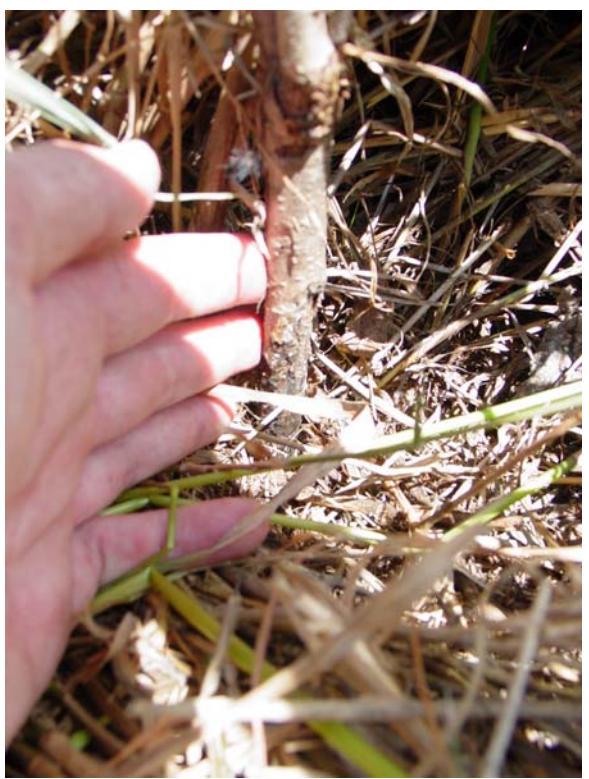
The remaining RPM trees, located southeast of the other mast tree plantings, were inspected next. These trees were planted by the IADNR and OD-MN. The survival on these trees is about 50%. Approximately 75 trees were found. Most of the trees had been browsed or rubbed by deer and had re-sprouted several times. A few were taller than 6 feet. The majority of the trees were found along the old road back where it cuts into the forest. The areas open to full sunlight had much fewer surviving trees. The herbaceous competition is all reed canary grass. The majority of the weed barrier mats are still in place and seem to be helping to a limited extent.

Photo 24 – Mast trees, rodent damage

(2) <u>Conclusions</u>. The objective of increasing the overall vegetation diversity and availability of preferred wildlife foods through mast tree plantings is being met. Based on the OD-MN inspection of the mast tree plantings, it is recommended that both sites be treated with herbicide. Also, it may be beneficial to place weed barrier mats at the mast tree plantings on the north-south berms, which would require mowing or weed whipping.

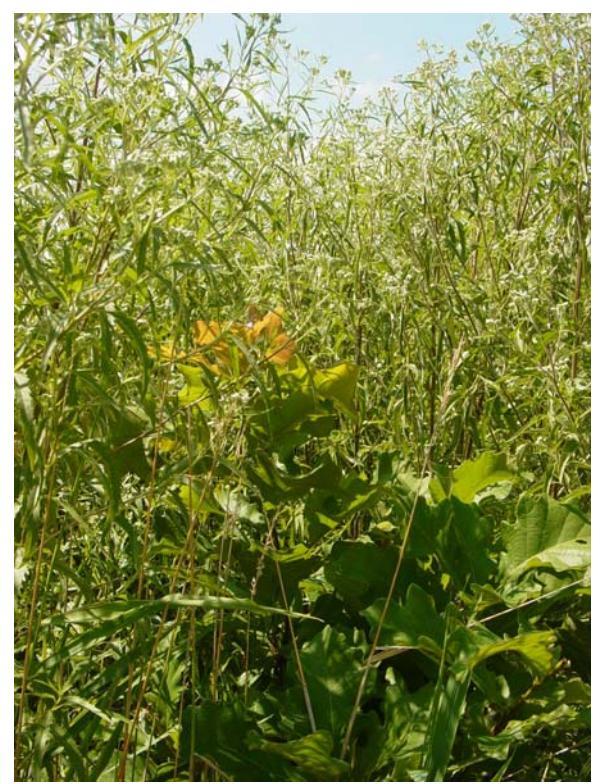
OD-MN conducted two inspections of the mast tree plantings in August 2002. The mast tree plantings on the north-south berms were inspected first. Trees on the east side of the berm are thriving despite competition from other vegetation (see Photo 25 in Appendix G). Trees that were planted on the west side were surrounded by reed canary grass and had a low survival rate. Very few trees were found alive; however, surrounding vegetation reduced the visibility of the surviving trees. Many of the trees still alive in the reed canary grass have sustained damage from deer browse and mice chewing the bark (see Photo 24 in Appendix G). These rows on the west side averaged 5 to 8 trees per row whereas the shorter rows on the east averaged over 10 trees per row.

Photo 25 – Mast trees, weed competition
