UMRR HREP INSPECTION OF COMPLETED WORKS 2016

Spring Lake Habitat Rehabilitation and Enhancement Project (HREP)

Pool 13, Mississippi River Miles (RM) 532.5 to 536.0, Carroll County, IL

2013 Annual Inspection Report

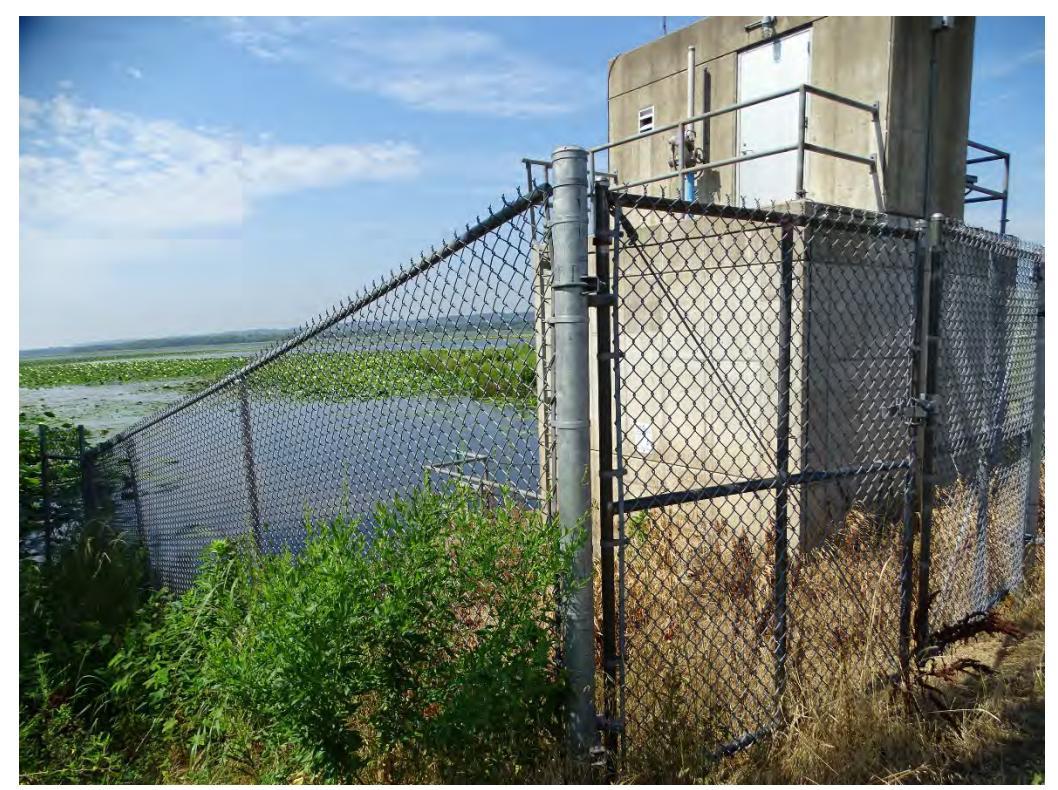
Photo 1: Pump Station

Pump Station: The pump station continues to be operable and it well maintained by the FWS. The pump records and electrical costs are available. The upstream inlet structure to the pump station originally did not have a top cover to the trash rack. During high water, the small opening would occasionally overtop, and fish would get caught and enter the pump house and be ground up by the pump. This would create a thick material which would eventually shut down the pump. The FWS would be required to manually remove the debris from inside the pump house, a time consuming and odorous task. The FWS constructed a top grate to the trash rack to keep fish out. This has greatly reduced maintenance.

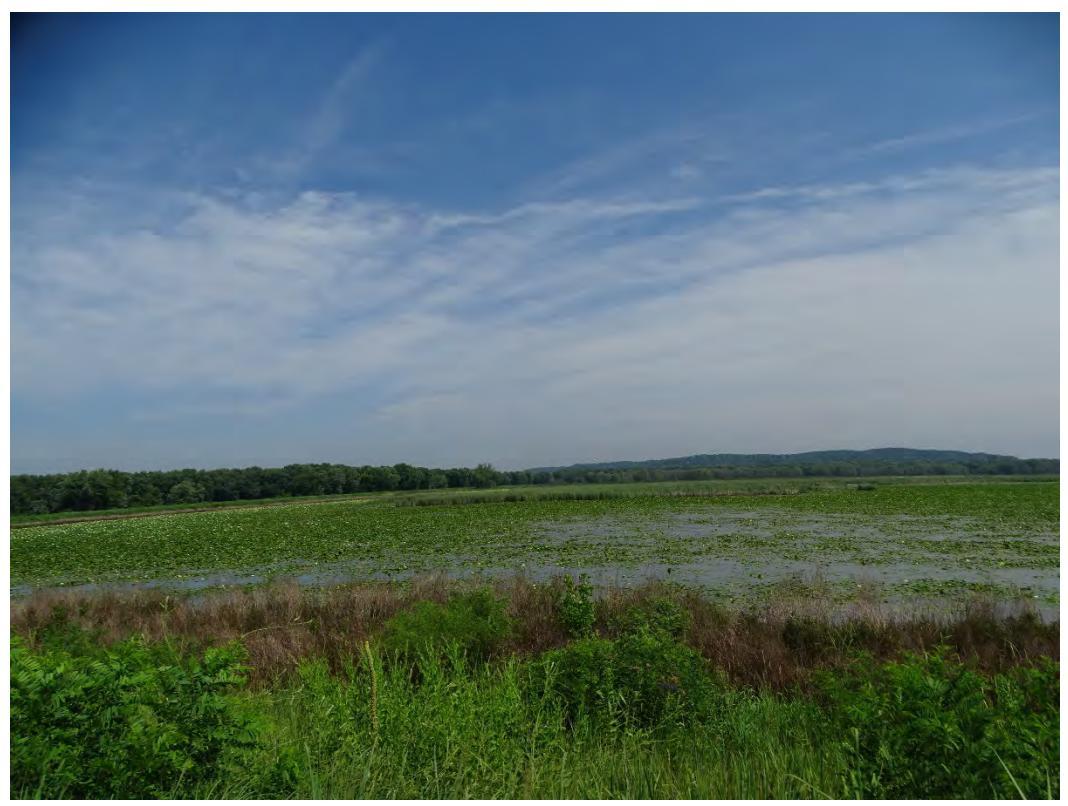
Cross Dike: The FWS previously constructed two additional spillways in the cross dike (total now of 4) at a slightly lower elevation to better manage the upper units during flood events. With the additional spillways, the upstream unit will fill more quickly, allowing it to be better protected in overtopping events. The spillways are generally constructed of riprap. The original design included fabric, however the fabric was placed longitudinally along the spillway, and was not well tied in, causing it to roll during overtopping events. Placing the fabric perpendicular to the flow of traffic, or parallel to the proposed flow could help prevent similar future issues. Also, it is important to anchor the upstream and downstream ends. This can be done by excavating a ditch on either side of the dike, burying the ends of the fabric, and covering them with a layer of riprap in addition to the anchors typically provided with the fabric.

Photo 10: Cross dike spillway

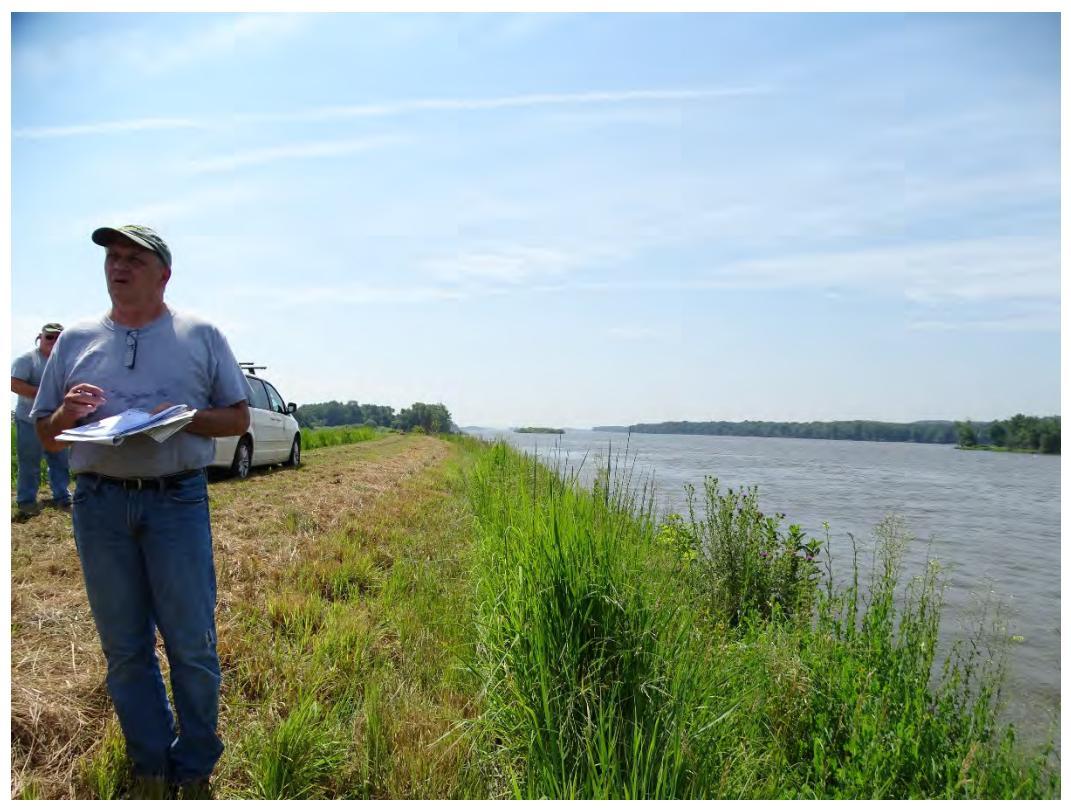
Near the southwest corner of the levee, ongoing erosion is occurring, and a deep hole continues to develop, causing some of the downstream riprap to roll into the hole. A few options discussed included additional riprap, relocating the levee (set back), rock deflection structures to deflect erosion based on river flow, or offshore islands or mounds to reduce wind wave induced erosion.

Photo 22: Perimeter levee looking upstream, riprap missing

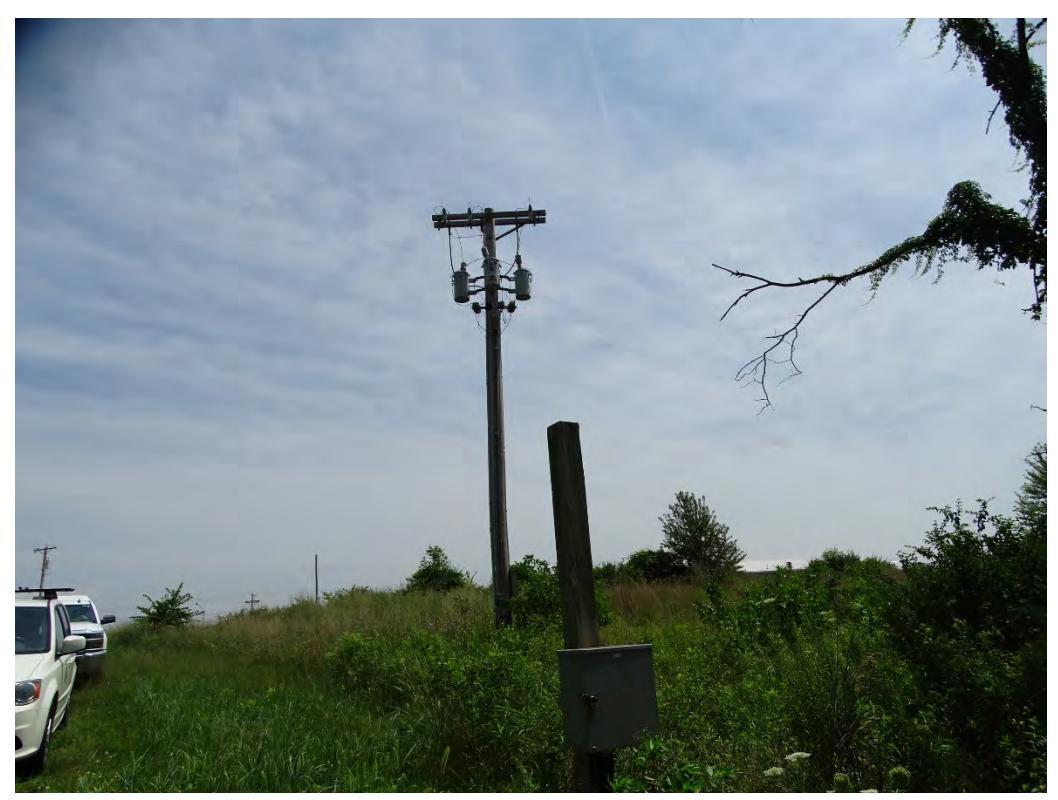
Hemi Marsh: The water level is controlled with a well pump. This pump was frequently struck by lightning. The FWS installed long copper lines underground to divert damage from the pump which has to date been successful. The pump casing has also been replaced. This marsh continues to provide diverse species and habitat for waterfowl feeding.

Photo 26: Hemi Marsh well

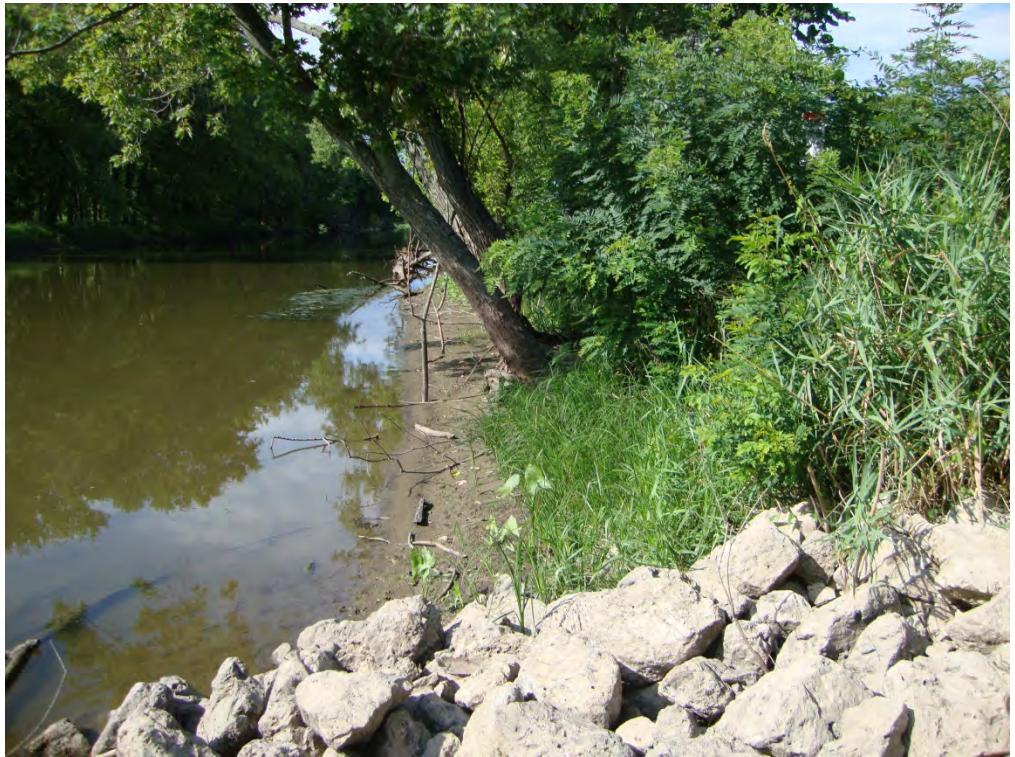
Photo 8: Perimeter Levee, 2009 erosion repair upper end tie-in.

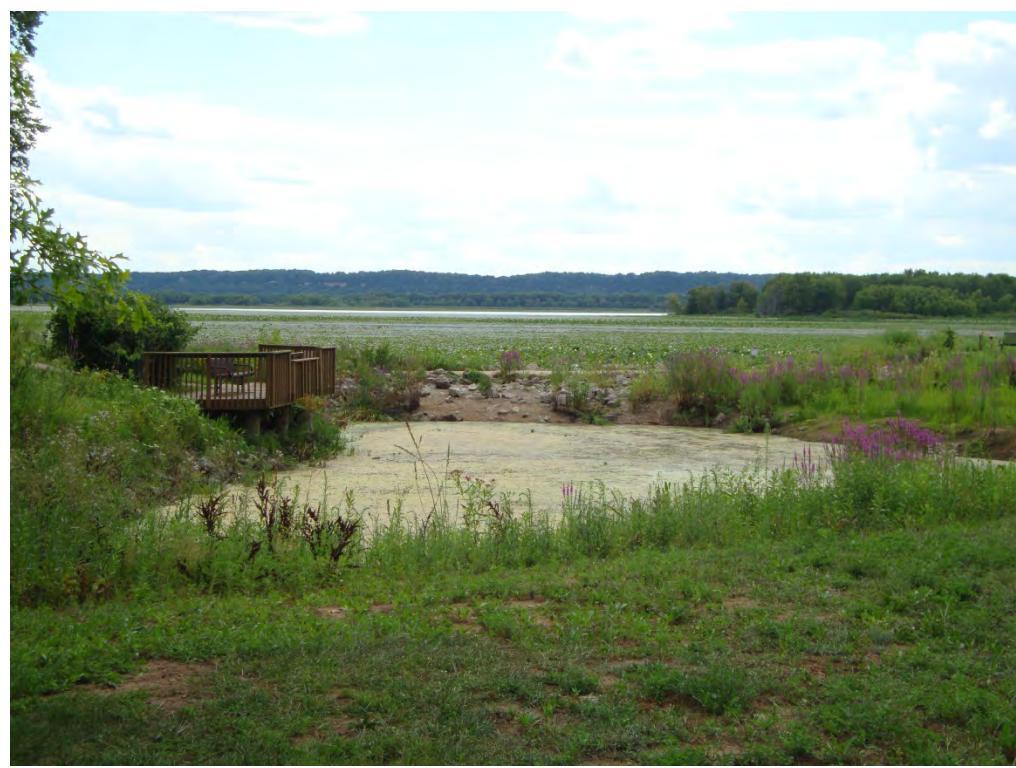
Item	Observations/Condition	Remarks/Recommendations
Entrance Area	Previously repaired area ok. Some	Continue to keep woody vegetation
Spillway	aggregate moves off road into	off spillway.
	river during flood events. Photos	
	9-10.

Photo 9: Cross Dike entrance spillway.

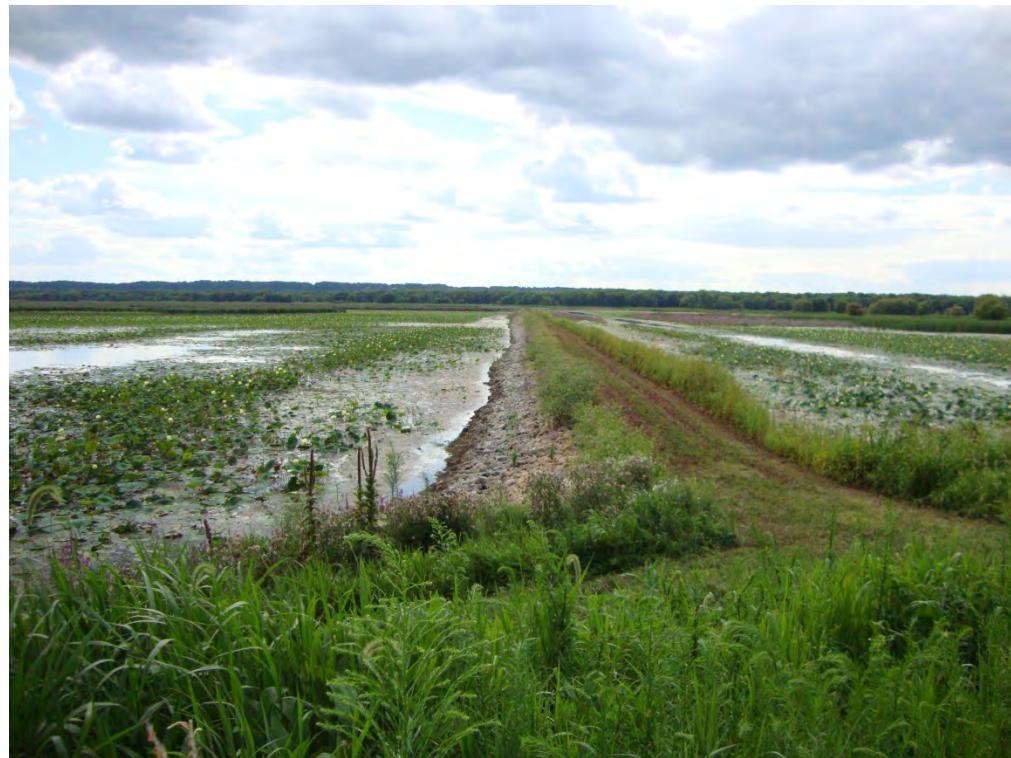
Photo 15: Interior Dike A, east end looking west. Example of riprap repair on south (left side) slope.

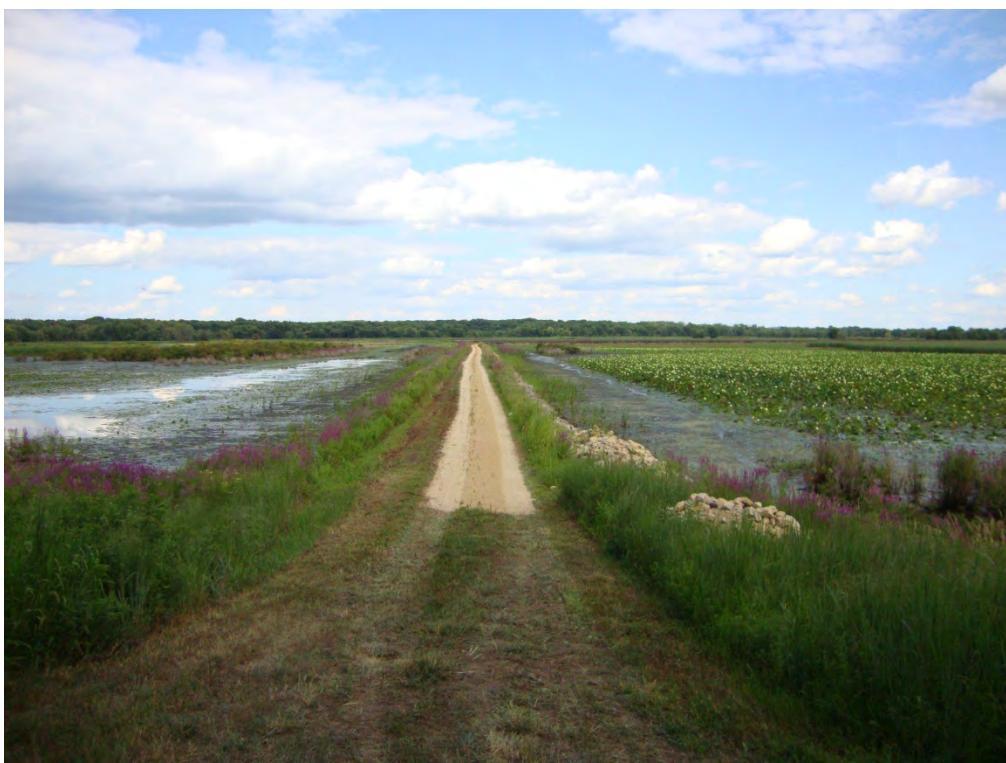
Photo 16: Interior Dike A, west side looking east. Riprap repair on south (right side). Aggregate surfacing being placed on dike.

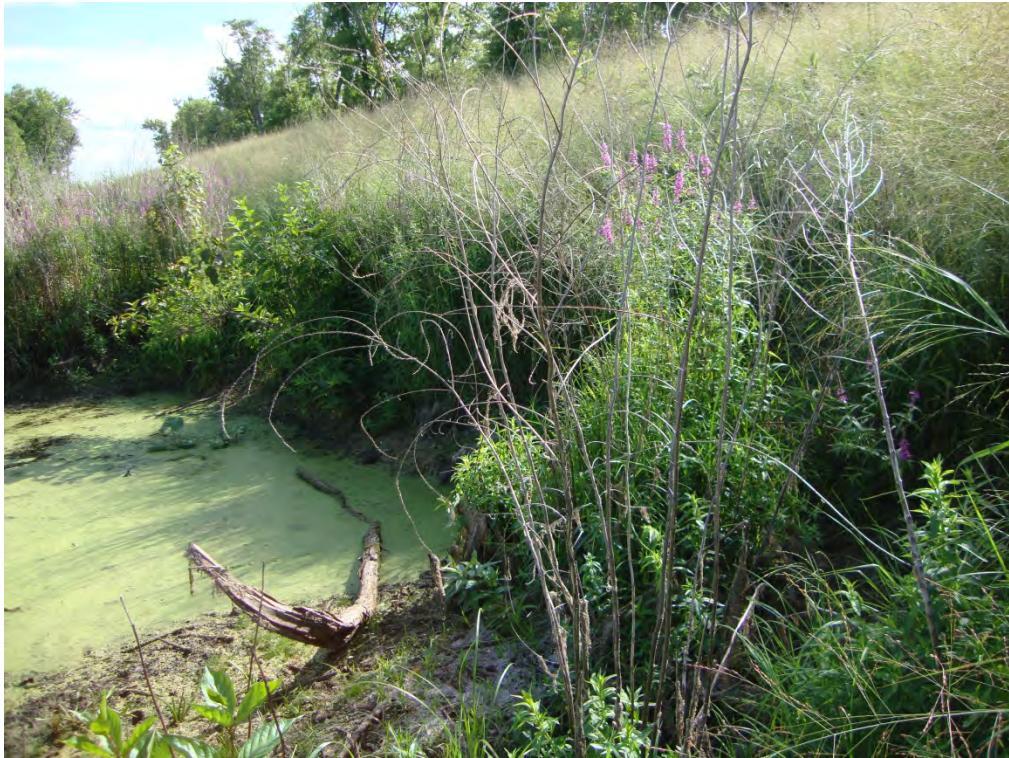
Photo 33: 24" Gatewell Structure, interior outlet. Outlet under water. Critter damage around outlet area.

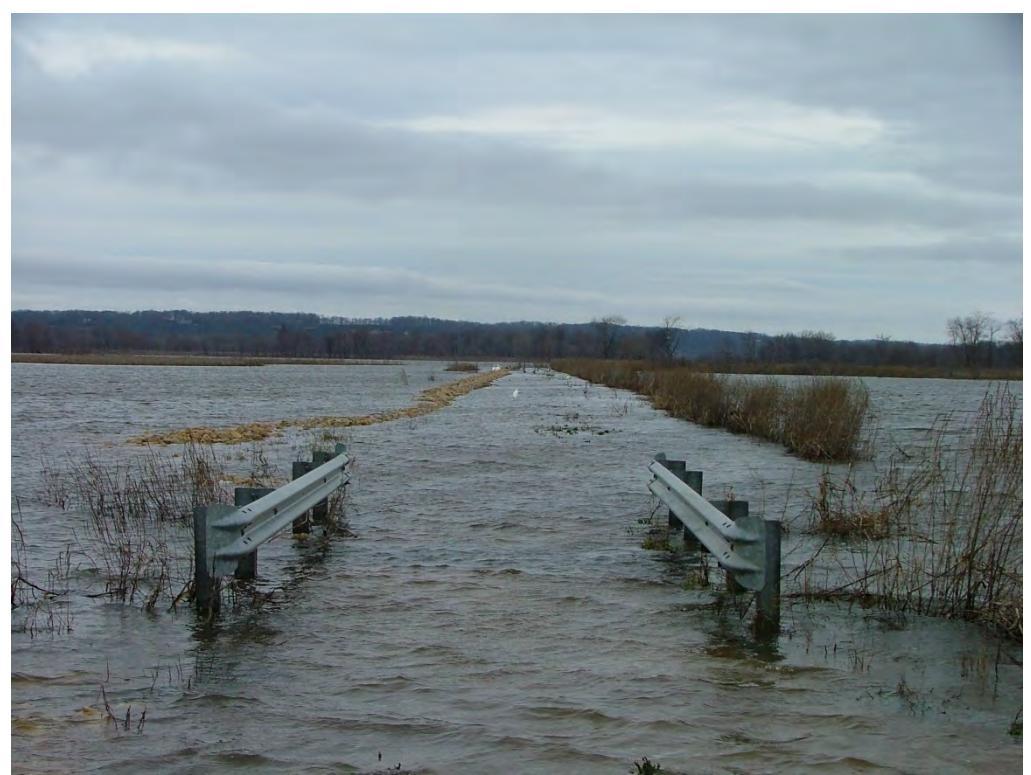
Photo 36: Hemi Marsh Levee stoplog structure, looking west. Flooding on April 23, 2013 (USFWS Engelke photo).
