# Appendix J Geotechnical Engineering

This Appendix presents more detailed information regarding the geotechnical aspects of the Yorkinut Slough Habitat Rehabilitation and Enhancement Project (Project). It contains all other relevant geotechnical and subsurface information necessary for a detailed and thorough understanding and review of work that was not included within the main report.

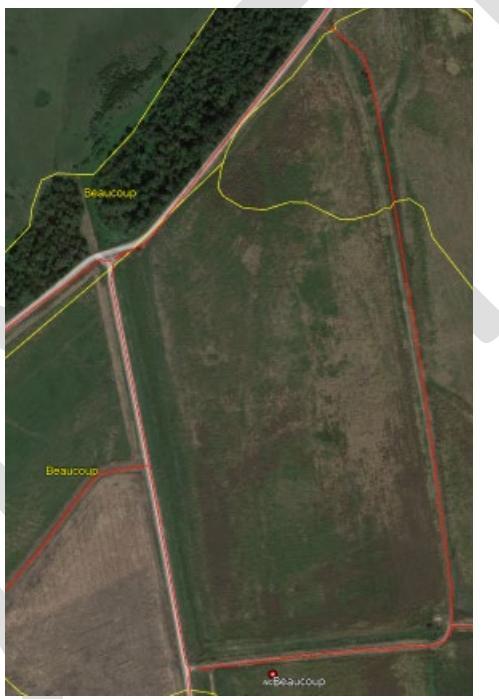
Figure 1. Pump Station ("Leaky") MSU shown with NRCS soil classification as mostly Beaucoup.

One of the geotechnical objectives of this Project was to determine the cause for the Pump Station MSU's inability to hold water (see Figure 1). This currently impacts the Sponsor's ability to manage the unit as intended or desired without incurring into additional pumping costs, further impacting their ability to provide refuge to migrating waterfowl. Observations from the Refuge staff indicate that it takes about a week of pumping to flood the MSU. As soon as the pumps are turned off, it takes roughly the same amount of time for the water to completely drain out.

The level of subsurface investigation performed as part of this study was unable to determine the cause of the Pump Station MSU's drainage problems. Insight for future investigations might be gained from proposed activities that will not be incorporated into this report. These activities are contingent on time and funding. As part of these, a trench will be dug along the ditch berm in an effort to locate the suspected clay drainage tiles. Separately, a Frequency Domain Electromagnetic (FDEM) survey is planned to look at areas of interest to detect any anomalies that might indicate the source or path of drainage. It is recommended the FDEM take a look at the two locations identified in Figure 4. The trench should be at least 20 ft away from the berm toe, no more than 3 ft deep, and the excavated material should be placed back and compacted as best as possible. If no further investigation will be pursued, or if the cause of the drainage cannot be determined, the

MSU should not be combined with other units. Alternate management strategies should, thus, be pursued.

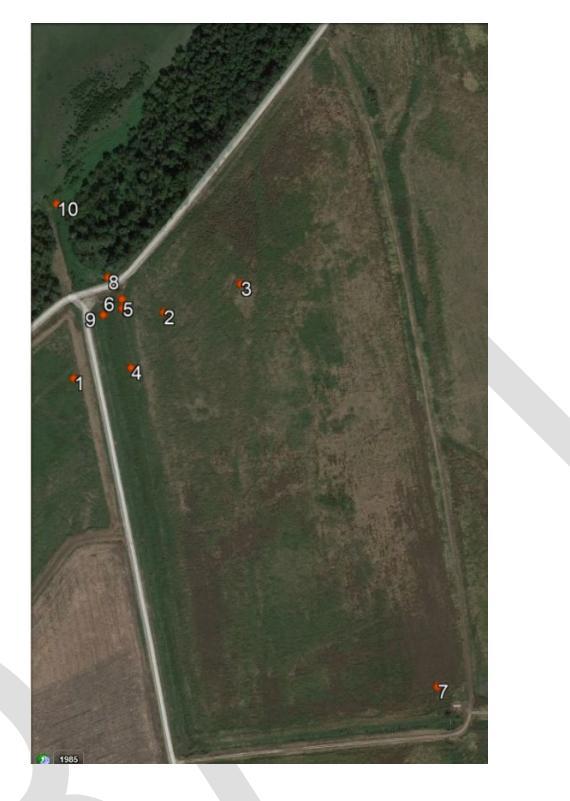
## Figure 3: Soil Probe Locations

issue. The study team conducted a site visit on July 27, 2022. At the time, the Refuge Manager stated that the ditch that runs alongside the Western edge of the MSU is not thought to have been designed whenever it was dug, and that it appears the MSU drains slower whenever the ditch is full. This observation points to the possibility of a sand lens being cut or a sand layer being exposed to surface. The drainage path would be through the sand lens into the ditch. A review of NRCS soils data from the Web Soil Survey (https://websoilsurvey.nrcs.usda.gov) (Figure 2) appeared to back this hypothesis up. The survey shows Beaucoup soils, the main constituent of the MSU, tend to experience a sharp increase in sand content from around 10% to 17% at a depth of 3.5 ft to 4ft. This jump in sand content translates to greater amounts of coarser material being present at that depth and would increase soil permeability, aiding seepage, Likewise, we see a decline in clay content. At that same depth, the clay percentage drops down from 30% to 23%. A soil needs a clay content of about 27% or 28% before it is able to start consistently ponding water, and here we see it decrease past that threshold. The study team visited the site a second time to perform soil probes. The intent was to verify the presence/depth of a sand layer consistent with the hypothesis that the water was draining through it. The visit took place on September 15, 2022. The 36-inch probes taken at the MSU all retrieved silt and clay soils. No sand samples were encountered within the MSU during this site visit. A control sample taken at an adjacent MSU did find a sand lens, however that MSU does not experience seepage issues. The findings at the time were inconclusive. The locations of the soil probes can be seen in Figure 3.

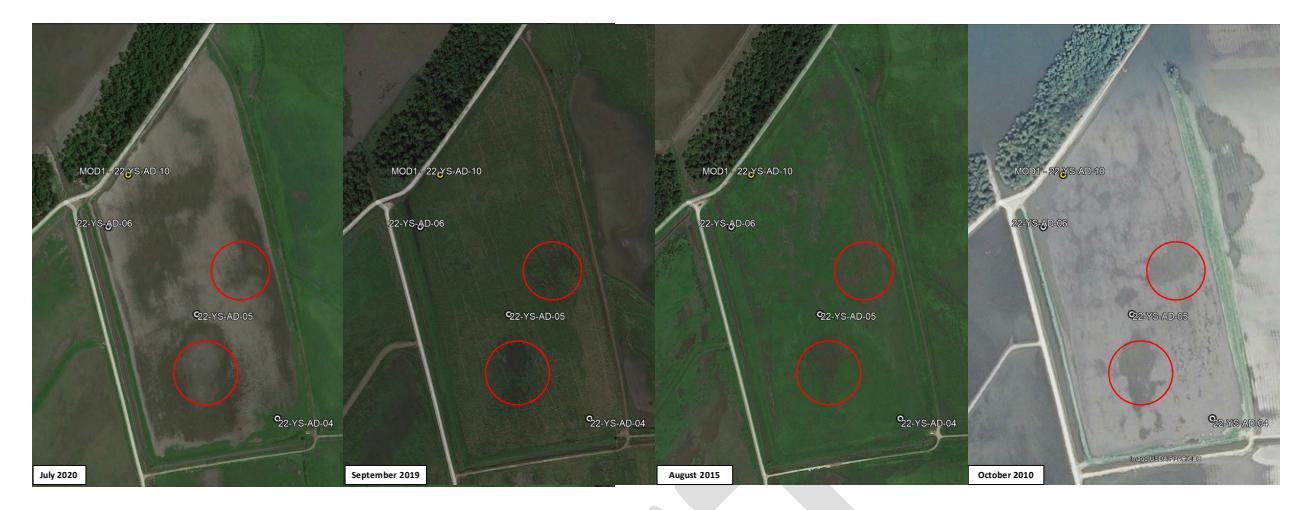
Review of historical aerial imagery and the boring logs later revealed another possibility. Borings 04, 06, and 10 had clay caps at the ground surface some 9 to 10 feet thick underlain by sands. Boring 05 only had 5.5 feet of clay cap, also underlain by sands. Historical aerial images show that close to boring 05 is an area that is consistently wet and lacking vegetation. This could indicate a sandy outcrop at or near the surface where the water is draining from the MSU at low stages in Swan Lake and could possibly seep in during higher stages. The lack of vegetation can also be indicative of sand outcrops since vegetation does not grow easily in sands. Two of these possible outcrops are shown in Figure 4.

Figure 4. Historical images showing possible areas of shallow sand at Pump Station MSU.

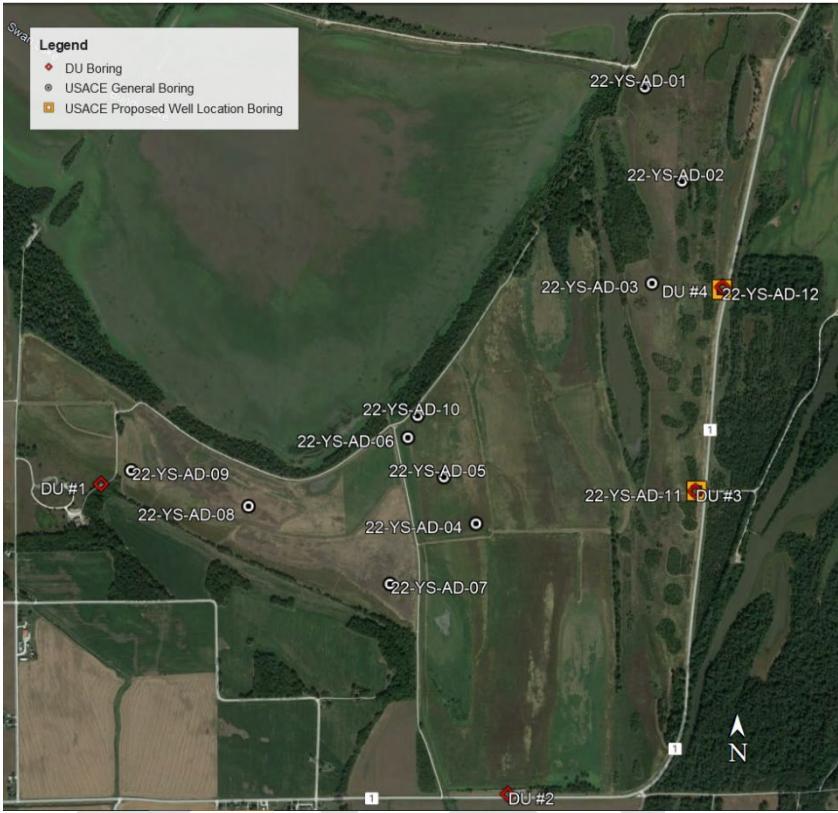
## Figure 5. Boring locations.

The study area stratigraphy generally consists of a clay cap at the ground surface underlain by sands. The clay cap is generally some 9 to 10 ft thick. Clay lenses are also present deeper down. Borings 02 and 03 had an additional clay layer about 20 to 25 ft down. A clay cap of only 5.5 ft was observed at borings 05 and 08. Although, the clay cap in boring 05 is thought to be associated with the drainage issue of the Pump Station MSU, it is not considered to be an issue in boring 08 since the Lower Calhoun MSU holds water. Boring 09 shows 25 ft of clays and clayey sands before transitioning to sands. Borings 11 and 12 encounter the aquifer at a depth of 13 and 20.5 ft, respectively, and boring 12 hit rock at 108.5 ft of depth while boring 11 never encountered rock. The water table ranges from 6.6 ft deep to 16.8 ft deep throughout all the borings drilled. At the Calhoun Point Well location (22-YS-AD-12), the water table is 13 ft below ground surface, while at the Yorkinut Well location (22-YS-AD-11) it is 16.8 ft below ground surface.
