Performance Monitoring

Rock Island District

Kara N. Mitvalsky, P.E. CEMVR-EC-DN

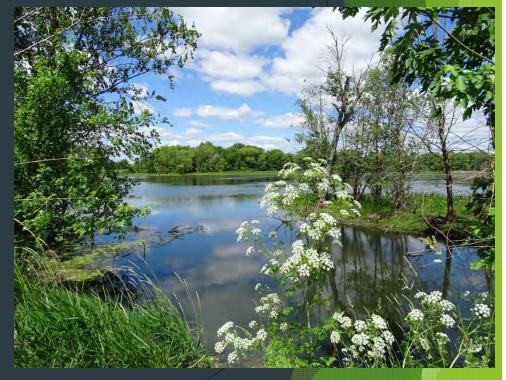
View of Northern Unit which is operated as a closed area within the refuge. This photograph was taken from a water control structure located on the cross dike.

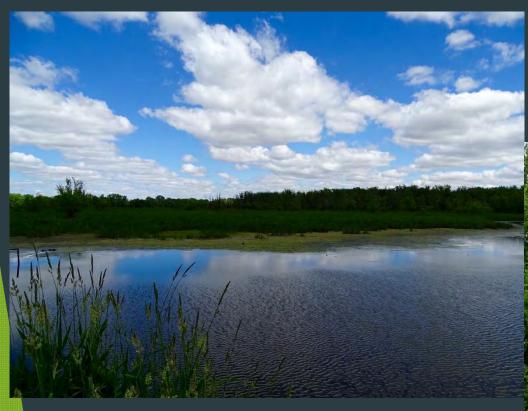
Southern Unit: Photo was taken from the water control structure located adjacent to the pump station. The photograph is looking towards the southern unit, with the restored perimeter levee noted on the left hand side of the photo.

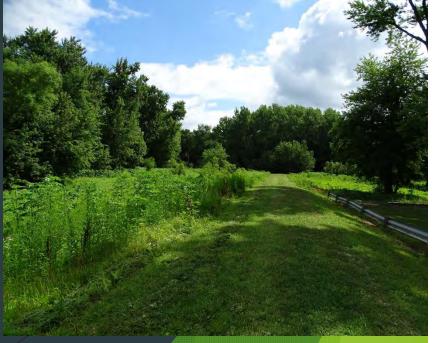
Existing pump station was pulled and the unit is being maintained with temporary pumps as well as possible until a permanent pump can be reinstalled.

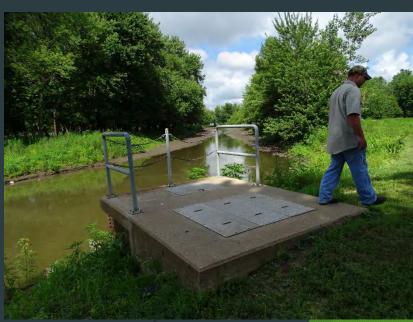
Operating 4 bays with stoplogs was not necessary in most conditions, so a local friends group funded the construction of aluminum gates, which were installed in ¾ of the 3 stoplog bays.

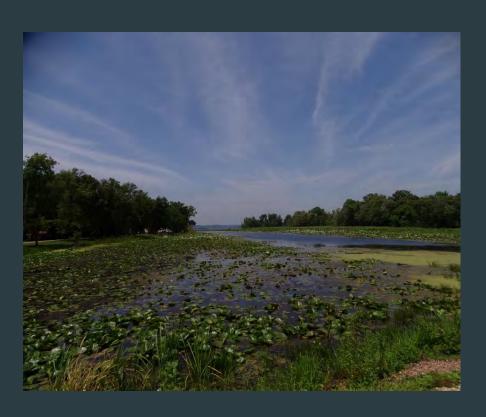
View from Thomson
Causeway Recreation Area
access road - Sediment Trap
and Hydraulic Dredging
According to the FWS, the
excavation into the project
(near the bridge/causeway)
has filled in.

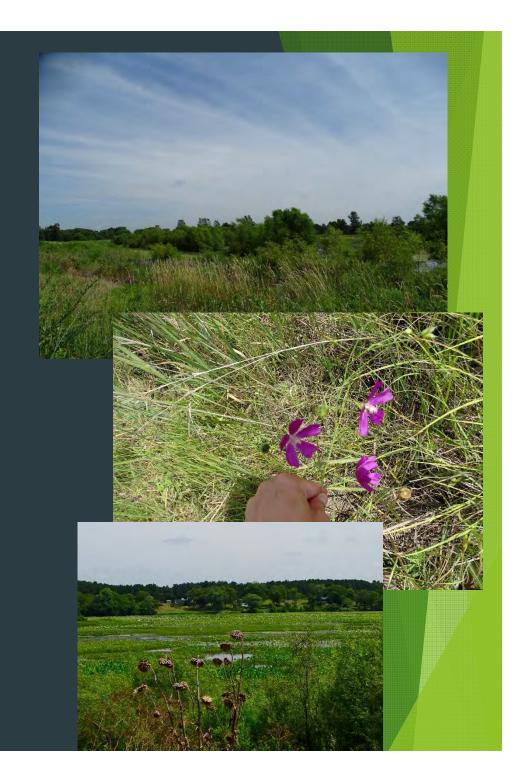
- Some of the dredge cut locations could be observed by changed or lack of aquatic vegetation.
- Most of these cuts have filled in more than expected, especially at the downstream end of the site.

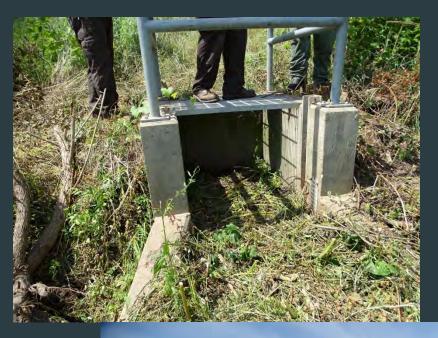
This structure is a favorite location for beavers, who enjoy filling the structure. This is removed as needed; however, the beavers also have constructed an access hole through their debris which allows for some water movement. The gage on the structure has numbers that no one was sure what were tied to, so the FWS constructed their own gage off shore (not far from the large beaver lodge) to gage interior water levels. While a beaver was not observed on this site visit, stories of beavers the size of hogs have been reported in this area.

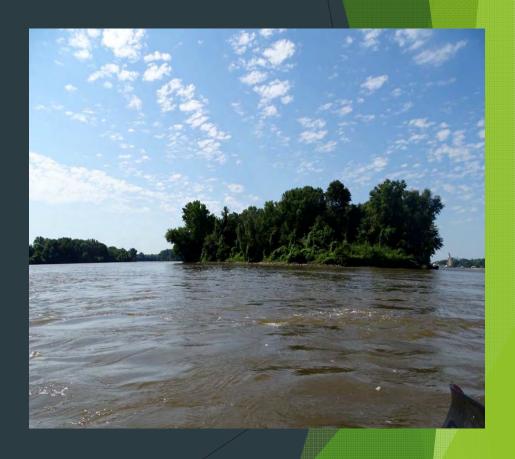
Small islands protected throughout the complex appeared to be well protected by the riprap, although downstream of riprap protection, active erosion was noted.
