**UPPER MISSISSIPPI RIVER SYSTEM
ENVIRONMENTAL DESIGN HANDBOOK**

CHAPTER 3

LOCALIZED WATER LEVEL MANAGEMENT

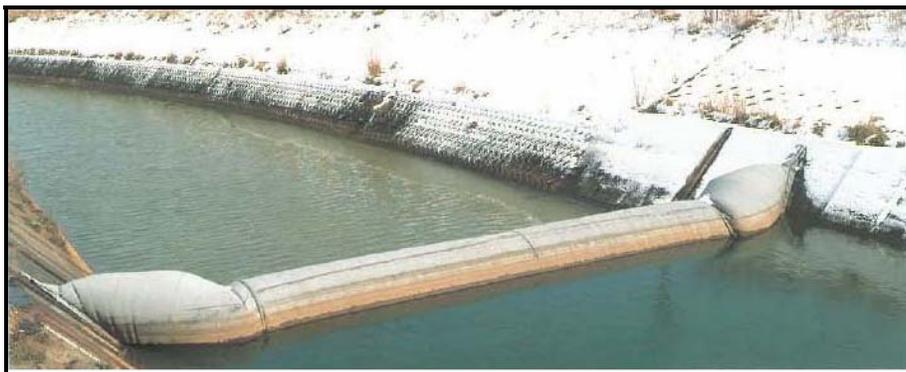
Photograph 3.1. Typical Rubber Dam Application (Sumitomo Electric)

3.5.6.1. Design Methodology and Criteria. Rubber dams are becoming an increasingly popular alternative to more tradition dam structures, as they are easier to install and are more environmentally friendly. Photograph 3.1 and figure 3.1 show examples of rubber dams. The design, installation, and operation of each of these gates are basically identical even if they come from different manufacturers. Each gate uses an inflatable rubber bladder (made from 3-ply nylon) that can be adjusted to produce a desired pool elevation. The first step in the installation of a rubber dam is to construct a foundation structure for the dam. The bladder is then connected to the foundation using anchor bolts and steel plates to clamp the bladder in place. Finally, the bladder is inflated using a blower system with 0.05kgf/cm² to 0.6kgf/cm² of air (Bridgestone) to the desired elevation. Once inflated, the dam is idle and an air pressure sensor alerts the compressor to keep the dam at a constant pressure. The bladder can also be filled with water.

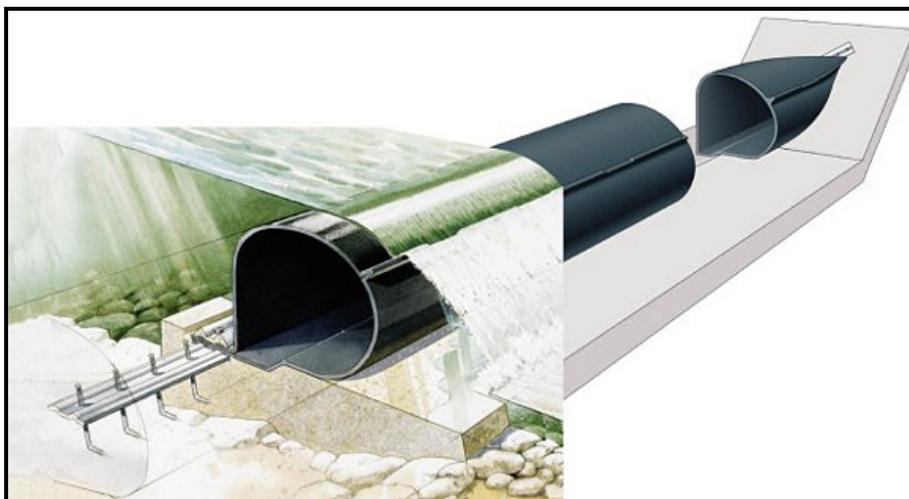
Figure 3.1. Overview of a Rubber Dam (Bridgestone)

Similar to the Obermeyer Gate, the rubber dam can be regulated automatically via an electrical or mechanical control system. A generator is needed to supply the necessary power for the operation of the dam. Maintenance is minimal as there are no moving parts within the dams and they are known to be naturally self-cleaning of debris. Also, according to Bridgestone, debris rarely punctures the bladder. However, like other inflatable dam alternatives, rubber dams are prone to vandalism as they are possible to puncture, resulting in a failure. The cost for a rubber dam depends heavily on the size and other variables; however, the smallest rubber dams generally cost around \$200,000 (Bridgestone).

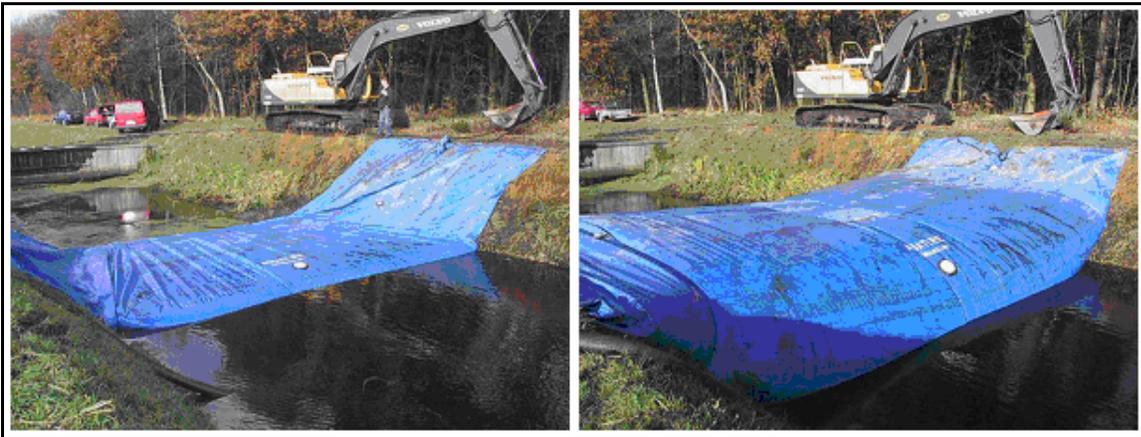
Photograph 3.2. Installation of an Aqua-Barrier

Photograph 3.3. Inflation and Operation of an Aqua-Barrier (Aqua-Barriers)

3.5.7.1. Design Methodology and Criteria. The Aqua-Barrier is a water-filled dam that can be used in a variety of applications. Photographs 3.2 and 3.3 show Aqua-Barriers in use. The most common applications of the Aqua-Barrier are flood protection, construction site dewatering, and containing spilled hazardous materials. The barrier is available in a variety of standard sizes, with a height ranging from 2 to 8 ft and a length from 25 to 100 ft (custom sizes are available as well), and is made from a 30 oz. PVC vinyl. The installation and operation of the aqua barrier is relatively simple. The barrier is unrolled and placed along its desired location. It is then filled with water that is pumped from a local source. Once the barrier has been filled with water, it is held in place by its own weight and surface friction (no ties). It is important that the barrier is completely filled with water in order to create a stable structure. The aqua barrier can generally be moved or re-filled 15 to 20 times before it needs replacing.

Maintenance is minimal as the structure contains no moving parts. In the event of a rupture, the barrier can be repaired without necessarily being completely removed from the field. The cost per linear foot ranges from \$19 to \$95 (EconoDam), but depends heavily on the site specifications.

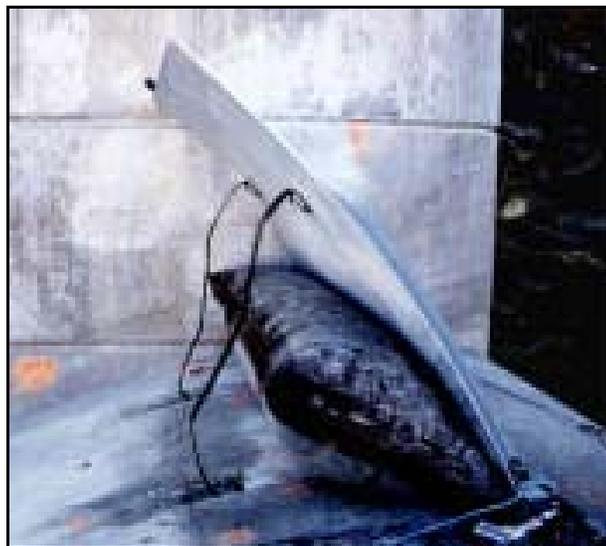
Photograph 3.4. Typical Gate Section - (Obermeyer Hydro Inc.)

3.5.8.1. Design Methodology and Criteria. An Obermeyer Gate (photograph 3.4 and figure 3.2) is a spillway/overflow gate that is often used in dam applications. The Obermeyer Gate is composed of steel plates that are supported by an inflatable air bladder on their downstream side. The bladder is made of “A Butyl rubber inner liner provides excellent air retention characteristics. A section of high tensile strength rubber compounds containing multiple layers of polyester or arimid, e.g. duPont Kevlar® tire, cord reinforcement provide the mechanical strength needed to contain the internal pressure. A cover compound utilizing aging and ozone resistant polymers such as EPDM is used to protect the bladder from wear and weathering.” (Obermeyer Hydro Inc.). The installation process for the gate is relatively simple. First, anchor bolts are connected to the foundation for the gate. The bladders are then secured to the anchor bolts and are connected to an air source. Finally, the steel panels are attached to the hinge flaps on the bladder.

Once installed, the gate can be raised or lowered by controlling the amount of air that is being supplied to the bladder. Air is not constantly supplied to the bladder. The internal pressure is regulated by a system of valves and is adjusted by an external compressor. A control system can also be used to automatically regulate the elevation of the gate. The two major types of control systems are solar powered and pneumatic water level controls. The solar powered controls use 12 volt solar panels, a battery, and a compressor in order to supply power to the control system and compressor. The pneumatic water level controls are the most popular because they do not require any electrical power. However, most applications involve the use of a generator unless they are small enough to employ the solar power system.

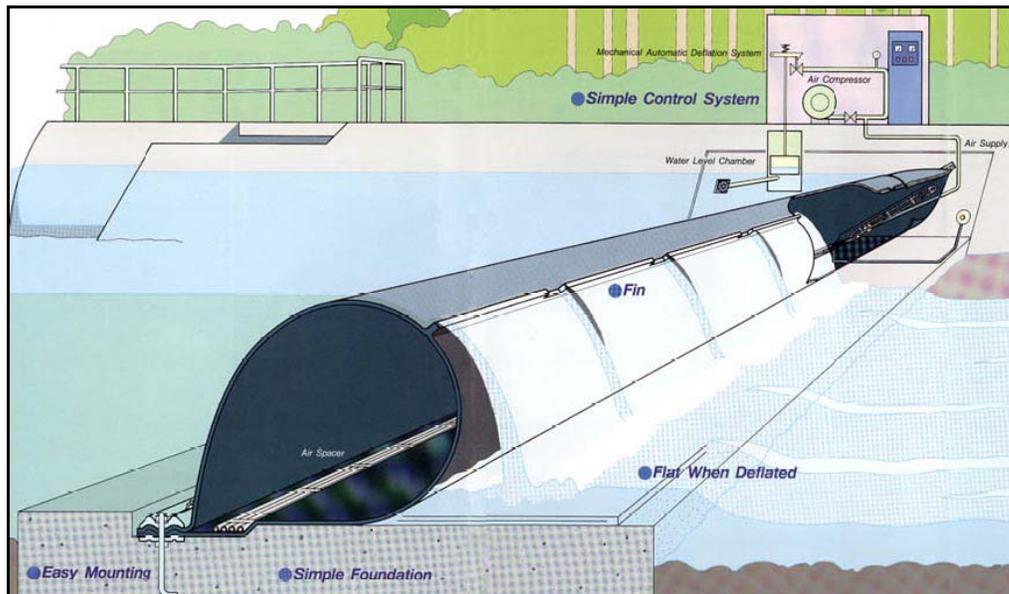
Figure 3.2. Overview of an Obermeyer Gate System (<http://www.crrel.usace.army.mil/ierd/tectran/IERD30.pdf>)

The profile of the Obermeyer Gate does little to disturb its surrounding environment as debris, ice, and fish can easily pass over the structure depending on its elevation. The major problem associated with an Obermeyer Gate is that it is vulnerable to vandalism. A puncture to the air bladder could cause a section of the gate to deflate completely. Fortunately, the steel panels on the upstream side of the gate form a protective covering over the bladder. Also, depending on the size of the gate, multiple air bladders can be used and separated by check valves so that a puncture to one section of the bladder will not result in a complete failure.

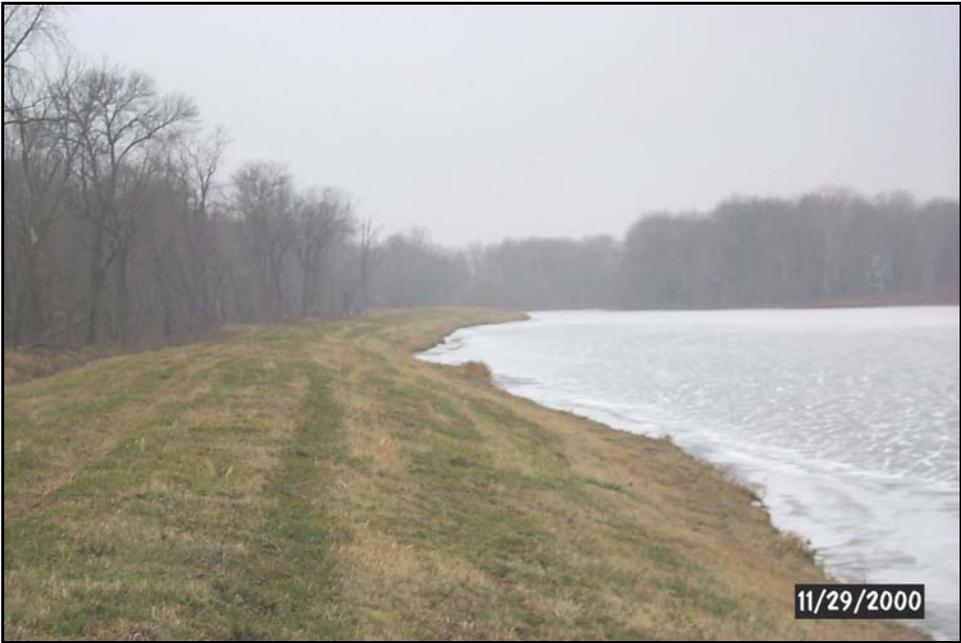
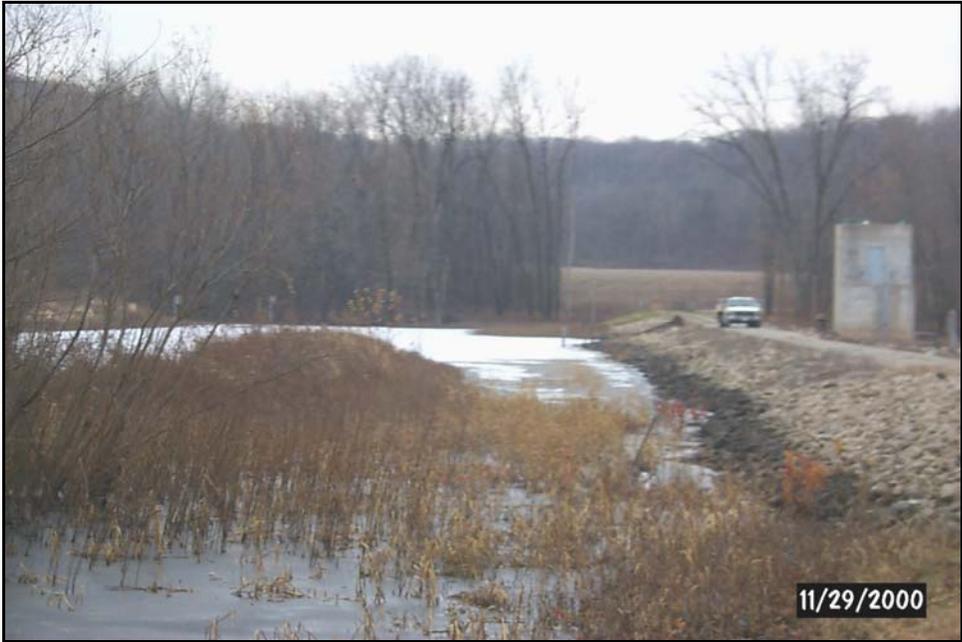
Andalusia Refuge HREP, Pool 16, Upper Mississippi River Miles 462.0 - 463.0, Rock Island County, Illinois, CEMVR

3.6.1. Perimeter Levees, Cross Dikes, and Overflow Spillways

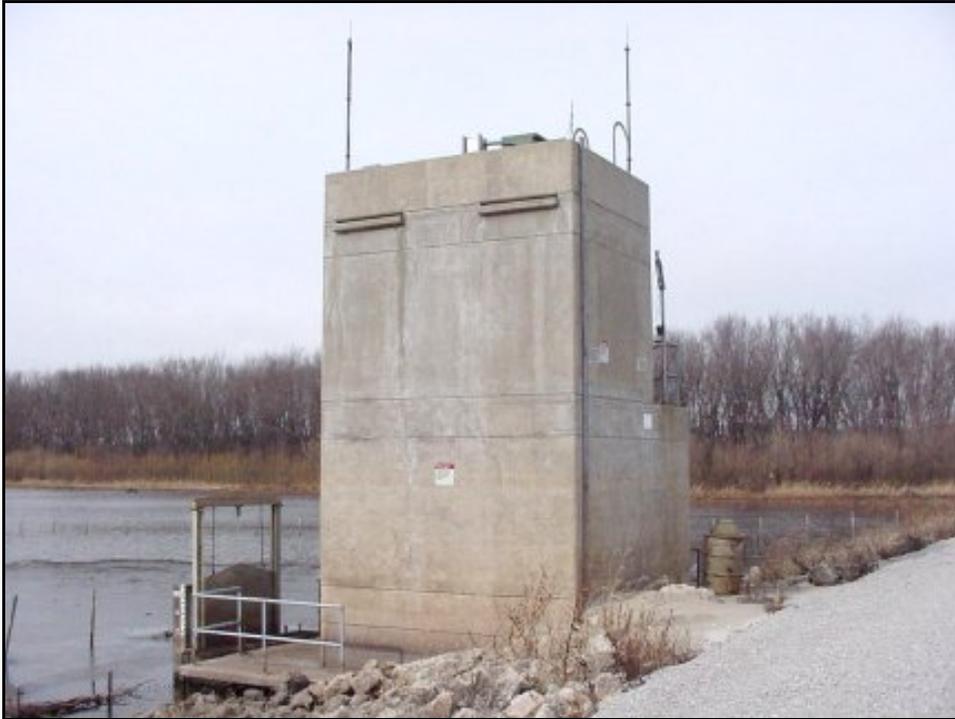
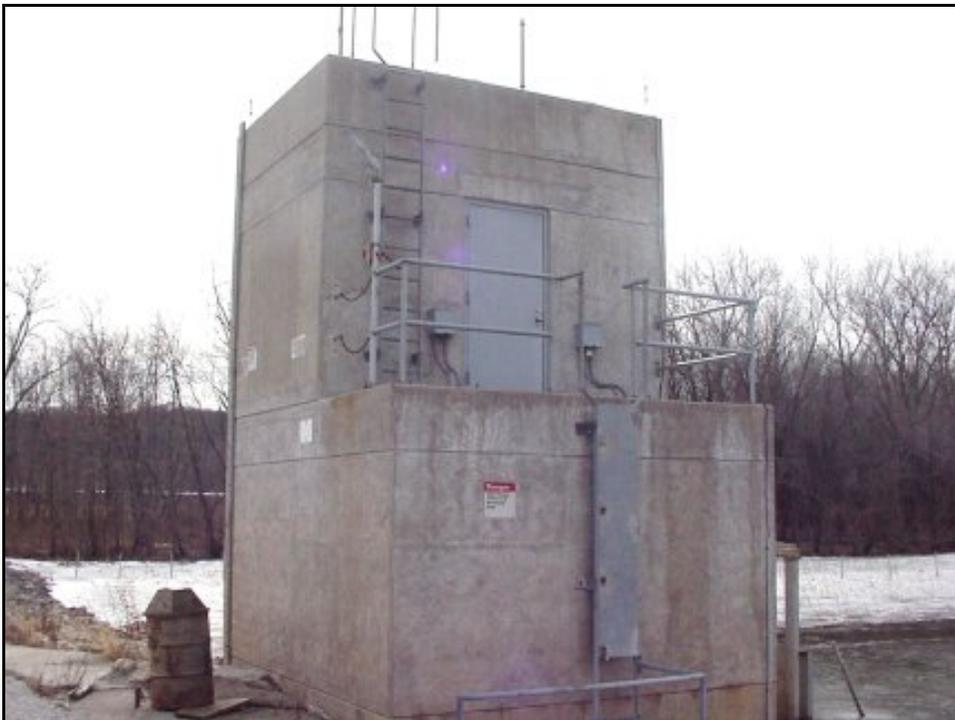
Andalusia Refuge HREP, Pool 16, Upper Mississippi River Miles 462.0 - 463.0, Rock Island County, Illinois, CEMVR

3.6.2. Pump Stations and Wells

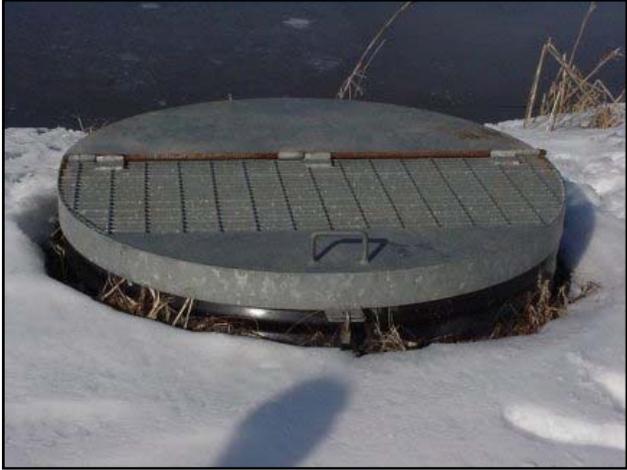
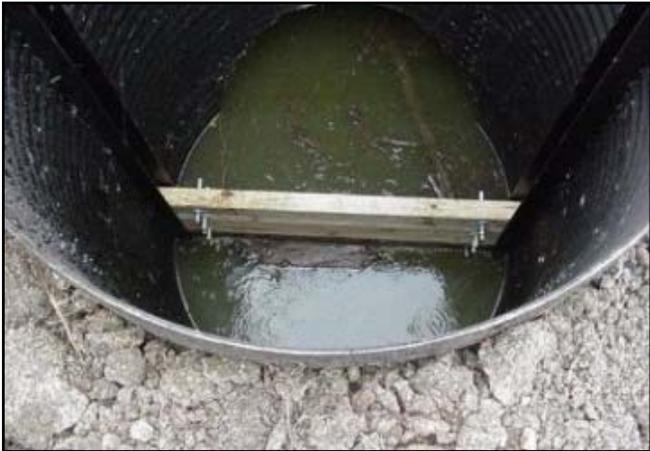
Banner Marsh HREP, LaGrange Pool, Illinois Waterway River Miles 138.0 - 144.0, Fulton and Peoria Counties, Illinois, CEMVR

3.6.3. Stoplog Structures

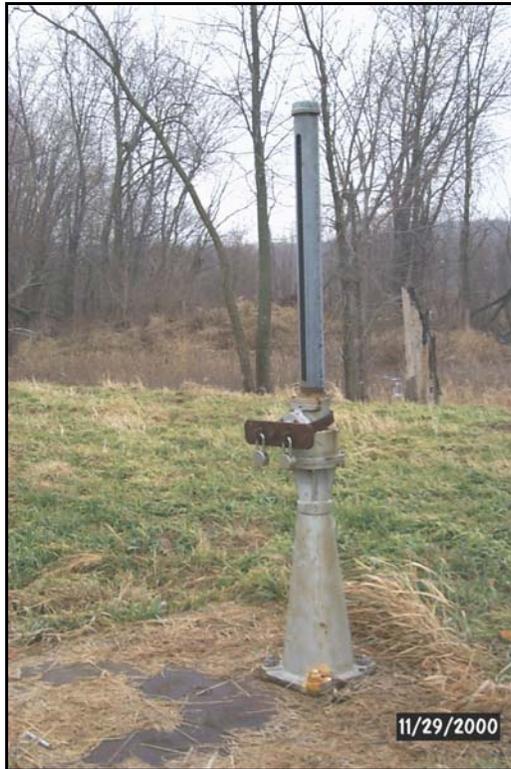
Andalusia Refuge HREP, Pool 16, Upper Mississippi River Miles 462.0 - 463.0, Rock Island County, Illinois, CEMVR

3.6.4. Gatewell Structures
