**UPPER MISSISSIPPI RIVER SYSTEM
ENVIRONMENTAL DESIGN HANDBOOK**

CHAPTER 9

ISLANDS

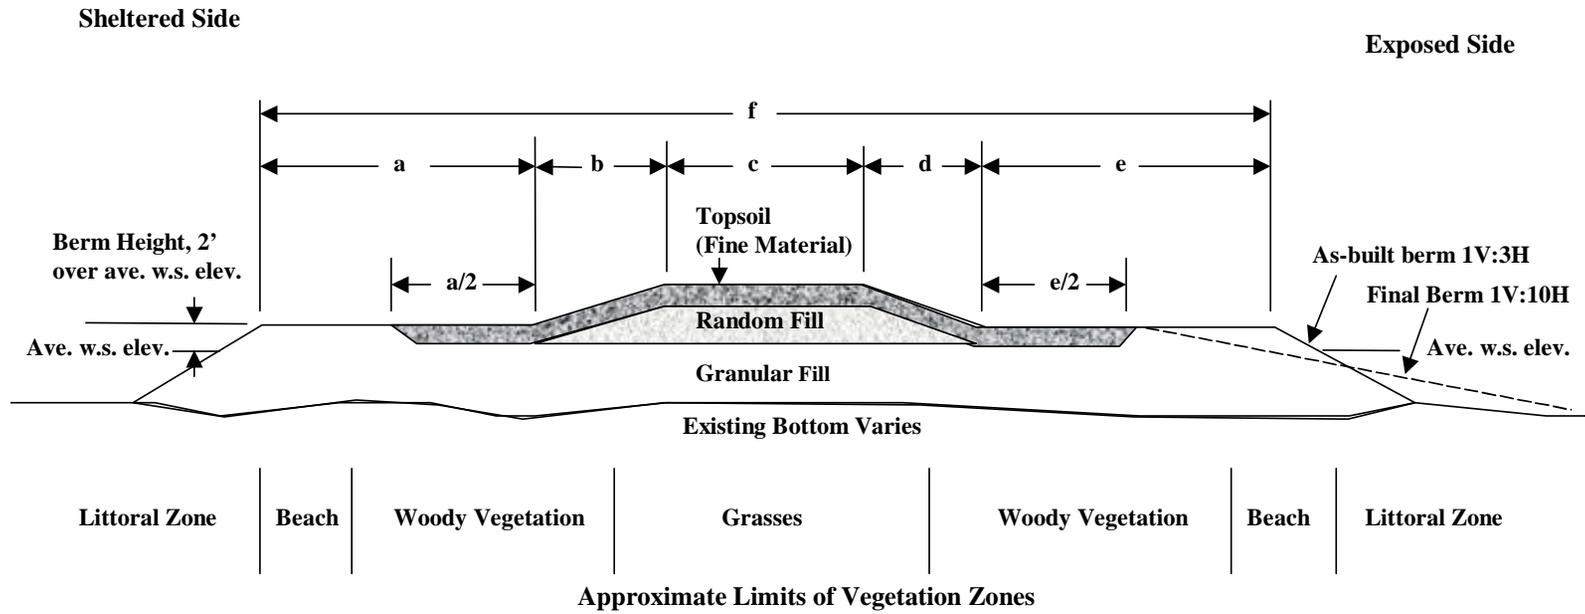
Figure 9.1. Typical Island Cross Section

9.3.1. Island Cross Section. Figure 9.1 shows a typical island cross section (though many exceptions exist). Islands have a main section (dimension c) with berms on either side (dimensions a & e). The elevation and width of the main section is a function of habitat objectives, engineering considerations such as flood conveyance needs, economics, stability, and lessons learned. Early designs in the mid to late 1980s resulted in islands constructed to a 10-year flood elevation or higher. The higher islands, it was believed, would be more stable due to less frequent overtopping and provide a greater barrier to sediment laden flow from the main channel, reducing sediment deposition in backwaters. With the occurrence of several floods in the 1990s, it became apparent that islands were stable during overtopping events as long as the head differential from one side to the other was less than 0.5 feet and as long as there was topsoil and vegetation on the island. This led to lower design elevations. The berms are constructed to an elevation between 1 and 2 feet above the average water surface elevation. They provide sacrificial sand for beach formation, which occurs due to wave action, and substrate for willow growth, which prevents erosion of the main section of the island during flood events. Because the berms are usually lower than the main section of the island, they provide elevation diversity also.

Table 9.3 provides design dimensions for constructed island projects. The variables “a” through “f” are as shown in figure 9.1. The top elevation is listed and the corresponding flood that would overtop that elevation. The two side slopes that are listed are for the exposed or channel side and the sheltered or floodplain side of the island. The distribution of top elevations versus flood frequency is shown in figure 9.2. Generally, top elevations have decreased with each successive project, and the variability of elevations has increased.

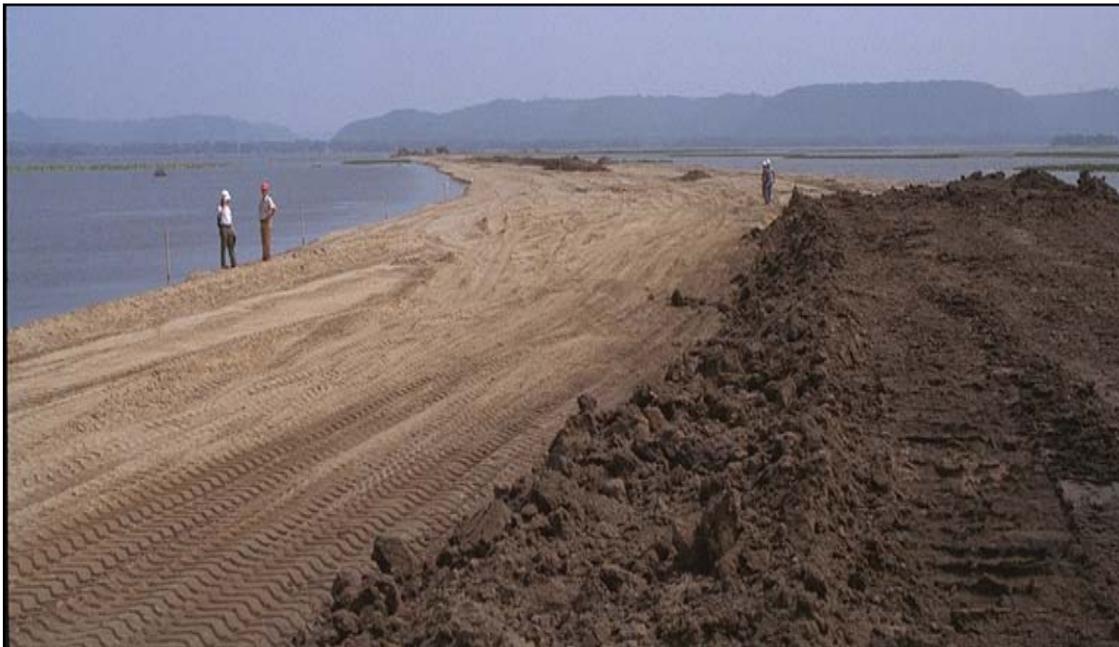
Photograph 9.10. Pool 8, Phase I, Stage II, Boomerang Island

Fine sediments have been placed on top of a sand base to form a topsoil layer. These fine sediments were mechanically excavated and placed on the island (as opposed to hydraulic placement)

Islands in the northern reaches of the UMR are usually constructed with sand (granular fill) and mixtures of fine sediments and sand. The mixtures are called by various terms including fine material, random fill, topsoil, fines, and select fines. Fine sediments are defined as silts and clay size material passing the no. 200 sieve or the .075 mm sieve. Table 9.2, which provides information on the quantities of sand and fines that were used on three island projects, indicates that islands consist of approximately 75 percent sand and 25 percent fines. The base of the island is constructed of sand to provide a stable work surface for construction equipment; then mixtures of fine sediments and sand are placed on top of the sand as random fill or as a fine material layer that acts as topsoil (photograph 9.10).

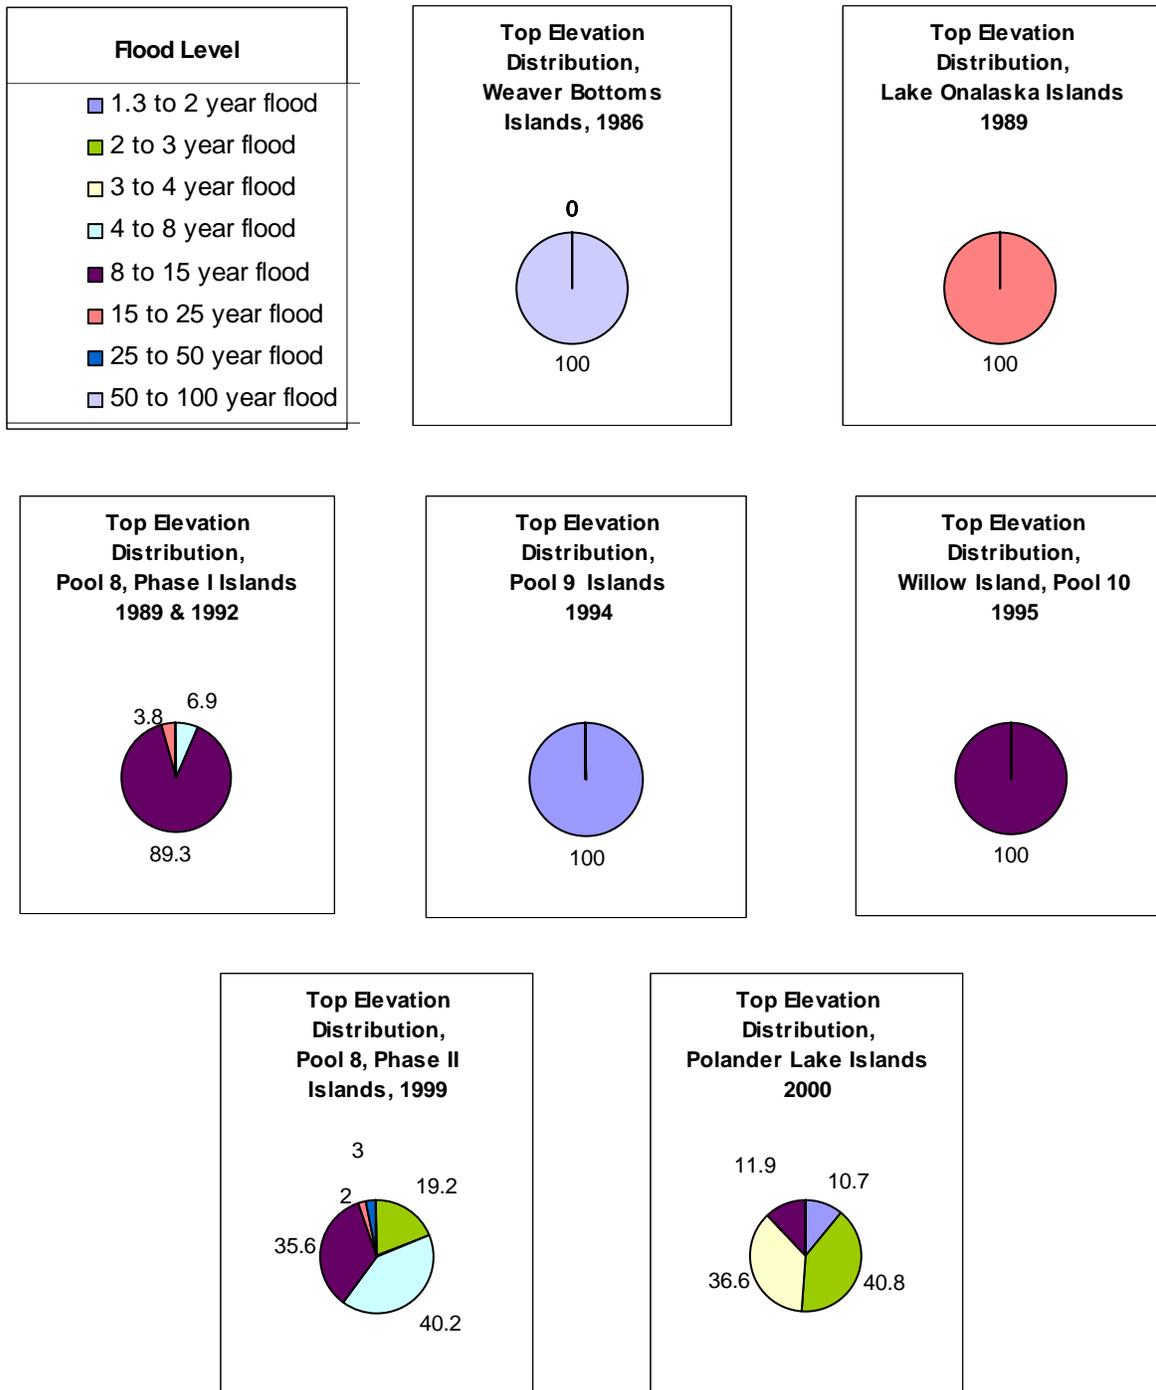
Figure 9.2. Distribution of Top Elevations Based on Flood Frequency for Constructed Island Projects

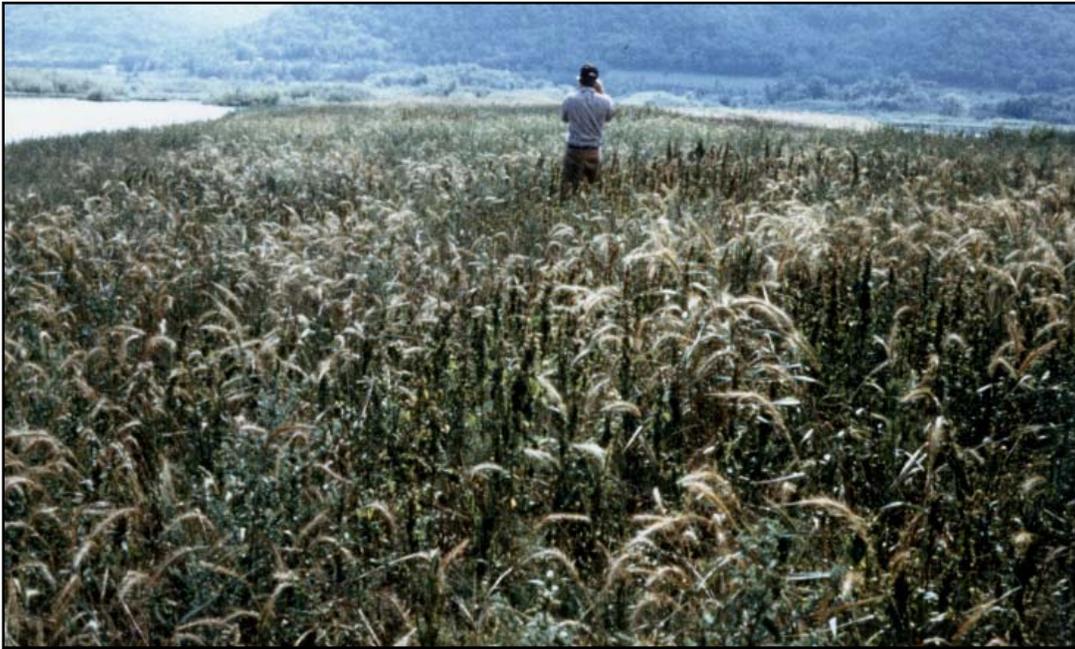
Photograph 9.11. Pool 5, Weaver Bottoms, Swan Island
Native prairie grasses were planted to provide nesting habitat and stabilize the top of the island.

Islands are planted with or are naturally colonized by woody and herbaceous plants that stabilize the island and provide habitat (photograph 9.11). The four vegetation zones that can occur on islands include grasses (and sometimes woody vegetation) on the higher main section of the island, woody vegetation on the low elevation berms, a beach zone that doesn't have vegetation due to wave action or ice action, and a littoral zone just below the water surface along the shoreline. Depending on a variety of factors, one or more of these zones may be absent. For instance, low elevation islands tend to be colonized with woody vegetation across the entire island, eliminating the grasses. Shorelines in sheltered areas may have woody vegetation right to the waters edge, eliminating the beach zone.

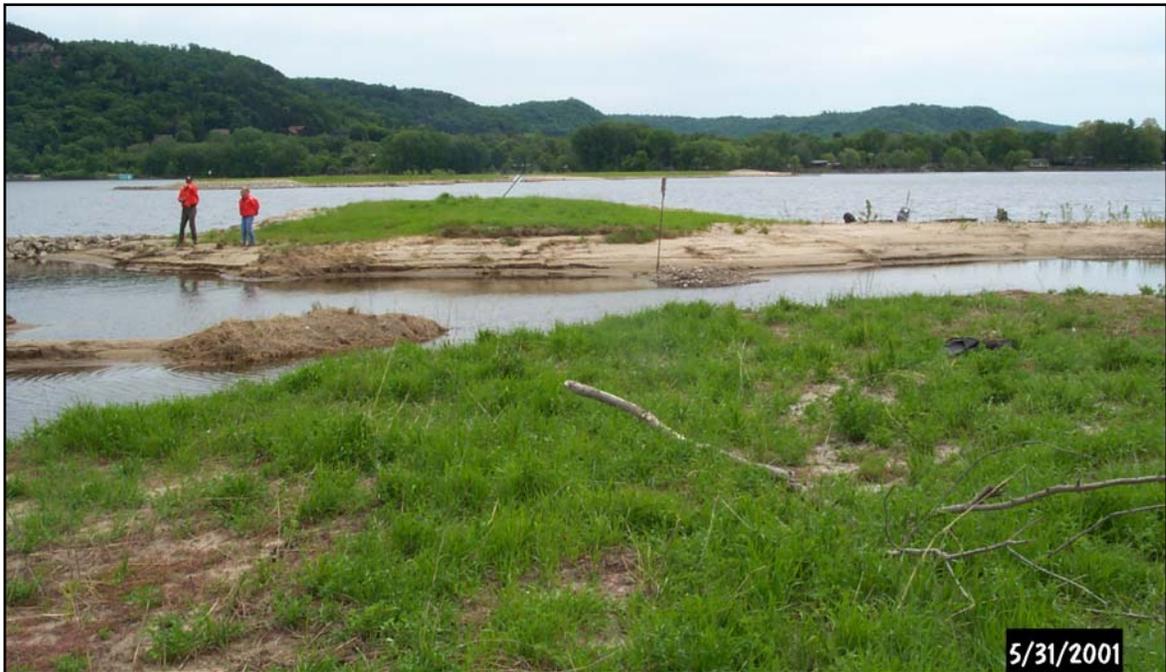
Photograph 9.12. Pool 8, Phase II, Slingshot Island

island, erosion was usually minimal. When topsoil had not been placed and sand was exposed to wave action and/or river currents during the flood, significant erosion usually occurred. To maintain sandy substrate for turtle nesting, small sections of the Pool 18, Phase II Islands were constructed at a higher elevation and did not have topsoil placed on them. Several of these turtle nesting sections were severely eroded when they were overtopped by 1 to 2 feet of water during the 2001 flood, which was an 80-year flood event). Photograph 9.12 shows open water where there once was a sand section. The adjacent island sections, were stable because of the topsoil and grass growing on them. The fix that was implemented here was simply to line the existing cut with rock or cobbles so that it wouldn't get any larger. At the Swan Lake project on the Illinois River, vegetation that was planted on the islands was quickly grazed by waterfowl leaving these islands relatively bare during the first few years after construction. Protecting the island vegetation with bird netting or other techniques until the vegetation has matured adequately would have improved conditions on the island.

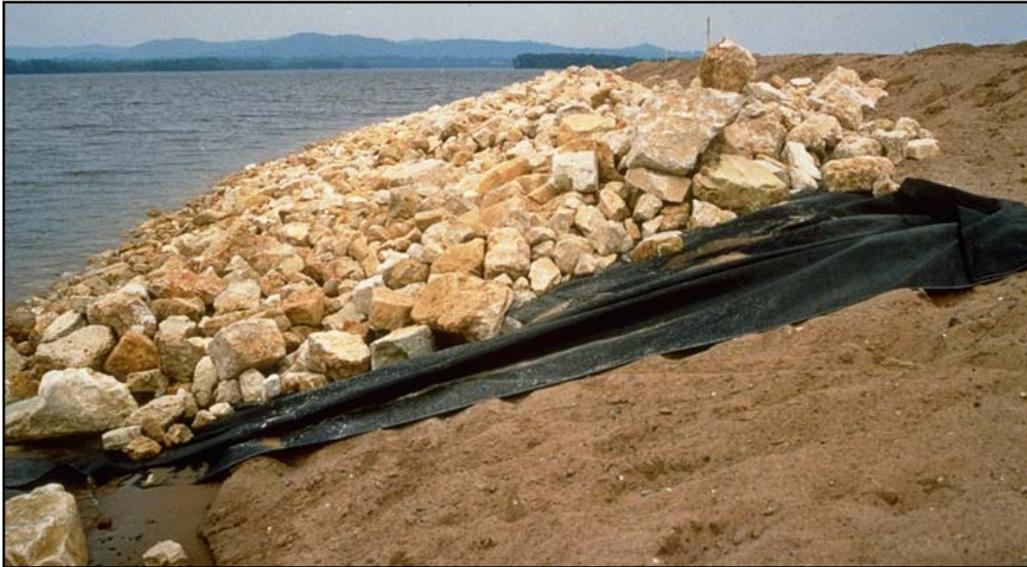
Photograph 9.14. Lake Onalaska - Riprap and Geotextile Filter Placed on Sand

9.3.3 Shoreline Stabilization. A shoreline stabilization plan that involves the use of vegetation, rock, logs, synthetic grids, or some combination of living and inert materials is needed for all projects. At the Weaver Bottoms, Swan Lake, and Peoria Lake, unprotected shorelines were severely eroded following construction. The primary forces that affect island shorelines are river currents and wind driven wave action, though ice action and waves created by towboats or recreational boats can also cause erosion. Shoreline stabilization of islands includes riprap (photograph 9.14), biotechnical methods (photographs 9.15 and 9.16) and vegetative stabilization (photograph 9.17).

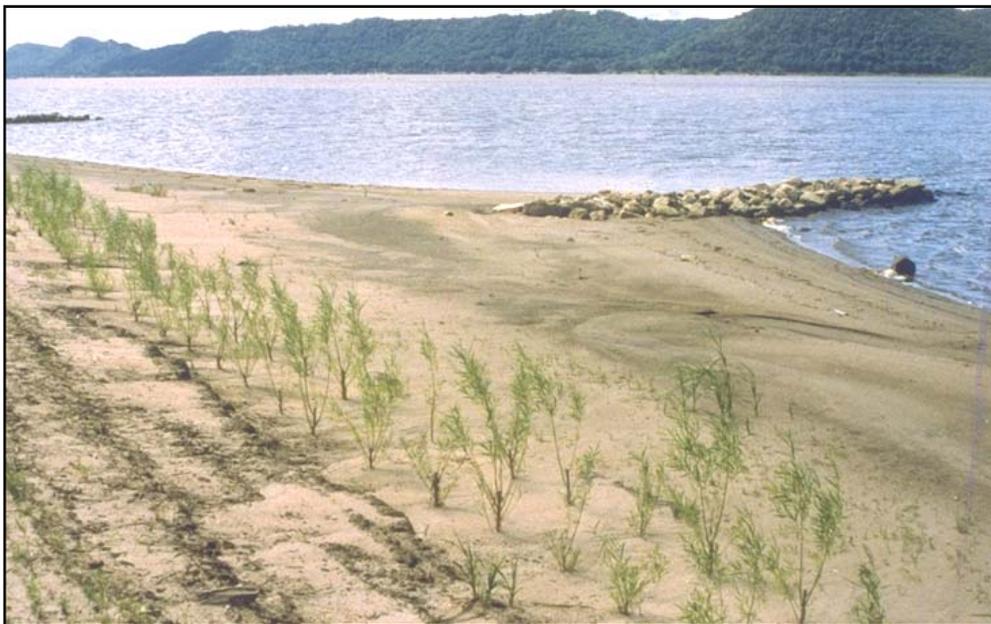
Photograph 9.15. Pool 8, Phase II, Boomerang Island - Biotechnical Stabilization with Groins and Willows

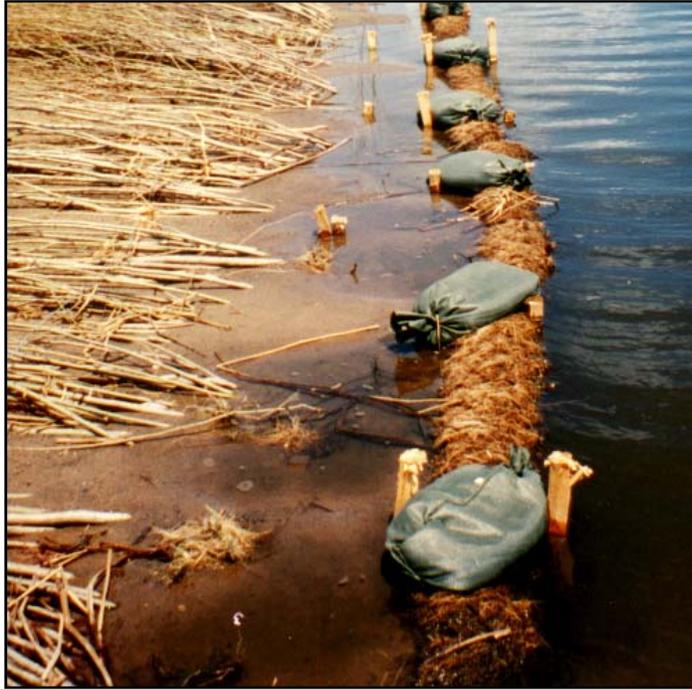
Photograph 9.16. Weaver Bottoms, Swan Island -
Biotechnical Stabilization with Fiber Rolls, Sand Bags and Willow Mats

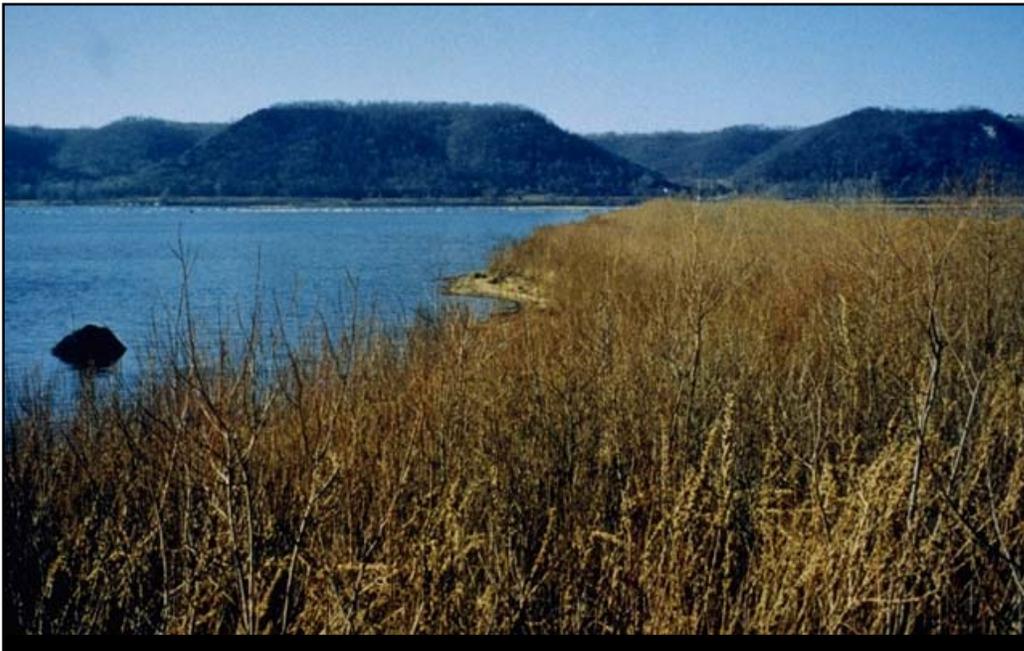
Photograph 9.17. Pool 8, Phase II, Boomerang Island
Vegetative stabilization was used on over 60% of the shorelines on Boomerang Island.

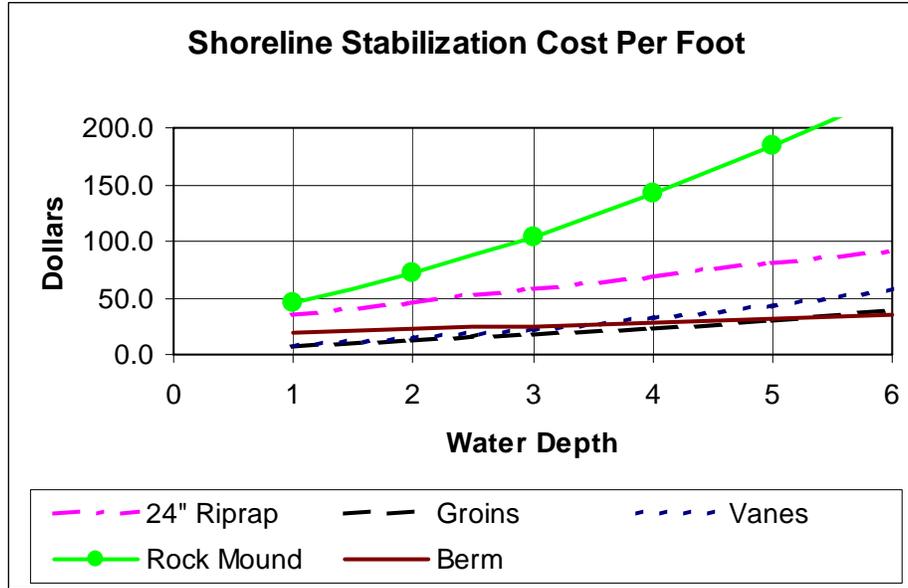
Shoreline stabilization costs include earth fill (granular and fines) for the berm, rock, and the cost of willow plantings. Figure 9.3 shows estimated costs for constructing various types of shoreline stabilization in water depths of 1 to 6 feet. The berm cost must be added to the cost of the various types of rock structures. Groins and vanes are the cheapest stabilization option, regardless of water depth. Rock mounds are the most expensive option in all cases. The cost for planting willows was assumed to be \$2 per linear foot based on the bid prices for the Pool 8 Phase II and Polander Lake projects (table 9.10).

1. Rock cost equals \$35/ton or \$49 cubic yard in place
2. Sand cost equals \$3/cubic yard
3. Fines cost equals \$12/cubic yard
4. Height of rock structures above average water surface is 2 feet.
5. Side slope of 24 inch rock fill equals 1V:3H
6. Side slope of groins, vanes, and rock mound equals 1V:1.5H
7. Top width of groins, vanes, and rock mound equals 4'
8. Groin and vane length is 30 feet, and spacing is 180 and 90 feet respectively
9. Berm width equals 30 feet, half the berm (15 feet) is covered with topsoil to a depth of 1 foot, and willow cost is \$2 per foot for 2 rows of willows.
