UPPER MISSISSIPPI RIVER RESTORATION ENVIRONMENTAL MANAGEMENT PROGRAM ENVIRONMENTAL DESIGN HANDBOOK

CHAPTER 5

LOCALIZED WATER LEVEL MANAGEMENT

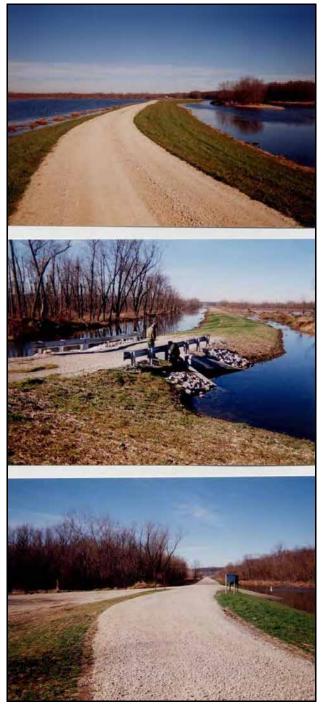
Photograph 5-2. Princeton Refuge HREP, Pool 14, UMR RM 504.0-506.4, Scott Co., IA, MVR

j. Photographs. Constructed HREPs with berms and/or spillways are shown here.

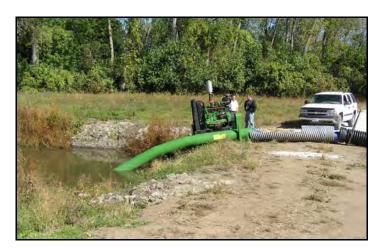
Photograph 5-5. Portable Pump-Lake Odessa HREP, Pools 17-18, UMR RM 435.0-440.0, Louisa Co., IA, MVR

- **a. Design Considerations.** Water can be introduced or removed from a MSMU or backwater lake through the use of a pump station, portable pumps, wells or a water control structure. Pumps can obtain either surface water, typically from a river, or groundwater.
- **b. Surface Water.** When evaluating a pump station versus a well (i.e. surface water versus ground water), keep in mind that reuse of surface water is desired where practicable. Surface water is often used as a source due to its abundance and ease of access. When surface water is used, it can remove sediment from its source, and add potentially nutrient rich sediment to the MSMU or backwater lake. Additionally, the use of surface water can remove nitrogen and phosphorous from the river system, with the nutrients eventually being uptaken by plant organisms within the MSMU.
