UPPER MISSISSIPPI RIVER RESTORATION ENVIRONMENTAL MANAGEMENT PROGRAM ENVIRONMENTAL DESIGN HANDBOOK

CHAPTER 4

SHORELINE AND RIVER BANK PROTECTION

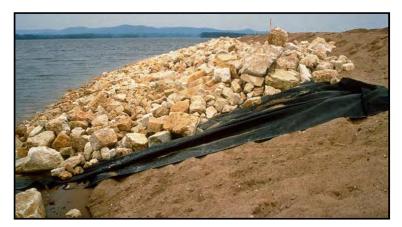
Photograph 4-2. Riprap and Geotextile Filter Placed on Sand (Lake Onalaska)

- Riprap (Photograph 4-2)
- Bio-Geo methods (Photographs 4-3 and 4-4)
- Vegetative stabilization (Photograph 4-5)

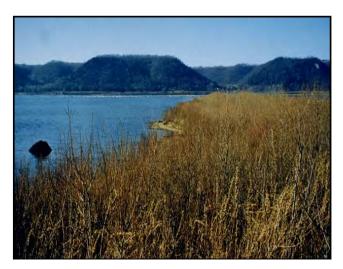
Photograph 4-5. Vegetative Stabilization (Boomerang Island)

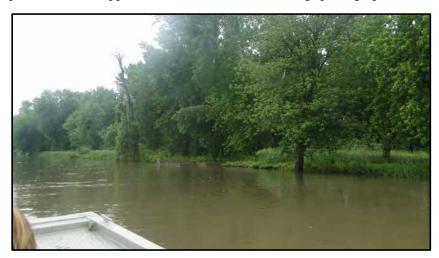
Photograph 4-6. Bankline Erosion at Huron Island, Pool 18 (note building foundation)

1. Site Identification. Typically, the project design team (PDT) works together to identify and prioritize areas requiring protection. Coordination with the project sponsor or resource agency is very important in evaluating shoreline erosion. For one project in Pool 18, there was no apparent visual bankline erosion during the site visit, however, based on information from the sponsor, a building foundation remnant was located which had once been 50 feet from the shoreline. At the time of the site visit, the foundation was located at the edge of the island. After researching real estate photograph from the 1930 land acquisition, it was apparent that erosion was occurring (photograph 4-6).

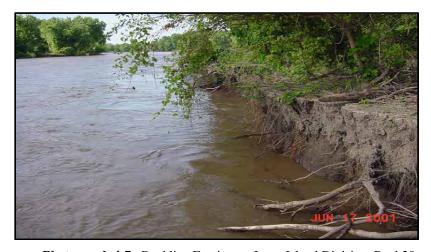
Photograph 4-7. Bankline Erosion on Long Island Division, Pool 20

Other banklines have more apparent erosion that can be observed during site visits, such as the location in Pool 20 shown in photograph 4-7.

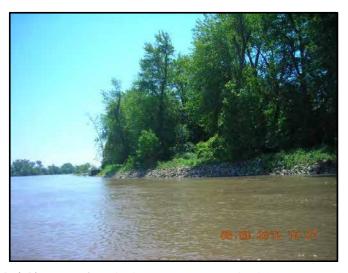
Photograph 4-10. Area of Rock Placement at Long Island 8 Years Post Construction

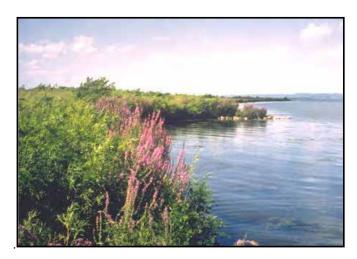
Photograph 4-12. Constructed Rock Groin in Pool 8 After a Few Years of Vegetation Growth)

The ratio of groin spacing to groin length varies from 4 to 6 for habitat projects. The height of rock groins varies from 1.5 to 2 feet above the average water surface. Table 4-7 shows typical design criteria and figure 4-3 shows an example design detail from Spring Lake Islands.

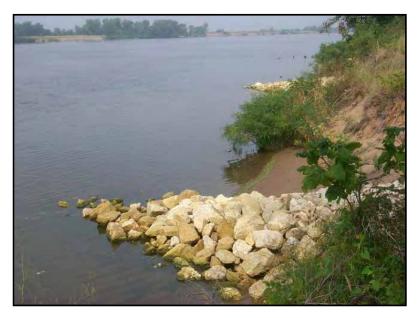
Photograph 4-13. Rock Vanes at Lost Island Chute, Pool 5

Vanes with angles ranging from 45 to 60 degrees have been constructed in an attempt to identify if there is an optimal angle for vanes on a large river system. In general, the vanes have not been in place long enough to draw a definitive conclusion. However, the vanes currently in place do seem to be performing well.

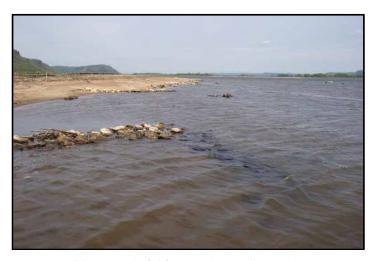
Photograph 4-14. J-Hook Vane in Pool 8

The plan view of a J-Hook style vane is shown in figure 6 and photograph 4-14. While the application of J-Hook vanes has been successful in the MVP, applications further down river have encountered performance issues. The increased scour created by the hook of the J caused the structure to cave into itself. The J-hooks also require almost double the material of a rock vane while providing similar protection. These structures may be better served in a smaller stream.

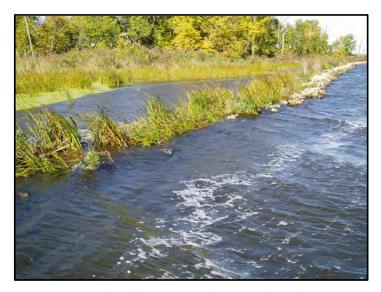
Photograph 4-15. Offshore Rock Mound at Peterson Lake in Pool 4

- **4. Offshore Rock Mounds.** Offshore rock mounds, shown in photograph 4-15 and figure 4-7, are used on natural shorelines in four situations:
 - 1. shorelines with shallow nearshore bathymetry which prevents access by marine plant
 - 2. low shorelines or marsh area where there is not a well defined shoreline (i.e. river bank) to place revetment on or tie groins or vanes into
 - 3. shorelines with shallow nearshore bathymetry where it is desirable to get the outside toe of the rock into deeper water to prevent undercutting
 - 4. shorelines with heavy wood debris that would prevent the direct placement of rock

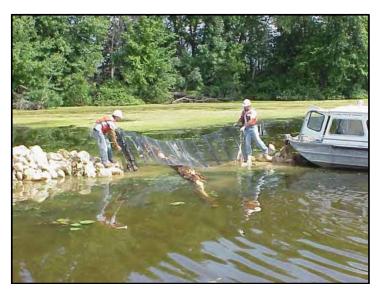
Photograph 4-16. Installation of a Rock log Structure

5. Rock-Log Structures. In protected areas with minimal ice impacts, rock-log structures provide an economical alternative to offshore rock mounds. These structures protect existing shoreline while providing woody structure for fish and loafing areas for wildlife. Photographs 4-16 and 4-17 show a typical rock-log structure application.

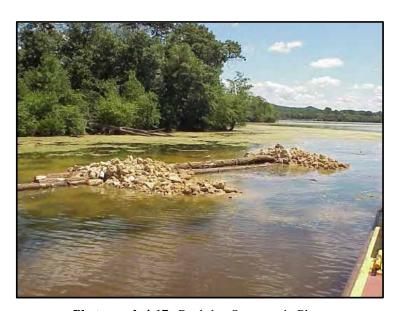
Photograph 4-17. Rock-log Structure in Place

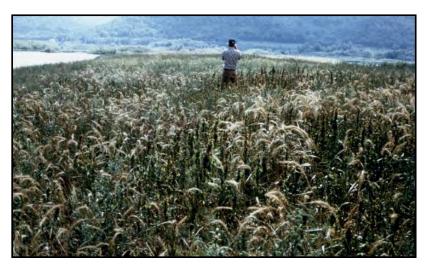
Photograph 4-18. Pool 5, Weaver Bottoms, Swan Island. Native prairie grasses were planted to provide nesting habitat and stabilize the top of the island.
