UPPER MISSISSIPPI RIVER SYSTEM
ENVIRONMENTAL MANAGEMENT PROGRAM
DEFINITE PROJECT REPORT/ENVIRONMENTAL ASSESSMENT (SP-17)

MISSISSIPPI RIVER BANK STABILIZATION
HABITAT REHABILITATION AND ENHANCEMENT PROJECT
POOLS 5-10, UPPER MISSISSIPPI RIVER
MINNESOTA, WISCONSIN, AND IOWA

ST. PAUL DISTRICT, CORPS OF ENGINEERS
ARMY CORPS OF ENGINEERS CENTRE
190 FIFTH STREET EAST
ST. PAUL, MINNESOTA 55101-1638
AUGUST 1995

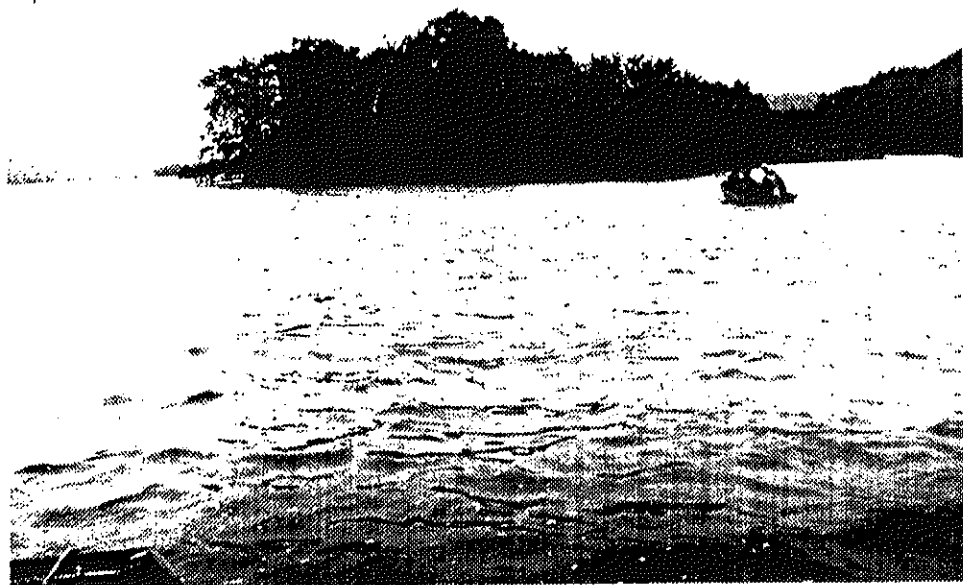
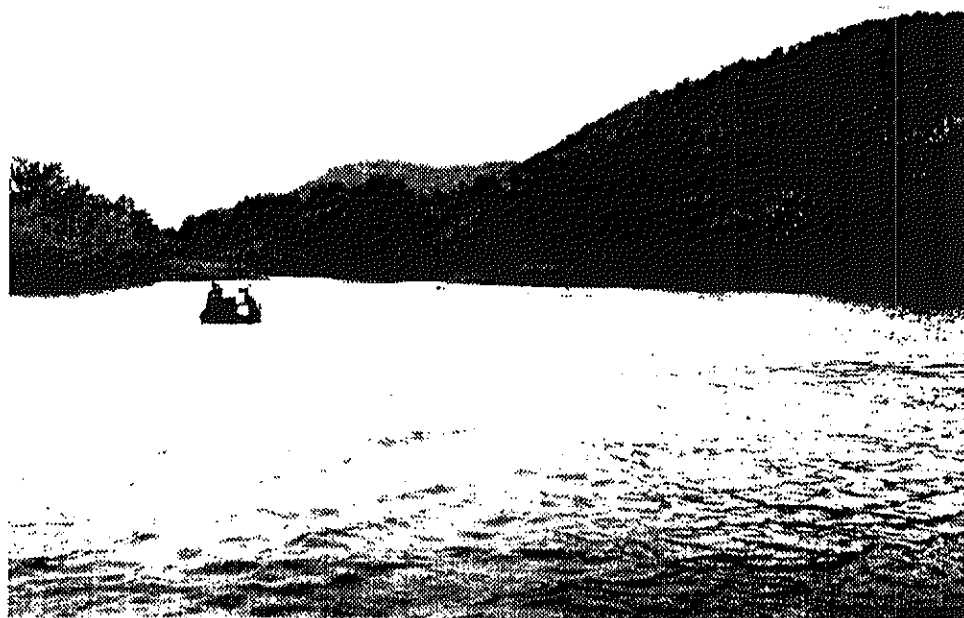
6-718.6-13

Observations		Site Number
Bank material: clay ____ silt ____ topsoil ____ (m) (c) gravel ____ cobbles ____ other info: ____		6-718.6-R (f) (c) sand ____
Existing bank protection?		
Apparent causes of erosion: river flows ____ wind waves ____ boat waves ____ (number in order of cause) prop wash ____ ice action ____		
Estimated rate of erosion or erodibility (low, moderate, high) (future rate)		
Source of local sediment transport (upstream, none)		
Bottom material		
Existing vegetation: nearshore -		
(density, type) shoreline -		
bank -		
top of bank -		
Trees (fallen, species, size range, average size, location, number) <i>downstream island is actively eroding - many exposed tree roots, etc</i>		
Habitat type and species impacted by continued erosion		
Quality of affected habitat (low, medium, high)		
Area protected by island (shadow zone)		
Other impacts of erosion (future conditions) <i>side appears to be mainly impacted by high water events</i>

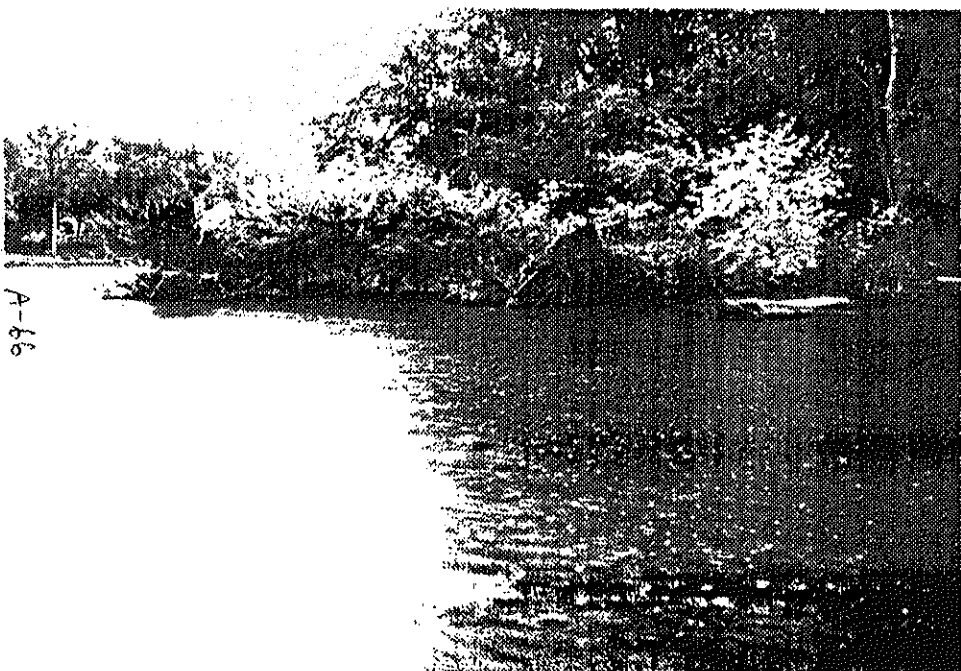
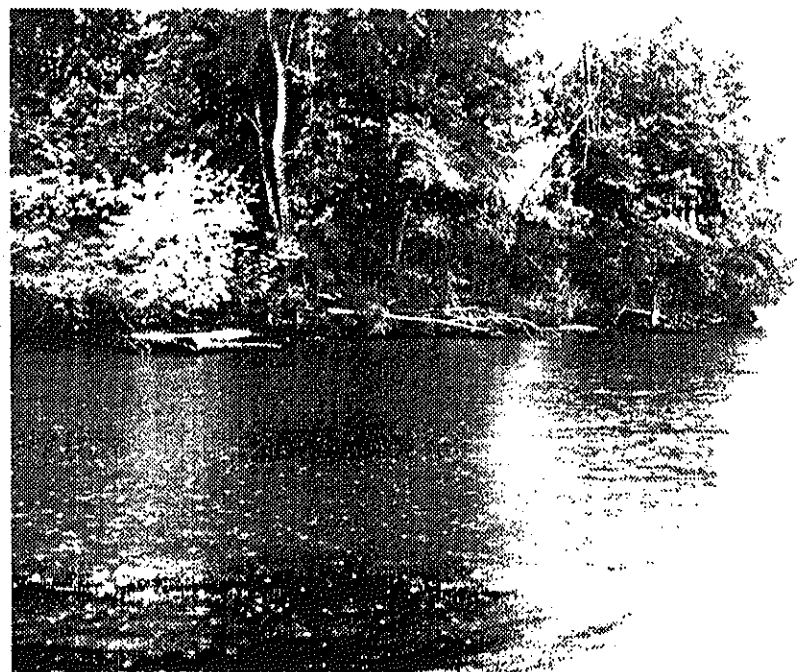
Observations		Site Number
Bank material: clay <input type="checkbox"/> silt <input type="checkbox"/> topsoil <input type="checkbox"/>	7-713.3-L	
(f) (m) (c) gravel <input type="checkbox"/> cobbles <input type="checkbox"/> other info: <input type="checkbox"/>	(f) (c) sand <input checked="" type="checkbox"/>	
Existing bank protection? <u>No.</u>		
Apparent causes of erosion: river flows <u>1</u> wind waves <u>2</u> boat waves <u>4</u>	(number in order of cause) prop wash <u> </u> ice action <u>3</u>	
Estimated rate of erosion or erodibility (low, moderate, high) (future rate)		
<u>protection of this site is at best medium</u>		
Source of local sediment transport (<u>upstream</u> , none)		
Bottom material <u>Sand</u>		
Existing vegetation: nearshore - <u>none</u>		
(density, type) shoreline - <u> </u>		
bank - <u>tree lined, grass, underbrush, tree roots</u>		
top of bank - <u>F.F.</u>		
Trees (fallen, species, size range, average size, location, number)

Habitat type and species impacted by continued erosion		
<u>eagle roosting</u>		
Quality of affected habitat (low, medium, high)		
Area protected by island (shadow zone)		
Other impacts of erosion (future conditions)		
<u>loss to the head of the island</u>		
Type(s) of stabilization proposed		
<u>rock at the head</u>		
<u>- appears to be erosion on shore side caused by eddy current - no one thought it was that big by itself</u>		
Other type(s) of stabilization possible		
Fill required?	Source?	
Bank shaping required?		
Construction access considerations or problems?		
<u>Not bad</u>		
Cultural resources?		
Other information		
<u>main channel side of island at the head there was active erosion occurring</u>		
<u>uprooted trees and much root exposure</u>		
<u>250 ft of RR along the main channel side</u>

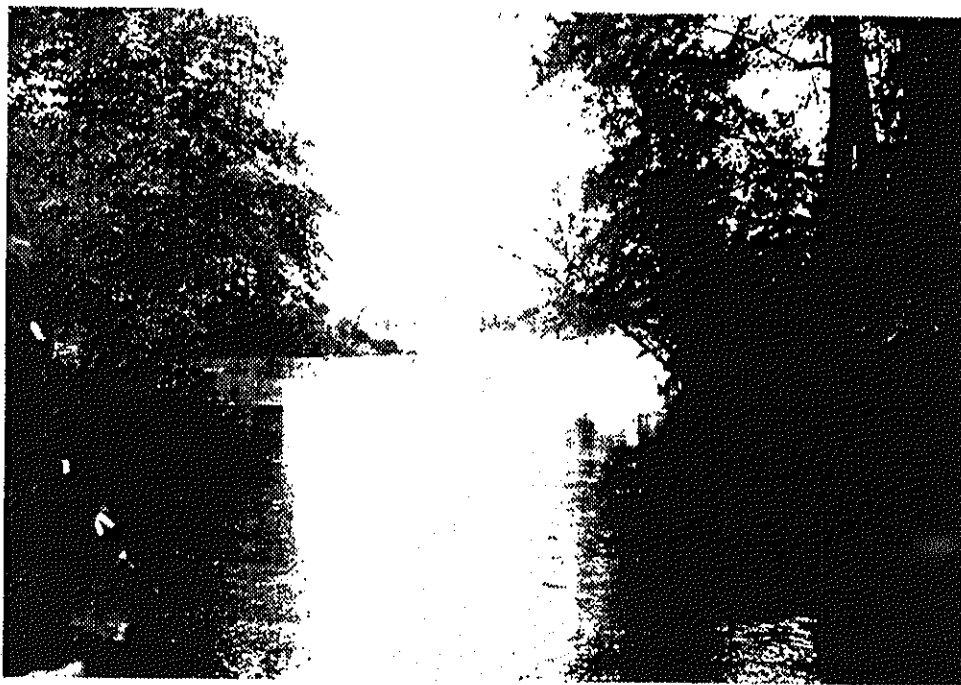
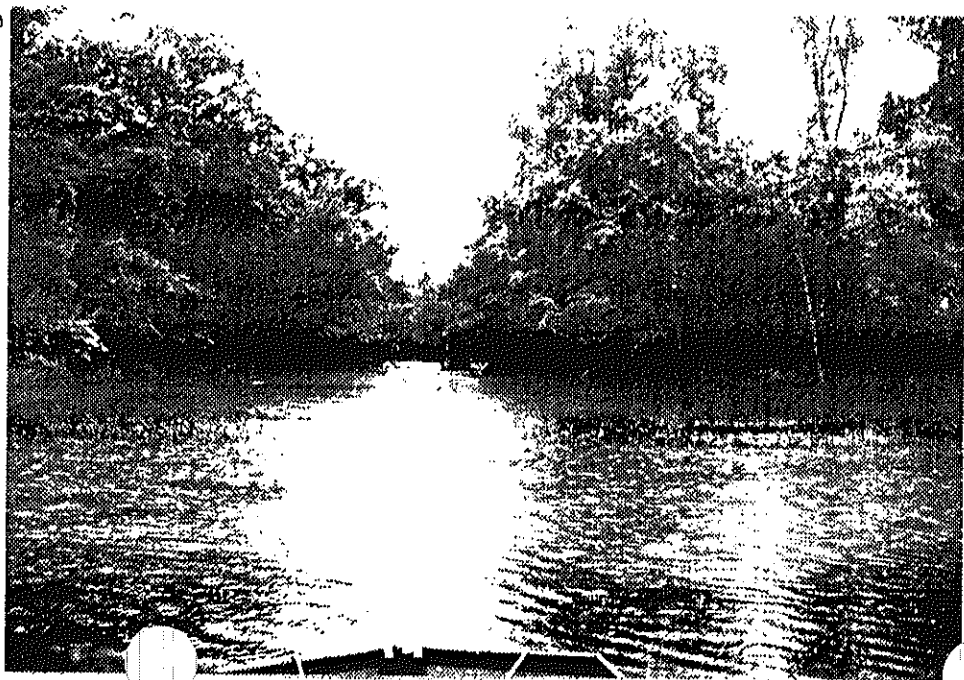
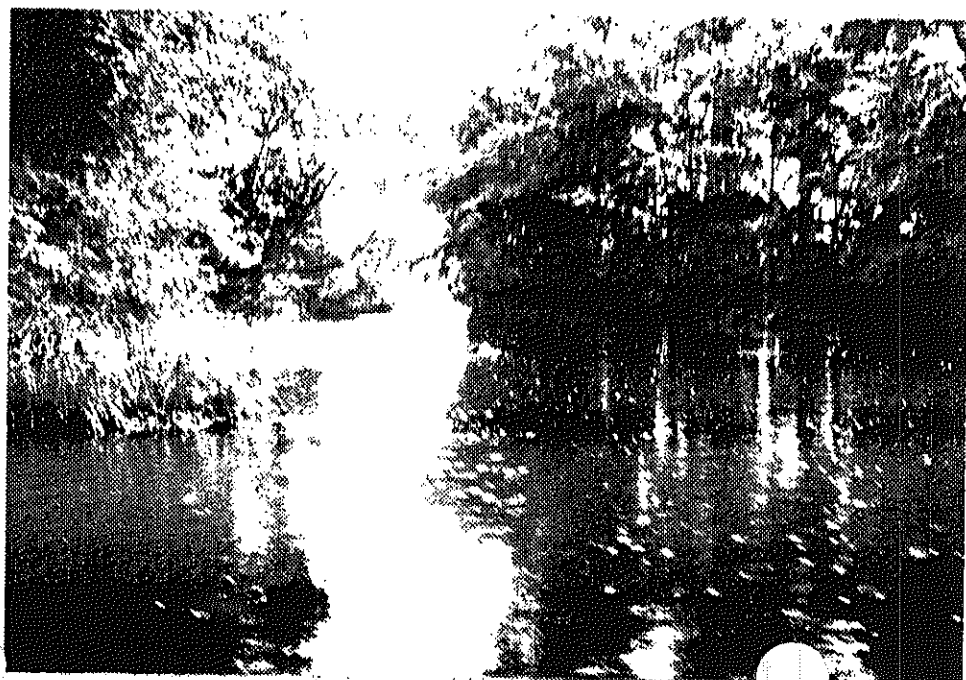
Observations		Site Number
Bank material: clay ____	silt ____	7-712.3-R
(f) (m) (c) gravel ____		(f) (c) sand ____
cobbles ____		other info: ____
Existing bank protection?		
Apparent causes of erosion:	river flows ____	wind waves ____
(number in order of cause)	prop wash ____	boat waves ____
		ice action ____
Estimated rate of erosion or erodibility (low, moderate, high) (future rate)		
Source of local sediment transport (upstream, none)		
Bottom material		
Existing vegetation: nearshore - <i>Sago, W. C., arrowhead</i>		
(density, type) shoreline -		
bank -		
top of bank -		
Trees (fallen, species, size range, average size, location, number)		
<i>Silver Maple, River Birch, Swamp W. O.</i>		
Habitat type and species impacted by continued erosion		
<i>Richmond Island wetland habitat would be severely impacted</i>		
Quality of affected habitat (low, medium, high)		
Area protected by island (shadow zone)		
Other impacts of erosion (future conditions)

<i>Loss of high quality wetland habitat</i>		
Type(s) of stabilization proposed		
Other type(s) of stabilization possible		
Fill required?	Source?	
Bank shaping required?		
Construction access considerations or problems?		
Cultural resources?		
Other information		
<i>appears much of the erosional damage is from barge traffic damage to trees from barge tie-off - may also be scoured from prop wash</i>

Protection of bottomland hardwoods and 20 acres of backwater. A breach in the island allows river flow into small backwaters behind island. High priority.

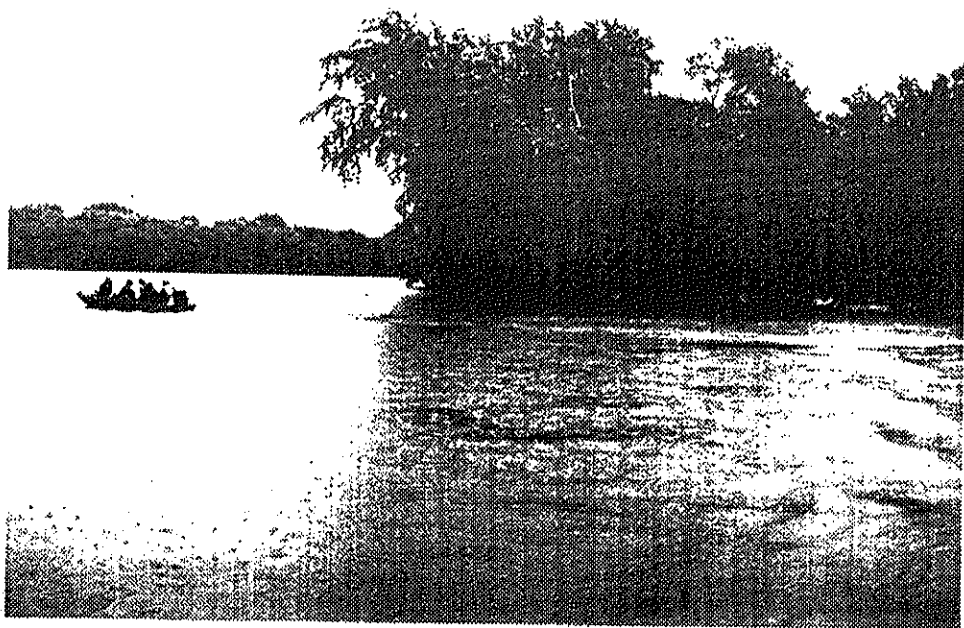
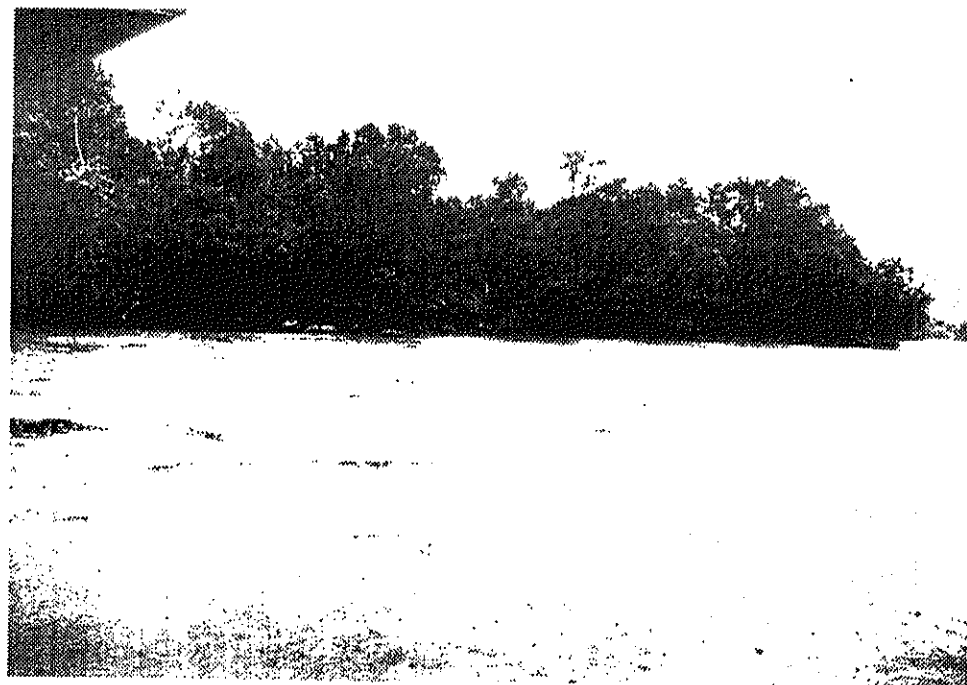
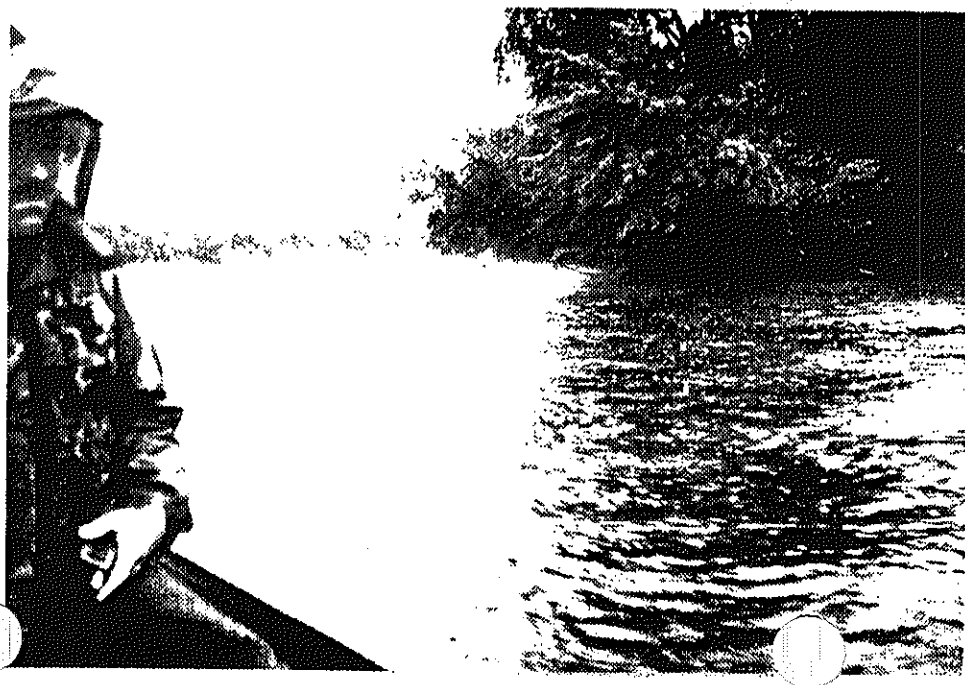
A-78

Observations		Site Number
Bank material: clay ____ silt ____ topsoil ____	7-703.8-L	
(f) (m) (c) gravel ____ cobbles ____ other info: ____	(f) (c) sand <input checked="" type="checkbox"/>	
Existing bank protection? <i>Some rock on ends</i>		
Apparent causes of erosion: river flows ____ wind waves <u>1</u> boat waves <u>3</u>		
(number in order of cause) prop wash ____ ice action <u>2</u>		
Estimated rate of erosion or erodibility (low, moderate, <u>high</u>) (future rate)		
Source of local sediment transport (upstream, none)		
Bottom material <i>Silt</i>		
Existing vegetation: nearshore - <i>submerged</i>		
(density, type)	shoreline - <i>none</i>	
	bank - <i>—</i>	
	top of bank - <i>Dead trees</i>	
Trees (fallen, species, size range, average size, location, number)		
Habitat type and species impacted by continued erosion		
Quality of affected habitat (low, <u>medium</u> , high)		
Area protected by island (shadow zone)

Other impacts of erosion (future conditions)		
Type(s) of stabilization proposed <i>Rock wedge or offshore mound</i>		
Other type(s) of stabilization possible		
Fill required? <i>No.</i> Source?		
Bank shaping required? <i>No.</i>		
Construction access considerations or problems? <i>Only 3' depths.</i>		
Cultural resources?		
Other information

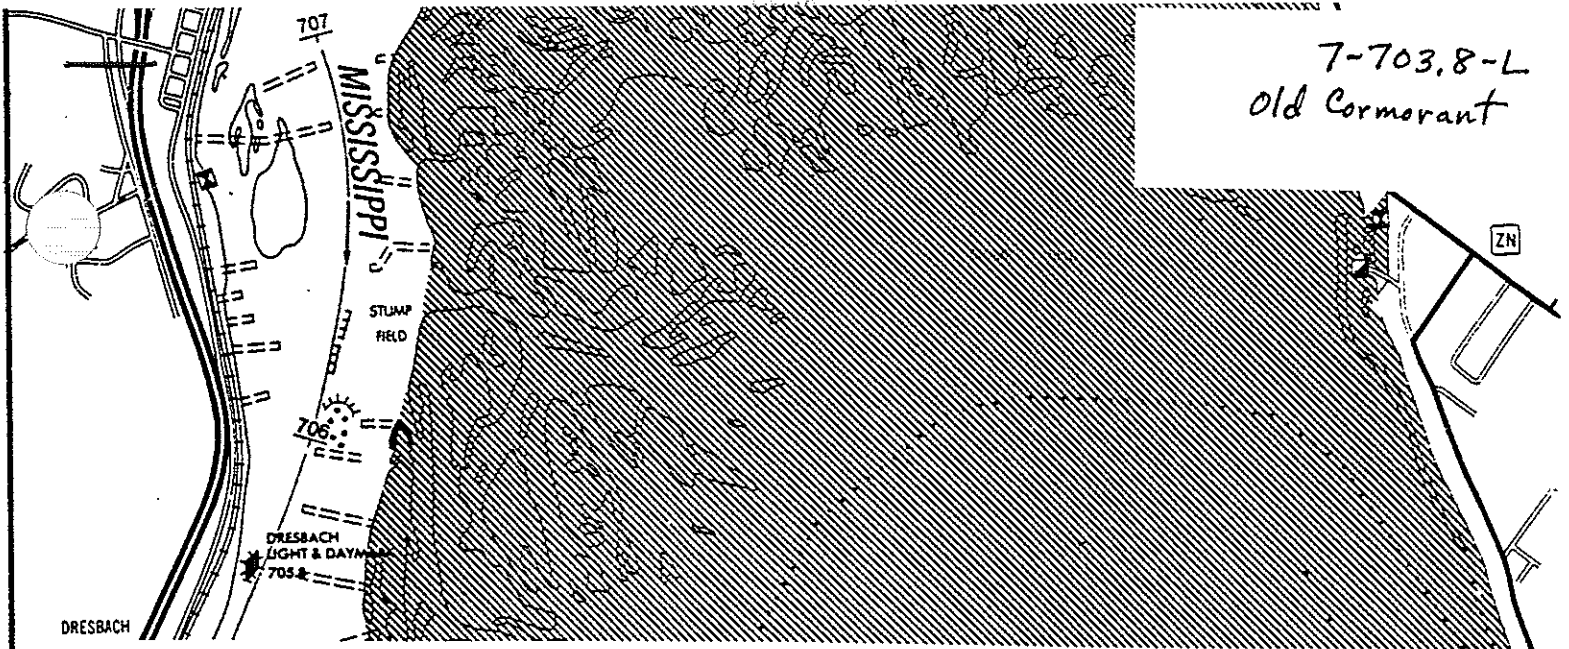
7-703.8-L
Old Cormorant

RM 703.5 N. tip Red Oak Ridge - 300
Lake Onalaska

Protection of significant cultural resources and
bottomland forest. High priority.

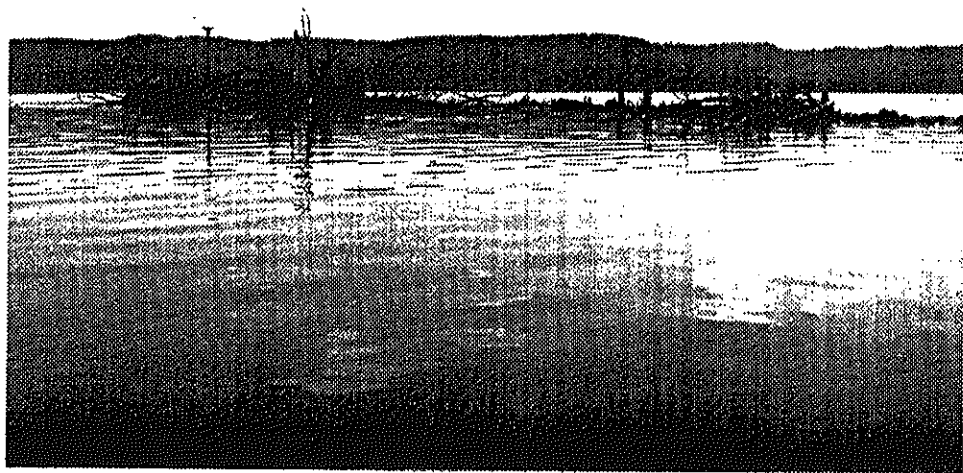
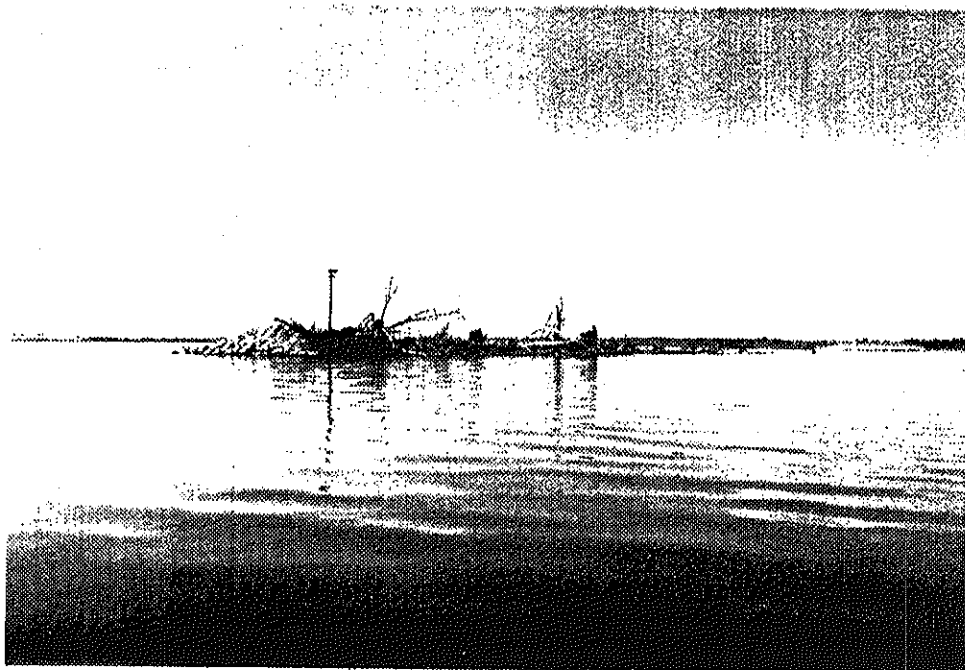
A-84

Observations		Site Number
Bank material: clay <input type="checkbox"/> silt <input type="checkbox"/> topsoil <input type="checkbox"/>	7-703,5-L	
(f) (m) (c) gravel <input checked="" type="checkbox"/> a little cobbles <input type="checkbox"/> other info: <input type="checkbox"/>	(f) (c) sand <input checked="" type="checkbox"/>	
Existing bank protection? none		
Apparent causes of erosion: (number in order of cause)	river flows <input type="checkbox"/> prop wash <input type="checkbox"/>	wind waves <input type="checkbox"/> boat waves <input type="checkbox"/> ice action <input type="checkbox"/>
Estimated rate of erosion or erodibility (low, moderate, high) (future rate)		
Source of local sediment transport (upstream, none)		
Bottom material f-c sand & some gravel		
Existing vegetation: nearshore - none		
(density, type)	shoreline - none to some indigo bush & elm & canary grass	
	bank - " " " " "	
	top of bank - trees grass cherry

Trees (fallen, species, size range, average size, location, number) elm, oak, sumac		
Habitat type and species impacted by continued erosion		
Quality of affected habitat (low, medium, high)		
Area protected by island (shadow zone)		
Other impacts of erosion (future conditions)		
Type(s) of stabilization proposed		
Other type(s) of stabilization possible		
Fill required?	Source?	
Bank shaping required?		
Construction access considerations or problems?		
Cultural resources?		
Other information

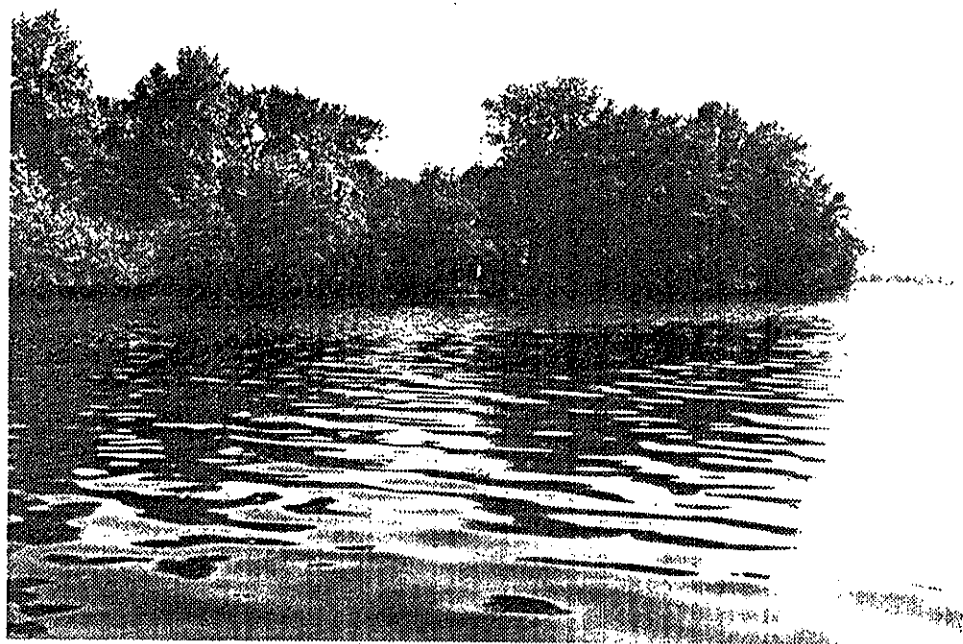
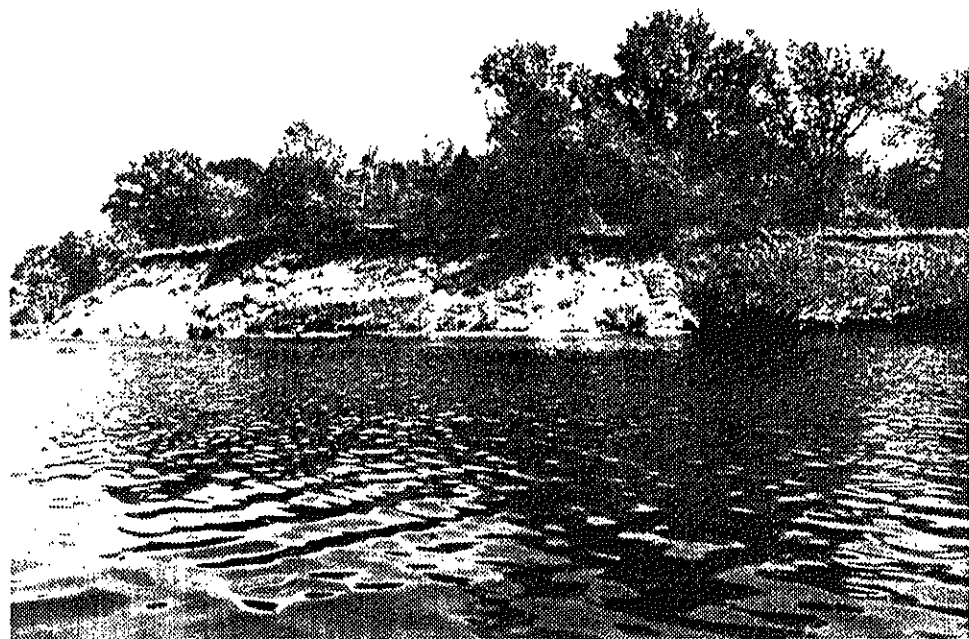
Small Island just east of Red Oak

Observations		Site Number
Bank material: clay ___ silt ___ topsoil ___	7-703.1-L	
(f) (m) (c) gravel ___ cobbles ___ other info: ___	(U) (c) sand <input checked="" type="checkbox"/>	
Existing bank protection? <u>no</u>		
Apparent causes of erosion: river flows ___ wind waves <u>1</u> boat waves ___		
(number in order of cause) prop wash ___ ice action <u>2</u>		
Estimated rate of erosion or erodibility (low, moderate, high) (future rate) _____		
Source of local sediment transport (upstream, <u>none</u>)		
Bottom material <u>fine sand</u>		
Existing vegetation: nearshore - <u>none sago</u>		
(density, type)	shoreline - <u>rocks, fallen trees, indigo bush, RCG, canary grass</u>	
	bank - <u>cheat grass, trees RCG</u>	
	top of bank - <u>basswood, red oak, Am. elm high diversity</u>	
Trees (fallen, species, size range, average size, location, number) <u>Oak, elm</u>		
Habitat type and species impacted by continued erosion <u>high</u>

Quality of affected habitat (low, medium, <u>high</u>)		
Area protected by island (shadow zone)		
Other impacts of erosion (future conditions)		
Type(s) of stabilization proposed		
Other type(s) of stabilization possible		
Fill required?	Source?	
Bank shaping required?		
Construction access considerations or problems?		
Cultural resources? <u>Yes Significant resources - burial mounds, graves, etc.</u>		
Other information

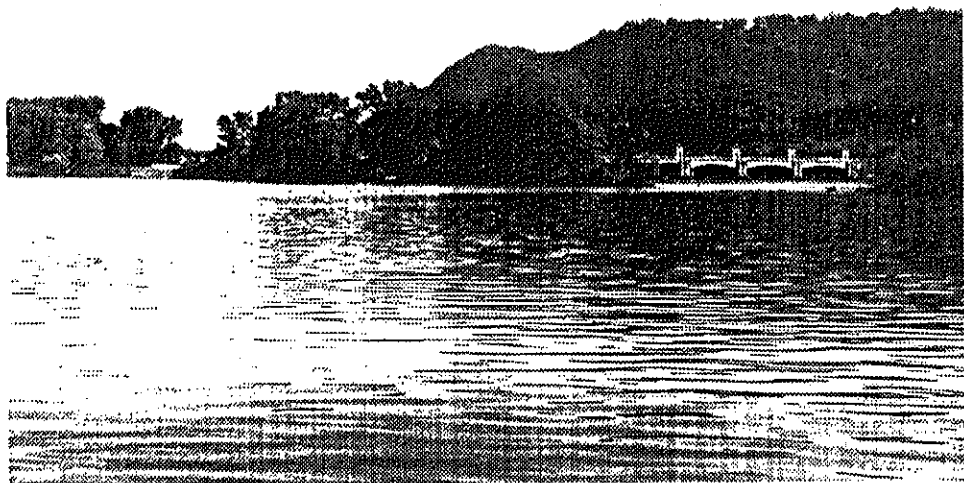
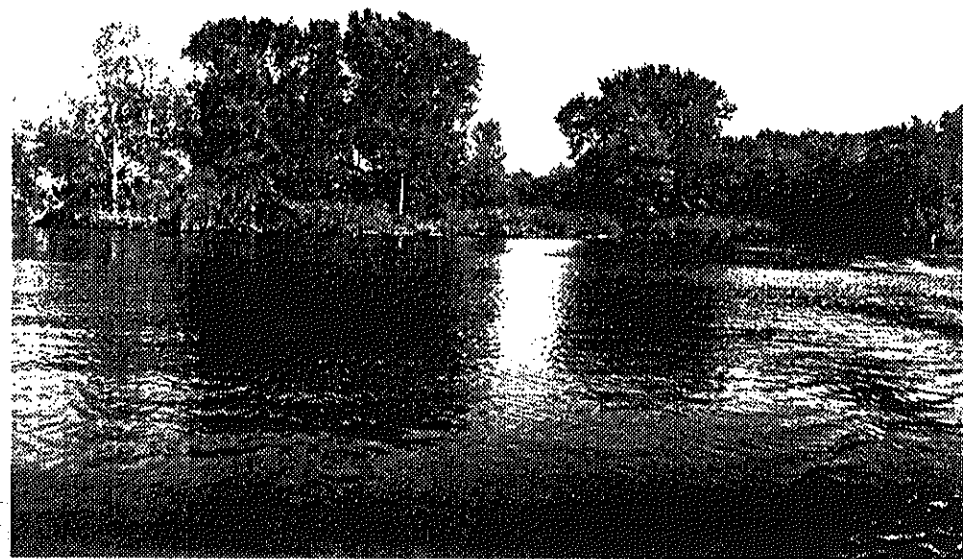
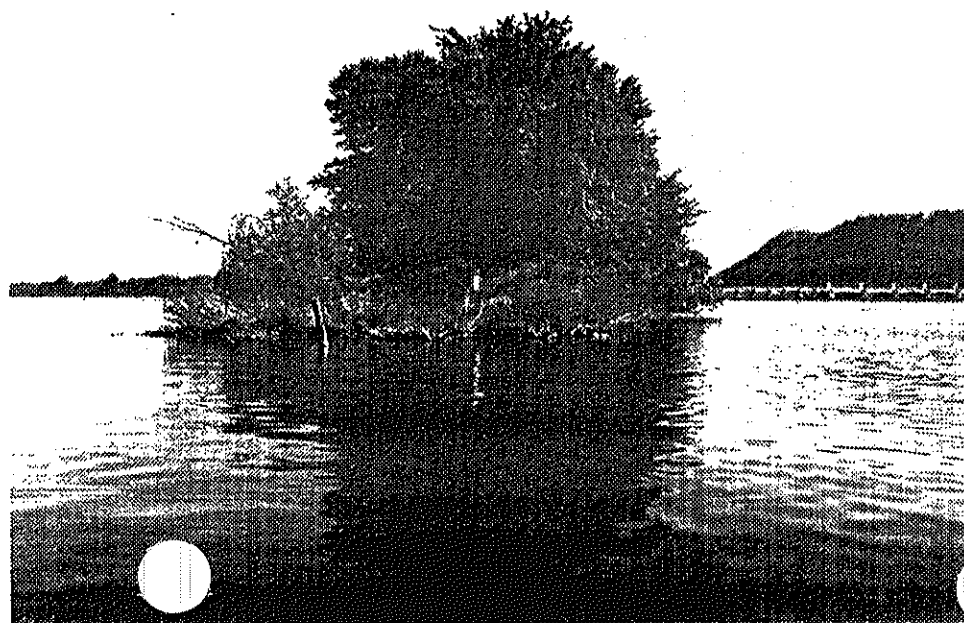
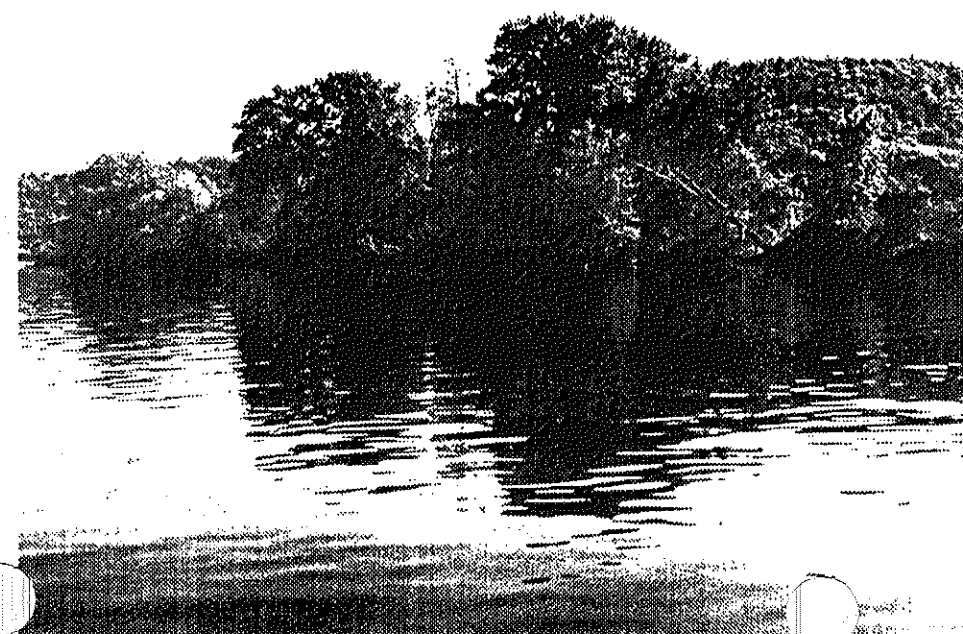
A-102

Observations		Site Number
Bank material: clay <u> </u> silt <u> </u> topsoil <u>1</u> (f) (m) (c) gravel <u> </u> cobbles <u> </u> other info: <u> </u>		699.3 8-688.5-L (f)(c) sand <u>✓</u>
Existing bank protection? <u>no</u>		
Apparent causes of erosion: river flows <u>1</u> wind waves <u> </u> boat waves <u>2</u> (number in order of cause) prop wash <u> </u> ice action <u> </u>		
Estimated rate of erosion or erodibility (low, moderate, high) (future rate)		
Source of local sediment transport (upstream, none)		
Bottom material <u>sand</u>		
Existing vegetation: nearshore - <u>none to some grass & fallen trees</u>		
(density, type) shoreline - <u>" " " "</u>		
bank - <u>some grass</u>		
top of bank - <u>canary grass @ 1</u>		
<u>" " & willow @ 2</u>		
Trees (fallen, species, size range, average size, location, number) <u>Willow maple</u>		
Habitat type and species impacted by continued erosion		
Quality of affected habitat (low, medium, high)

Area protected by island (shadow zone)		
Other impacts of erosion (future conditions)		
Type(s) of stabilization proposed		
Other type(s) of stabilization possible		
Fill required?	Source?	
Bank shaping required?		
Construction access considerations or problems?		
Cultural resources?		
Other information

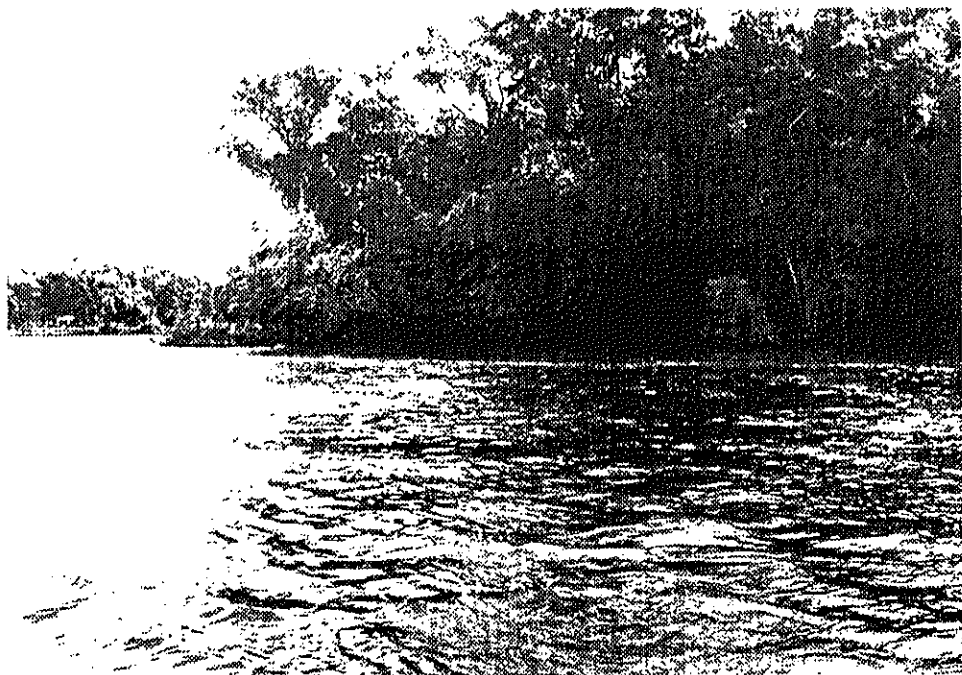
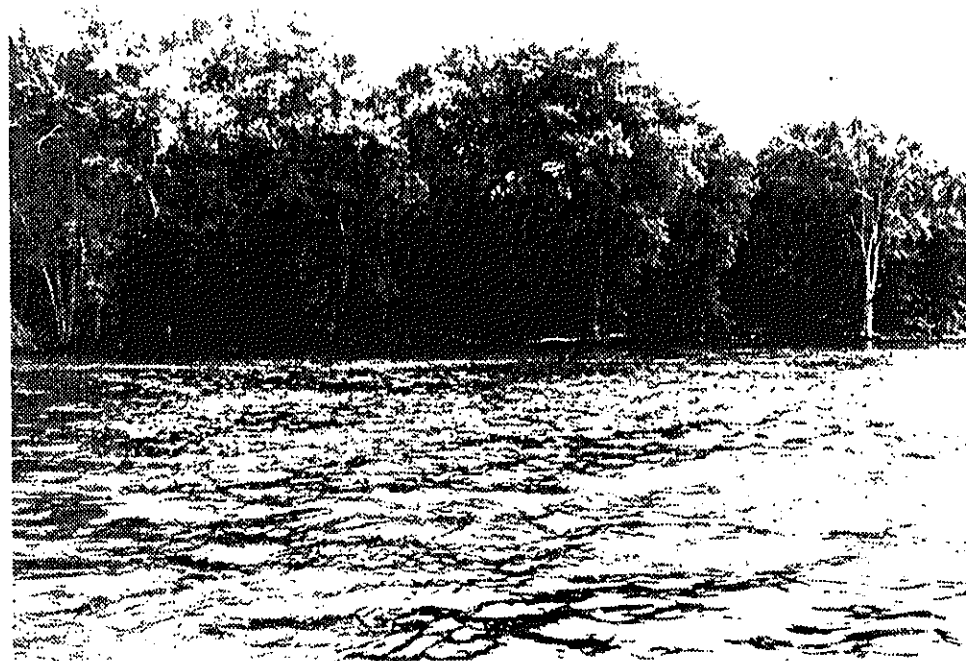
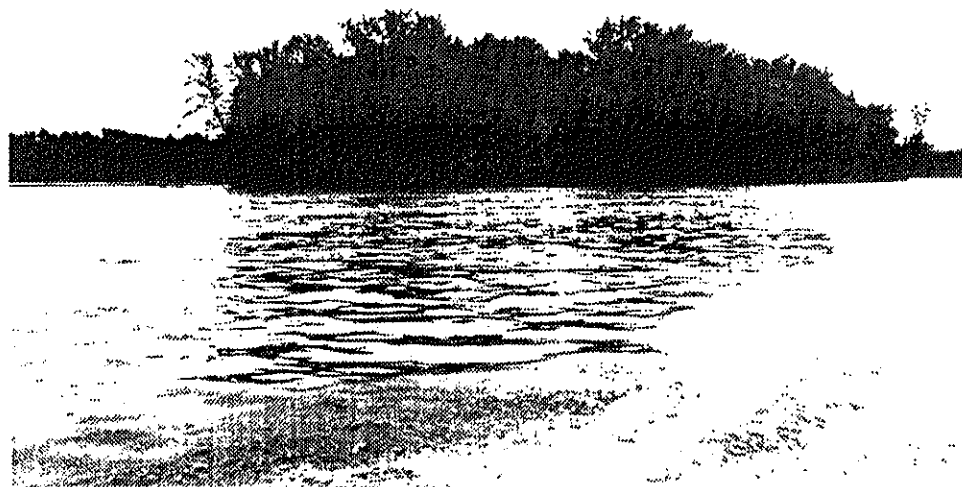
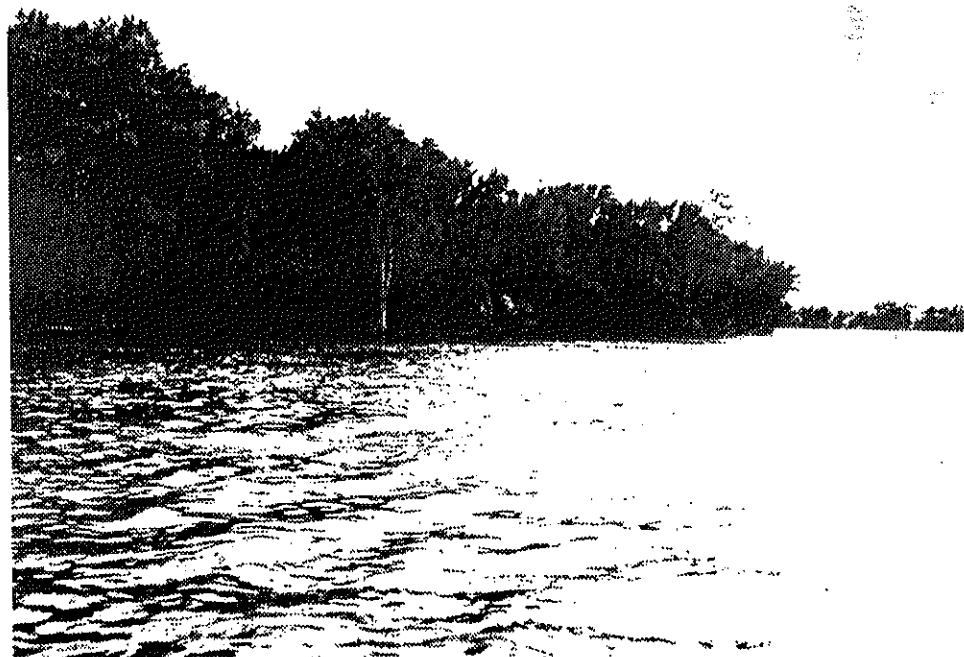
Head of Battle Island

Observations		Site Number
Bank material: clay ____ silt <input checked="" type="checkbox"/> topsoil ____ (f) (c) sand ____	(f) (m) (c) gravel ____ cobbles ____ other info: ____	9-666.1-R
Existing bank protection? <u>some riprap at head</u>		
Apparent causes of erosion: river flows <u>1</u> wind waves <u>2</u> boat waves <u>2</u>		ice action ____
(number in order of cause) prop wash ____		
Estimated rate of erosion or erodibility (<u>low</u> , moderate, high) (future rate)		
Source of local sediment transport (<u>upstream</u> , none)		
Bottom material		
Existing vegetation: nearshore - <u>none</u>		
(density, type) shoreline - <u>none - grass - trees</u>		
bank - <u>" " "</u>		
top of bank - <u>FF</u>		
Trees (fallen, species, size range, average size, location, number)		
Habitat type and species impacted by continued erosion		
Quality of affected habitat (low, medium, high)		
Area protected by island (shadow zone)

Other impacts of erosion (future conditions)		
Type(s) of stabilization proposed <u>4 100' d.s. on slough side revetment at head of island & ~3-400' d.s. on river side</u> <u>& possibly partial closure or rock sill ~170' across inlet which is ~13-15' deep</u>		
Other type(s) of stabilization possible		
Fill required?	Source?	
Bank shaping required?		
Construction access considerations or problems?		
Cultural resources?		
Other information

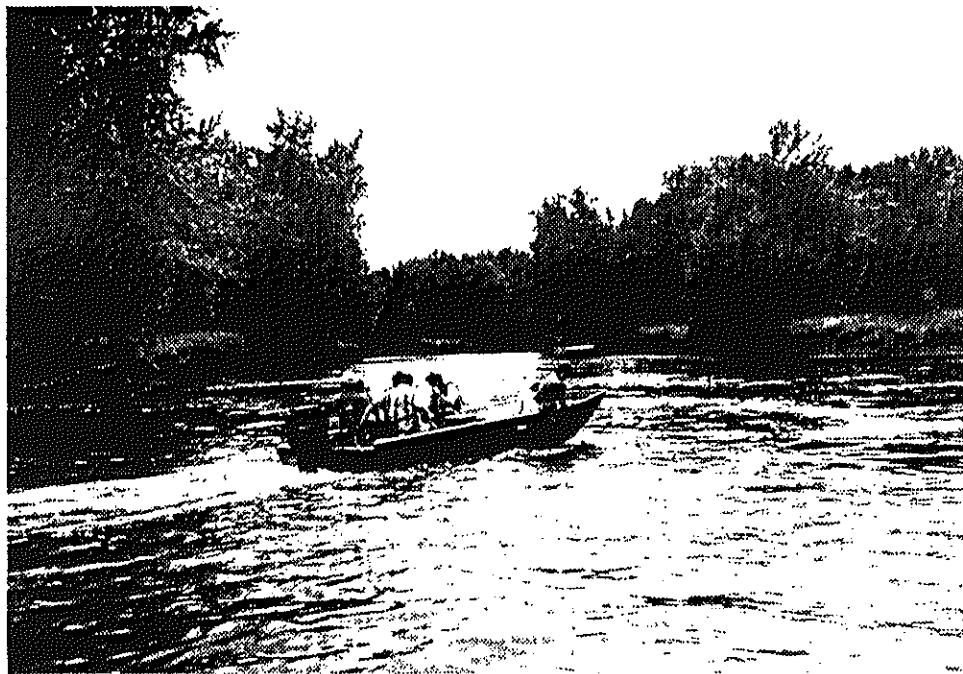
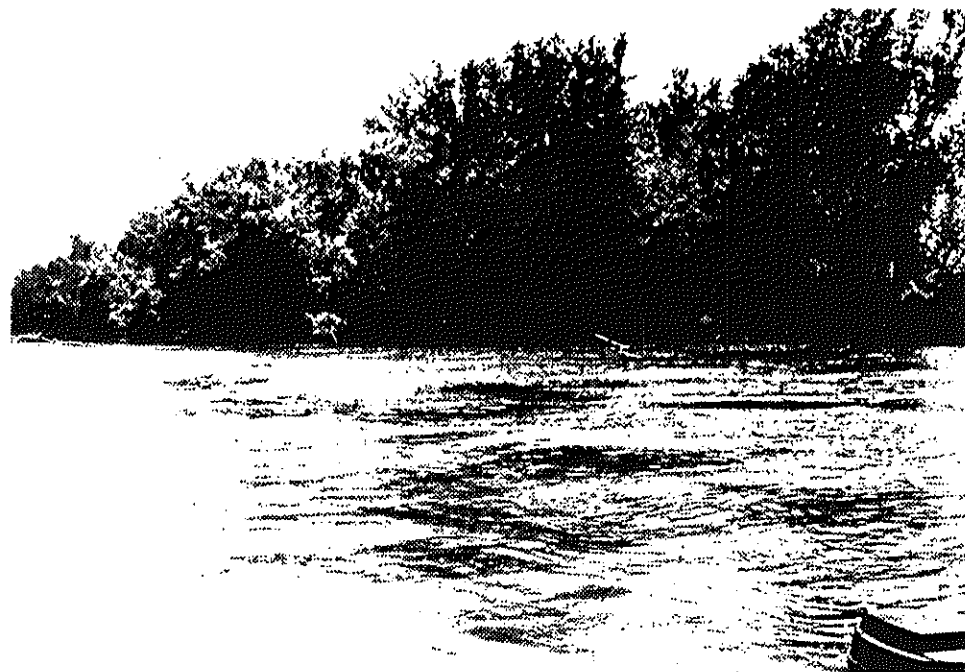
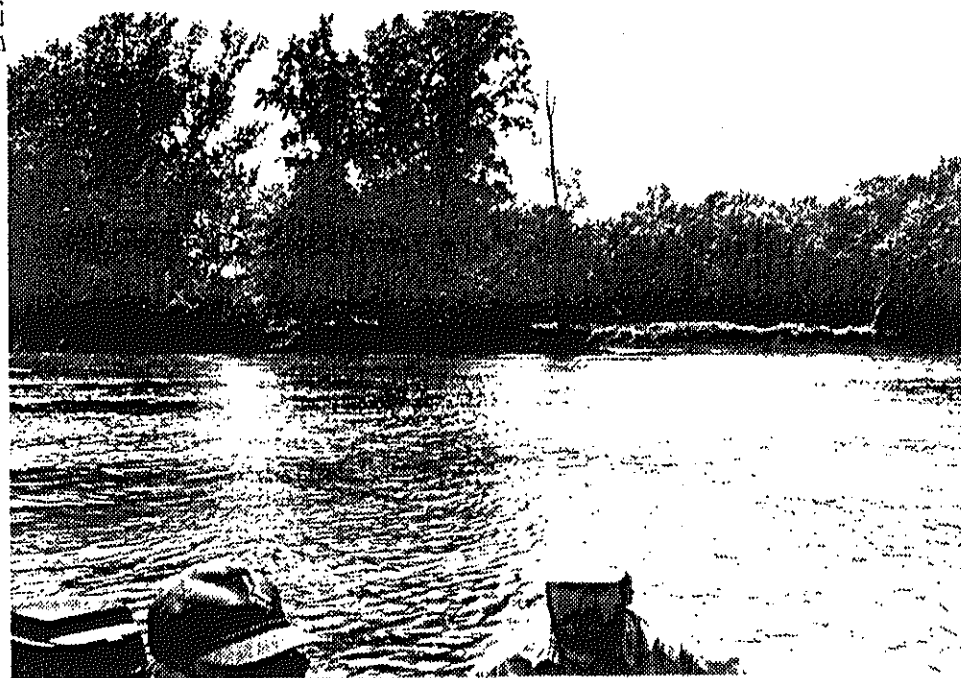
Head of Hummingbird Slough

Observations		Site Number
Bank material: clay ____	silt ____	9-664.9-R
(f) (m) (c) gravel ____	cobbles ____	(f) (c) sand ____
other info: _____		
Existing bank protection? _____		
Apparent causes of erosion:	river flows ____	wind waves ____
(number in order of cause)	prop wash ____	boat waves ____
		ice action ____
Estimated rate of erosion or erodibility (low, moderate, high) (future rate) _____		
Source of local sediment transport (upstream, none) _____		
Bottom material _____		
Existing vegetation: nearshore - _____		
(density, type)	shoreline - _____	
	bank - _____	
	top of bank - _____	
Trees (fallen, species, size range, average size, location, number) _____		
Habitat type and species impacted by continued erosion _____		
Quality of affected habitat (low, medium, high) _____		
Area protected by island (shadow zone) _____		
Other impacts of erosion (future conditions) _____		
Type(s) of stabilization proposed _____

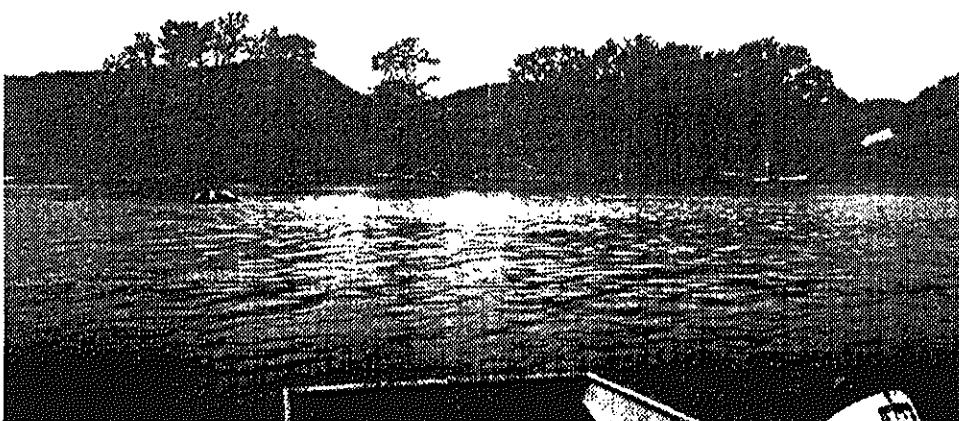
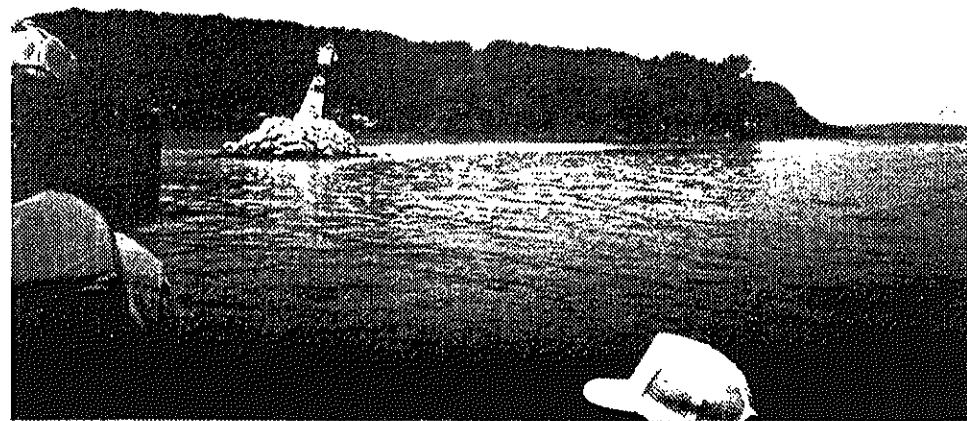
(f) (m) (c) gravel <input type="checkbox"/>	cobbles <input type="checkbox"/>	other info:	
Existing bank protection? <u>yes, submerged</u>			
Apparent causes of erosion:	river flows <u>3</u>	wind waves <u>2</u>	boat waves <u>1</u>
(number in order of cause)	prop wash <u> </u>	<u> </u>	ice action <u>4</u>
Estimated rate of erosion or erodibility (<u>low</u> , moderate, high) (future rate)			
Source of local sediment transport (<u>upstream</u> , none)			
Bottom material <u>sand</u>			
Existing vegetation: nearshore - <u>none</u>			
(density, type) shoreline - <u> </u>			
bank - <u>tree, grass, reeds</u>			
top of bank - <u> </u>			
Trees (fallen, species, size range, average size, location, number)			
Habitat type and species impacted by continued erosion <u>loss of backwater vegetation & associated habitat</u>			
Quality of affected habitat (low, medium, high)			
Area protected by island (shadow zone) <u>large backwater areas</u>

Other impacts of erosion (future conditions)			
Type(s) of stabilization proposed <u>revetment/breakwater on top of old riprap bank protection</u>			
Other type(s) of stabilization possible			
Fill required?	Source?		
Bank shaping required?			
Construction access considerations or problems?			
Cultural resources?			
Other information

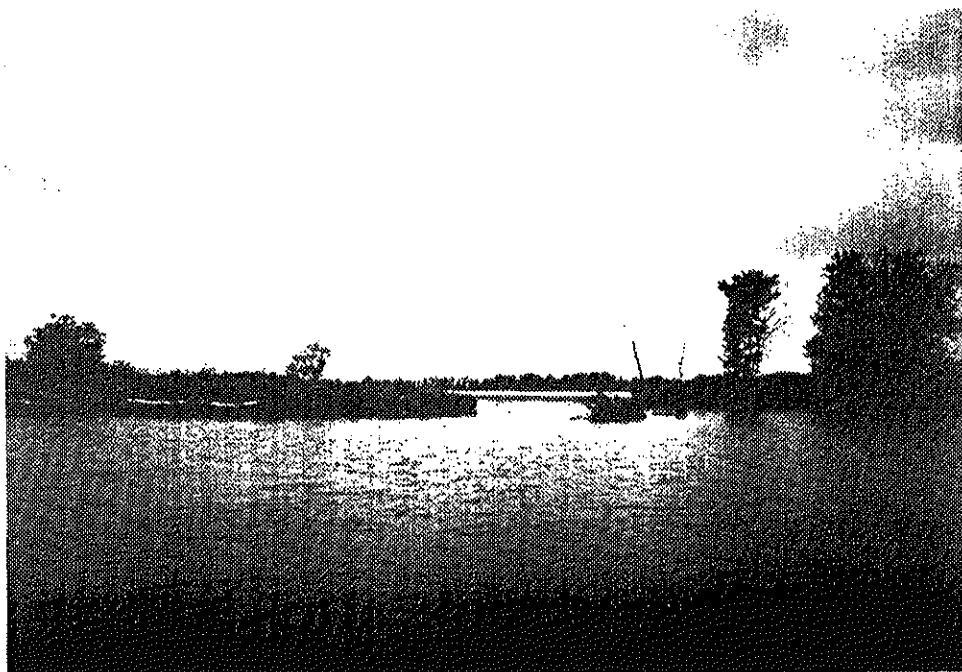
Site Name Dam 9 Island				Site number (pool-river mile-l/r bank) 9-648. - R	
Date investigated 6-23-92		Time		Year(s) of aerial photos (A) or maps (M) available (A) 9/10/89 (49-9) (M)	
Upstream L&D No. = 8		Tailwater Elev. =		Flow =	
Downstream L&D No. = 9		Headwater Elev. =		Flow =	
Other water surface elev. data in pool					
Estimated water surface elev. at site				Flow velocity (location, depth, fps)	
Location type (check all applicable)					
main channel <input checked="" type="checkbox"/>		backwater lake <input type="checkbox"/>		inside of channel bend <input type="checkbox"/>	
side channel inlet <input type="checkbox"/>		head of island or peninsula <input type="checkbox"/>		straight reach of channel <input checked="" type="checkbox"/>	
backwater channel <input type="checkbox"/>		outside of channel bend <input type="checkbox"/>			
Proposed length of stabilization				Wing or closing dams in area No

(f) (m) (c) gravel <input type="checkbox"/>	cobbles <input type="checkbox"/> other info:	
Existing bank protection?	yes, at n.w. corner only (~30')	
Apparent causes of erosion:	river flows <input type="checkbox"/> wind waves <input type="checkbox"/> boat waves <input type="checkbox"/>	
(number in order of cause)	prop wash <input type="checkbox"/>	ice action <input type="checkbox"/> 2
Estimated rate of erosion or erodibility (low, moderate, high) (future rate)		
Source of local sediment transport (upstream, none)		
Bottom material		
Existing vegetation:	nearshore - none	
(density, type)	shoreline - none	
	bank - grasses, vines	
	top of bank - trees, brush, vines	
Trees (fallen, species, size range, average size, location, number)		
Habitat type and species impacted by continued erosion sandy beds behind island eagle roosting birds nesting?		
Quality of affected habitat (low, medium, high)		
Area protected by island (shadow zone)

Other impacts of erosion (future conditions)		
Type(s) of stabilization proposed offshore rock breakwater		
Other type(s) of stabilization possible		
Fill required?	Source?	
Bank shaping required?		
Construction access considerations or problems? probable access problems due to shallow water		
Cultural resources?		
Other information
